**SH 7A (Lower)
Raymond to Lyons
Site Repairs between Mileposts 19 and 33**

**Boulder County
COLORADO**

Damage Assessment Report

**100% DRAFT
Revised: July 28, 2014**

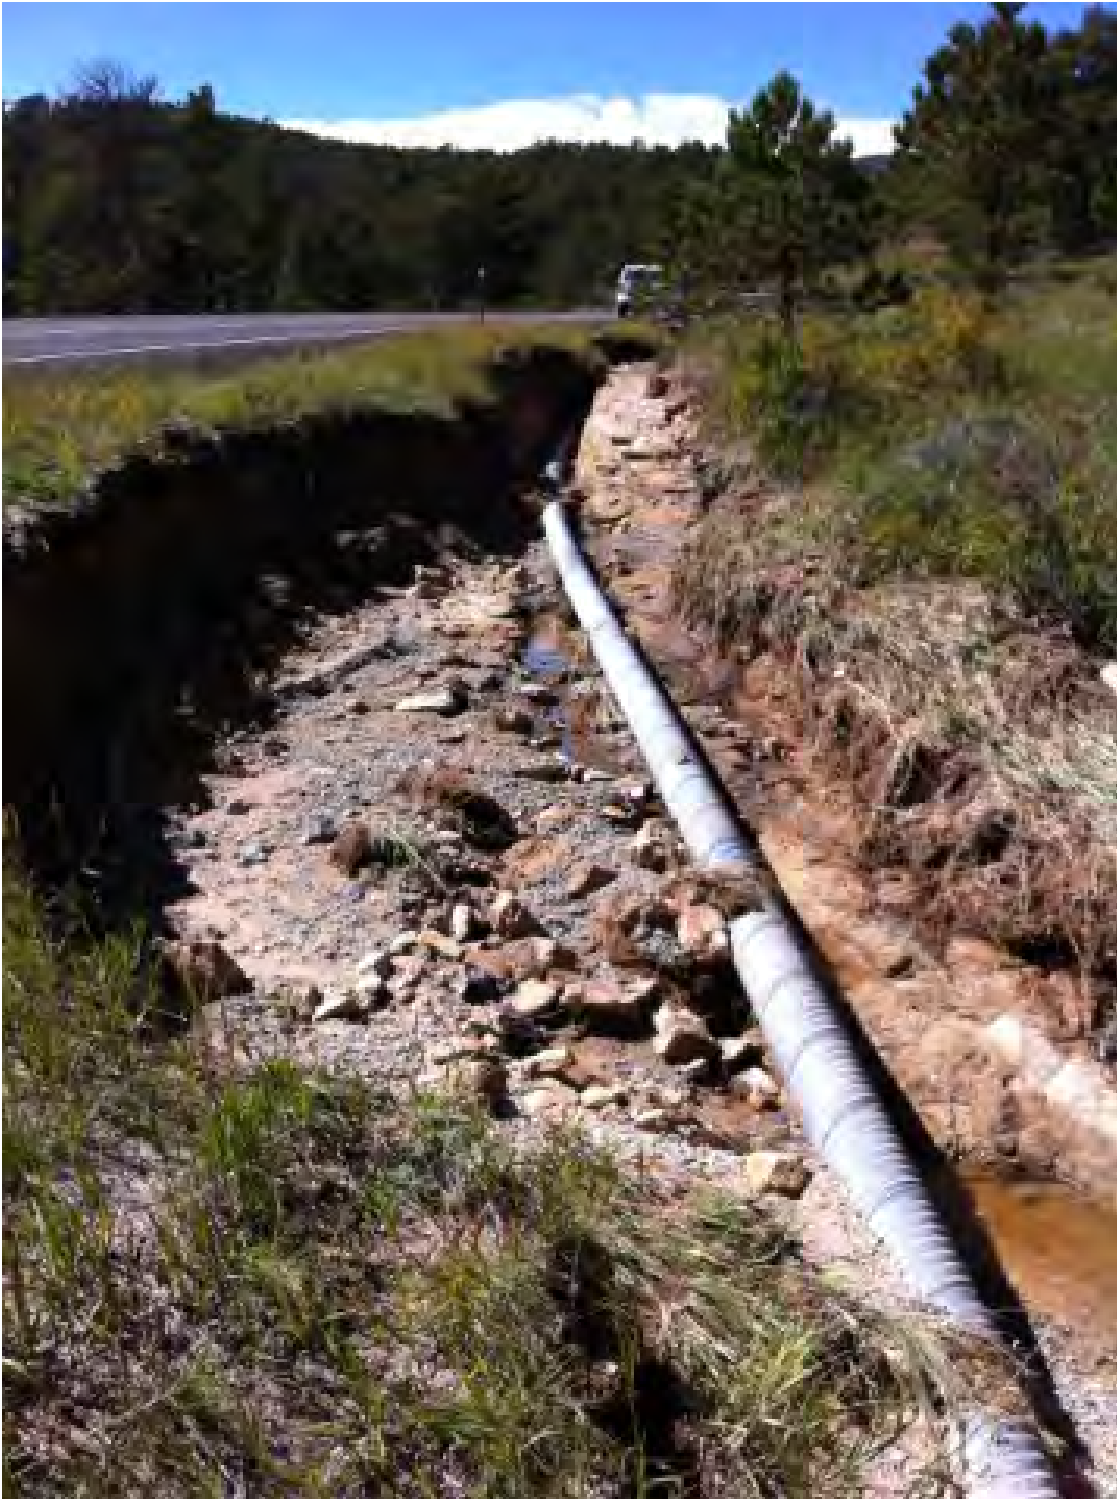
| Milepost | | Description of Damage |
|---|---|---|
| 19.06 | 19.35 | The roadside ditches on both sides of highway experienced erosion scour damage, washing out approximately 5-6 ft wide and 2-4 ft deep the full length of this section. Underground utilities were exposed in areas as a result. |

Figure 9 - MP 19.15, Eastbound ditch damage.

| Milepost | | ER Work |
|---|---|--|
| 19.06 | 19.35 | The damaged ditches were filled with locally available materials and regraded. |

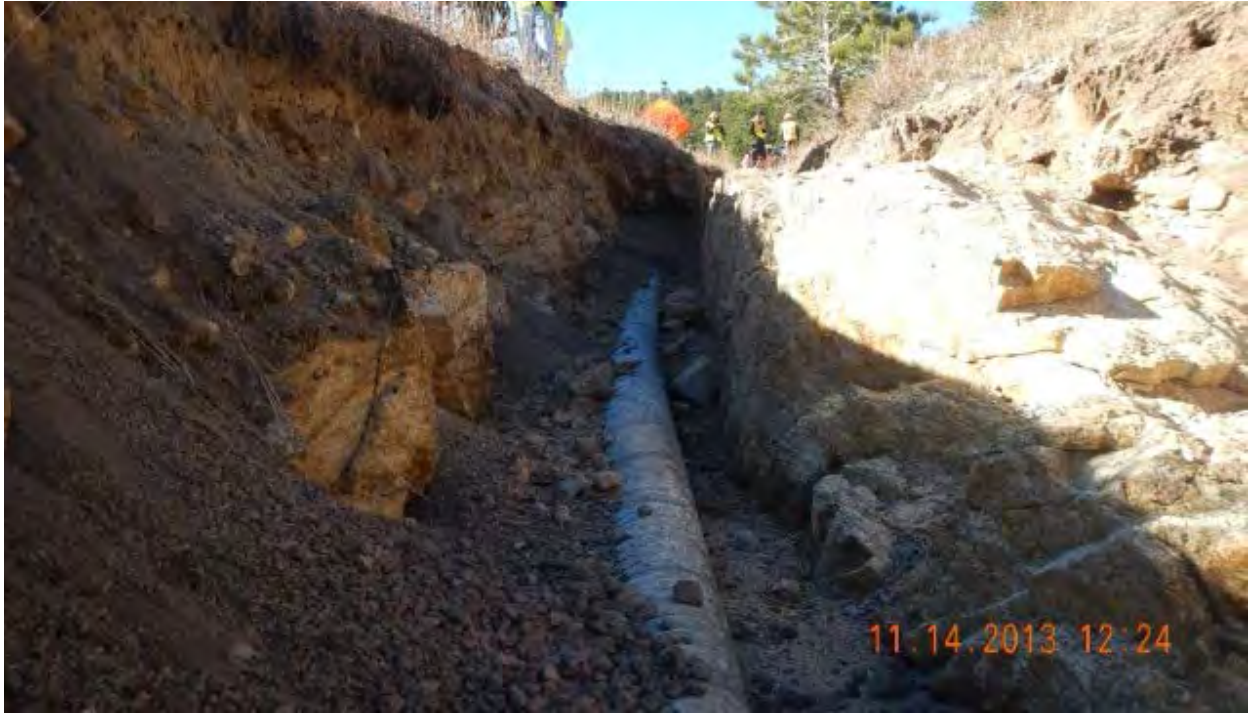
Figure 10 - MP 19.34, Westbound ditch damage.

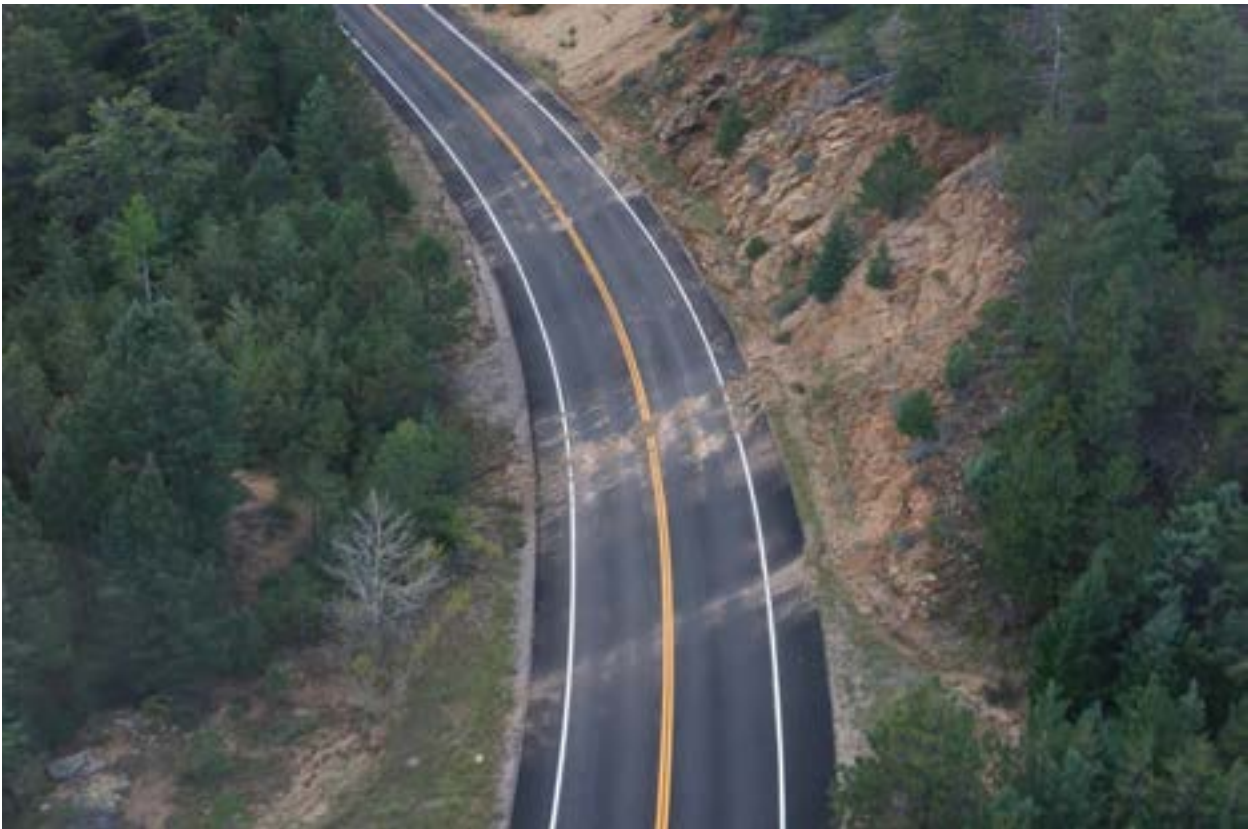
| Milepost | | Description of Damage |
|---|---|---|
| 20.58 | 20.66 | The eastbound roadside ditch experienced minor erosion scour damage, washing out approximately 0.5-1 ft deep and 1-2 ft wide in areas along this section. |

Figure 11 - MP 20.66, Westbound ditch damage and material slide.

| Milepost | | ER Work |
|---|---|--|
| 20.59 | 20.66 | The material deposited in the ditch and on the road was removed, the ditch was regraded and the eastbound embankment was repaired. |

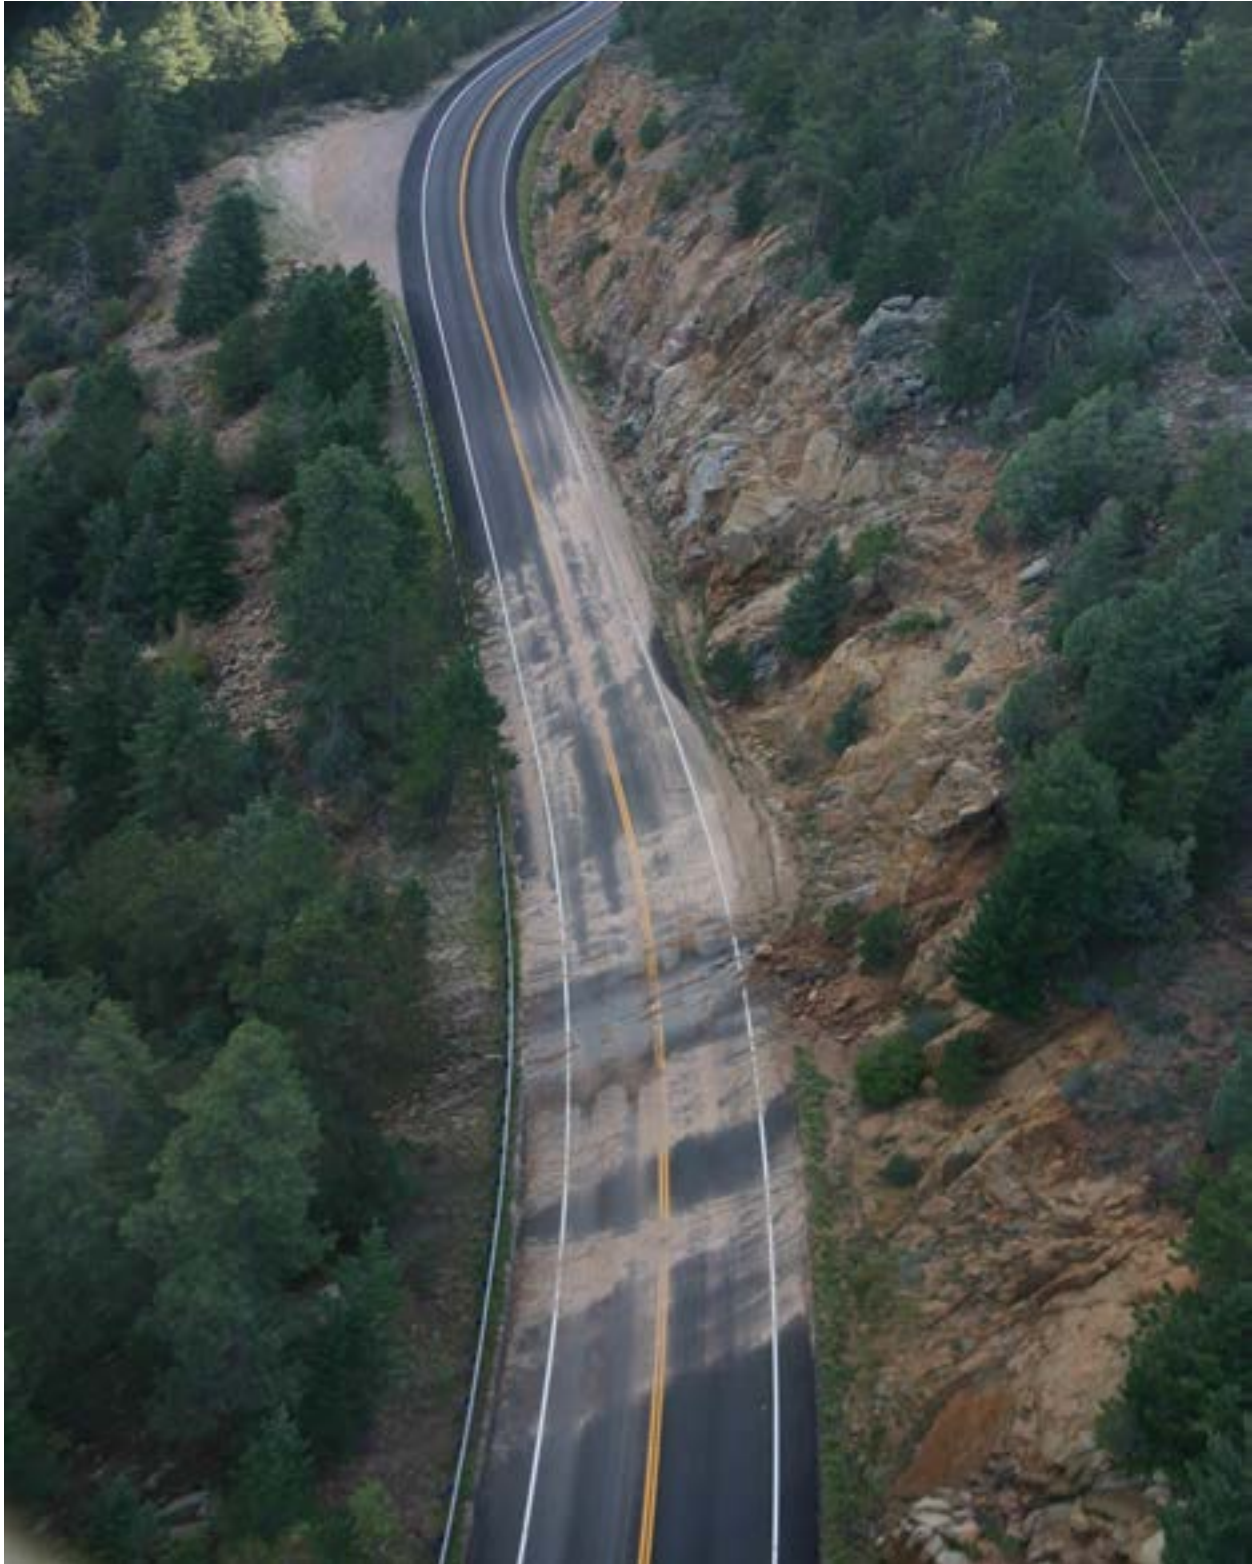
Figure 12 - MP 20.86, Material slide onto road.

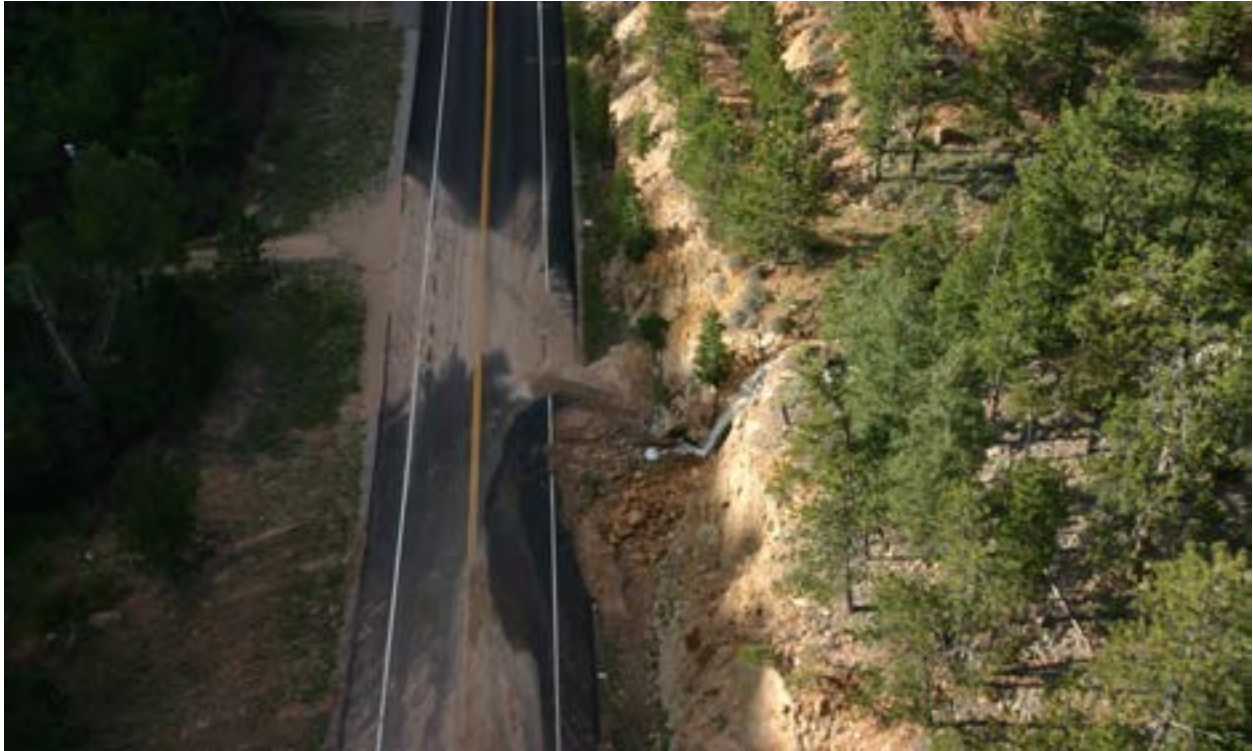
Figure 13 - MP 21.68, Material slide onto road.

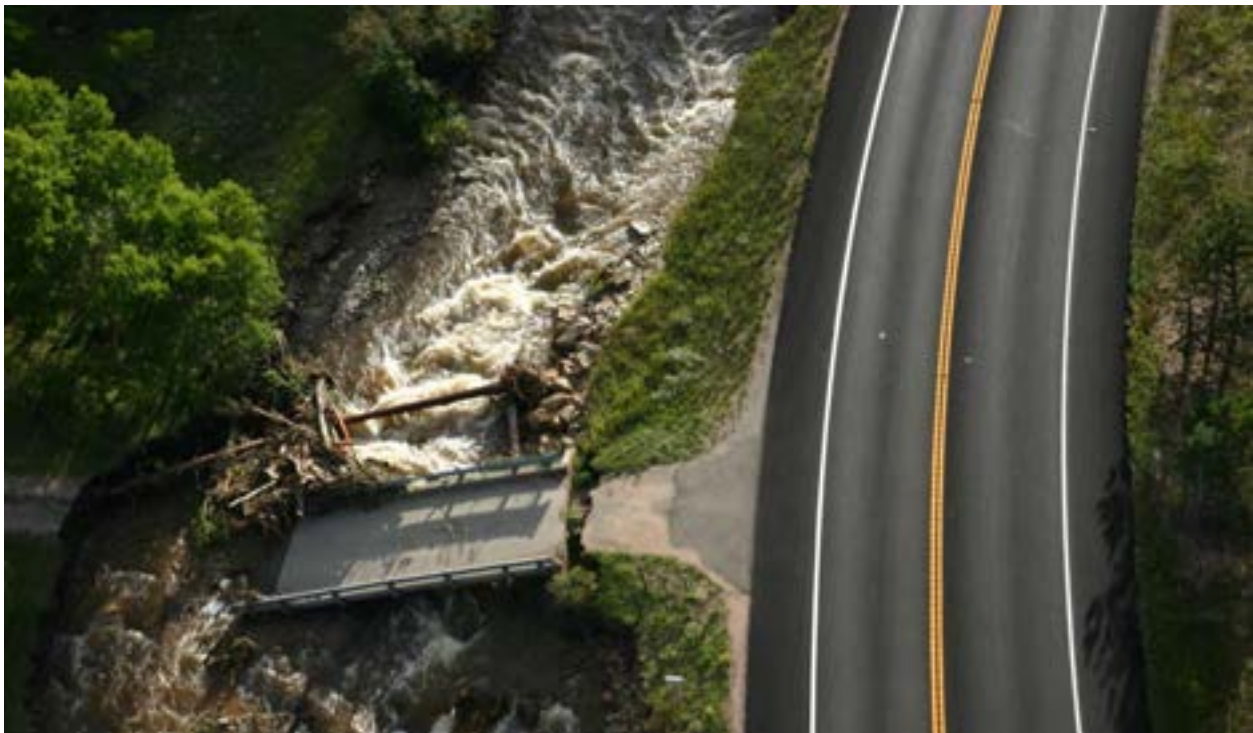
| Milepost | | Description of Damage |
|---|---|---|
| 21.92 | 21.93 | High flows in Middle Saint Vrain Creek caused severe scour damage to a local access bridge over the creek resulting in wash out of the bridge and scour damage to the eastbound roadway embankment slope upstream and downstream of bridge. |

Figure 14 - MP 21.68, Local access bridge washed out and embankment damaged upstream and downstream of structure.

| Milepost | | ER Work |
|---|---|--|
| 21.92 | 21.93 | The damaged roadway embankment slope was repaired. |

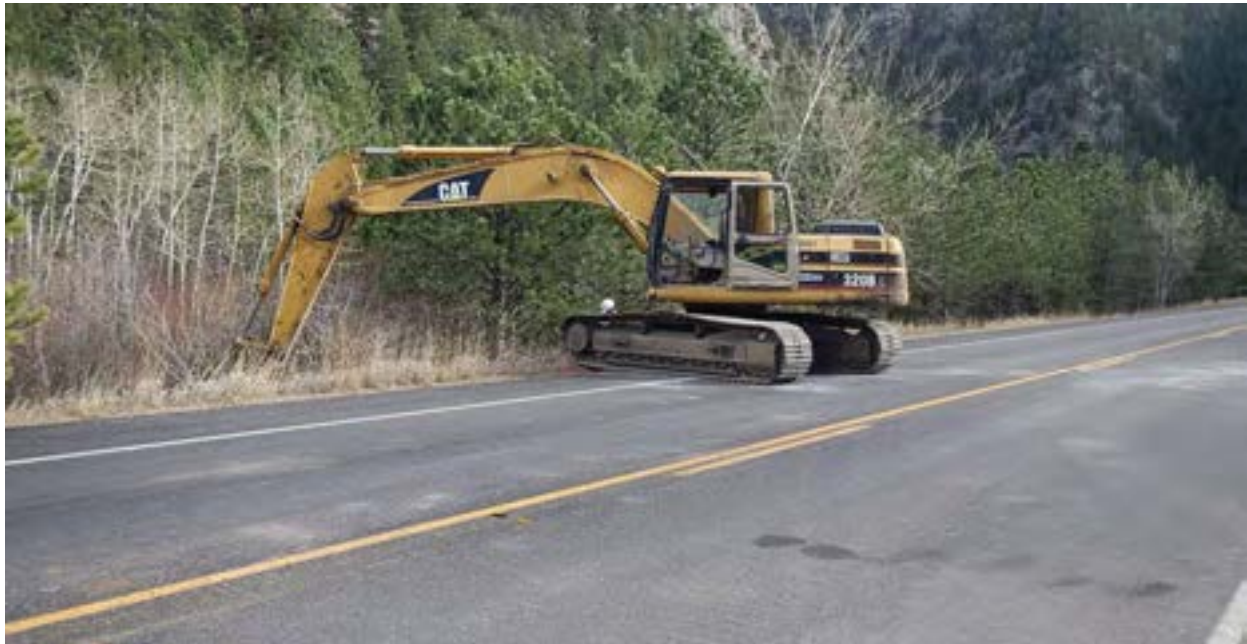
Figure 15 - MP 22, Emergency repair.

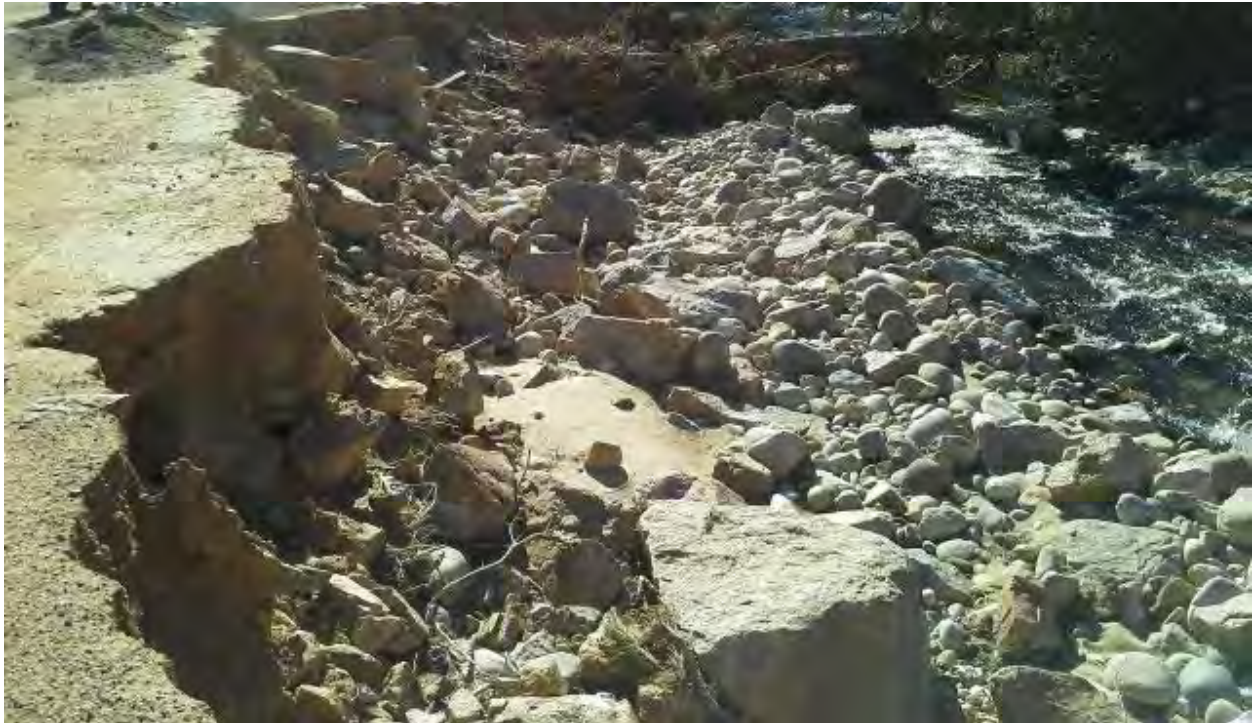
Figure 17 - MP 22.13, Eastbound roadway embankment scour damage.

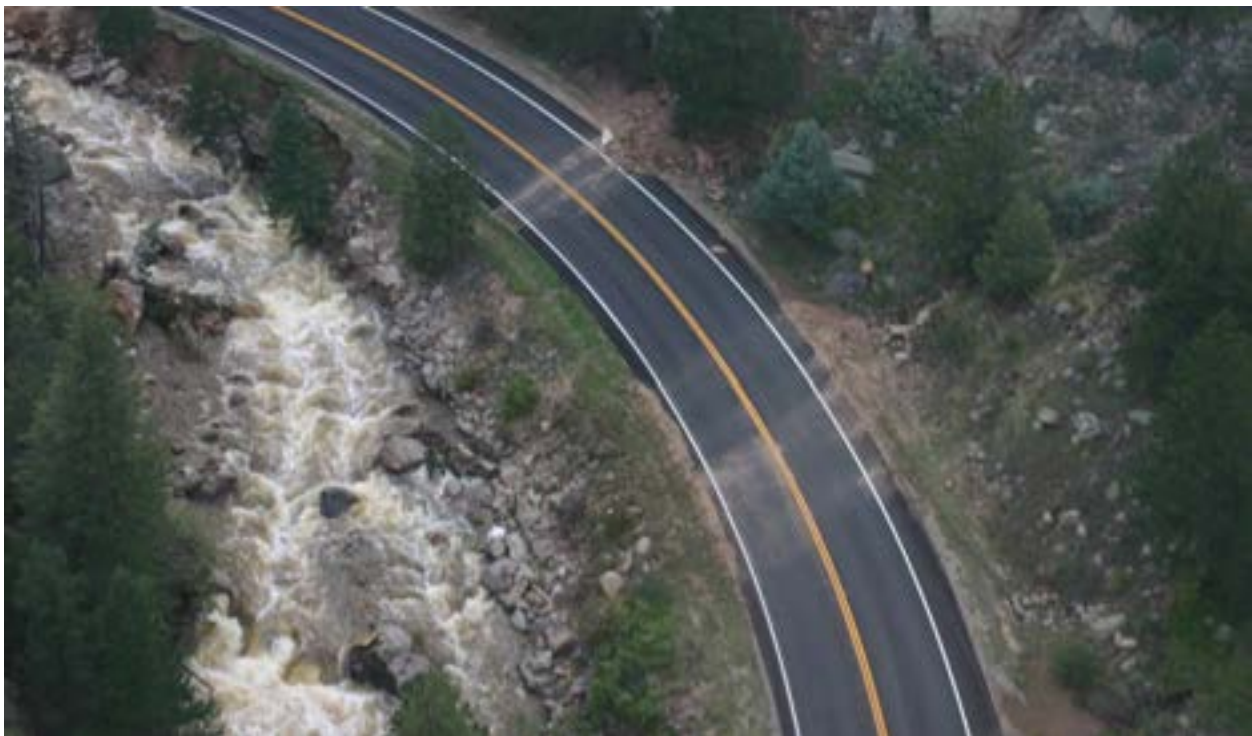
Figure 18 - MP 22.5, Riverside embankment loss and material slide onto the roadway.

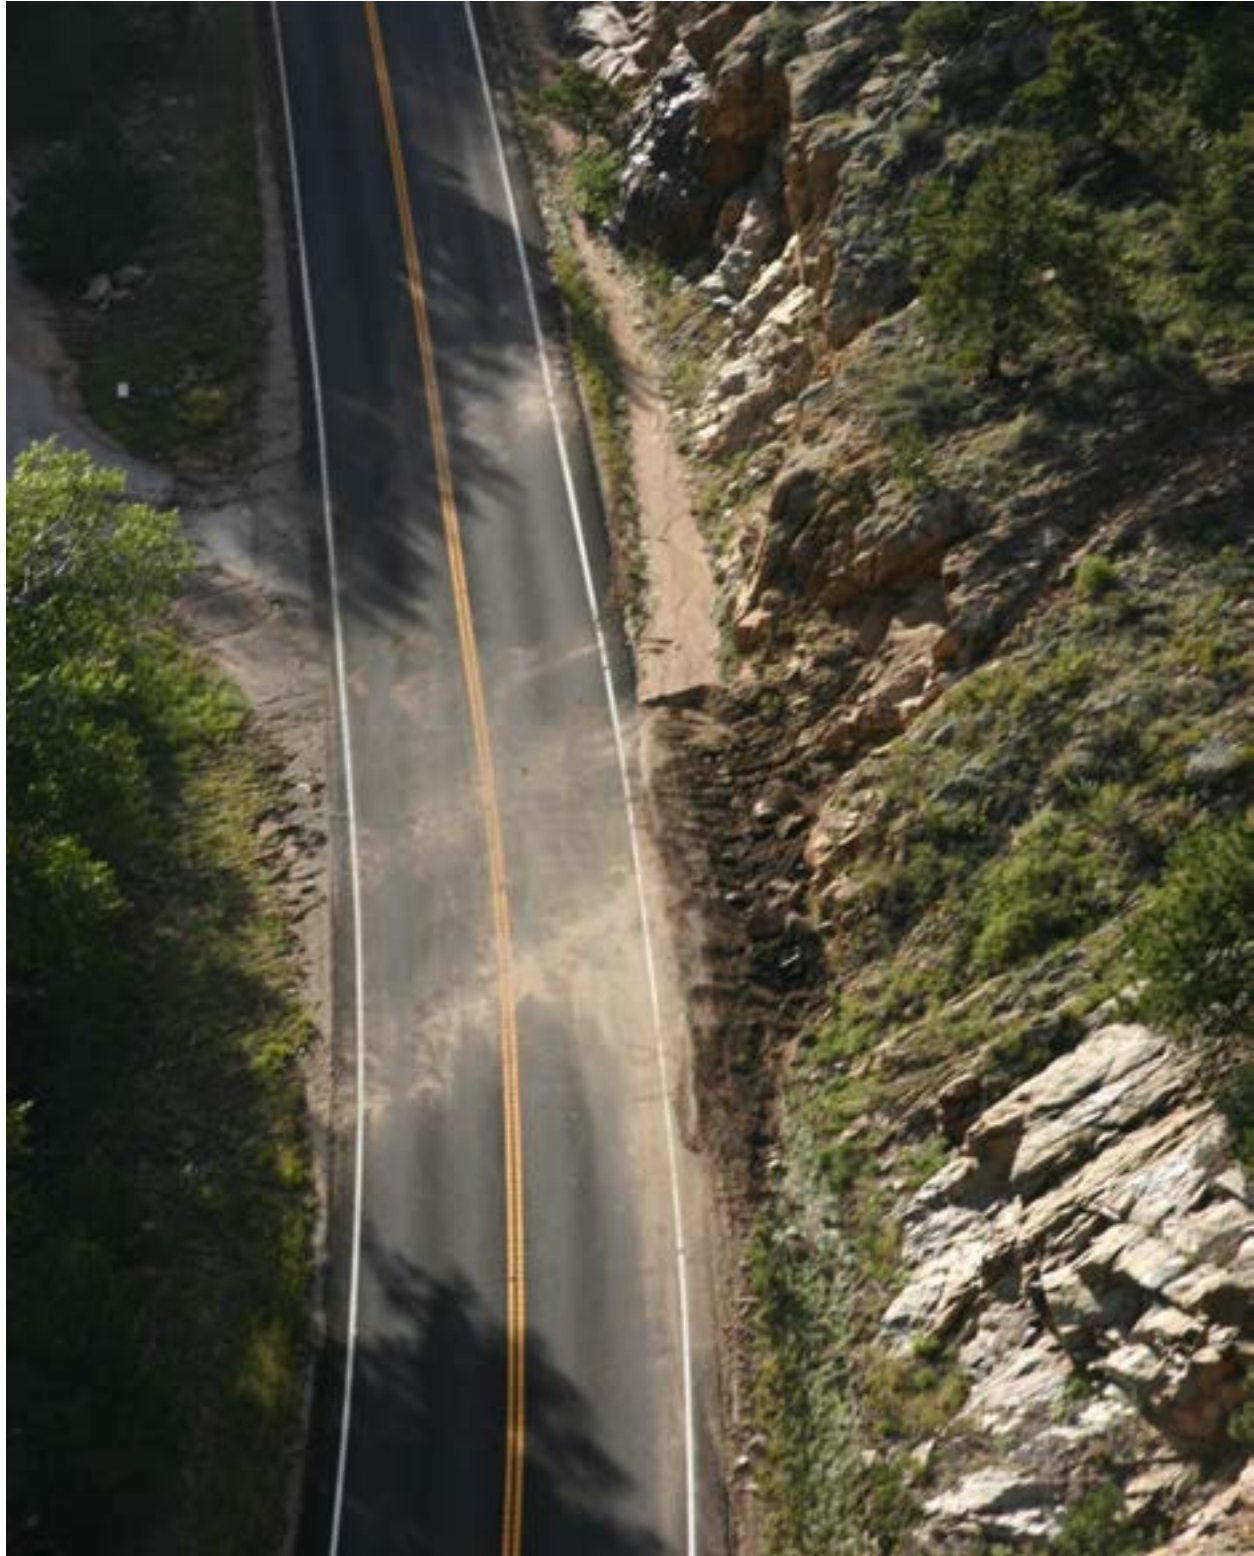
Figure 19 - MP 22.83, Material slide onto roadway.

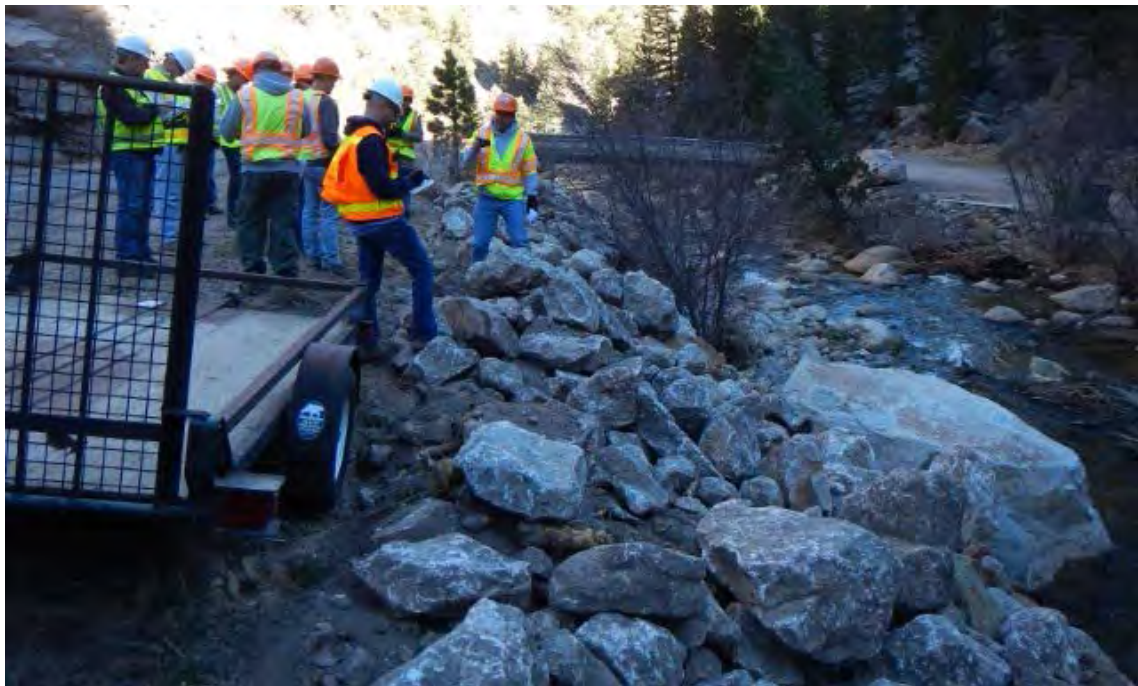
Figure 20 - MP 22.49, Eastbound roadway embankment repair.

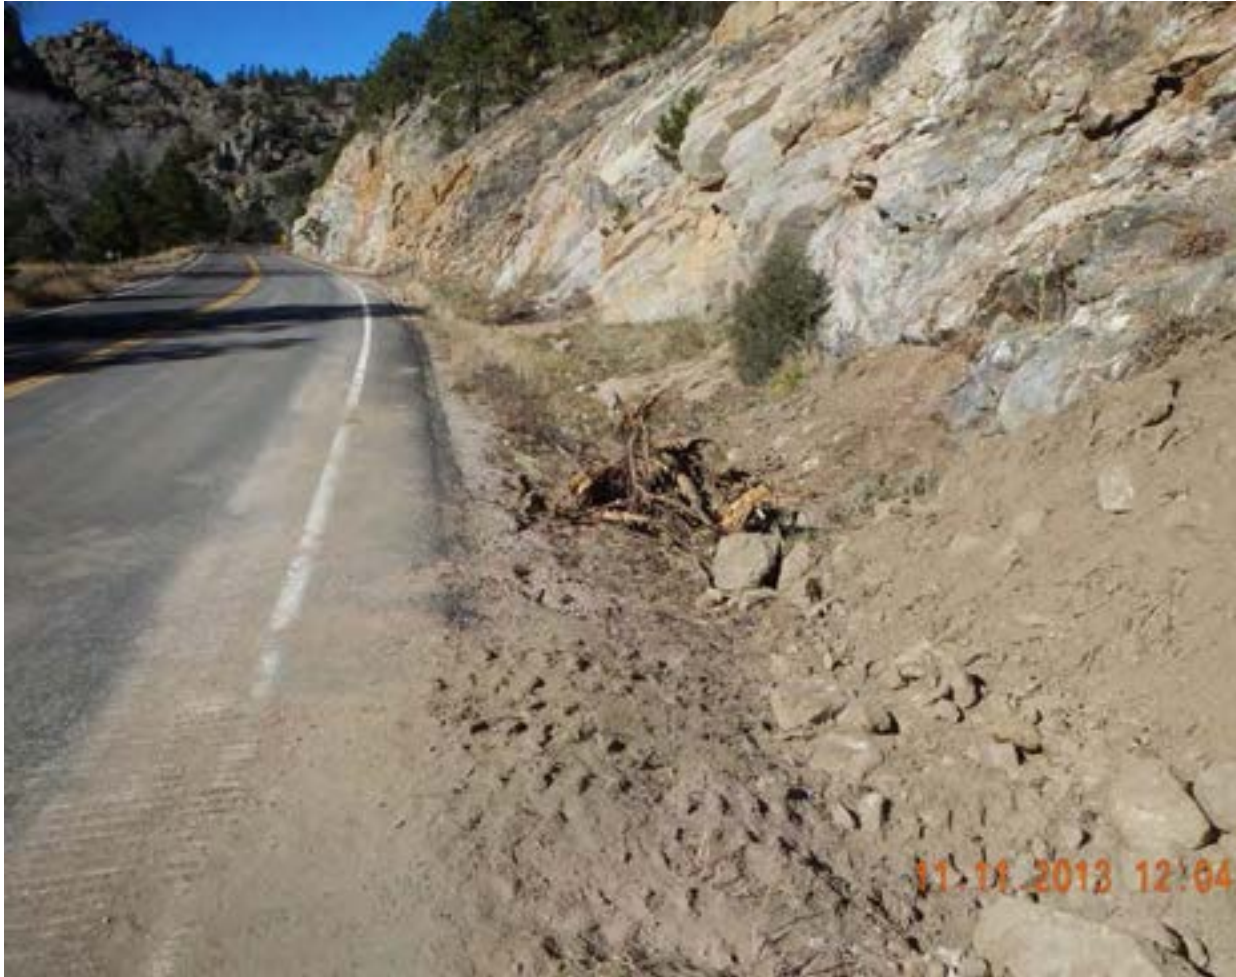
| Milepost | | Description of Damage |
|---|---|--|
| 22.95 | 22.97 | There was a material slide onto the westbound lane causing minor overtopping of the roadway with runoff and sediment. The outlet of the existing cross culvert was undermined. |

Figure 21 - MP 22.95, Removal of material from slide and regarding of westbound roadside ditch.

| Milepost | | ER Work |
|---|---|---|
| 22.95 | 22.97 | The slide material was removed, the westbound roadside ditch was regraded as needed and sediment was removed from the roadway. The damaged culvert outlet was repaired. |

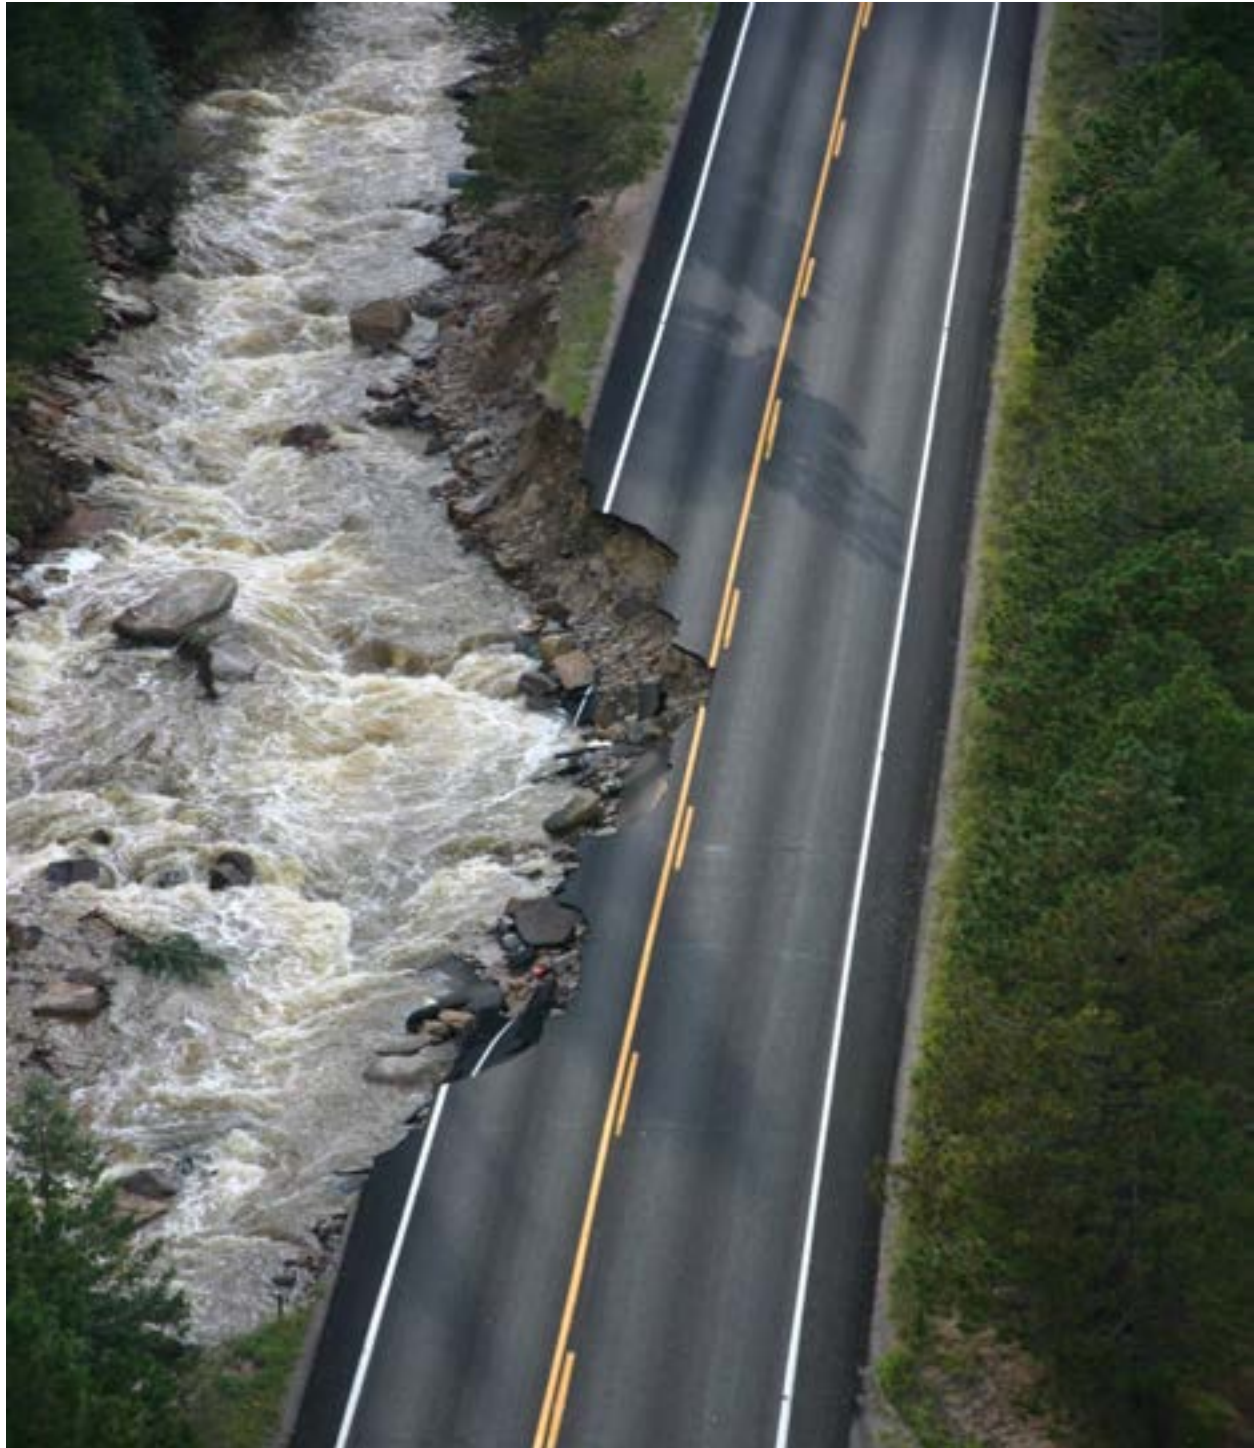
Figure 24 - MP 23.54, Roadway embankment damage, partial wash out of EB lane.

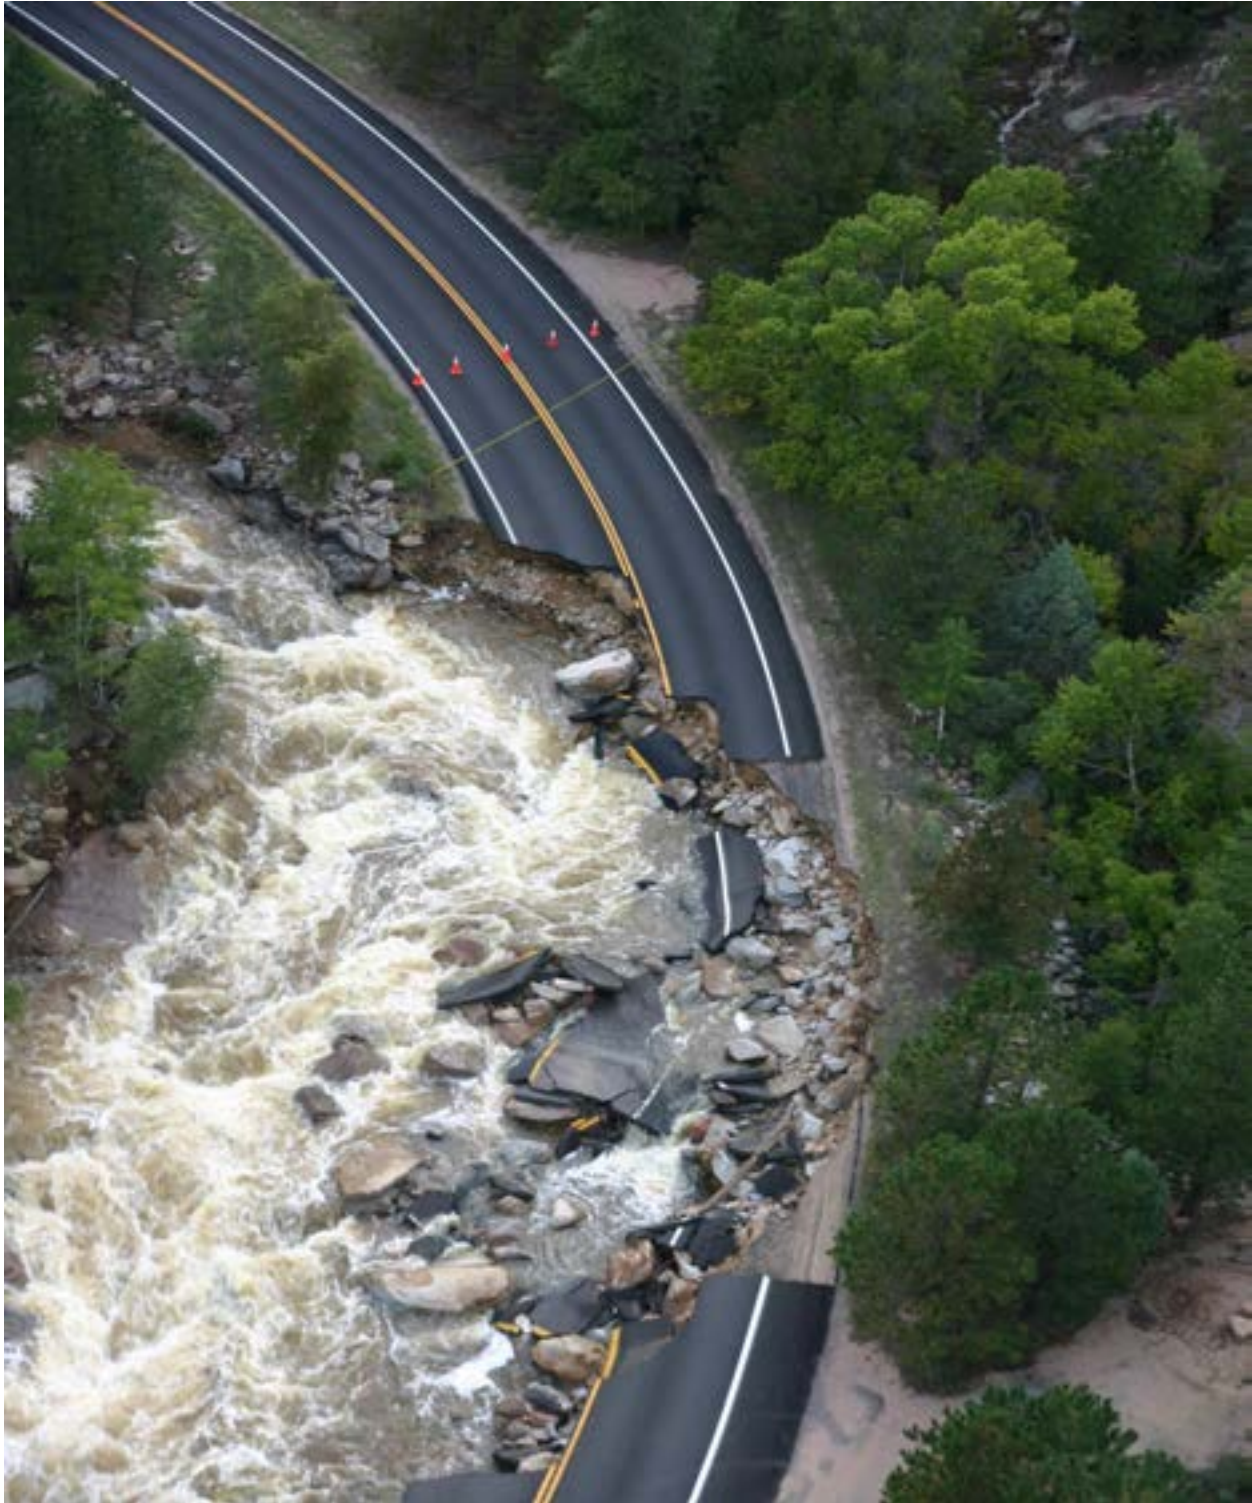
Figure 25 - MP 23.8, Complete 2 lane roadway wash out.

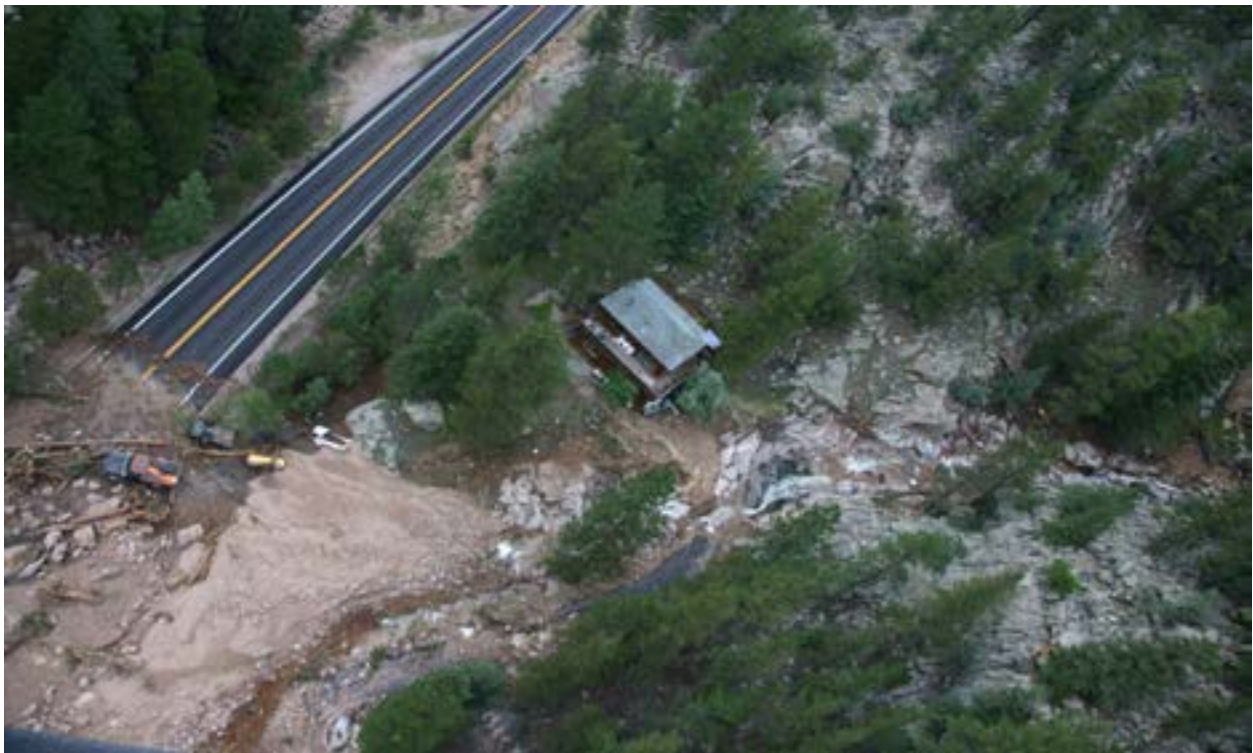
Figure 27 - MP 24.6, Rock slide, debris and sediment covering both roadway lanes.

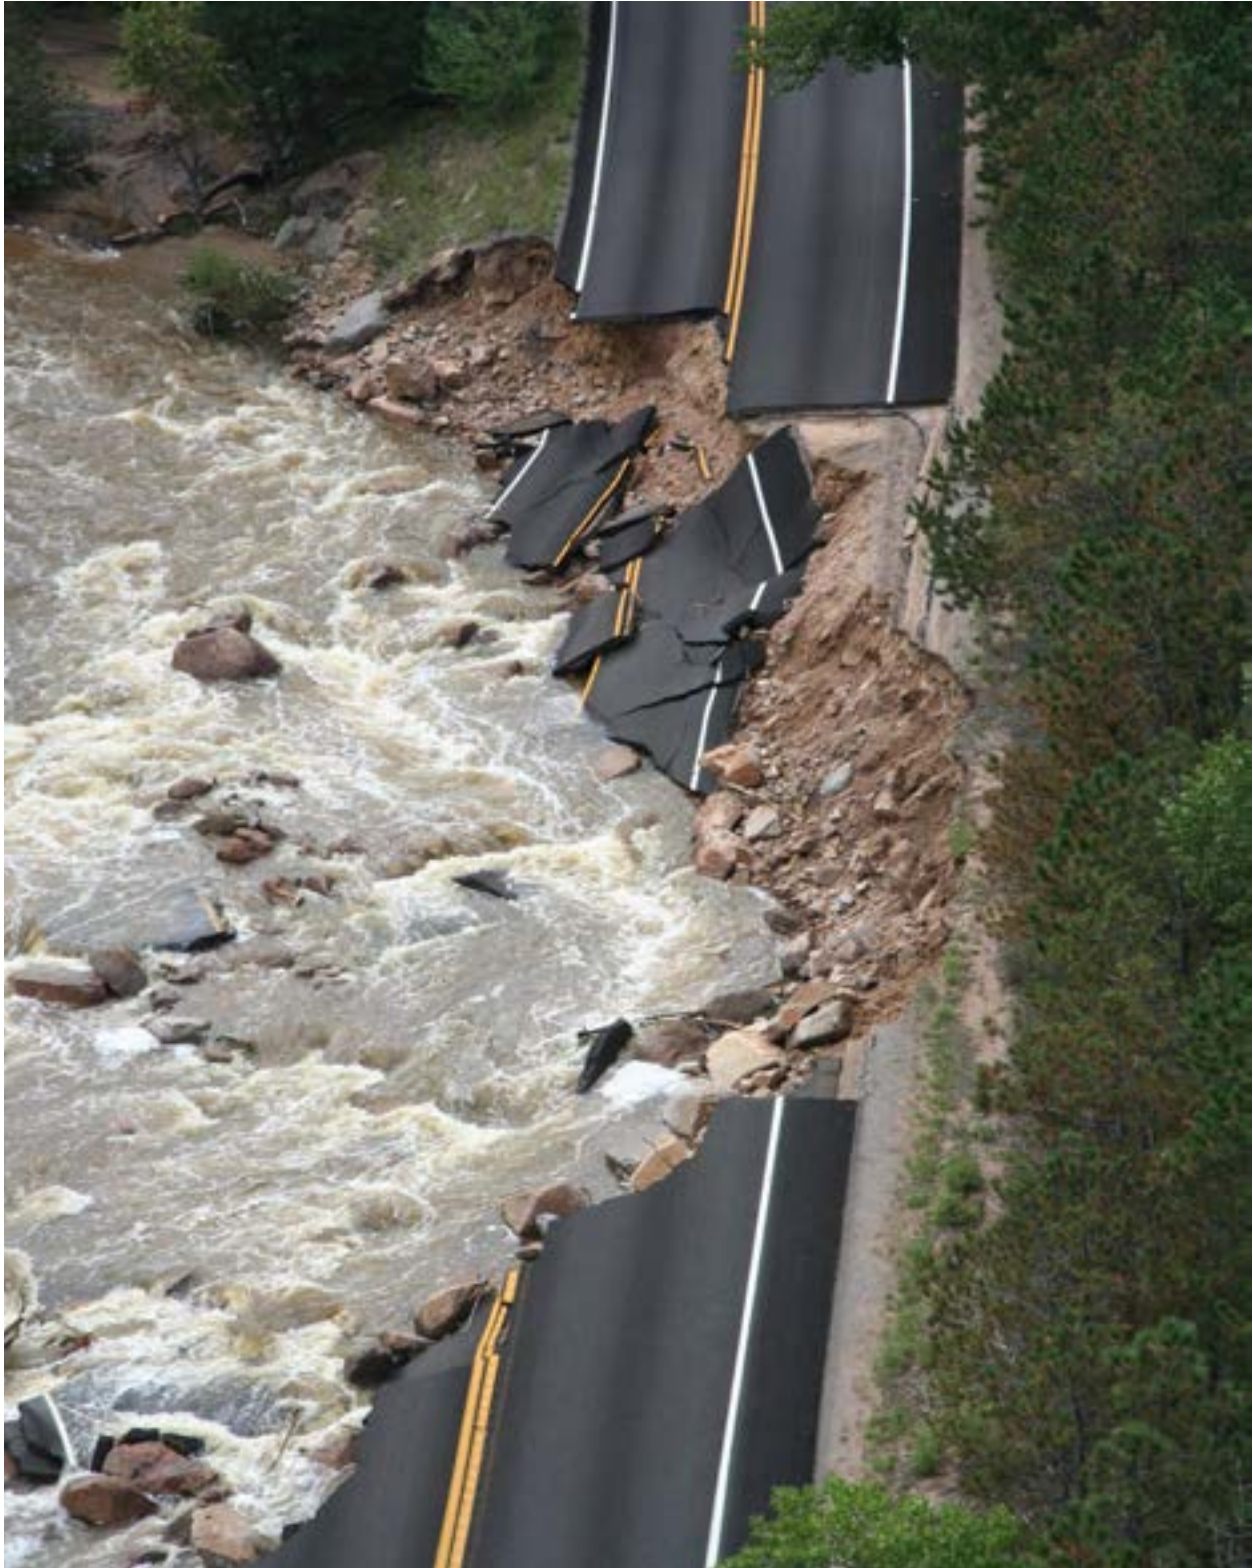
Figure 30 - MP 25.5, Embankment and roadway washout.

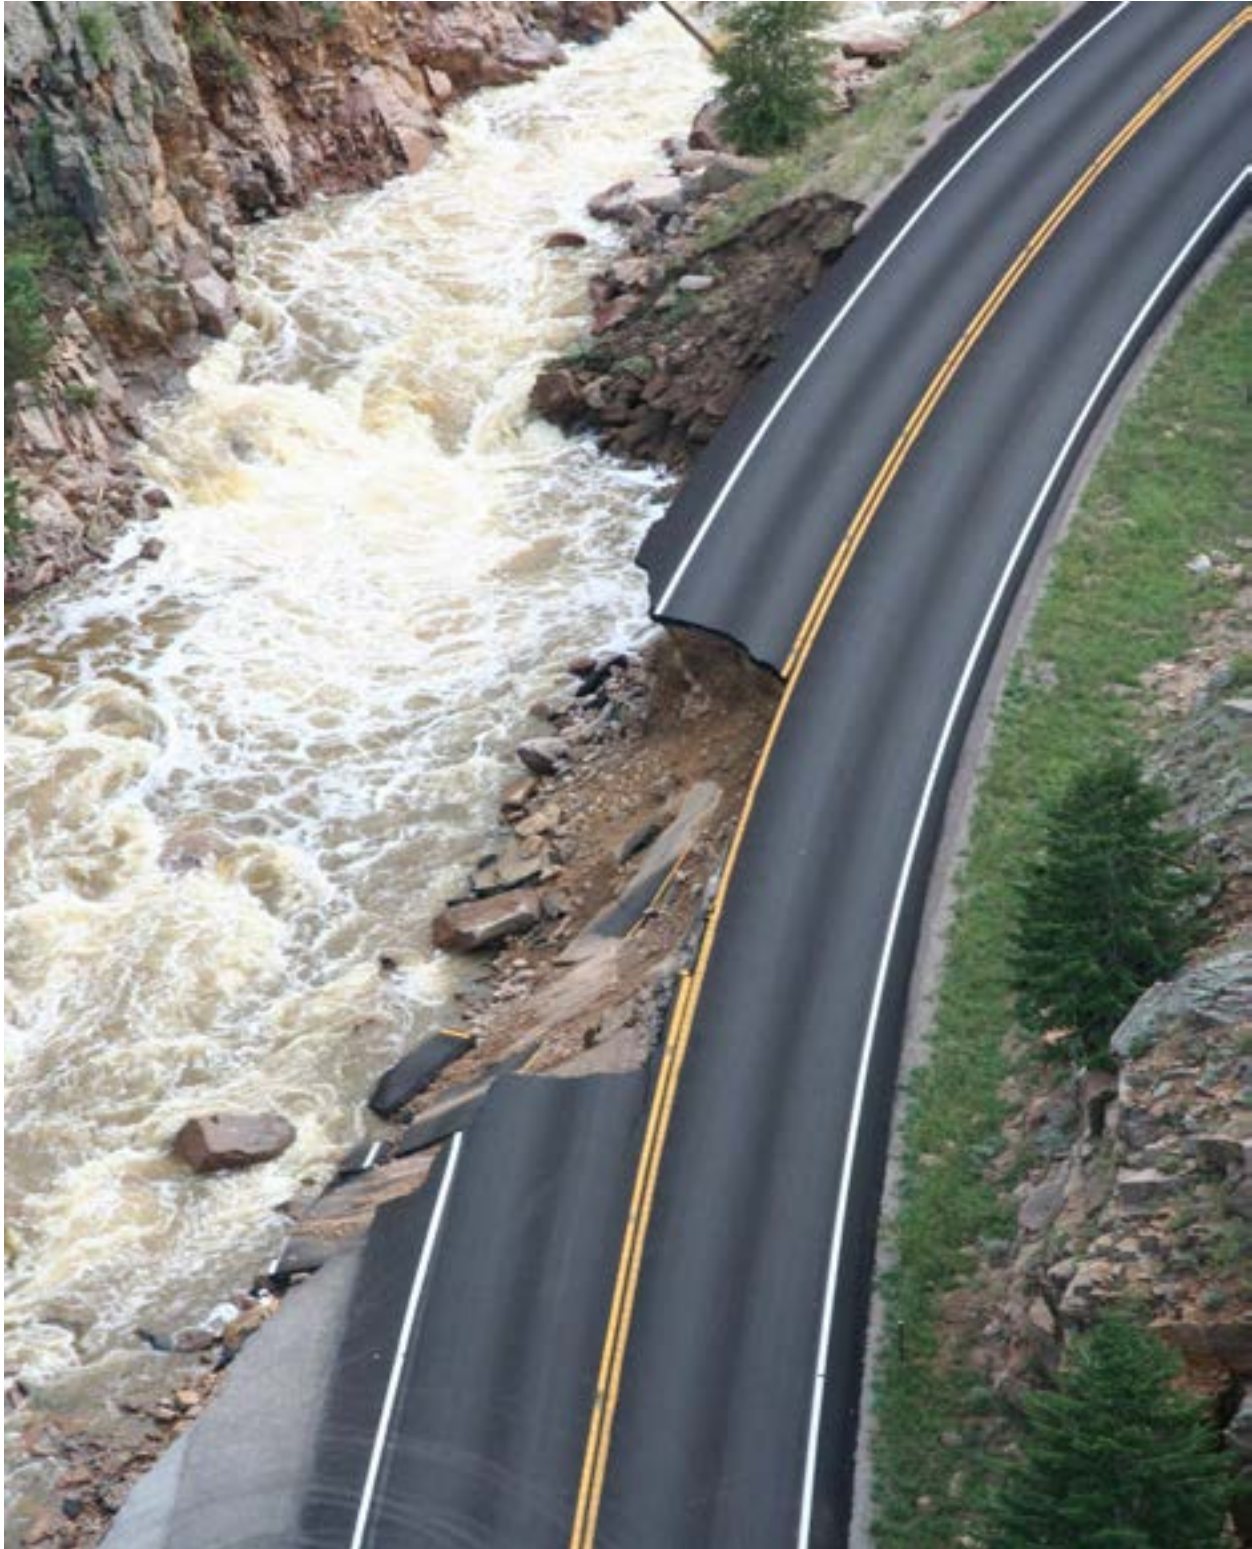
Figure 31 - MP 25.75, Embankment and partial roadway washout.
