**SH 7A (Lower)
Raymond to Lyons
Site Repairs between Mileposts 19 and 33**

**Boulder County
COLORADO**

Damage Assessment Report

**100% DRAFT
Revised: July 28, 2014**

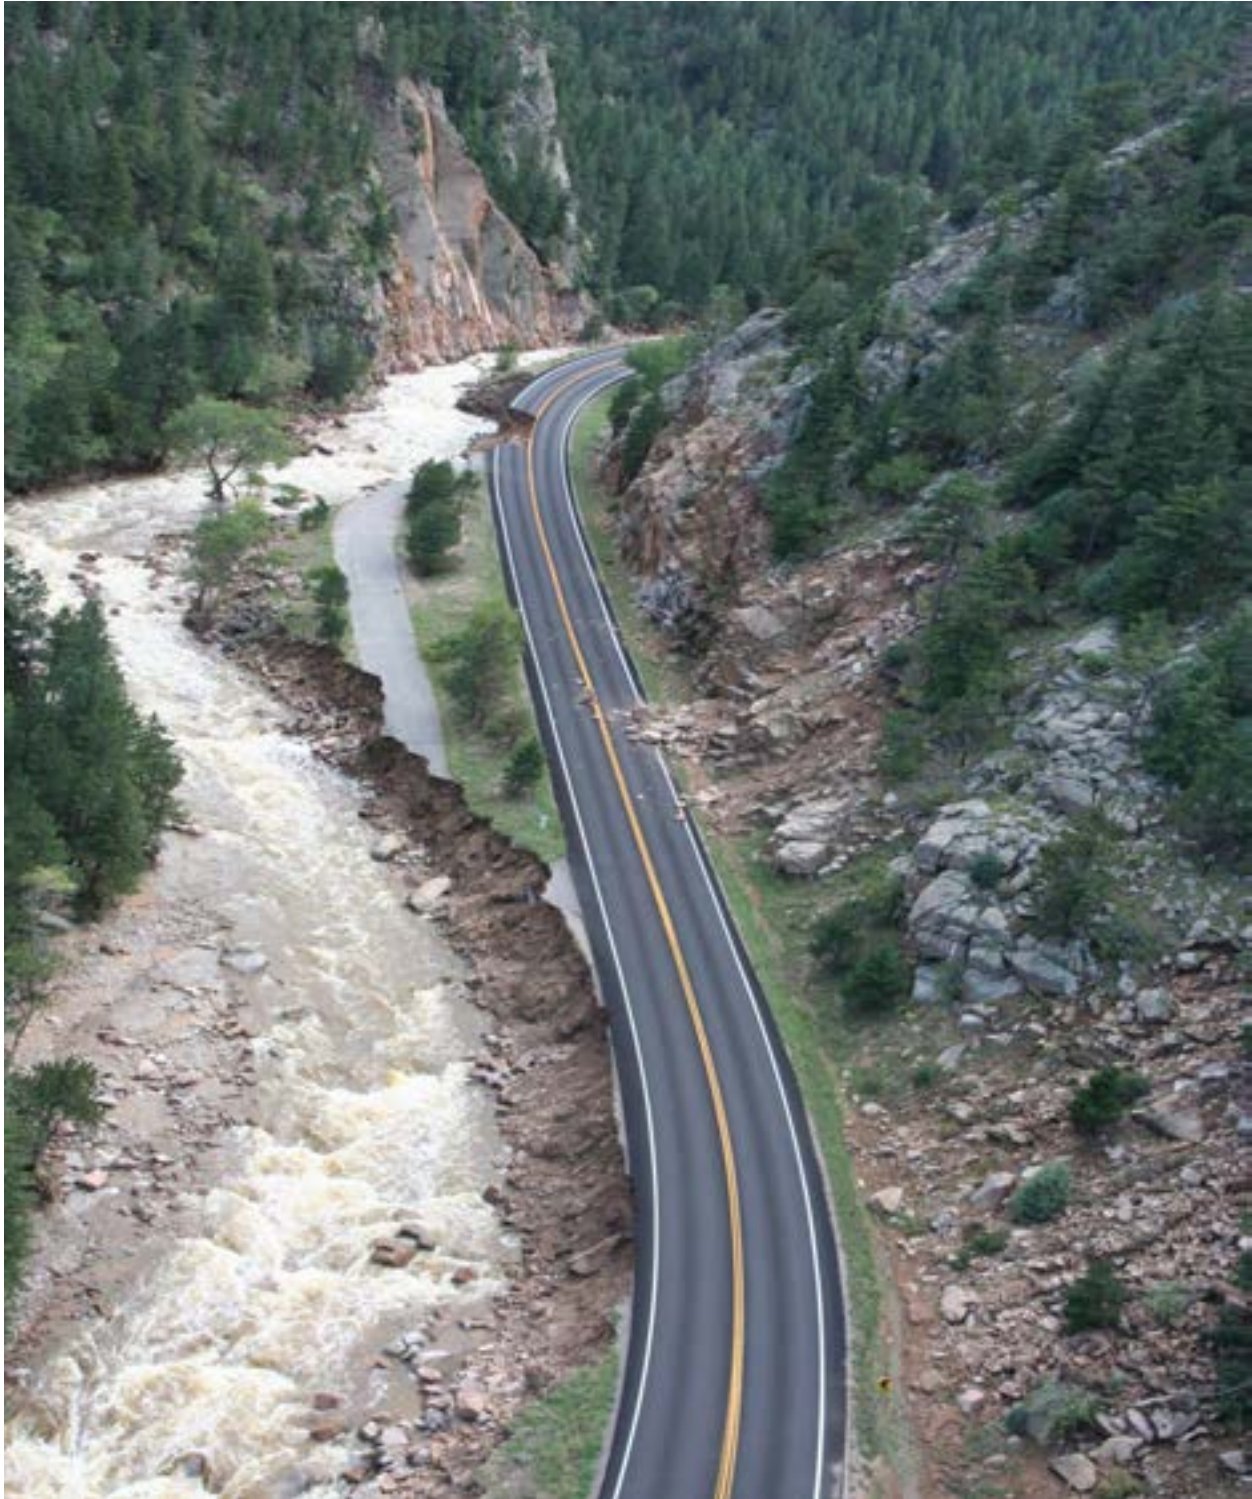
Figure 32 - MP 25.8, Embankment/pavement washout and rockslide.

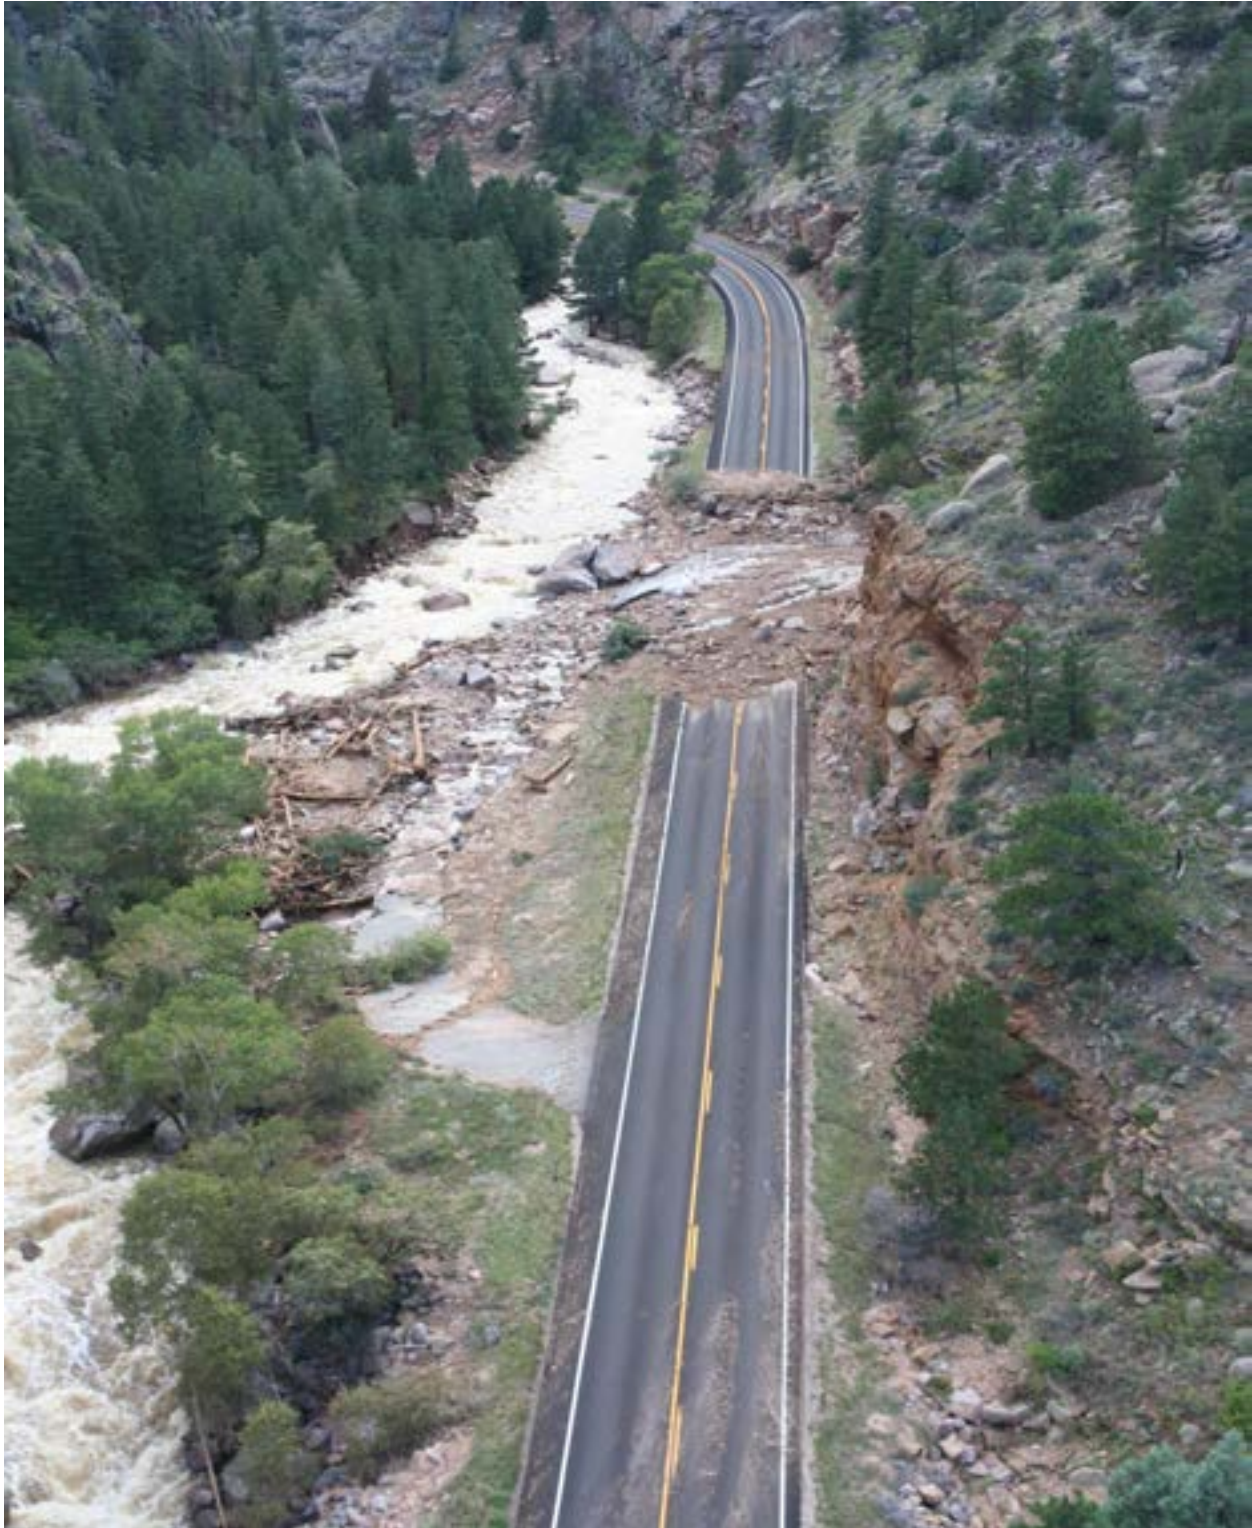
Figure 33 - MP 26.25, Rock slide and debris covering both roadway lanes.

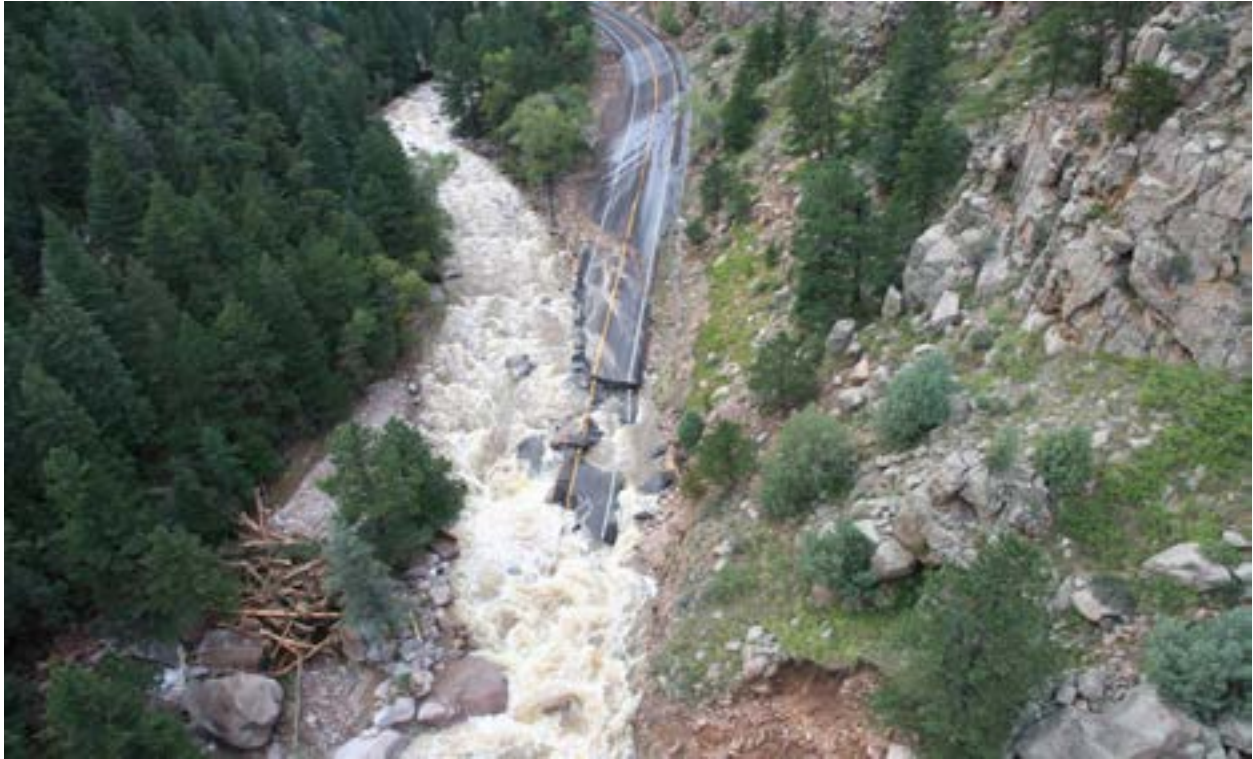
Figure 34 - MP 26.61, Complete roadway loss due to overtopping.

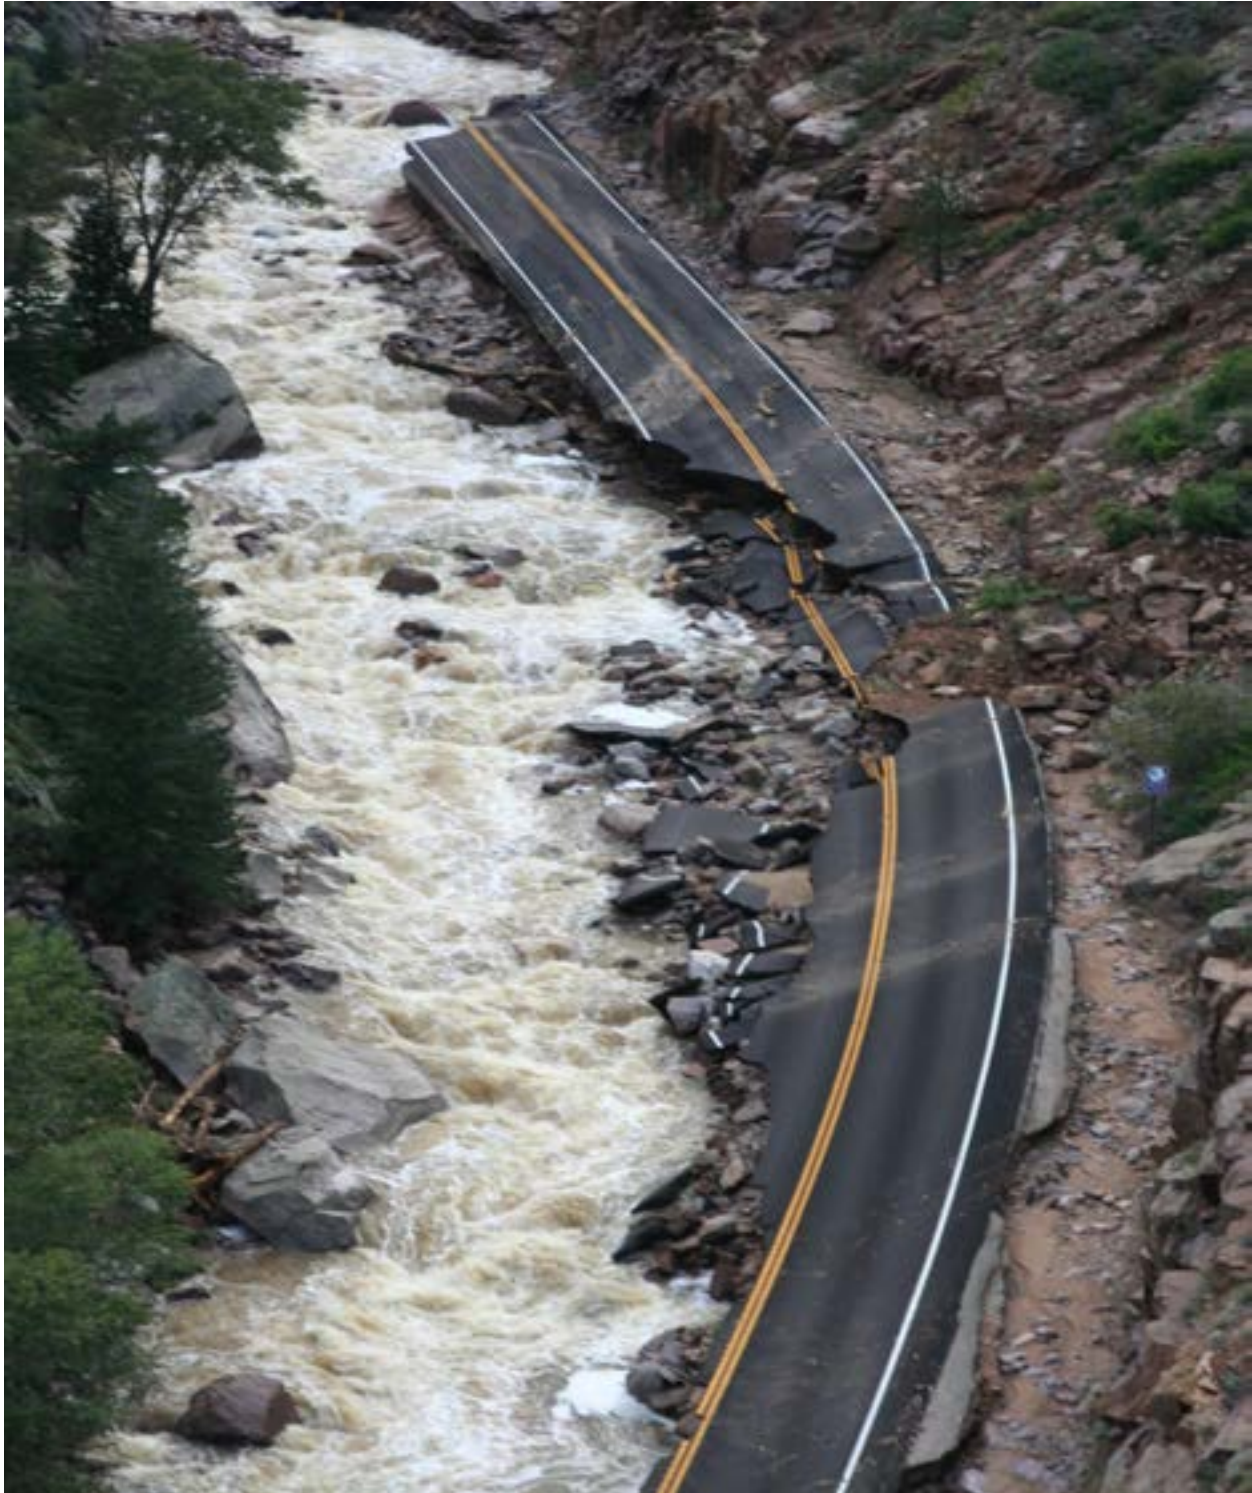
Figure 36 - MP 26.9, Roadway undermined and washed out embankment.

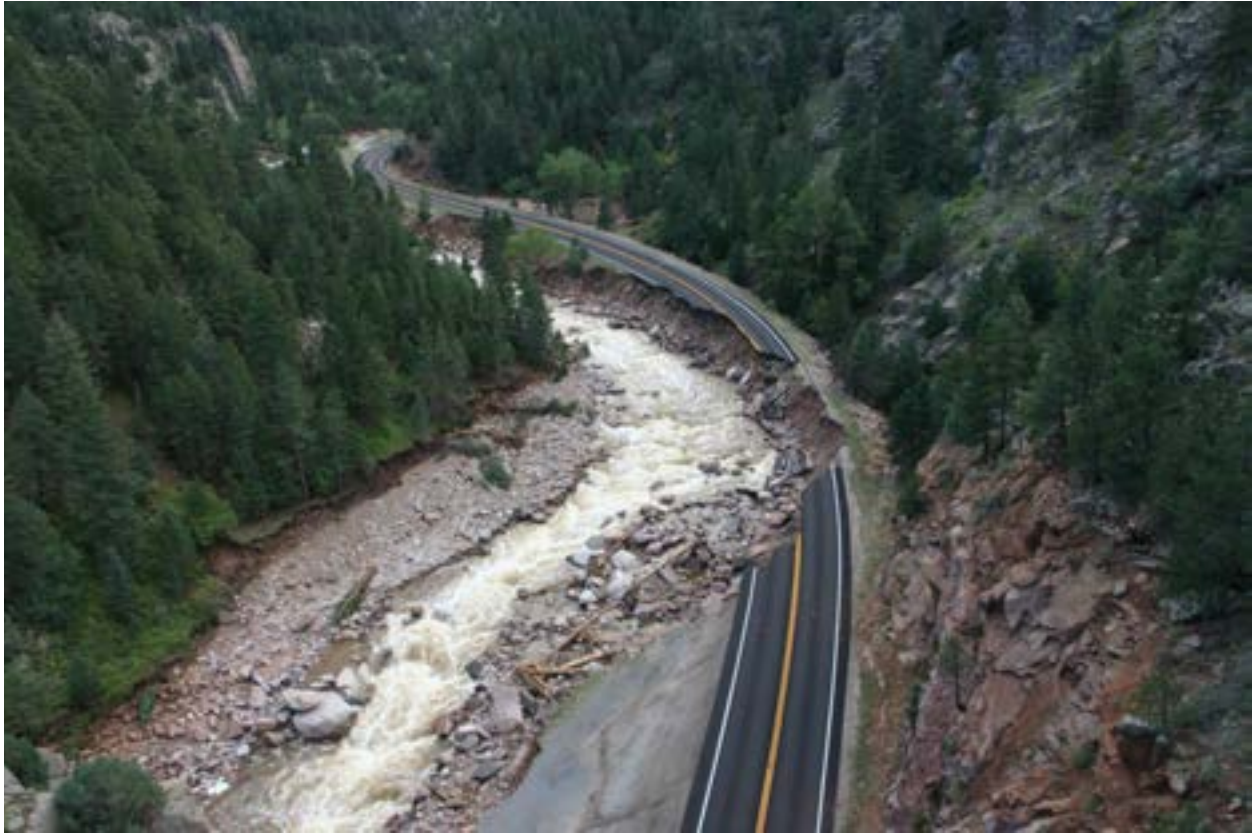
Figure 37 - MP 27.28, Complete roadway loss due to embankment scour damage at the river bend.

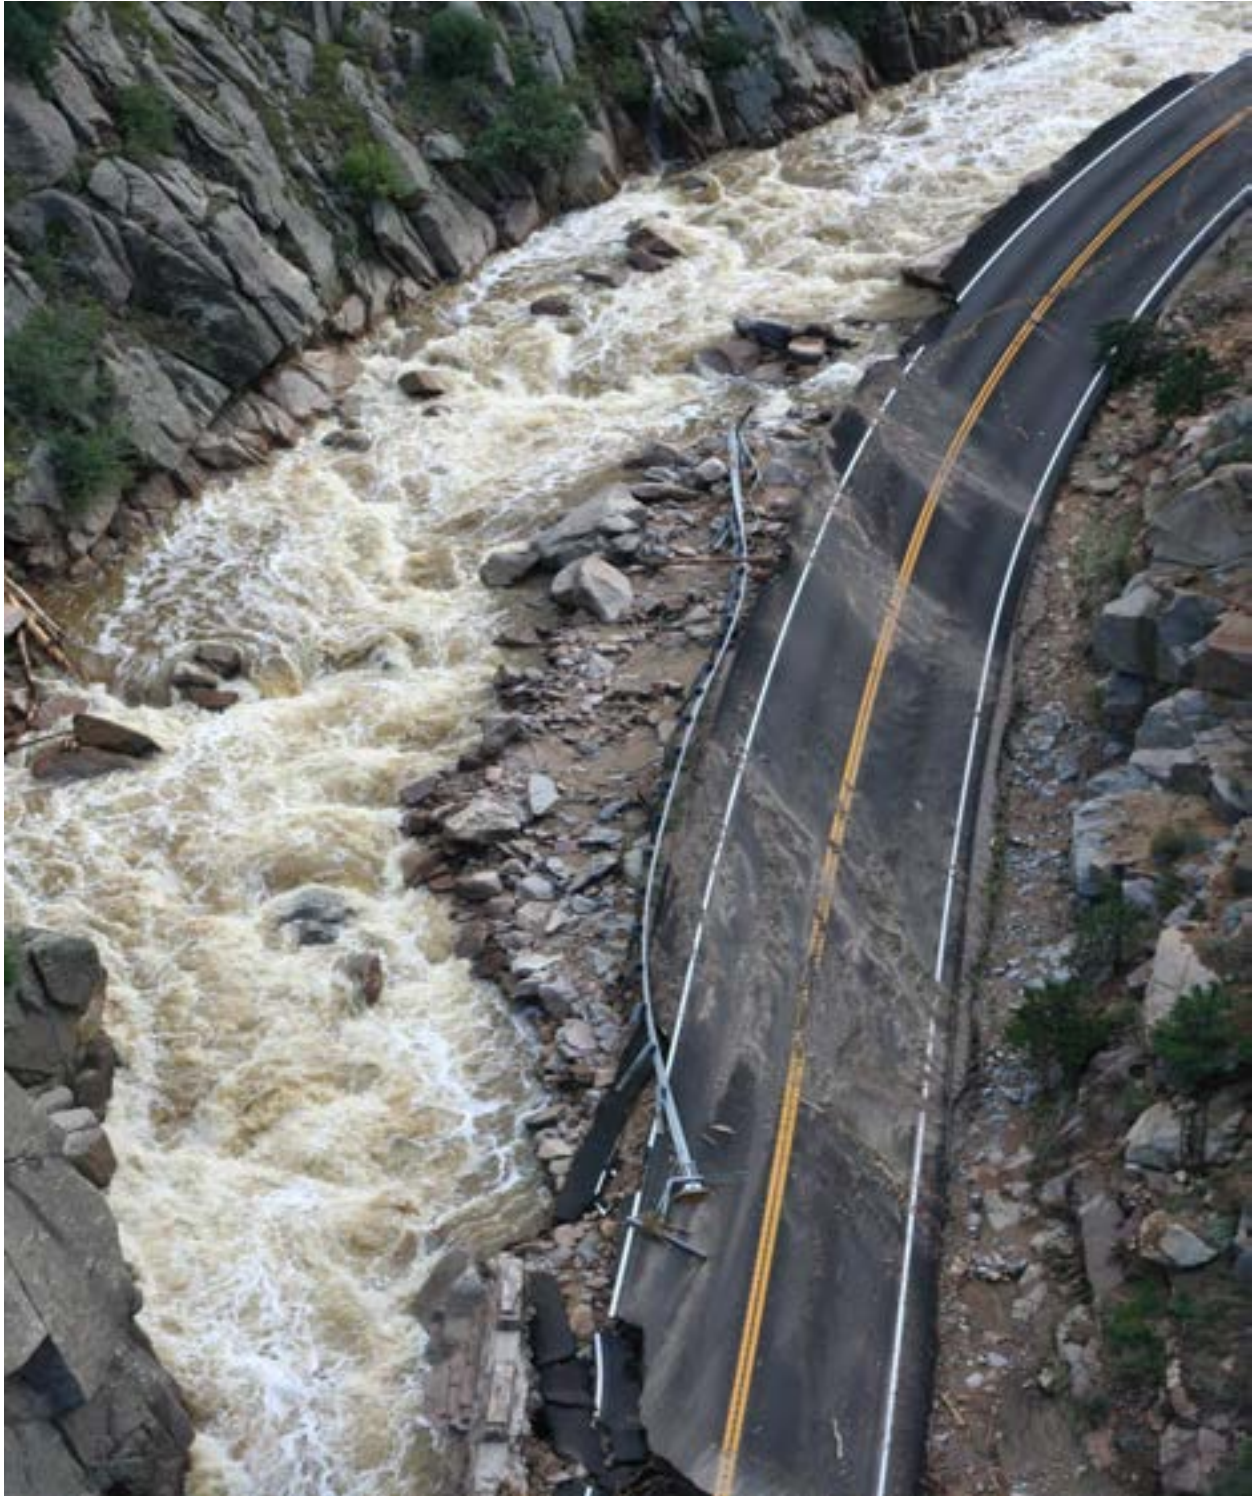
Figure 38 - MP 27.61, Riverside embankment and eastbound lane damage due to lateral scour and overtopping of the roadway.

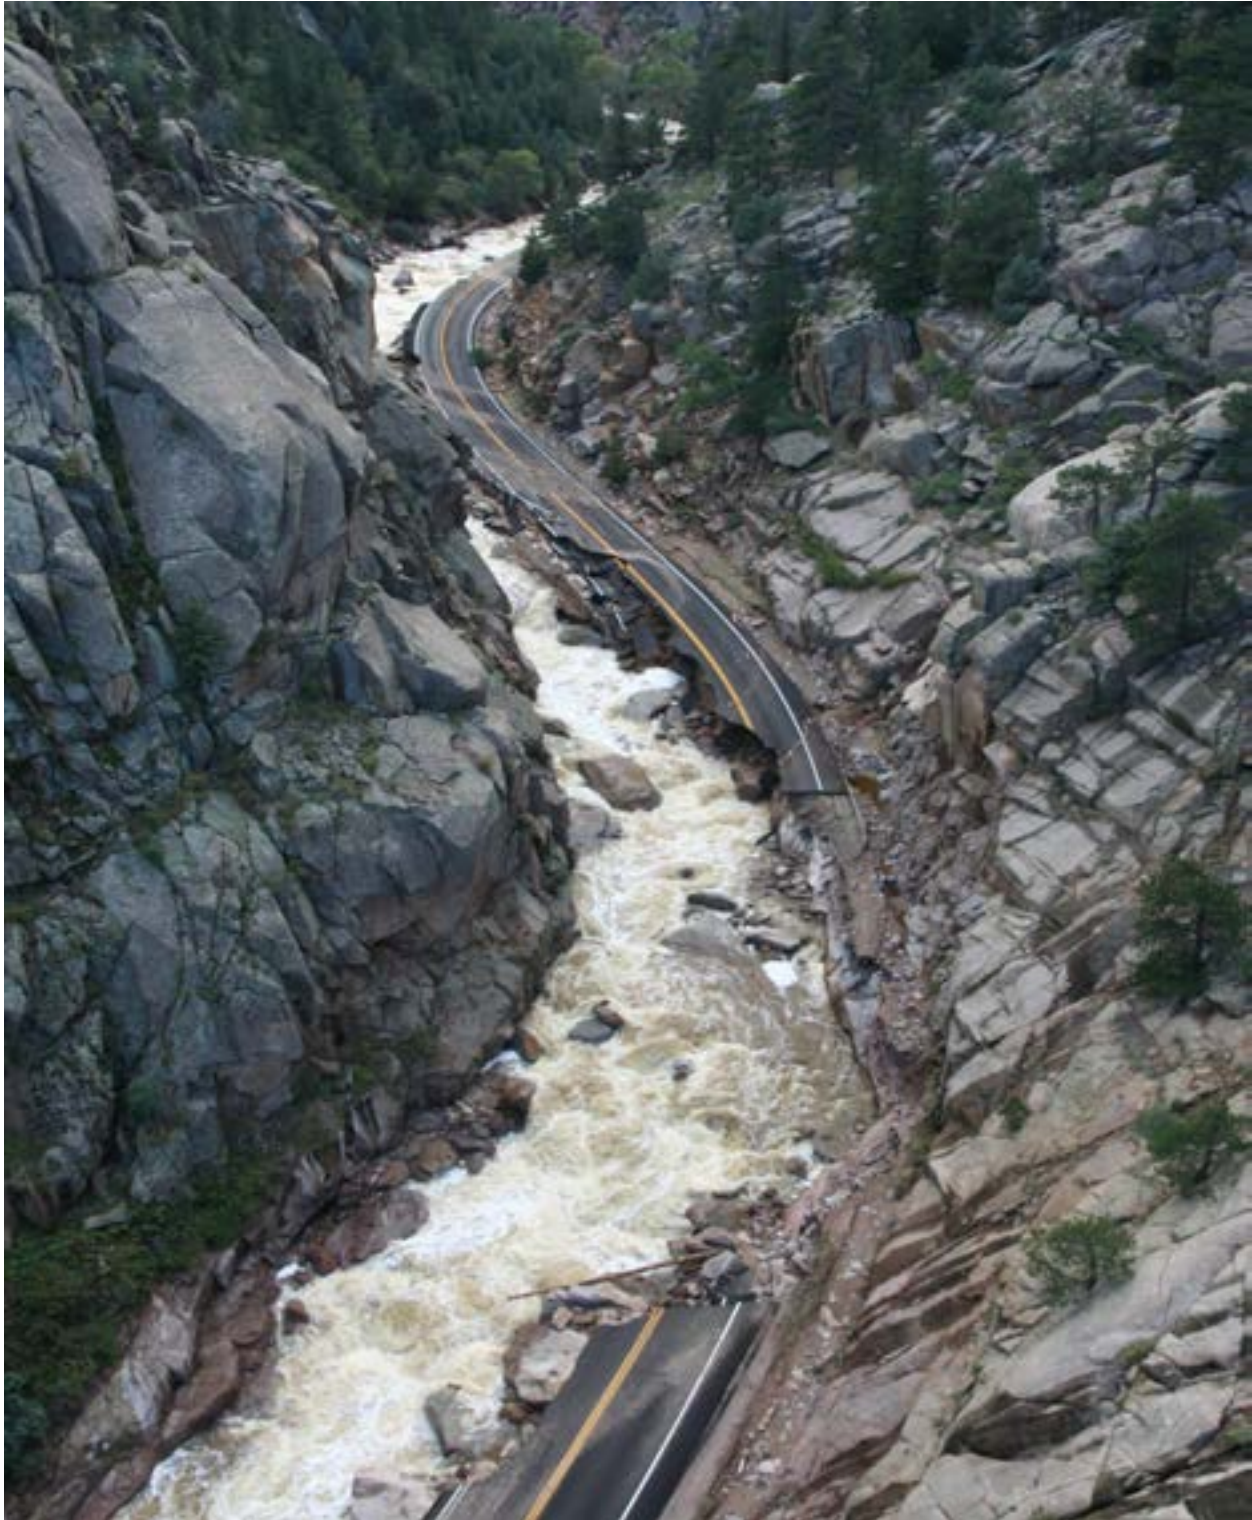
Figure 39 - MP 27.68, Wash out of riverside embankment and roadway due to lateral scour and overtopping of the roadway.

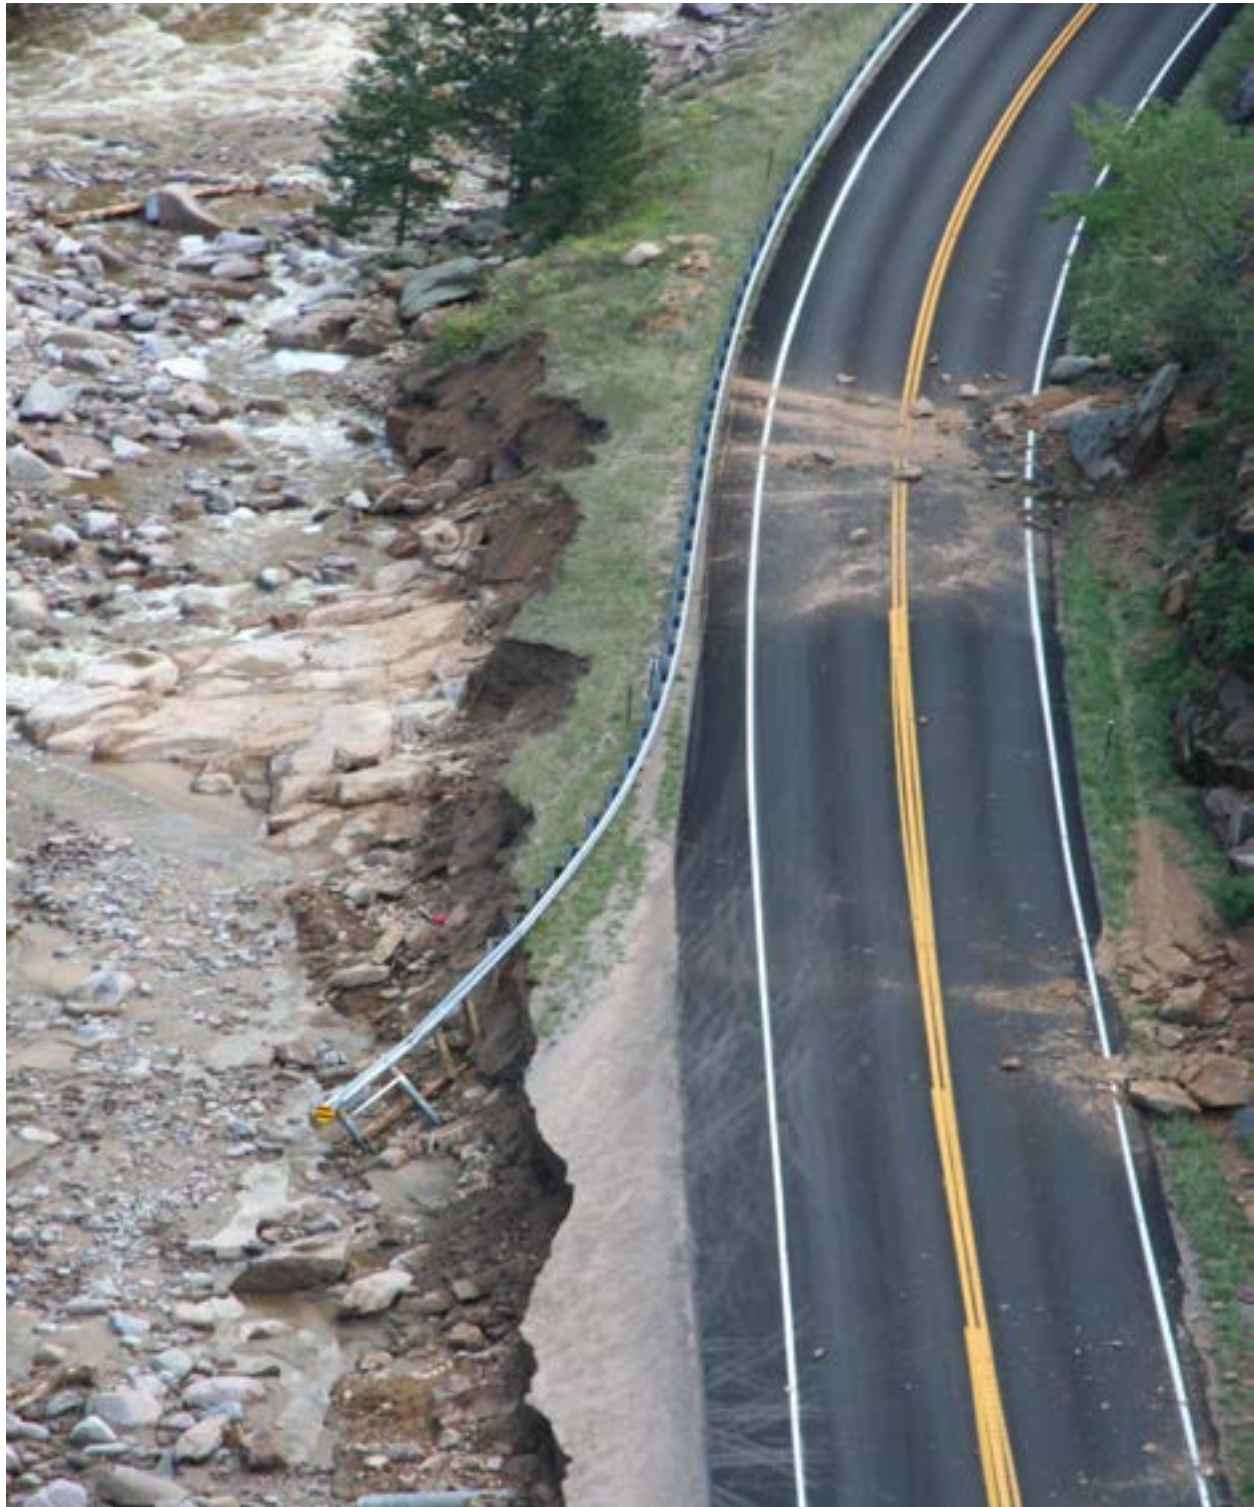
Figure 40 - MP 28.3, Scour damage to gravel pullout, EB embankment and guardrail; and material slides.

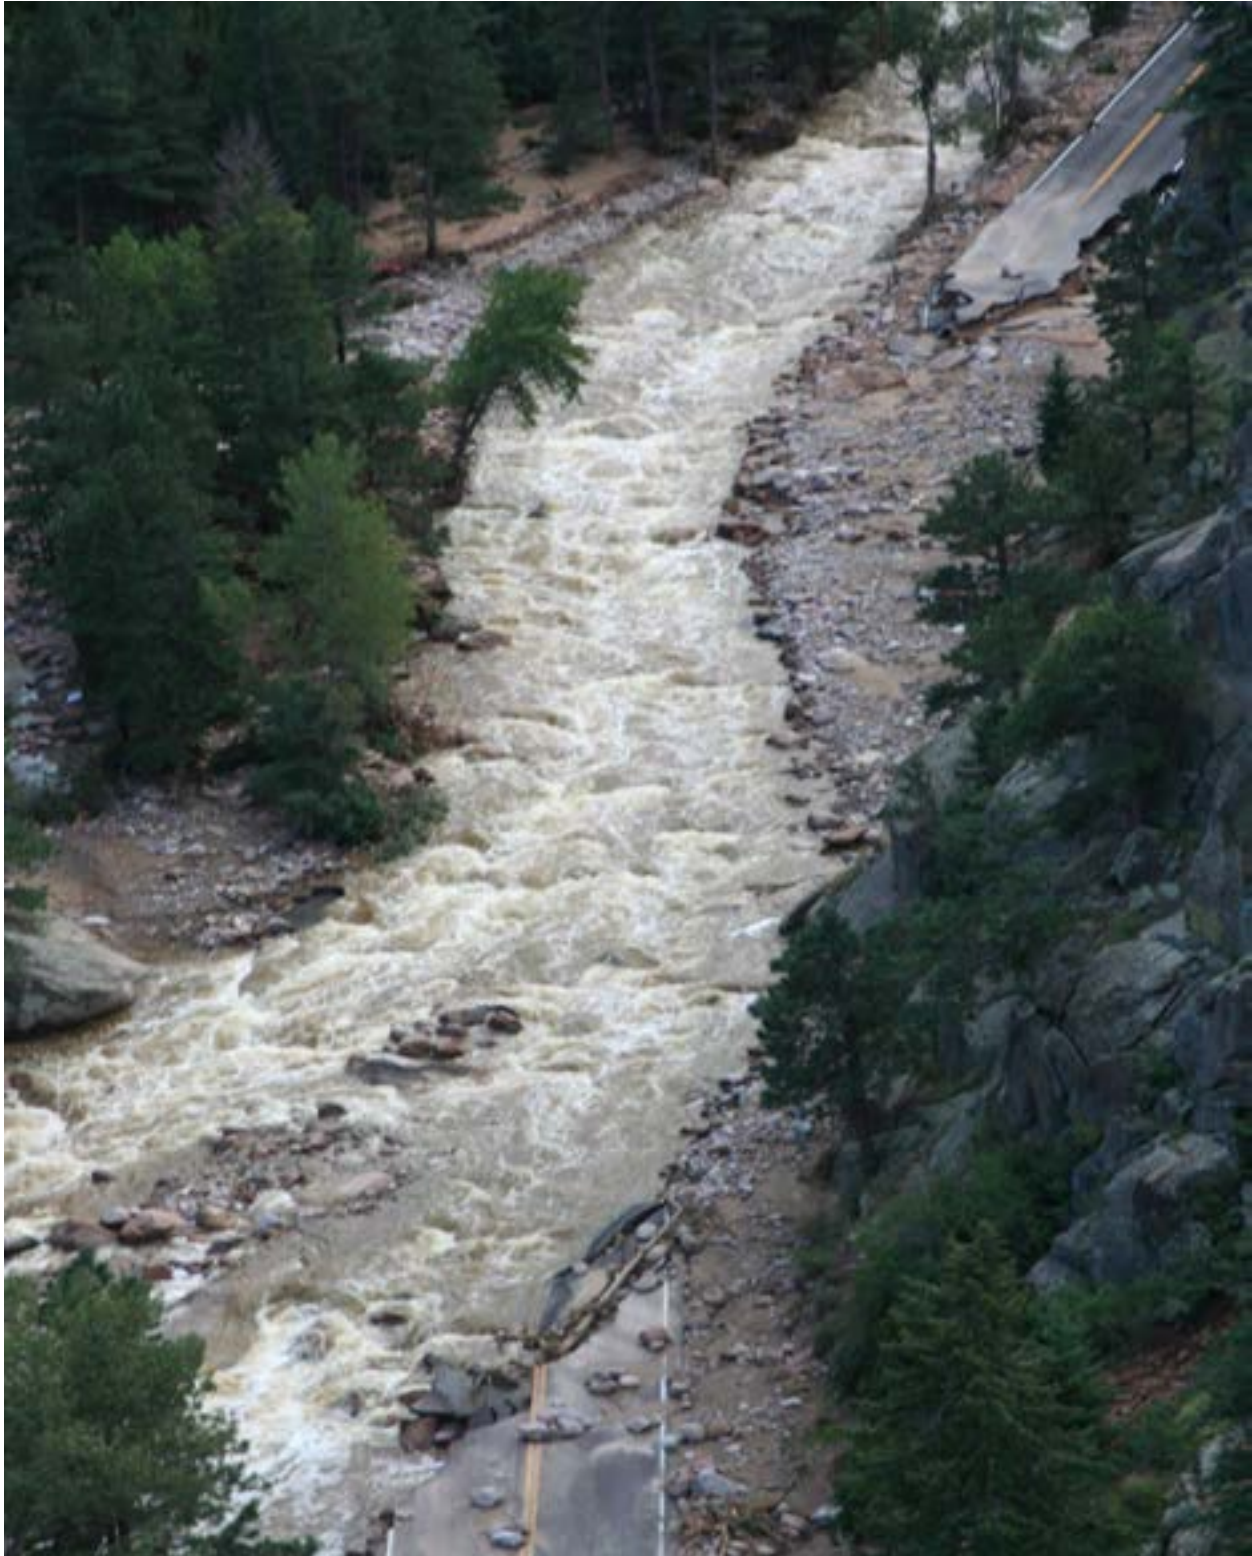
Figure 41 - MP 28.5, Complete wash out of the roadway due to lateral scour and overtopping of the roadway.

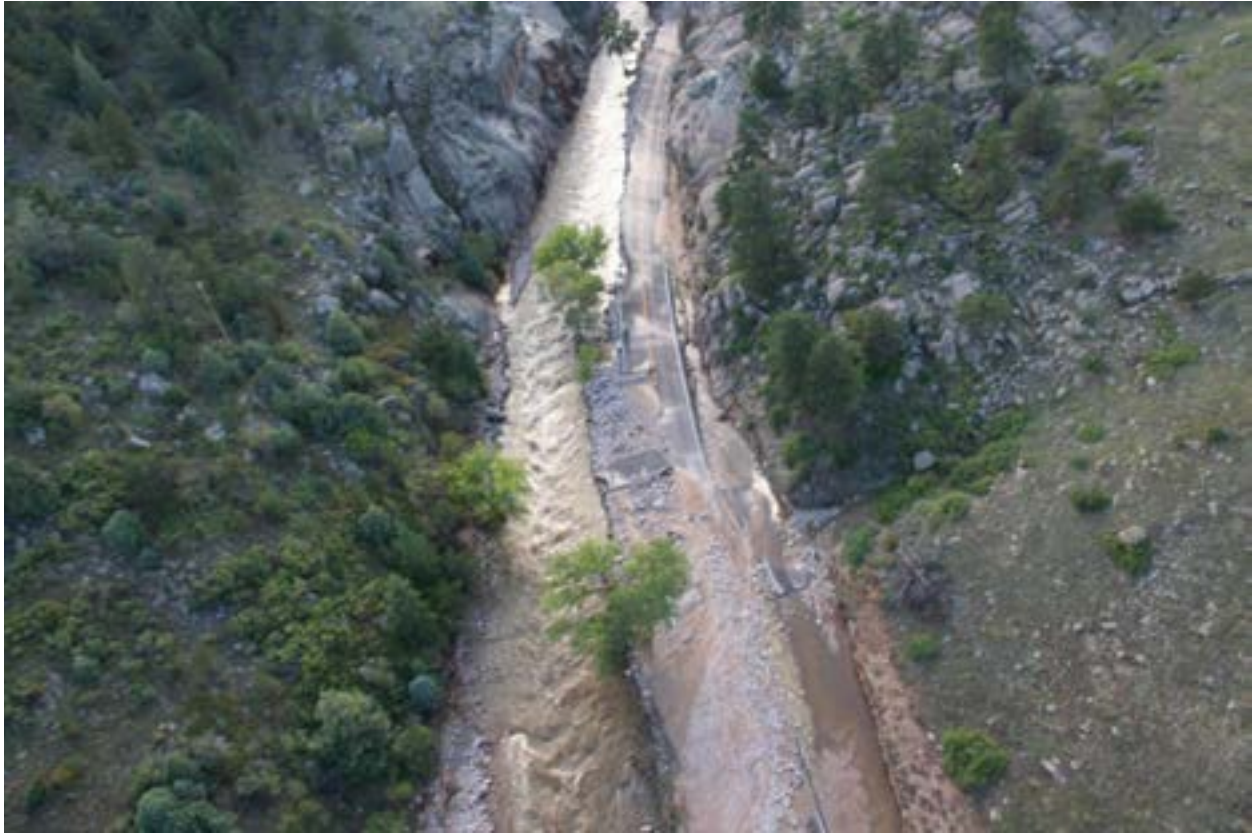
Figure 42 - MP 30.08, Wash out of the roadway embankment and pavement due to lateral scour and overtopping of the roadway. Sediment and debris deposition throughout.

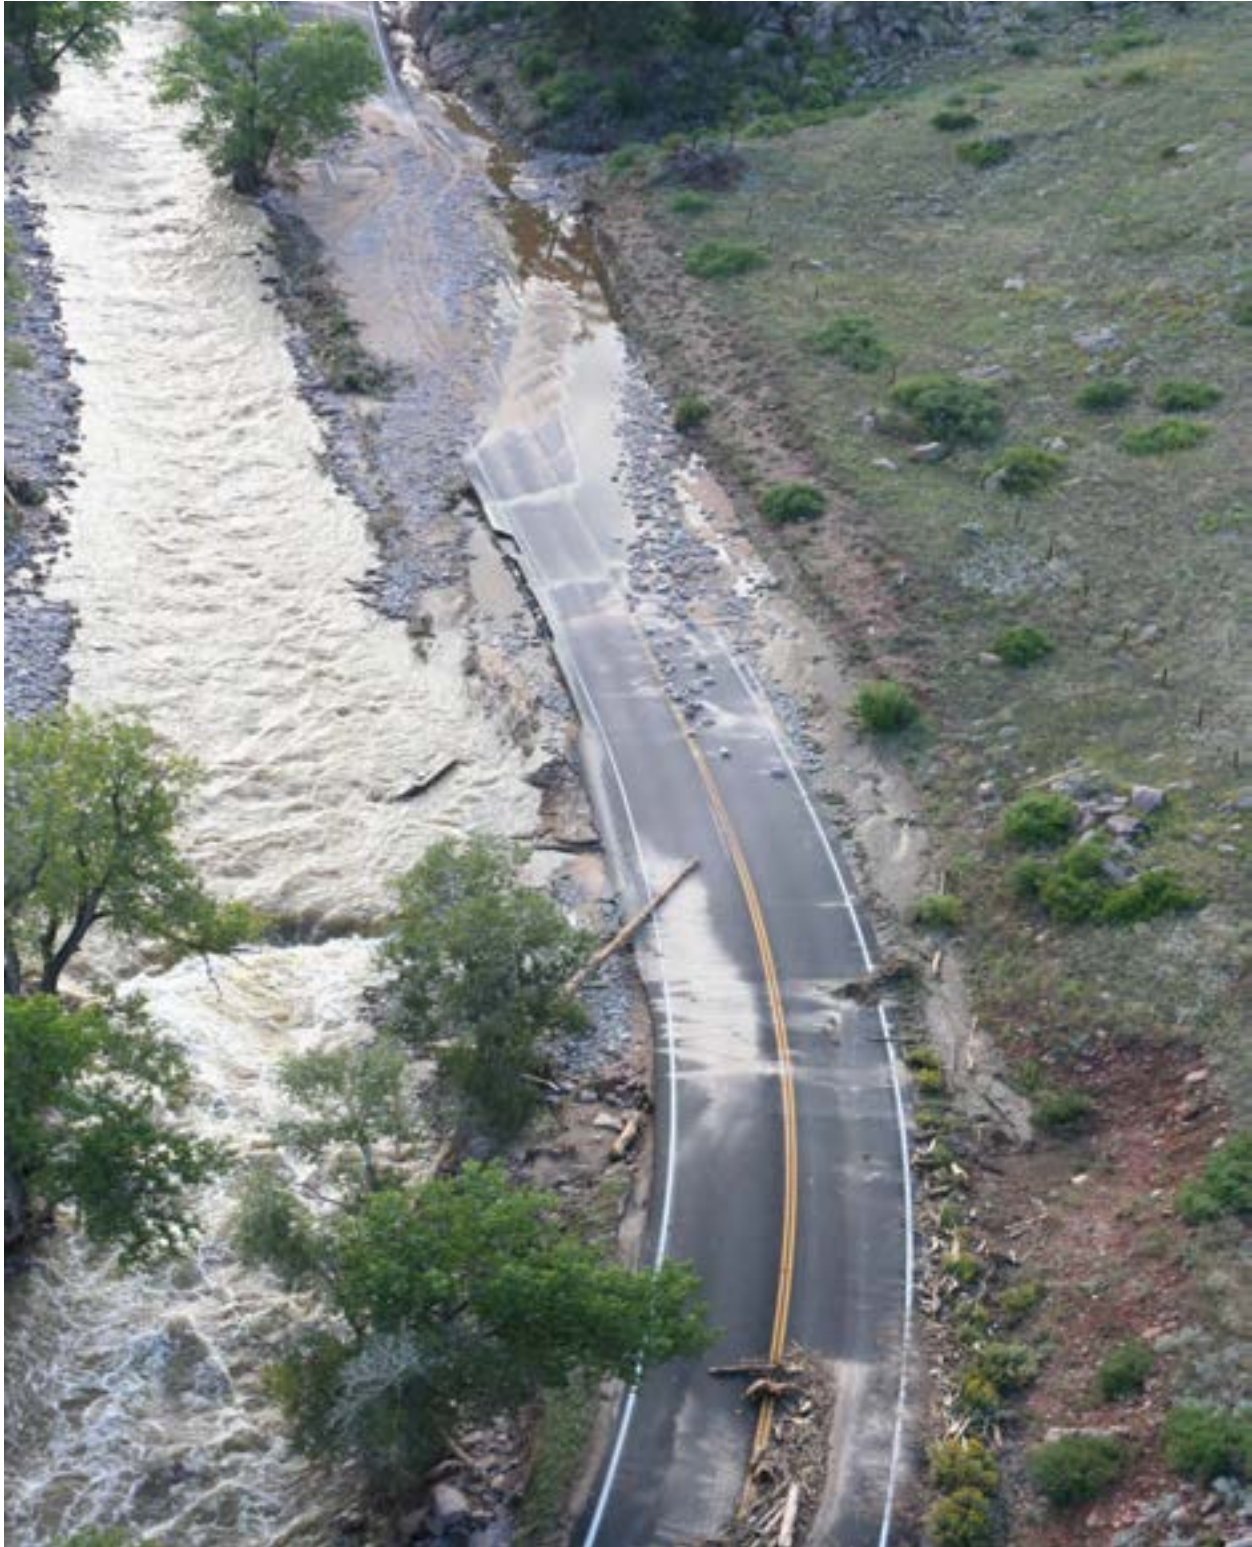
Figure 43 - MP 30.1, Wash out of the roadway embankment and pavement due to lateral scour and overtopping of the roadway. Sediment and debris deposition throughout.

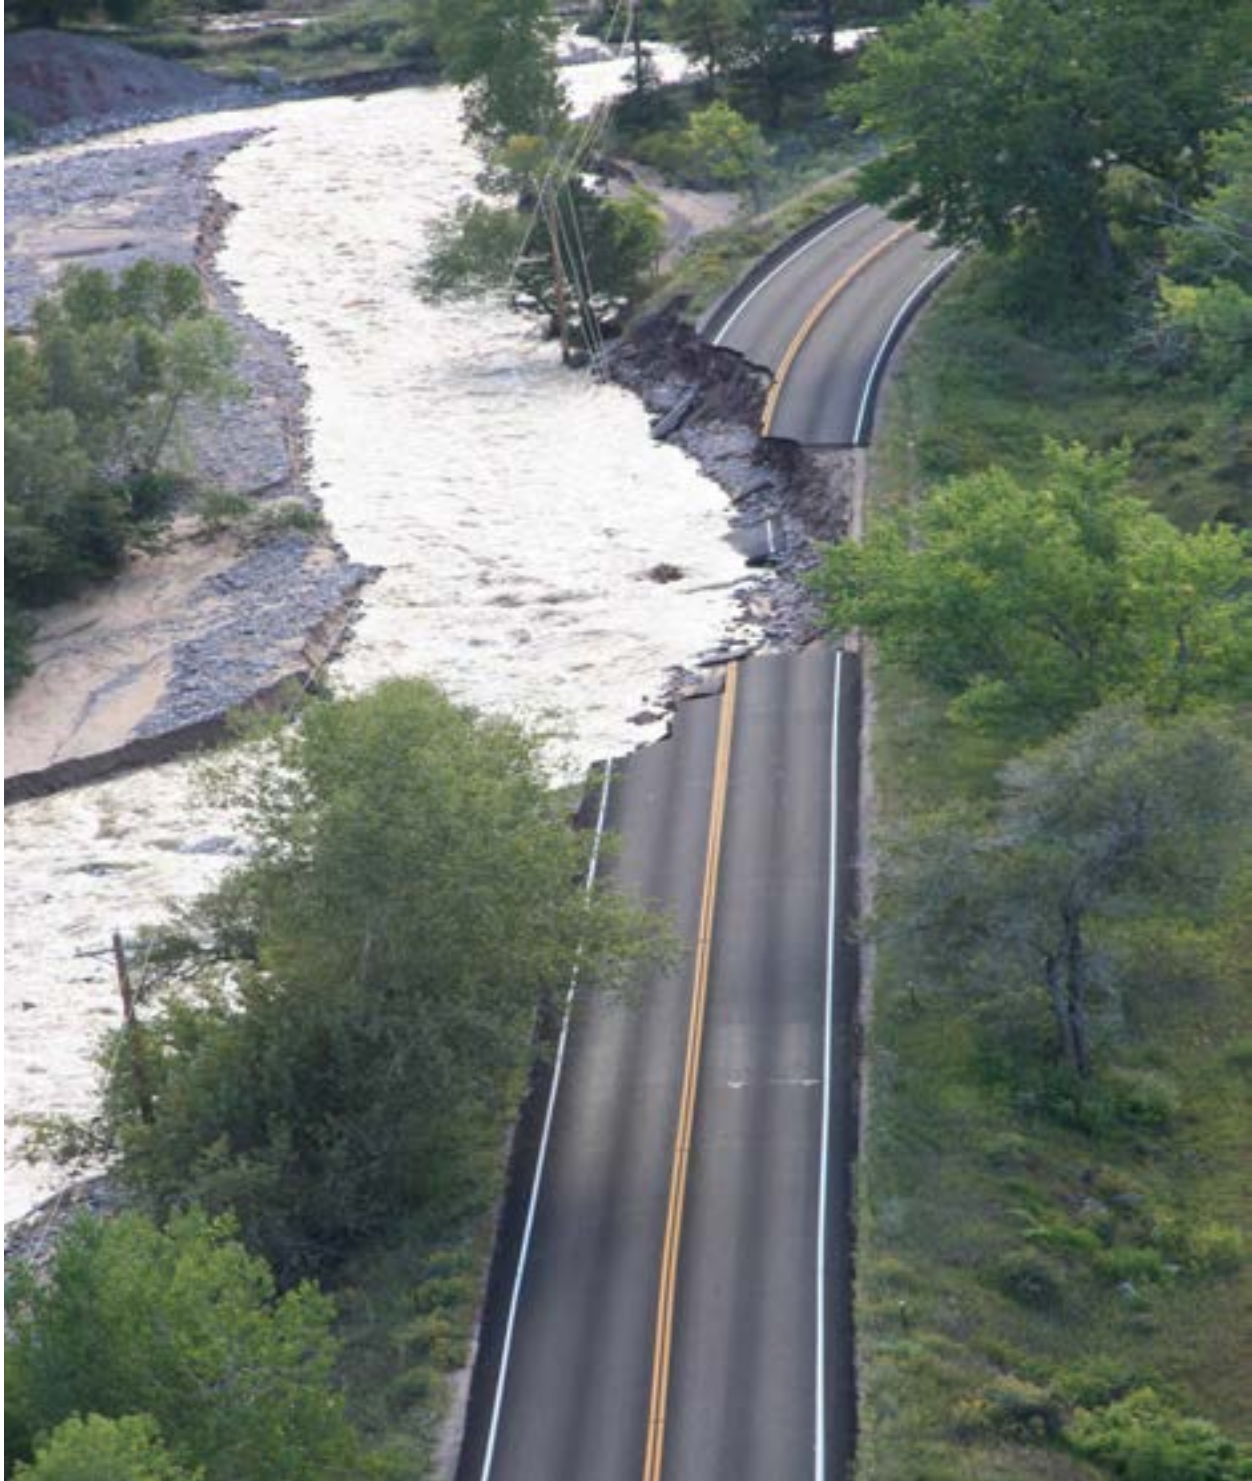
| Milepost | | Description of Damage - All Dimensions are "Approximate" |
|---|---|---|
| 30.48 | 30.54 | The 2 lane roadway was a complete loss for approximately 300 LF. |

Figure 44 - MP 30.49, Complete roadway loss

| Milepost | | ER Work |
|---|---|---|
| 30.48 | 30.54 | The full width roadway loss was repaired. |

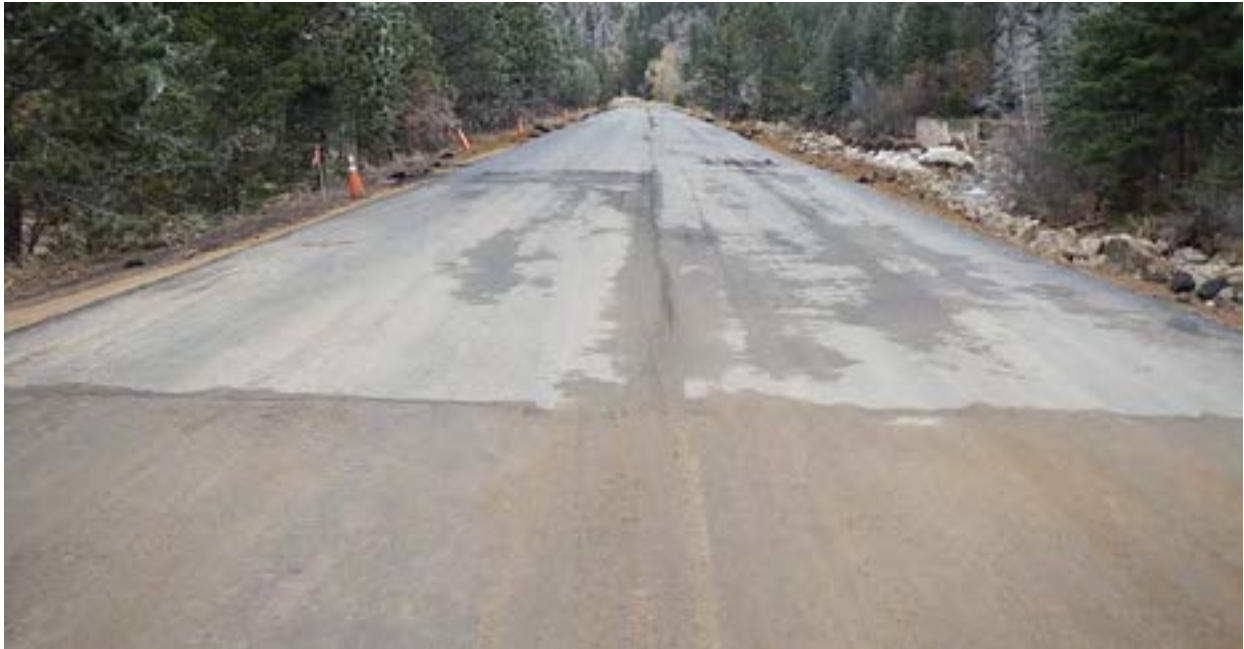
Figure 45 - MP 23.4 Facing east, Completed ER roadway section.

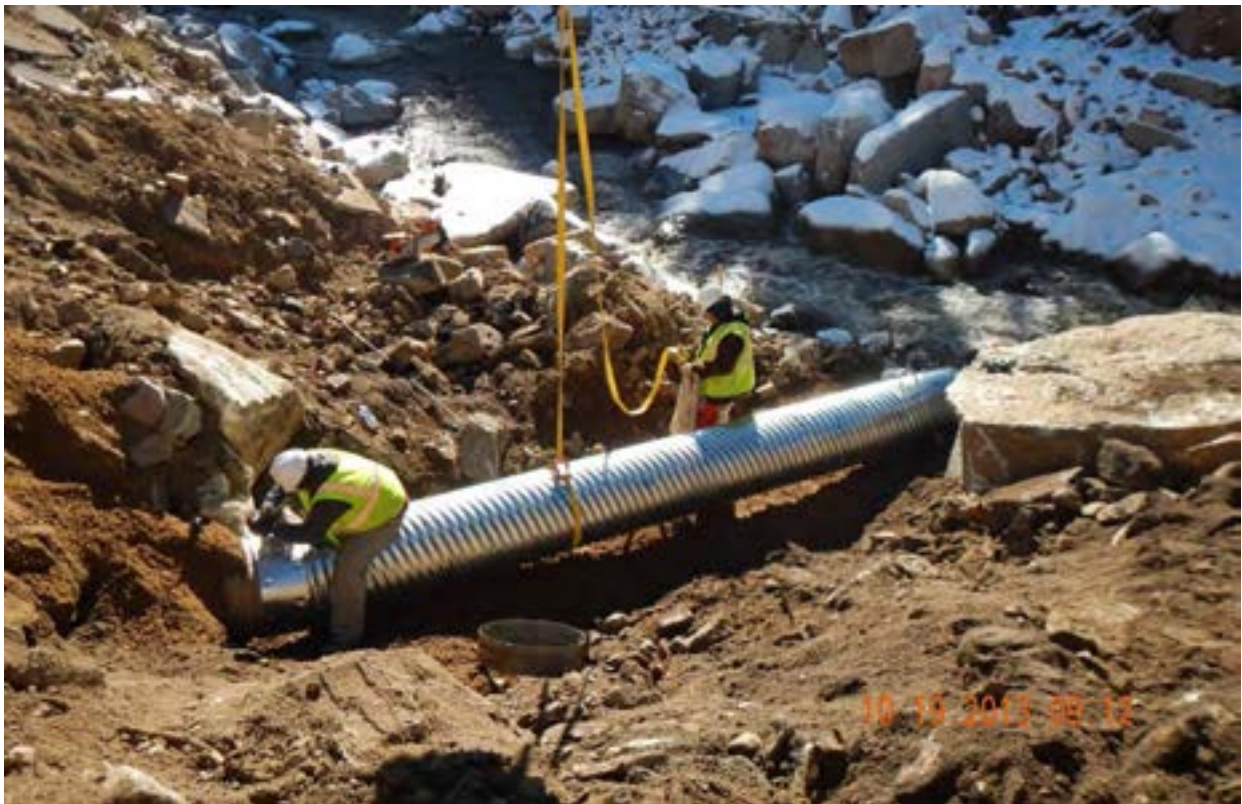
Figure 46 - MP 23.4, CMP repair.

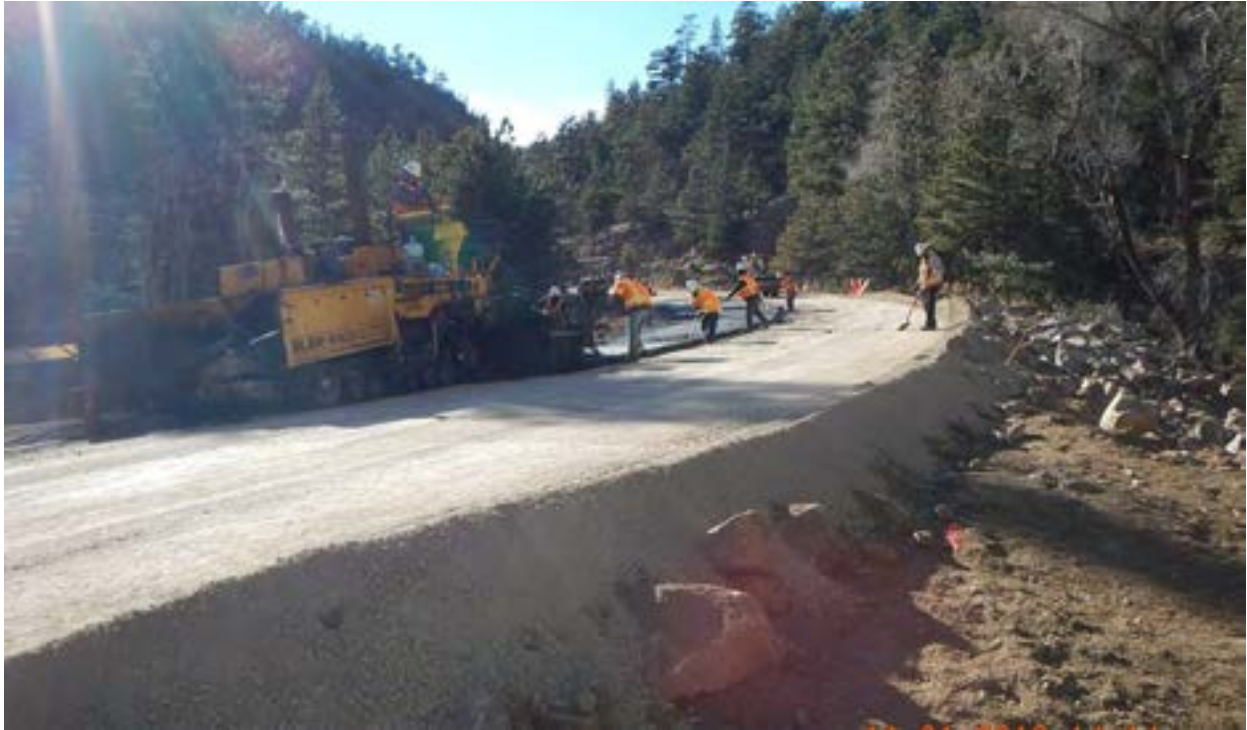
Figure 47 - MP 23.8 Facing west, Roadway repair.
