**SH 7A (Lower)
Raymond to Lyons
Site Repairs between Mileposts 19 and 33**

**Boulder County
COLORADO**

Damage Assessment Report

**100% DRAFT
Revised: July 28, 2014**

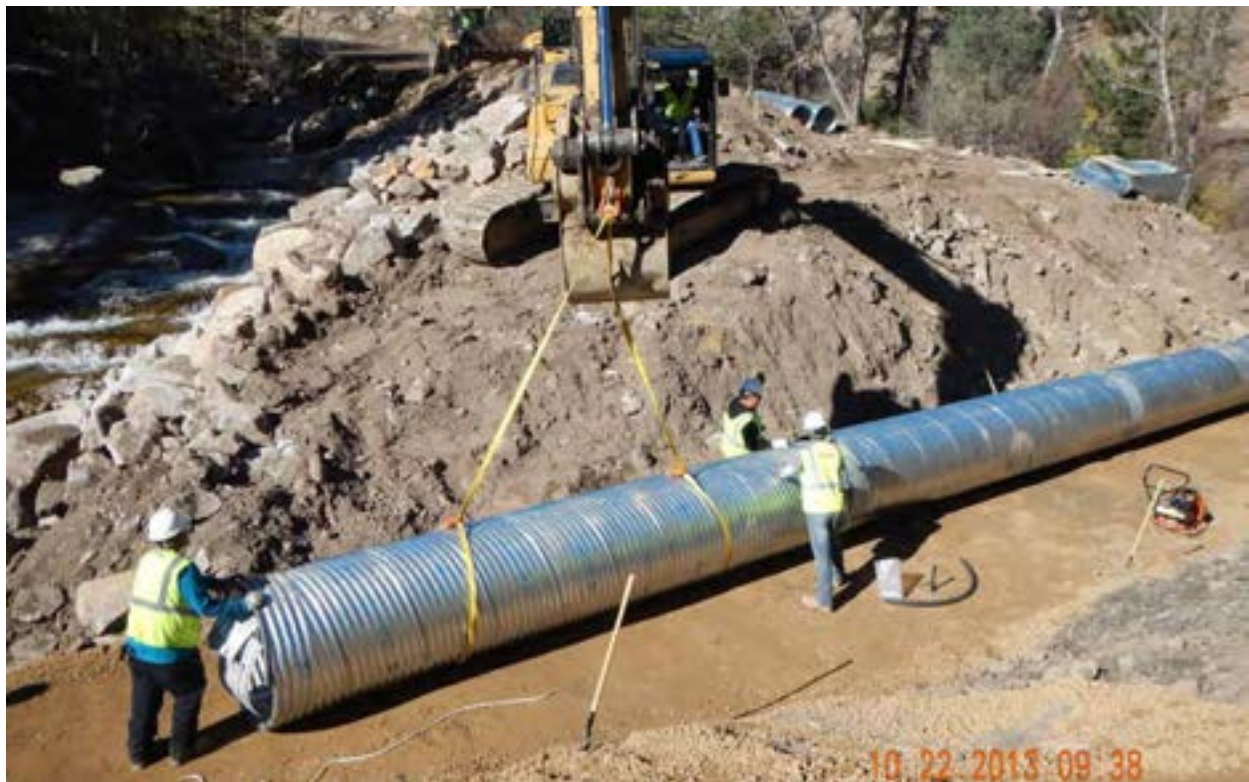
Figure 48 - MP 23.8 Facing northwest, CMP repair.

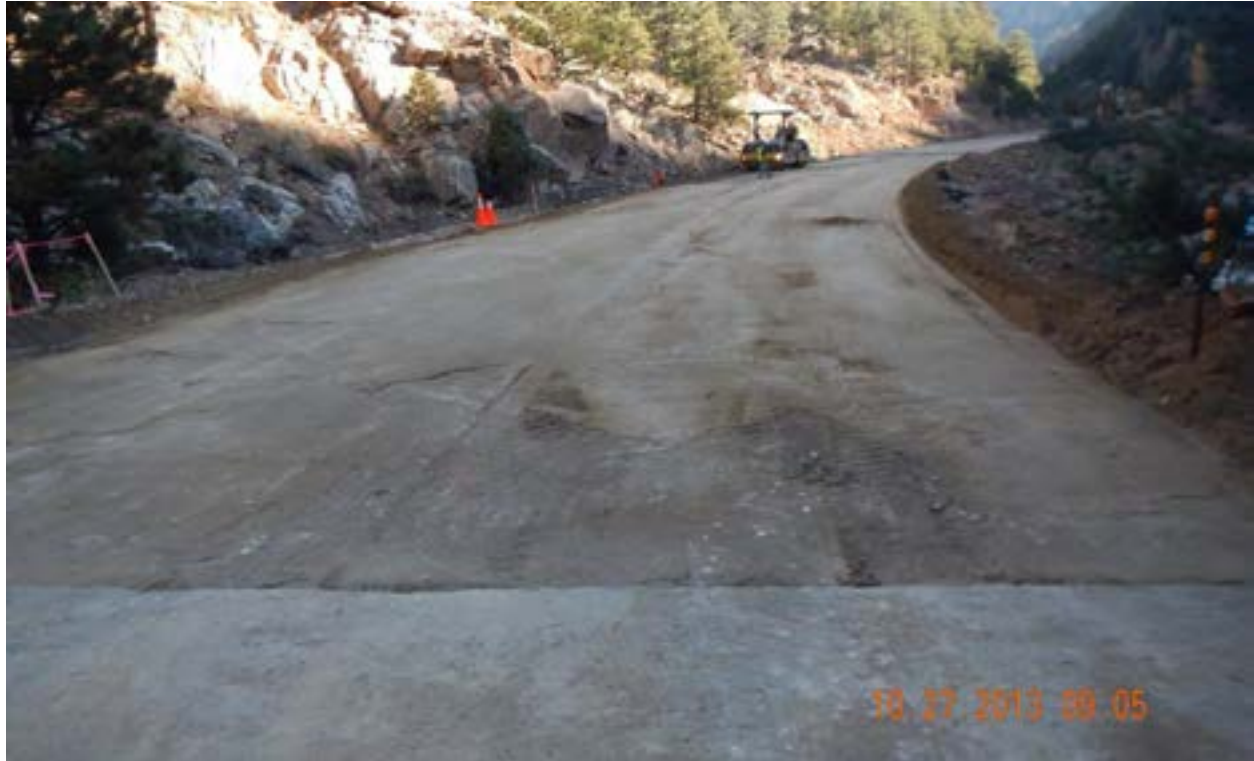
Figure 49 - MP 24.7 Facing northeast, Roadway repair.

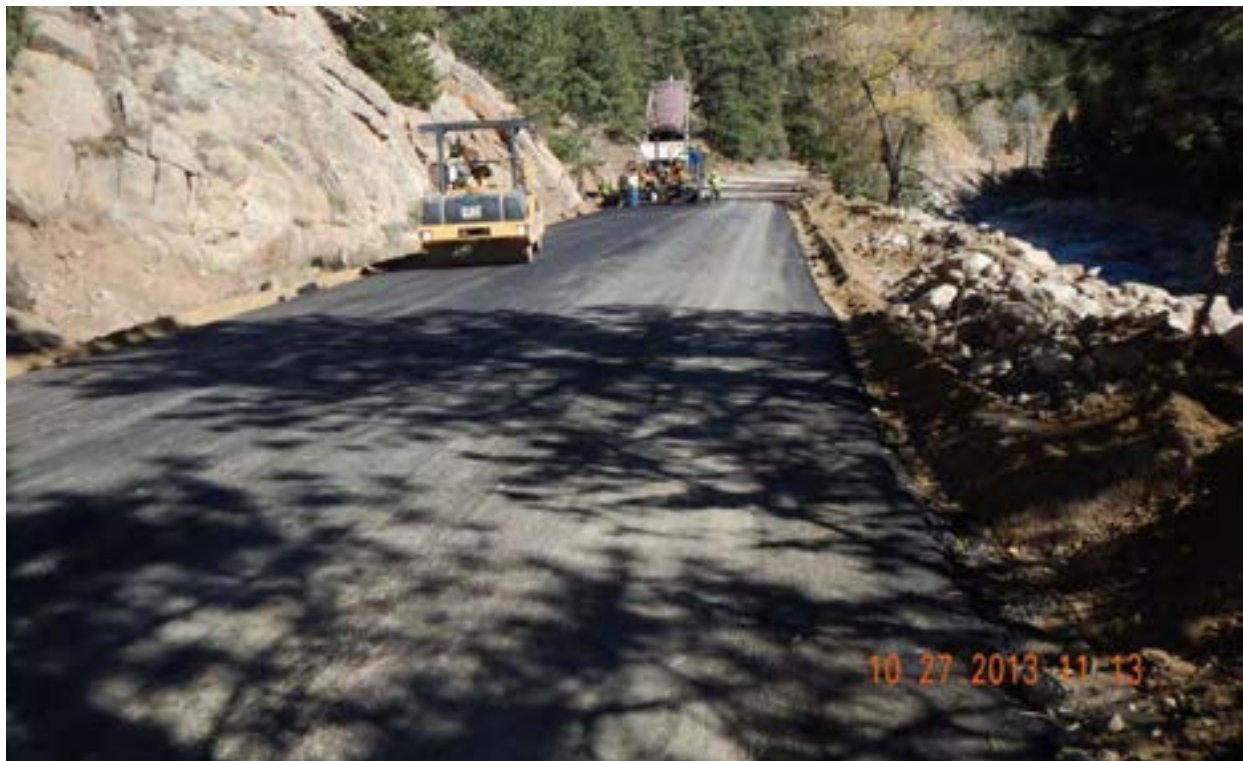
Figure 50 - MP 25.3 Facing east, Roadway repair.

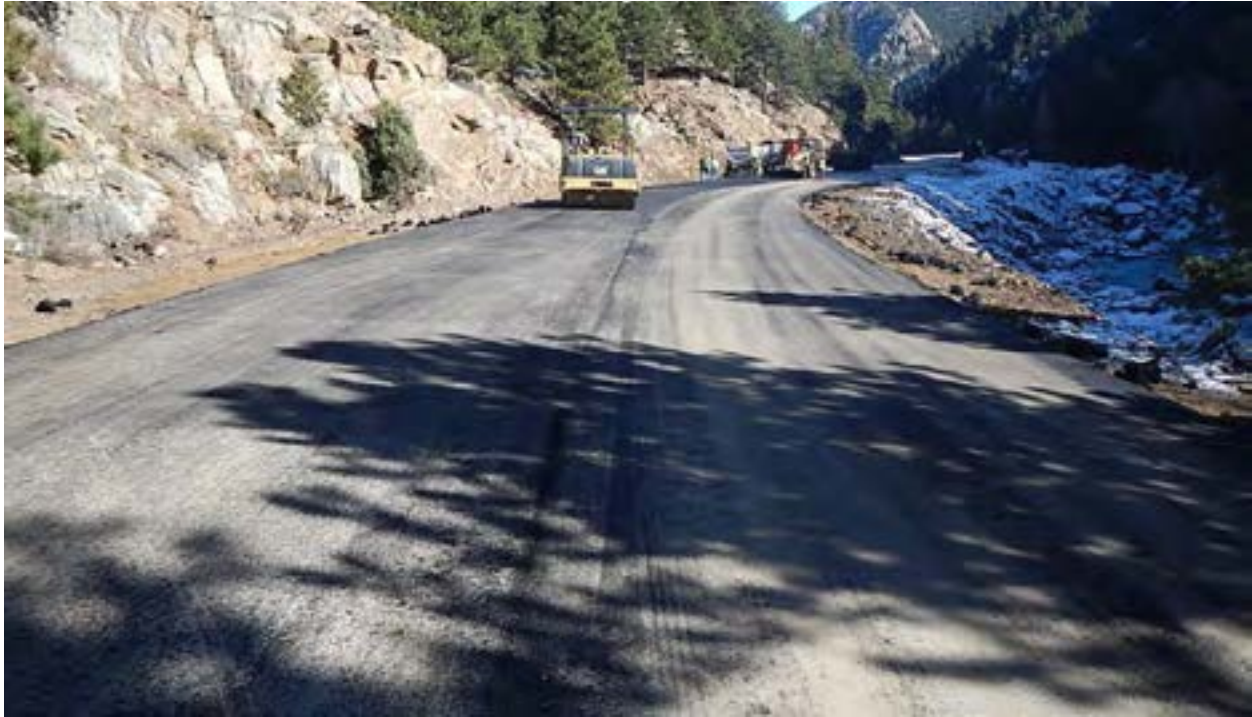
Figure 51 - MP 25.5 Facing east, Roadway repair.

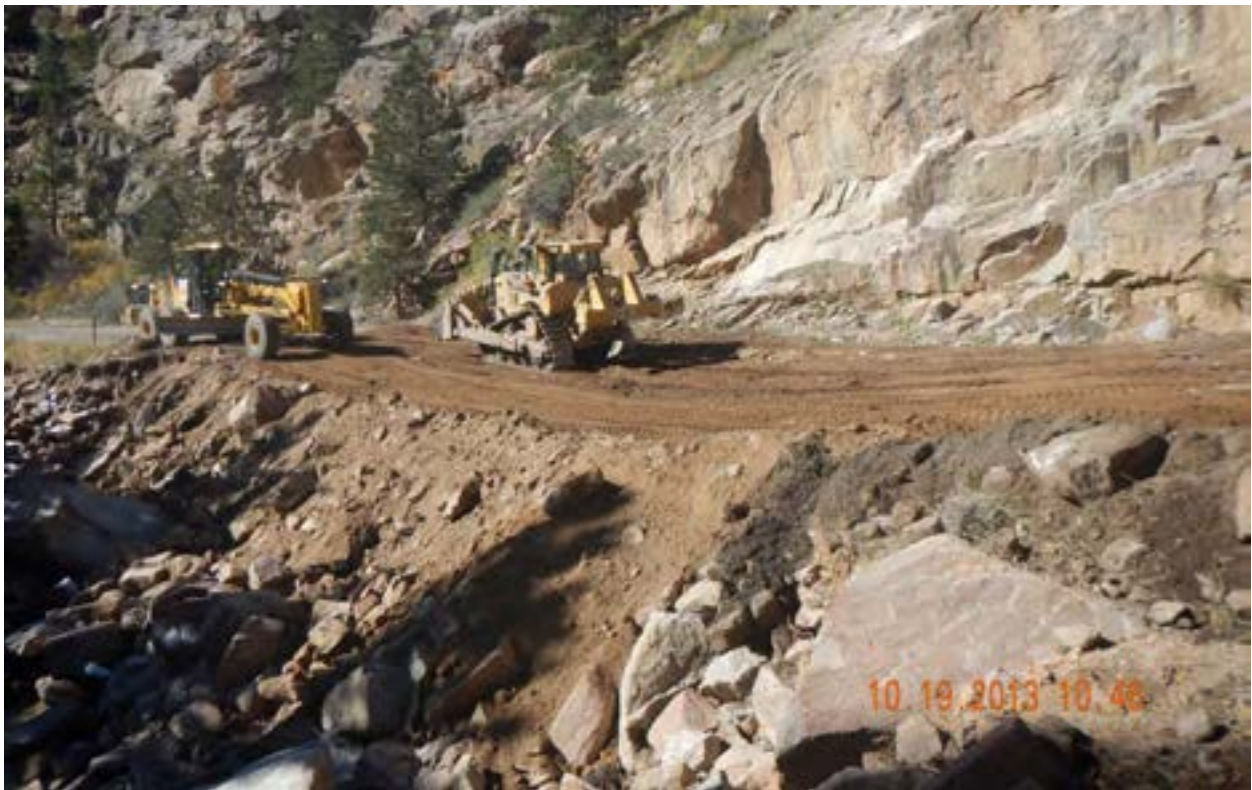
Figure 52 - MP 25.9 Facing west, Roadway repair.

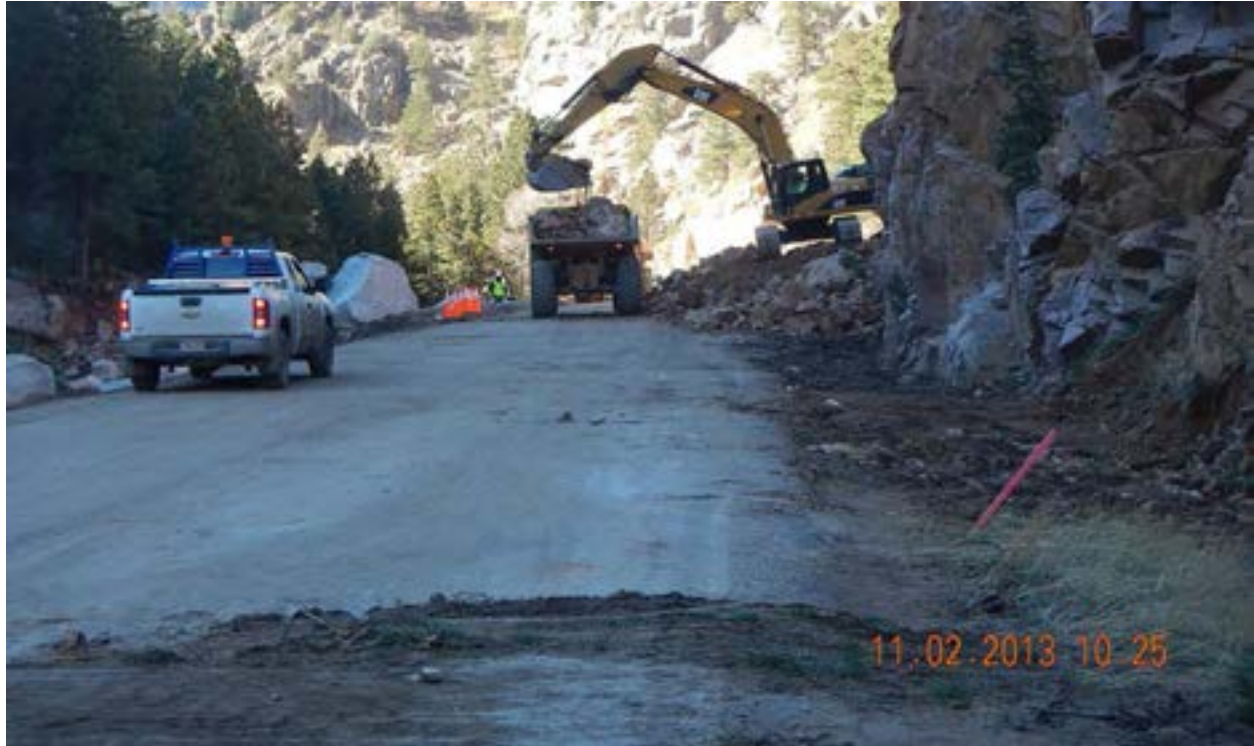
Figure 53 - MP 26.2 Facing west, Clearing rockfall.

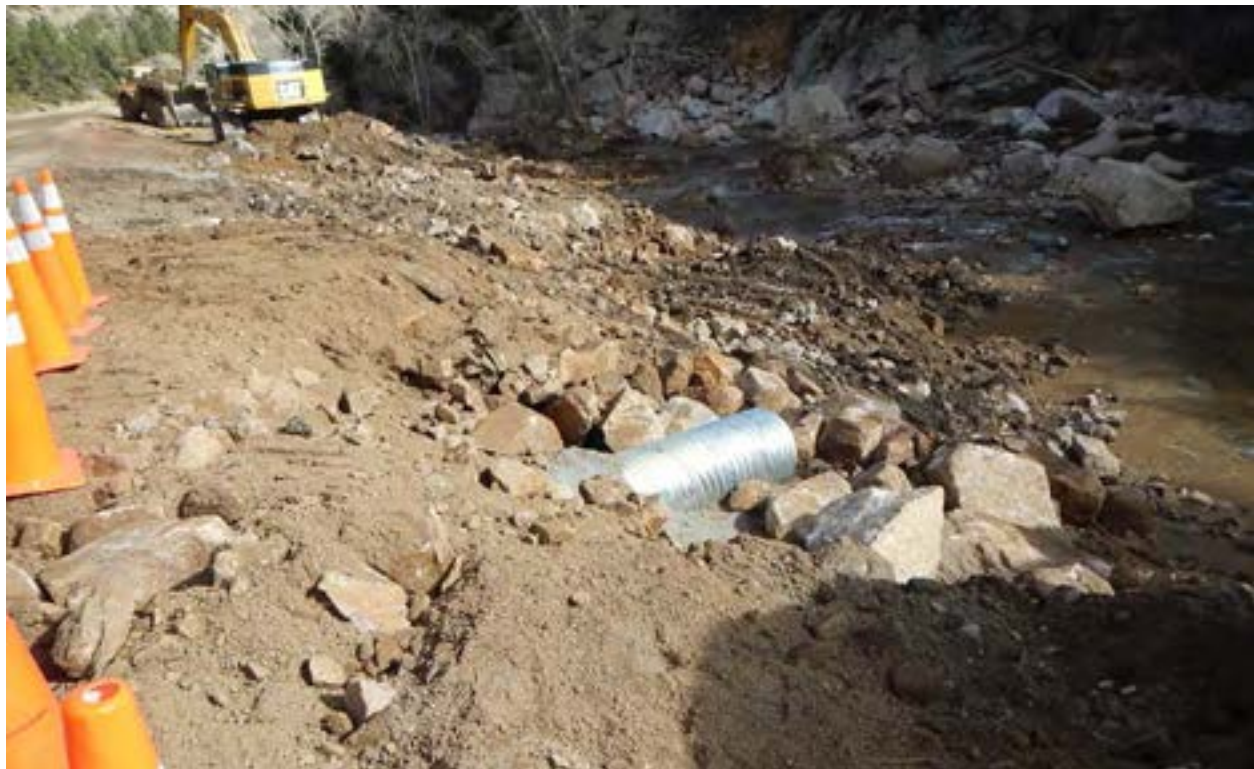
Figure 54 - MP 26.2, CMP Repair.

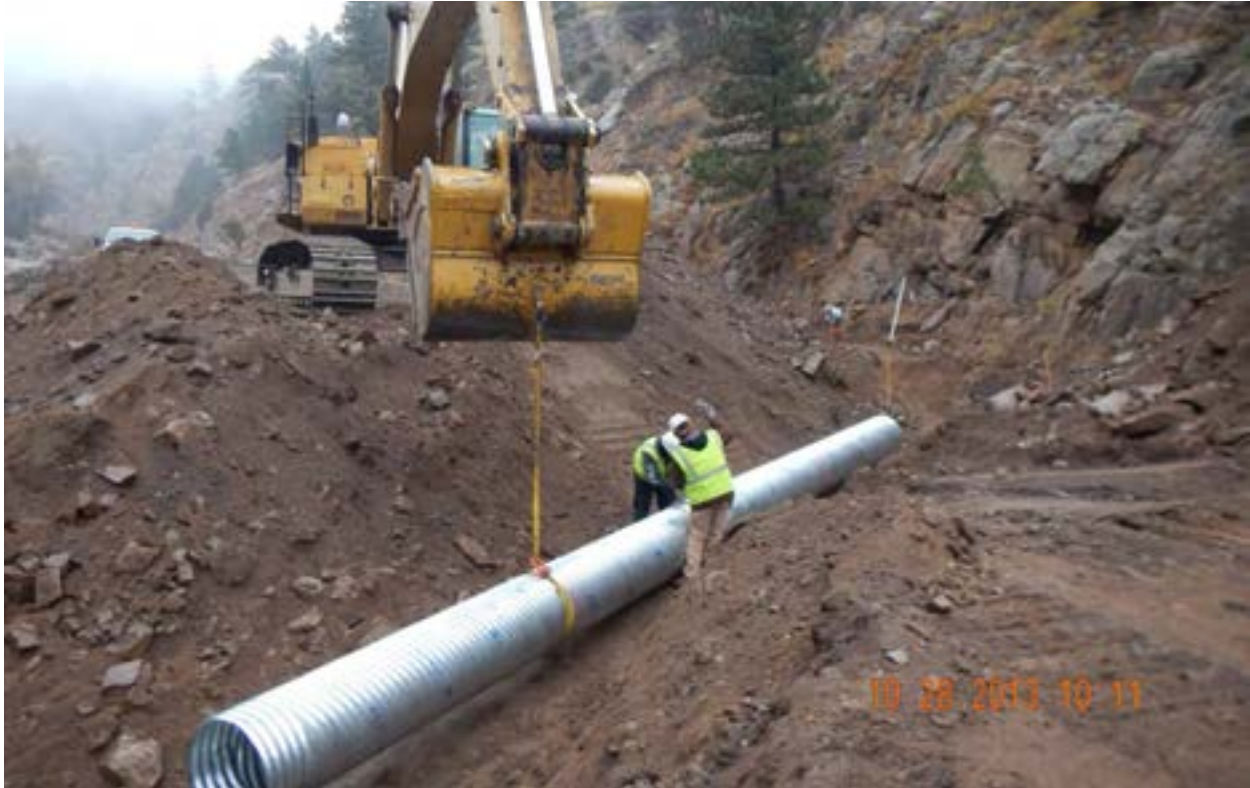
Figure 55 - MP 26.5, CMP repair.

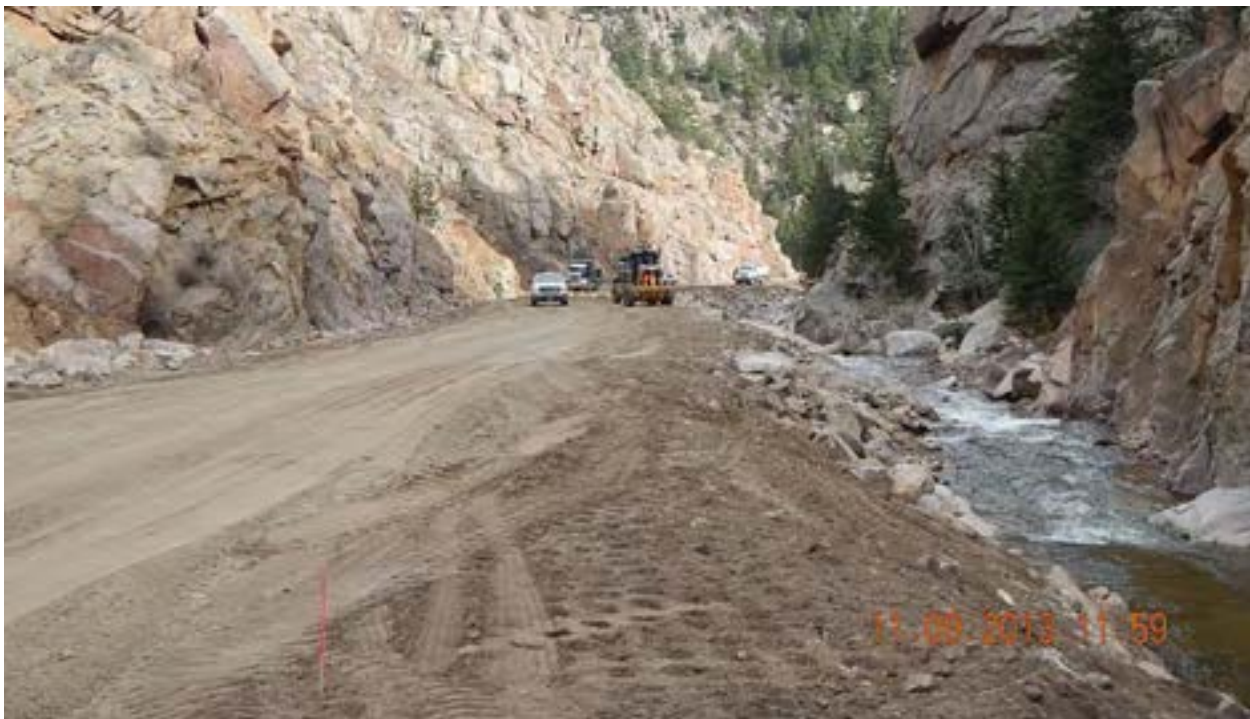
Figure 56 - MP 26.9, Facing northeast, Roadway repair.

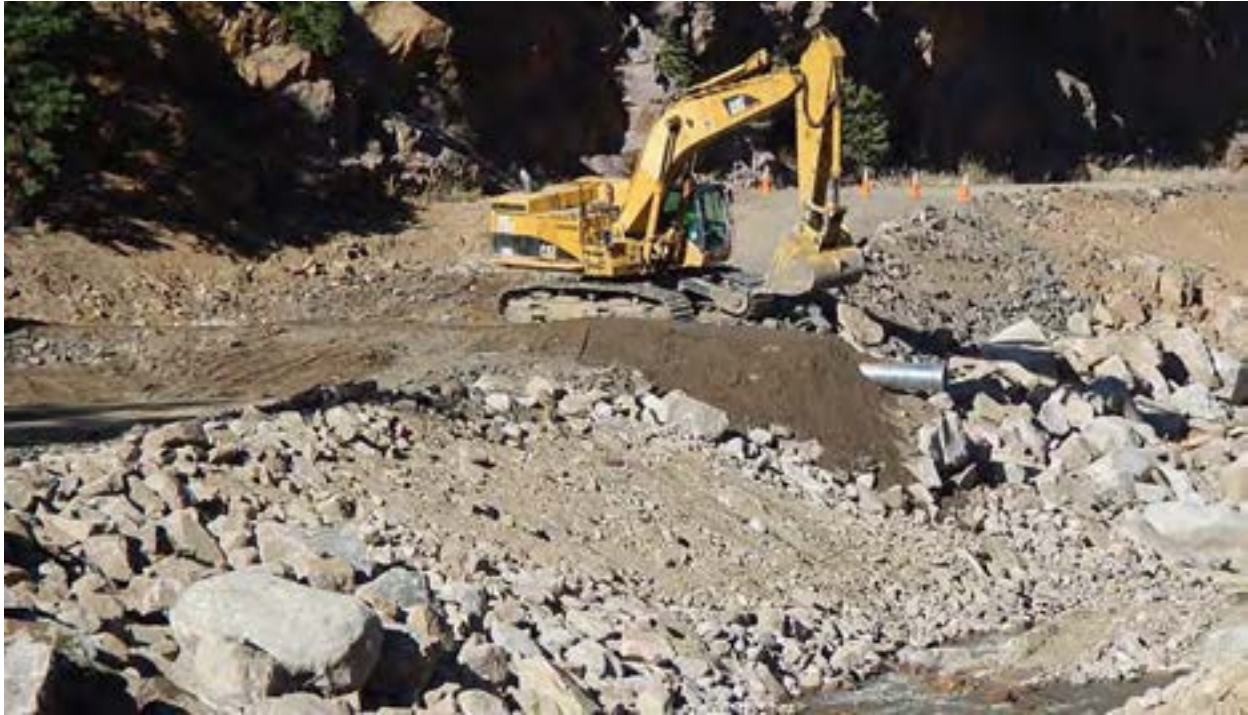
Figure 57 - MP 27.2, Facing north, Roadway and CMP repair.

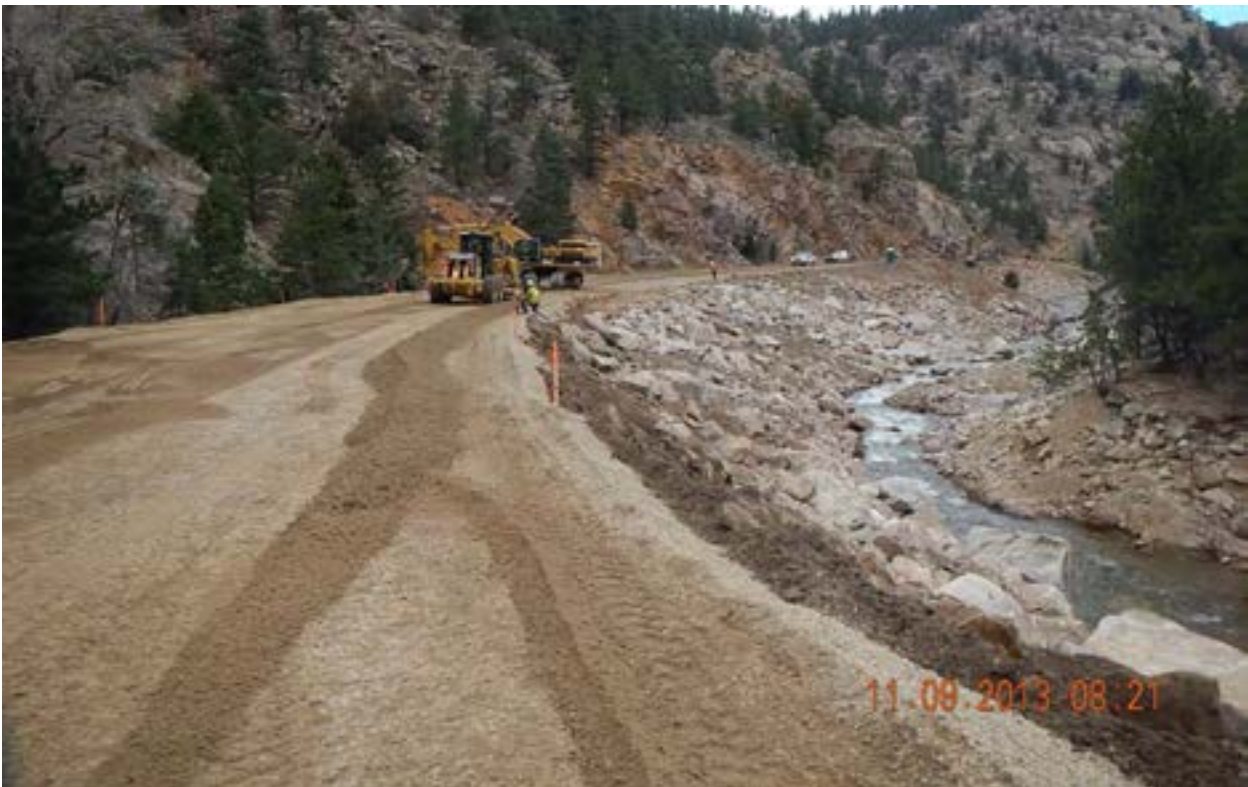
Figure 58 - MP 27.2, Facing north, Roadway repair.

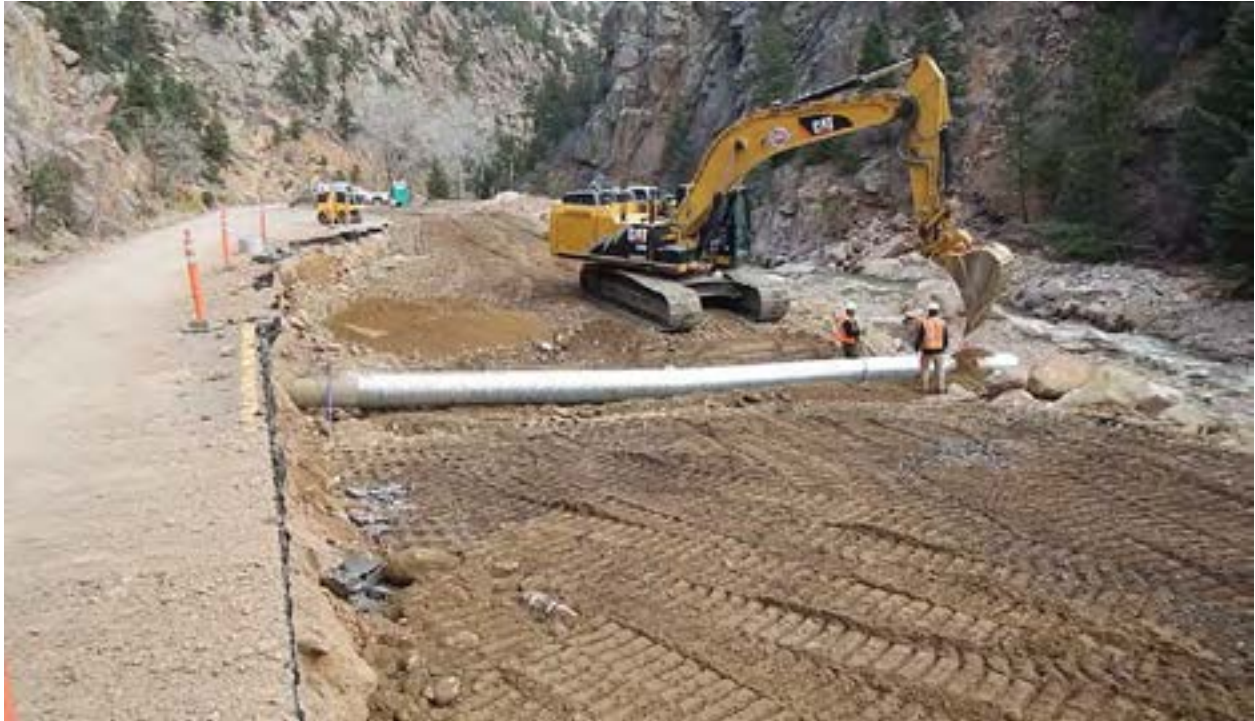
Figure 59 - MP 27.35, Facing North, Roadway and CMP repair.

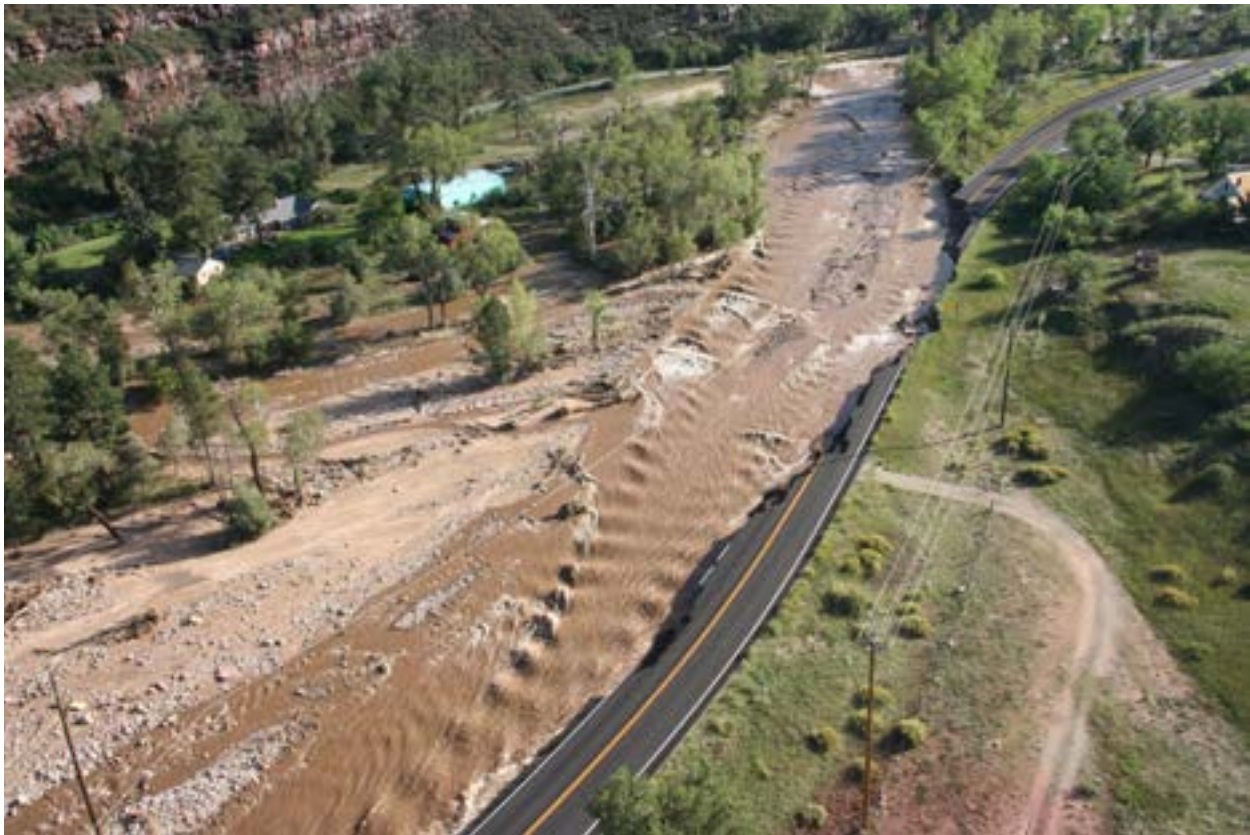
Figure 63 - MP 31.3 – 31.42, Riverside embankment washout and EB and WB undermined pavement loss.

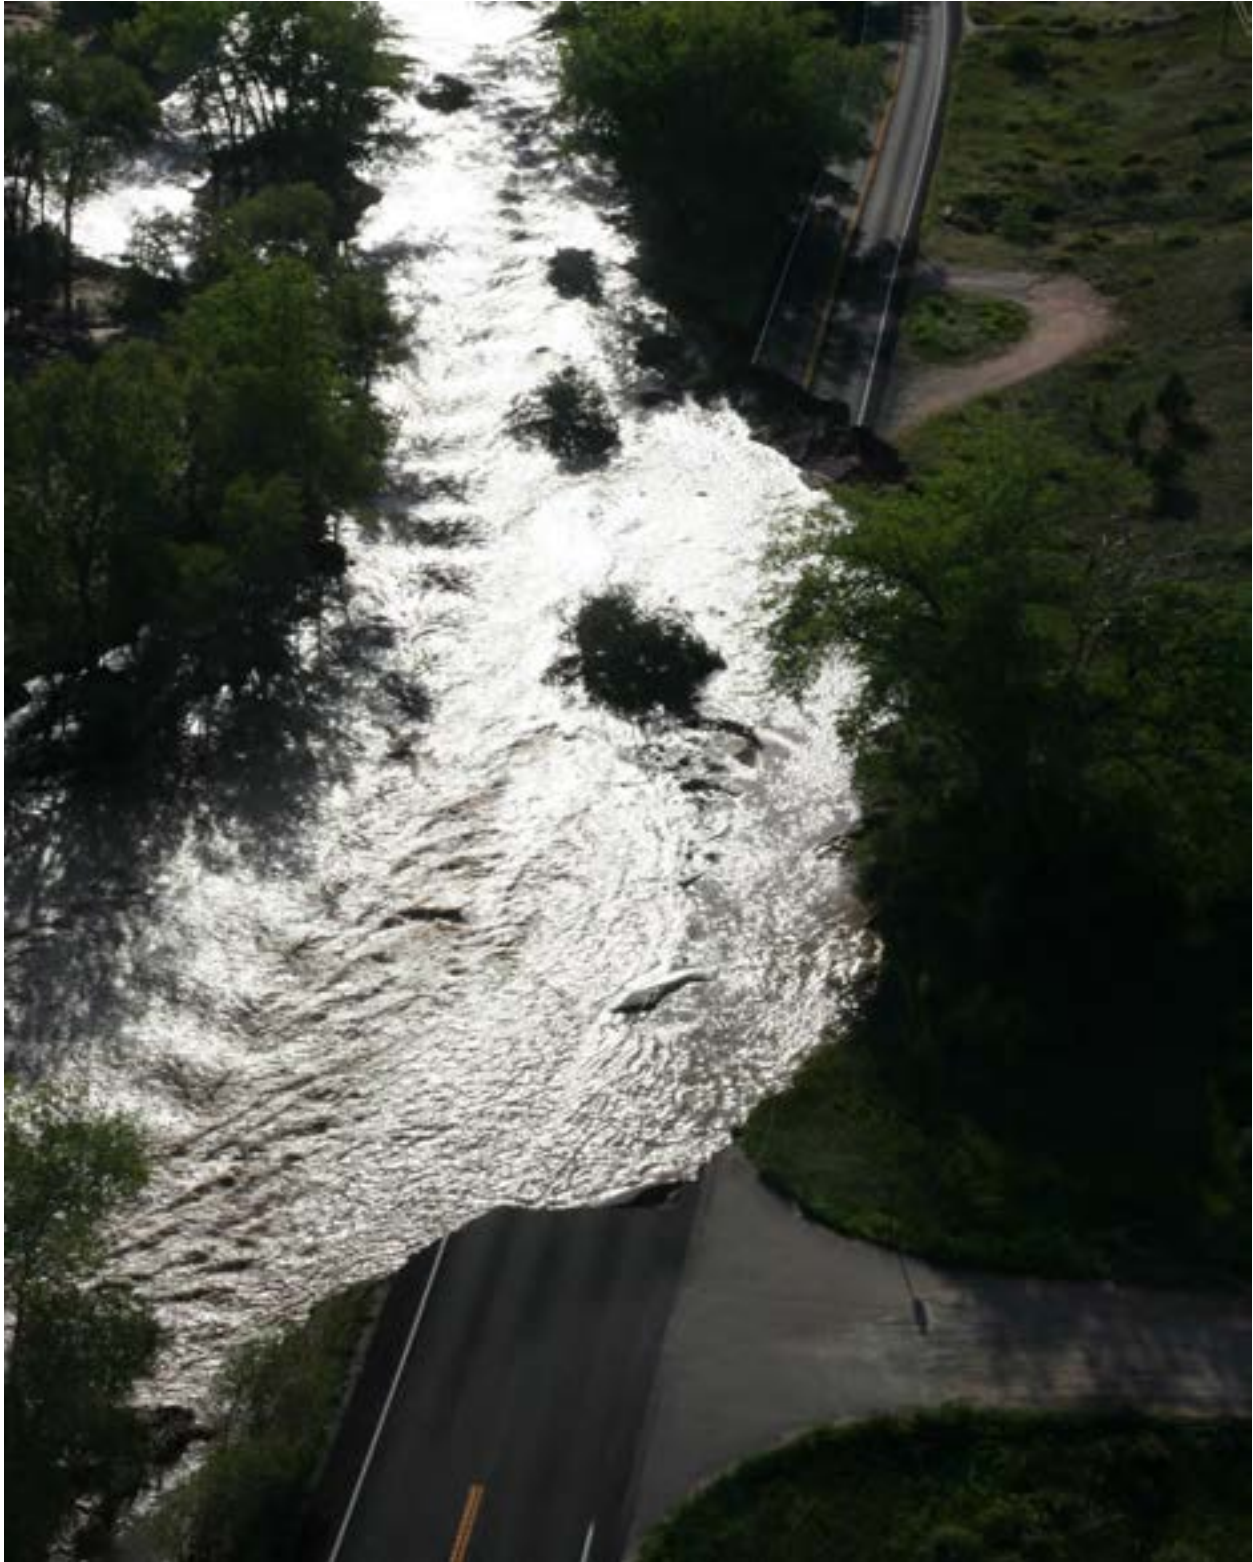
Figure 64 - MP 31.64, Complete loss of roadway.

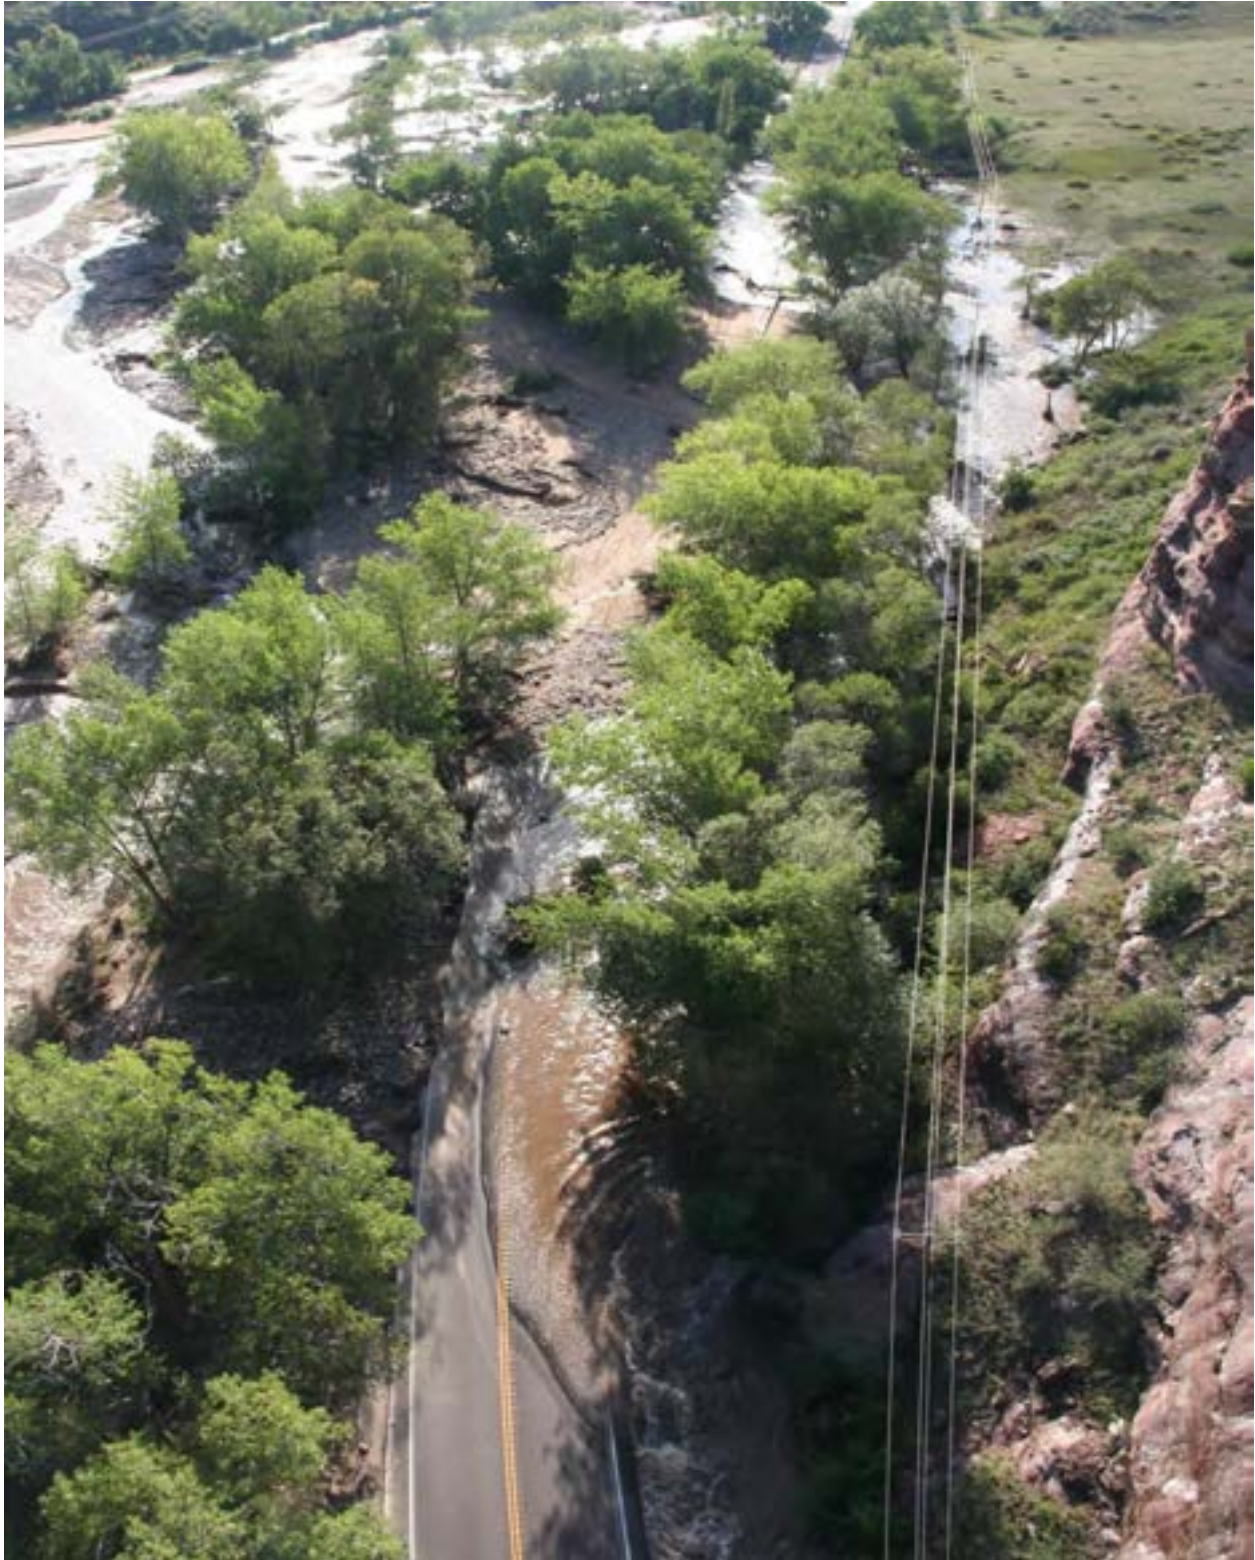
Figure 65 - MP 31.64, Roadway overtopped throughout section, shoulder and ditch washouts on both sides.

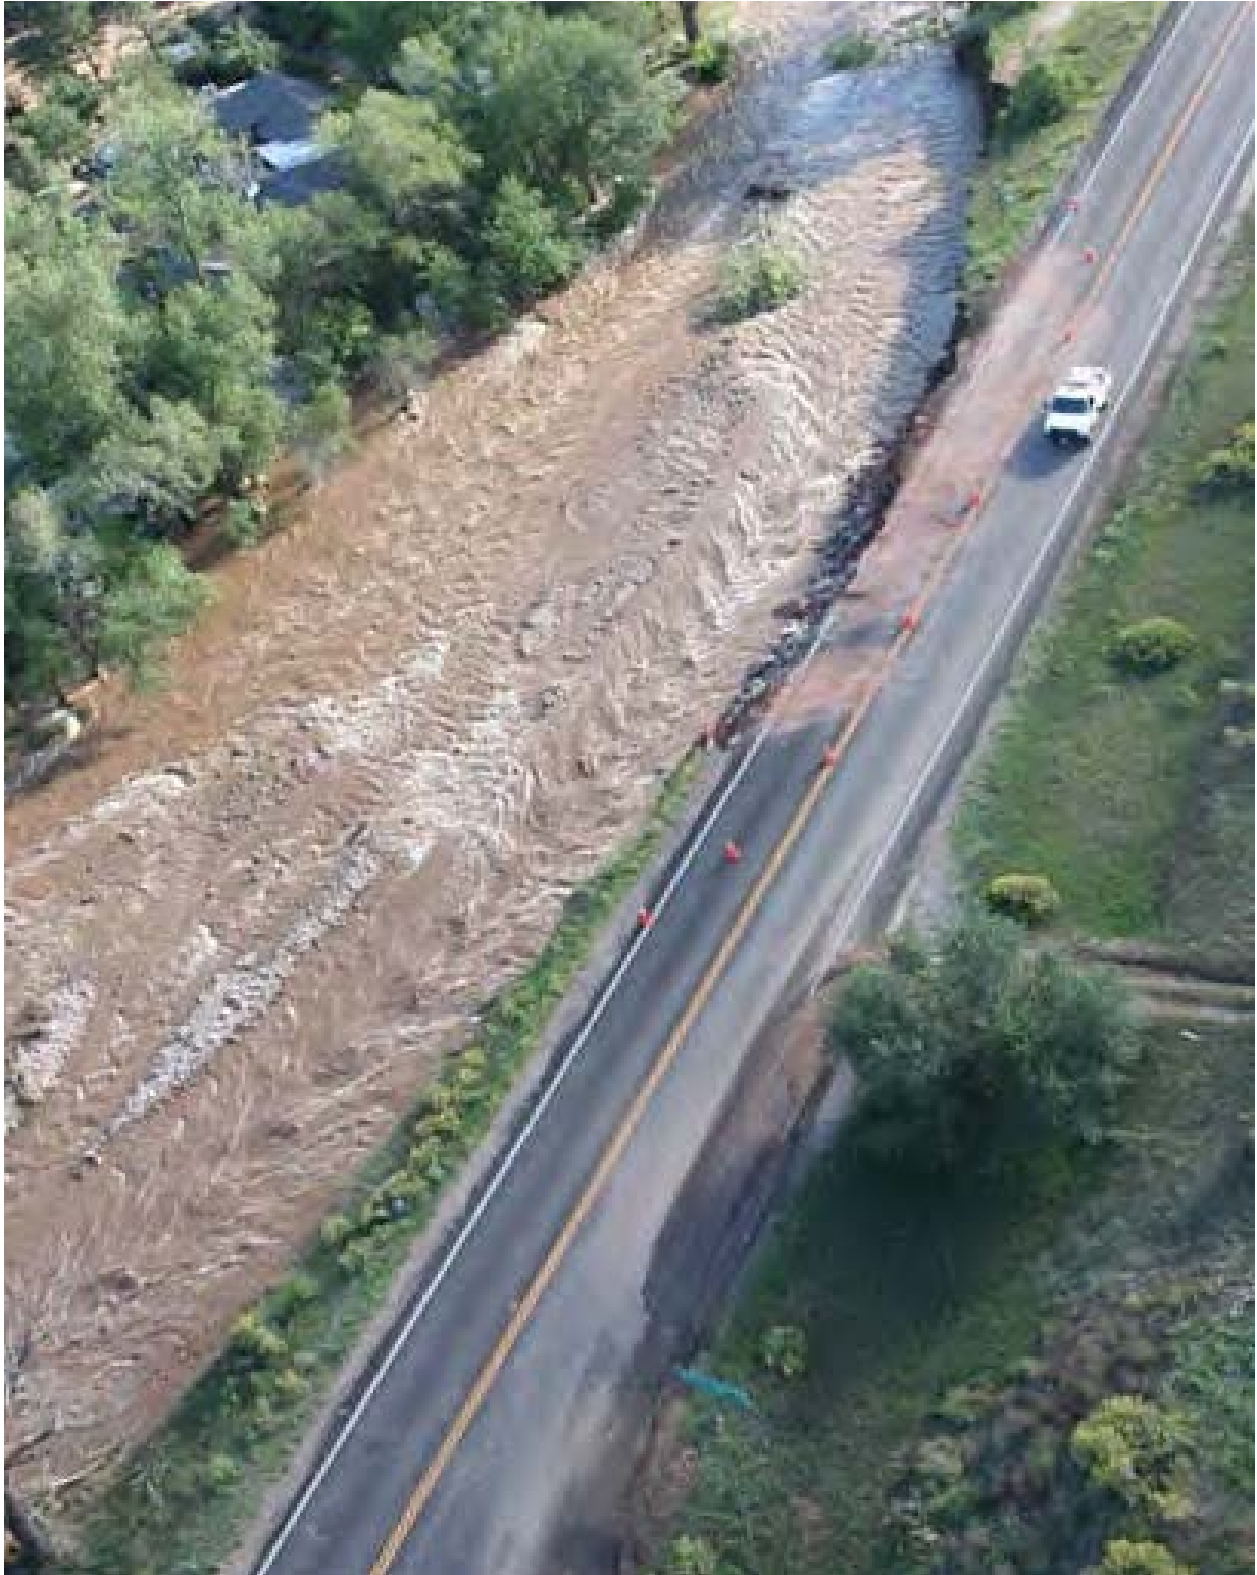
| Milepost | | Description of Damage - All Dimensions are "Approximate" |
|---|---|---|
| 32.66 | 32.7 | The riverside embankment washed out and the paved shoulder was undermined. |

Figure 66 - MP 32.7, Riverside embankment washout and undermined paved shoulder.

| Milepost | | ER Work |
|---|---|--|
| 32.66 | 32.70 | Repair embankment and undermined shoulder. |

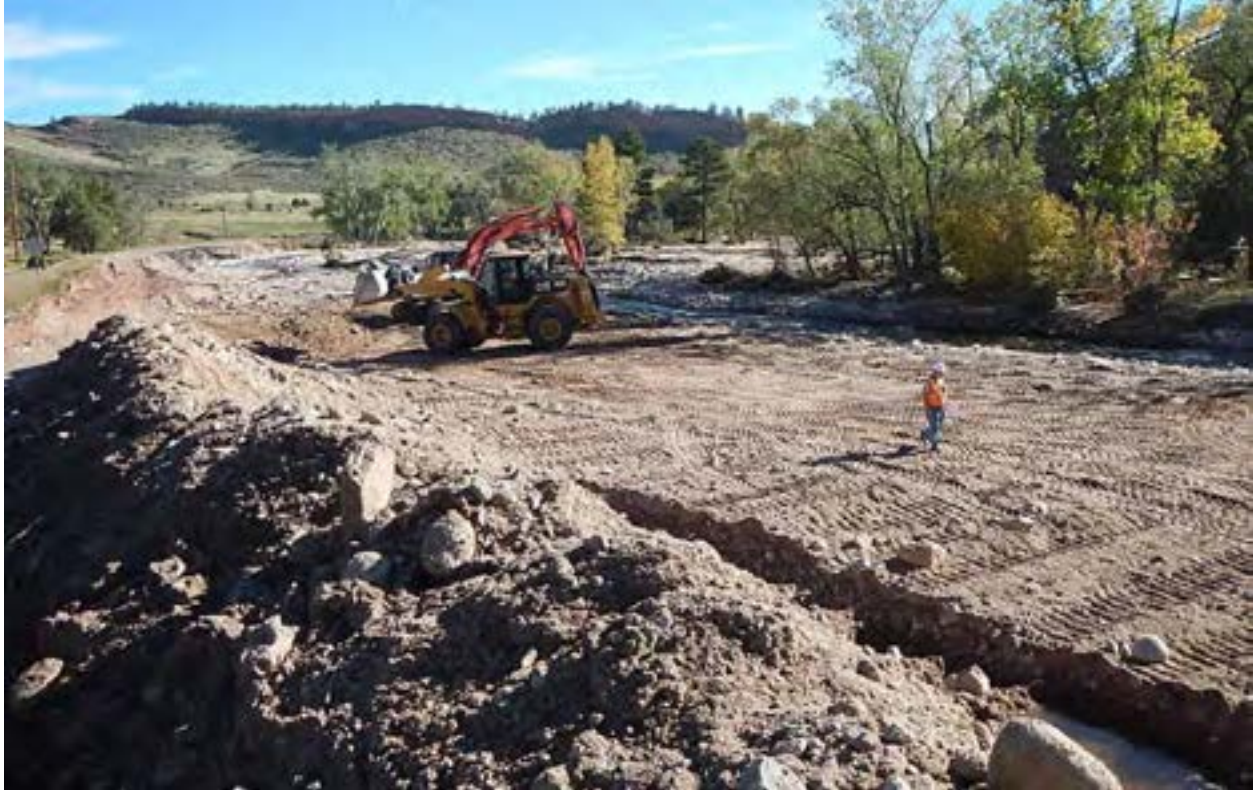
Figure 67 - MP 31.2, Facing southwest, ER Roadway repairs.

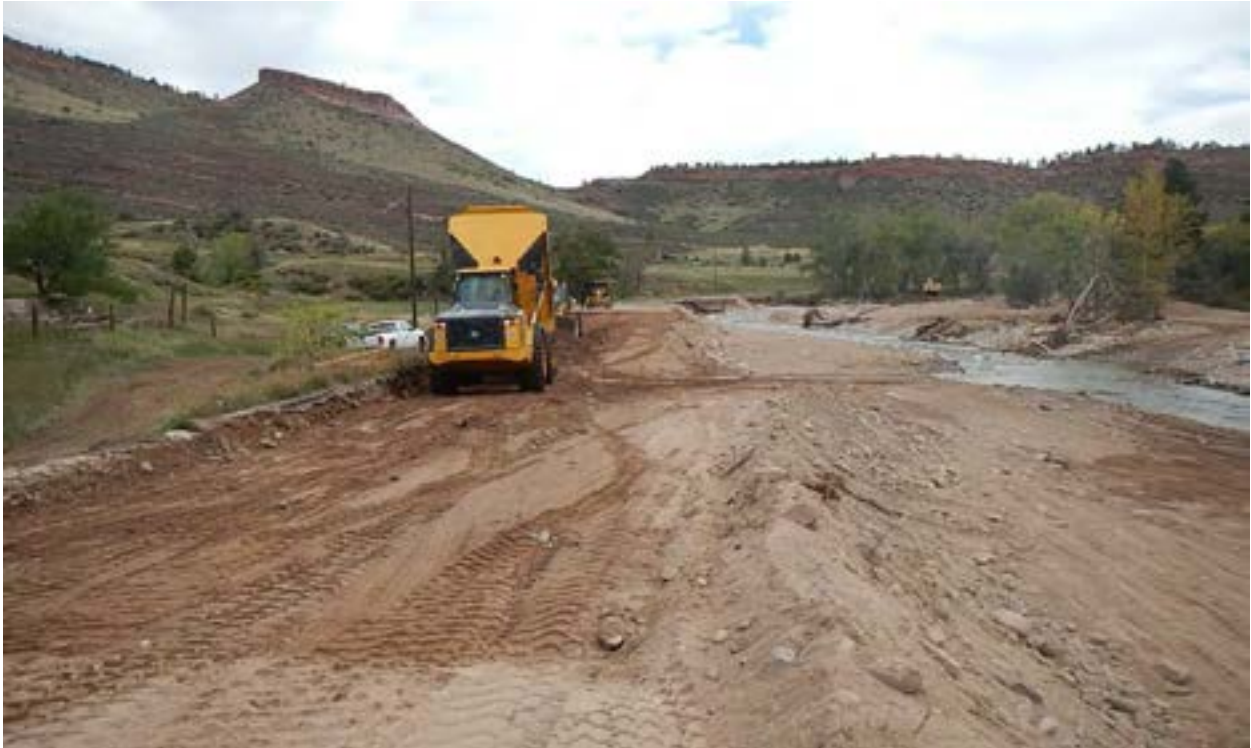
Figure 68 - MP 31.2, Facing northeast, ER Roadway repairs.

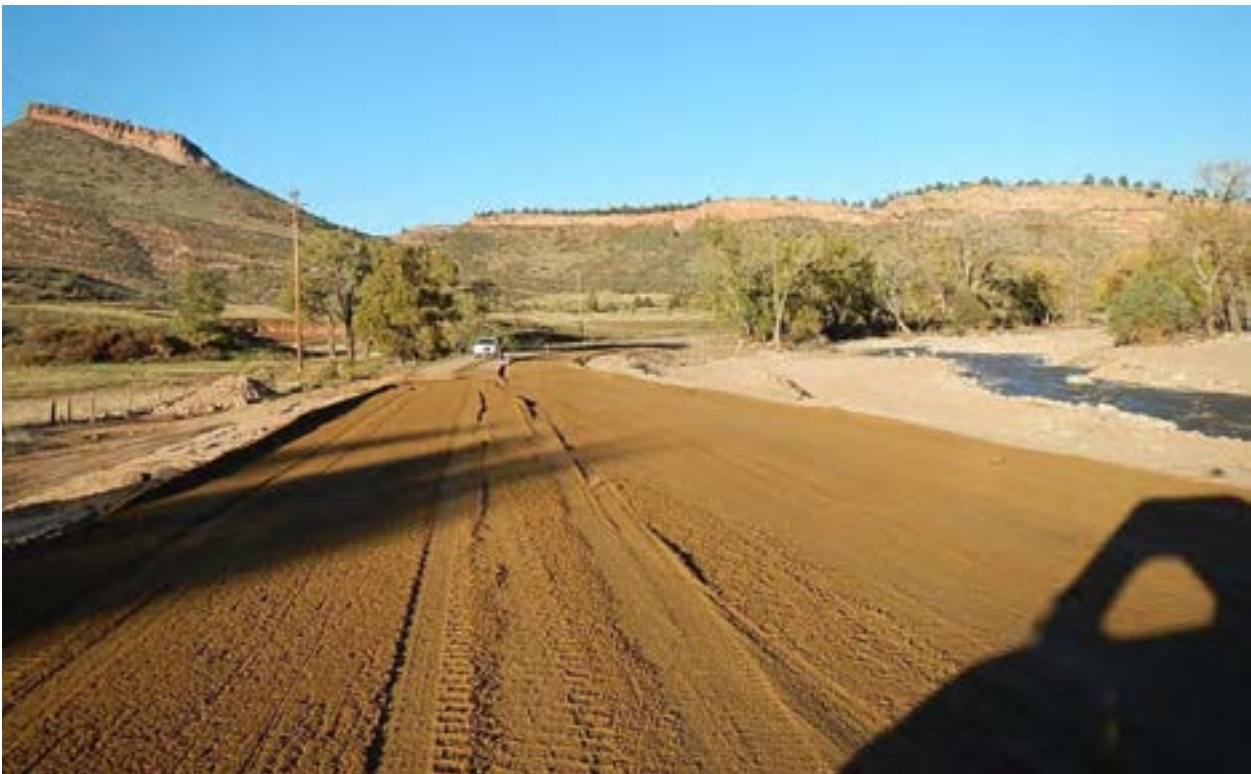
Figure 69 - MP 31.2, Facing northeast, ER Roadway repairs.

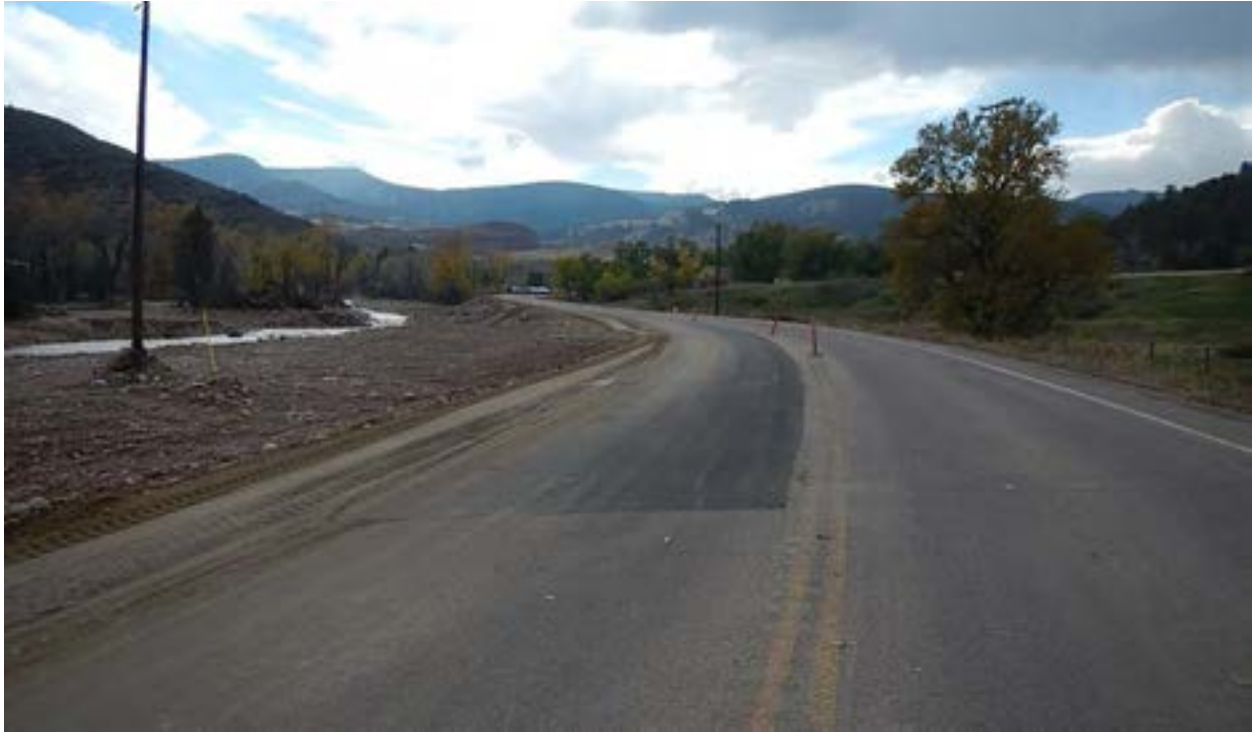
Figure 70 - MP 31.2, Facing southwest, ER Roadway repairs.
