**SH 7A (Lower)
Raymond to Lyons
Site Repairs between Mileposts 19 and 33**

**Boulder County
COLORADO**

Damage Assessment Report

**100% DRAFT
Revised: July 28, 2014**

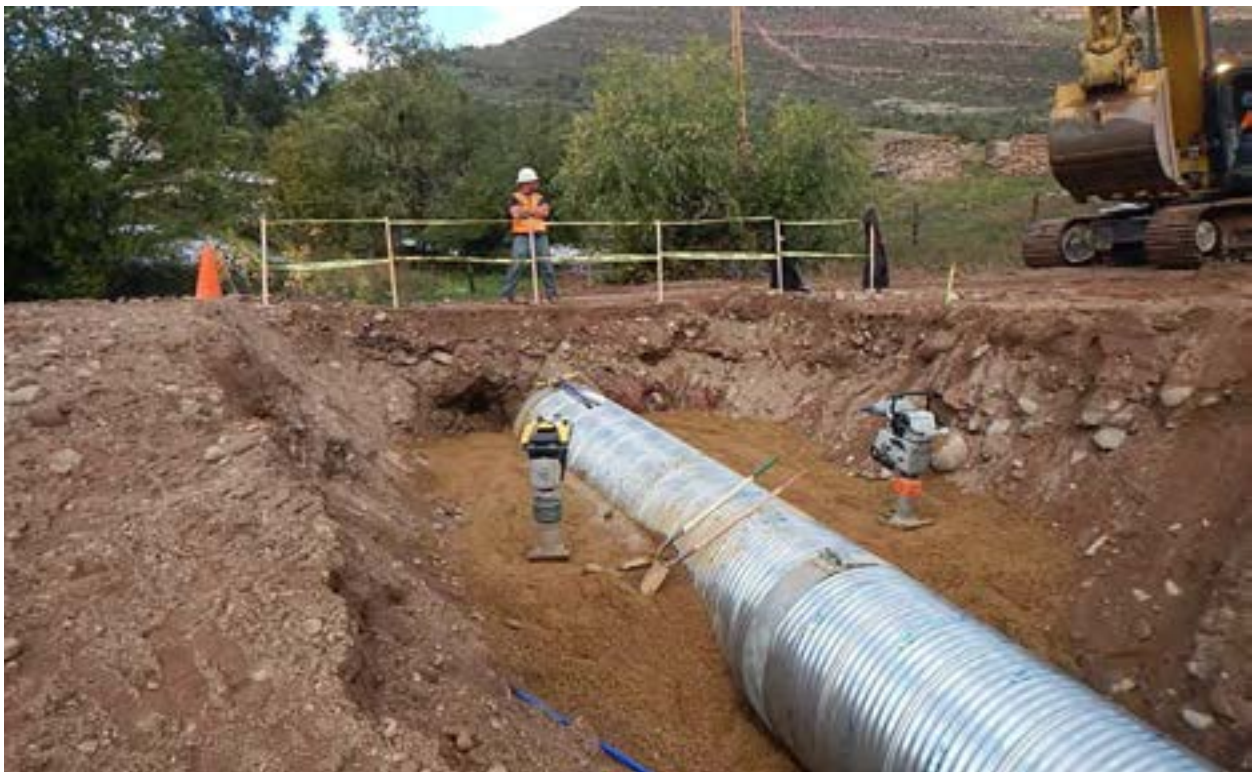
Figure 71 - MP 31.2, ER CMP Installation.

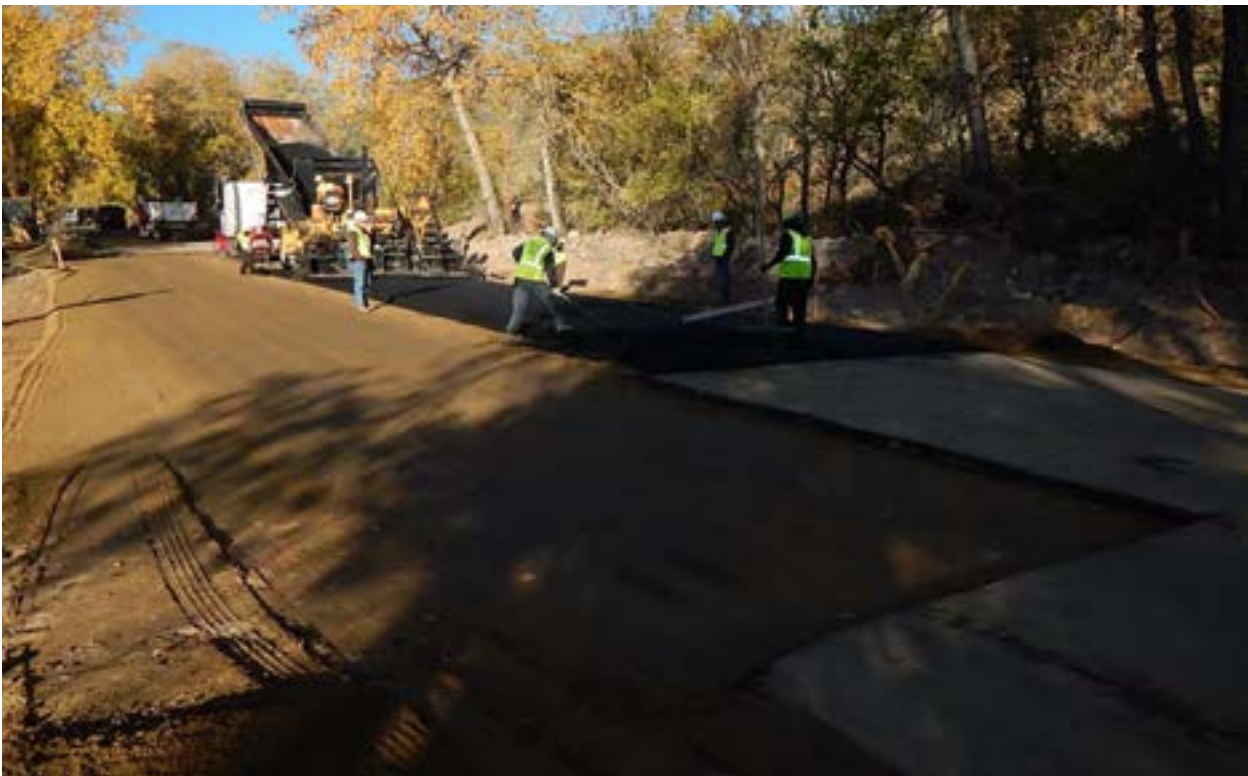
Figure 73 - MP 31.7, ER Paving operations.

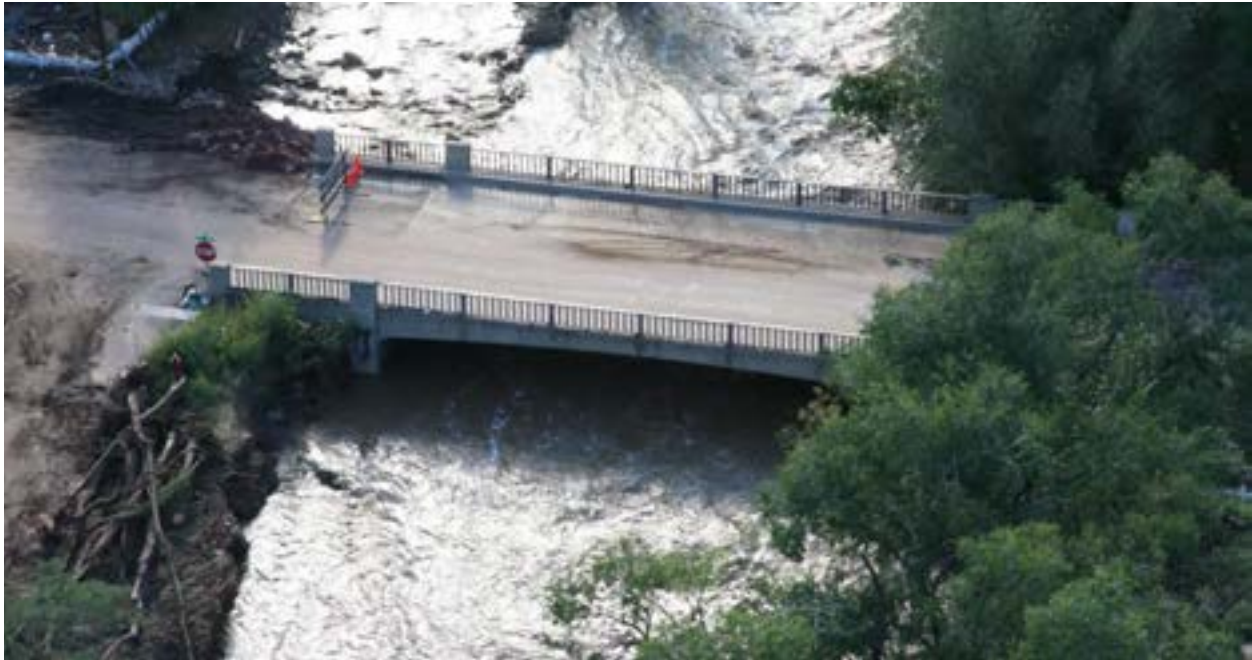
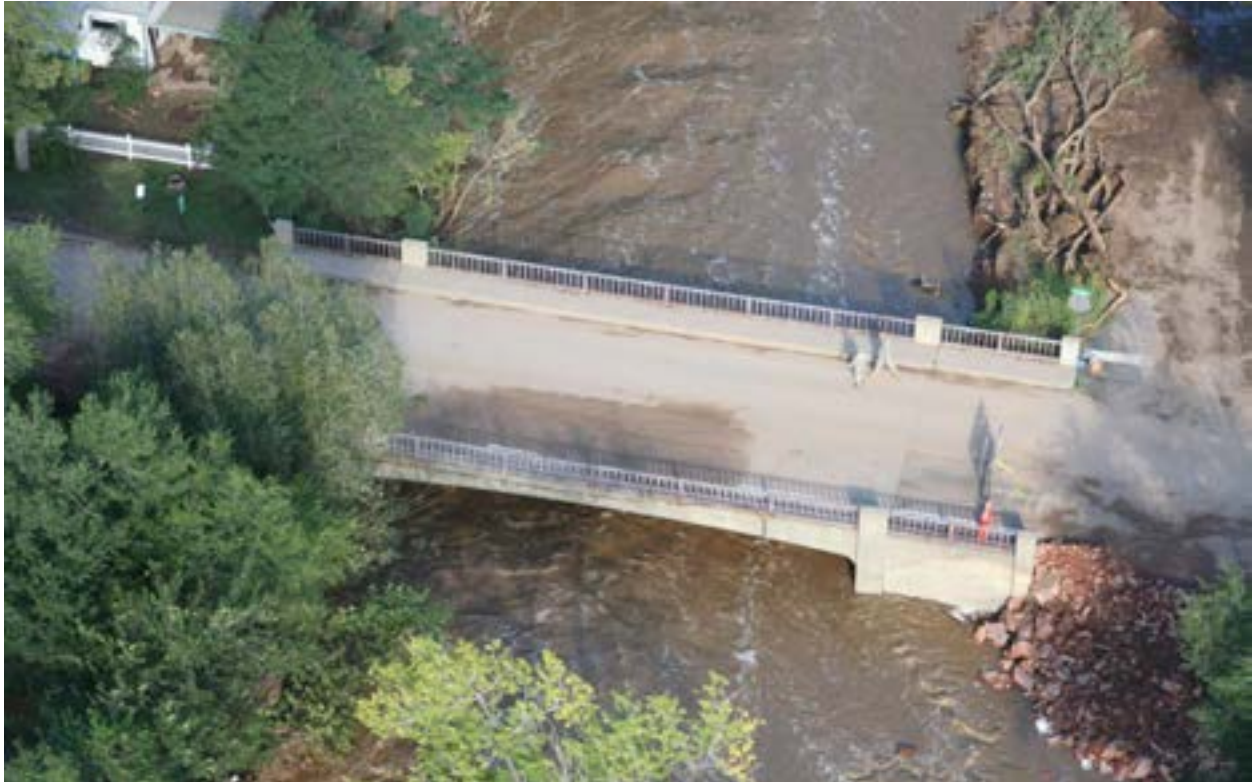
| Milepost | | Description of Damage |
|---|---|--|
| 32.98 | 32.98 | Structure D-15-A had scour damage at the south abutment, both on the upstream and downstream sides. The pavement was undermined behind the abutment at the southwest corner. |

Figure 76 - MP 32.98, Structure D-15-A with abutment scour and undermined pavement behind abutment.

Figure 77 - MP 32.98, Structure D-15-A with abutment scour and undermined pavement behind abutment.

| Milepost | | ER Work |
|---|---|--|
| 32.98 | 32.98 | Repaired abutment scour and undermined pavement. |

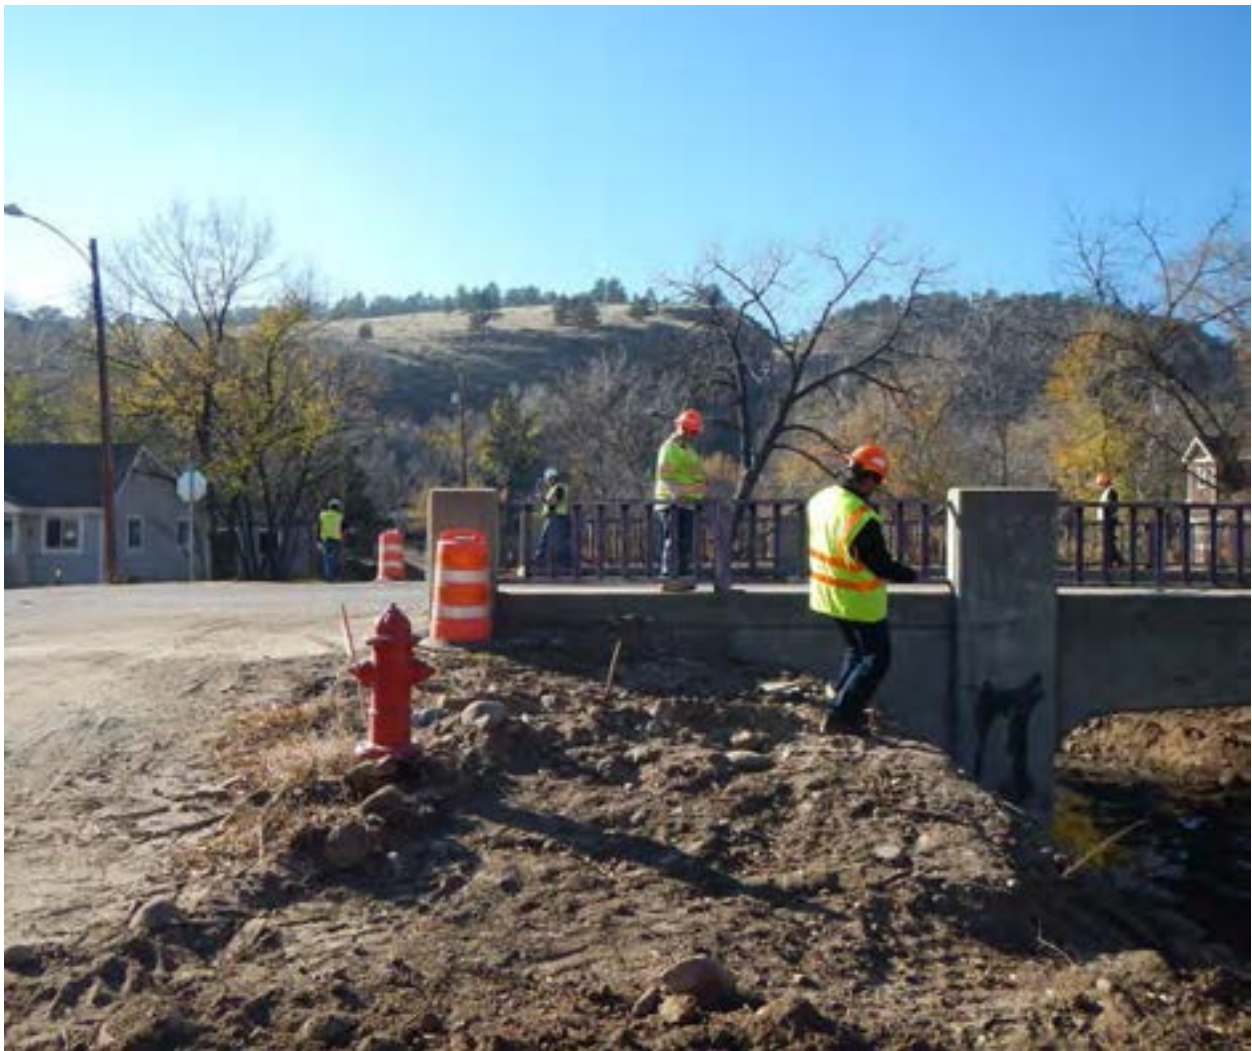
Figure 78 - MP 32.98, Facing west, Structure D-15-A embankment repair.

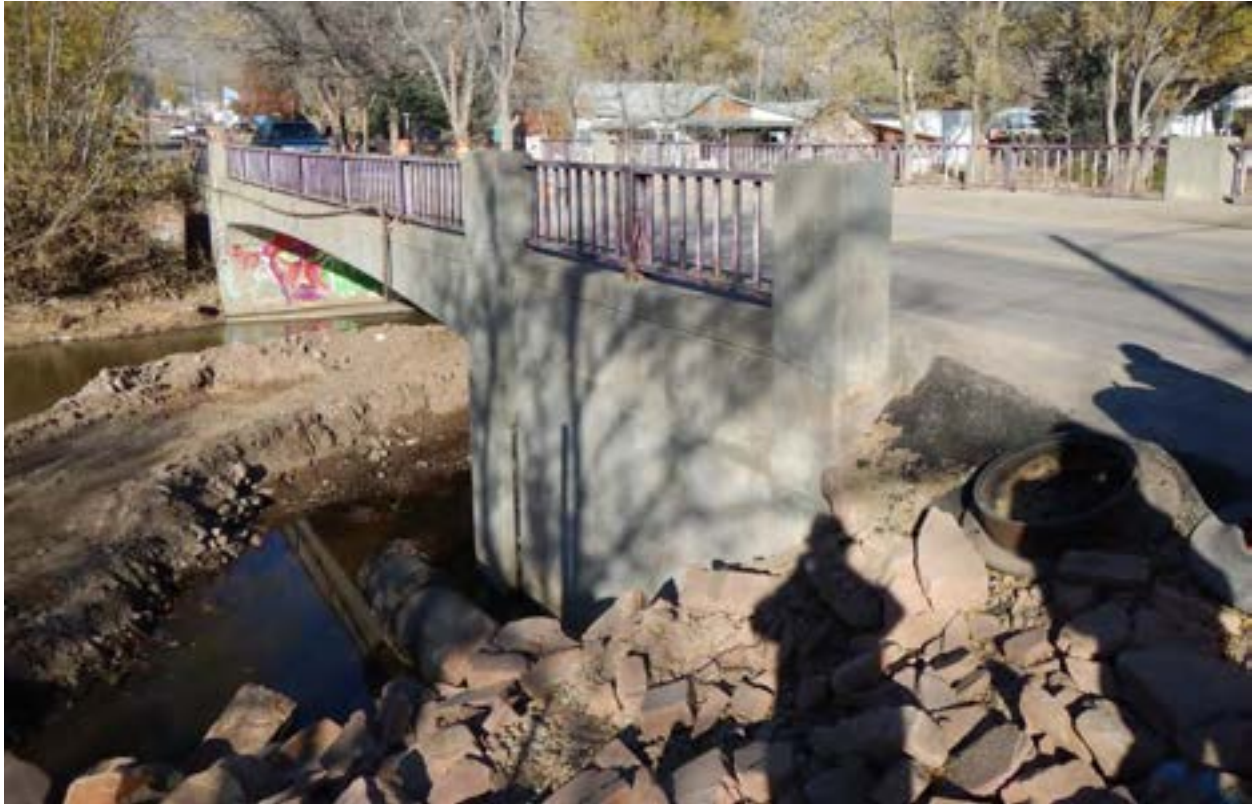
Figure 79 - MP 32.98, Facing northeast, Structure D-15-A temporary access.
