**Colorado City Rest Area - Cuerno Verde - I-25 MM 74.39**  
**Elevation 5853'**

**CDOT Region #2**

## Summary Observations

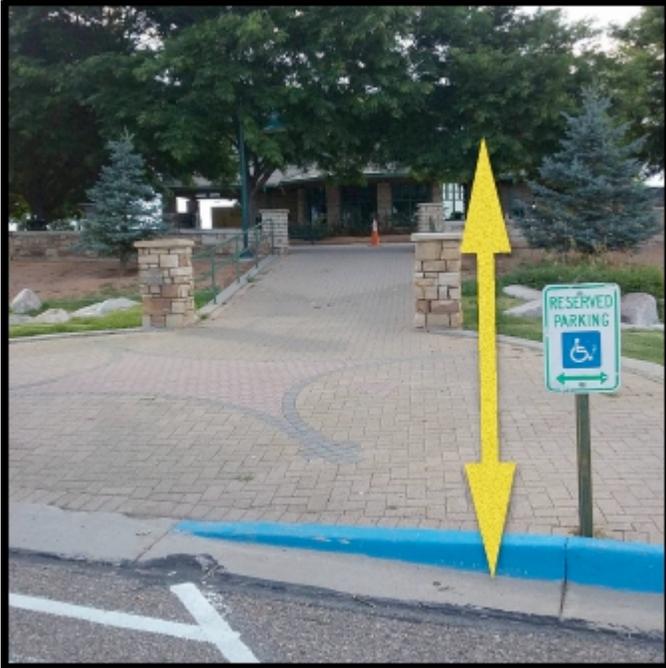
#1 - raise signs to 80"

The two vertical parking signs should be raised to a minimum 60" with a recommended height of 80" for adequate clearance along the pedestrian route. See picture.

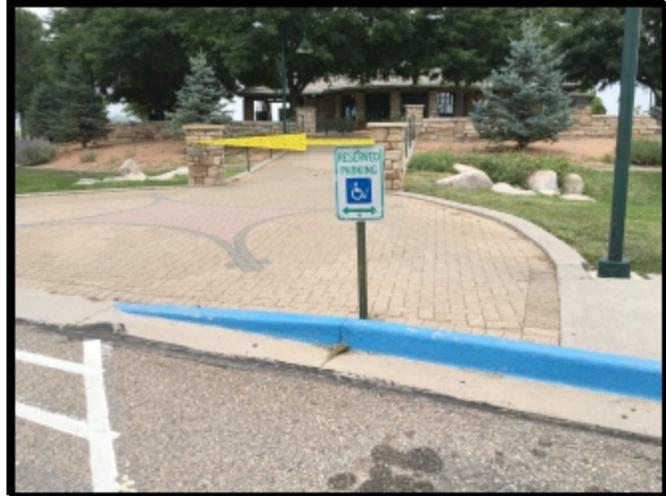
#2 - Install ISA symbol sign on stone pedestal with arrow to left

The route from the current accessible parking spaces to the building exceeds 8.33%. Suggest creating a new accessible route (**see small arrow in aerial photo above**) from two new parking spaces at the west side of the facility. This new designated accessible route has a modest slope with less than a 1:12 incline (approximately 6.5%). At the location of the current accessible parking spaces, add a directional sign with ISA (international symbol of accessibility ♿) - and an arrow pointing to the left/west.

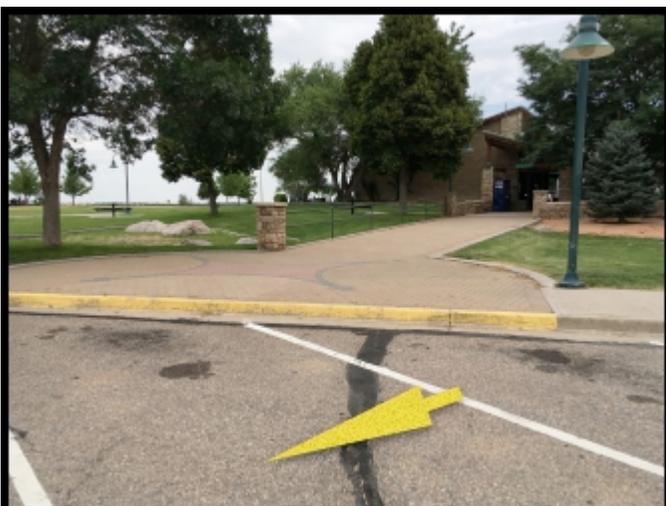
#3 & #4 - 2 new accessible spaces and curb cut

For the automobile parking area, it is recommended that two new accessible spaces be added. One of these new spaces should be identified as 'van' with an adjacent 8' access aisle. These two new spaces will serve a newly designated accessible path to the entrance at the west side of the building.

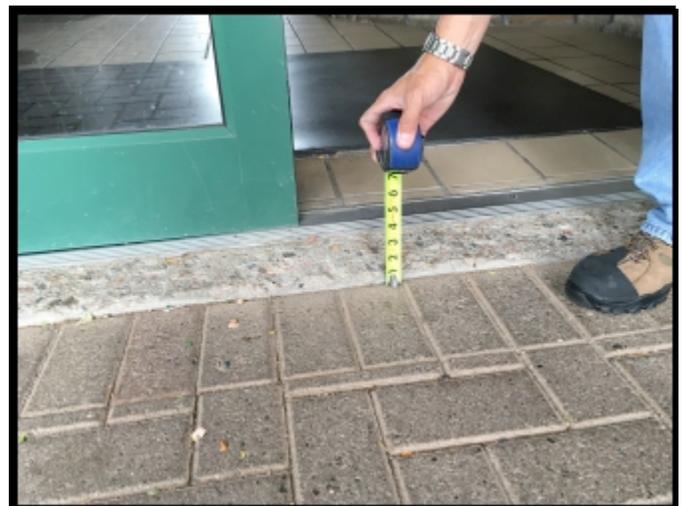
The two exterior entrances have a threshold that exceeds a 1/2" vertical lip and thus, should be fixed by grinding the leading edge or smoothing the transition from path to entrance. See picture.

#5 - Grind threshold lip/ edge <math>< 1/2''</math>

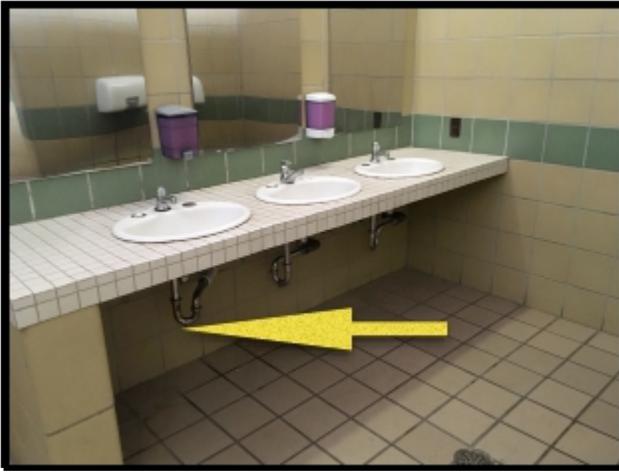
**#6 - Wrap left drain pipe  
men's room**

In general, the rest rooms are acceptable with just a few minor non-compliant elements. First, wrap the left lavatory water pipe in men's room. Secondly, add a sign on the wall on the latch side of door for the 'family' rest room. Thirdly, the women's rest room has six stalls, with one ADA accessible. With six or more stalls there should also be an ambulatory stall. This may be accomplished by just adding grab bars on each side of a regular stall, positioned next to the ADA accessible stall.

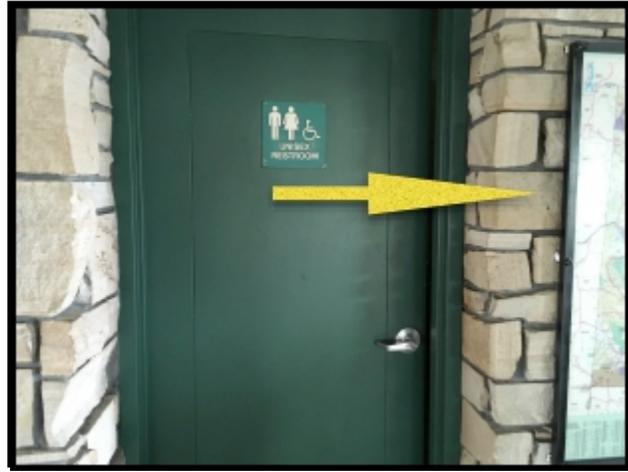
**#7 - Add sign on latch  
side of door**

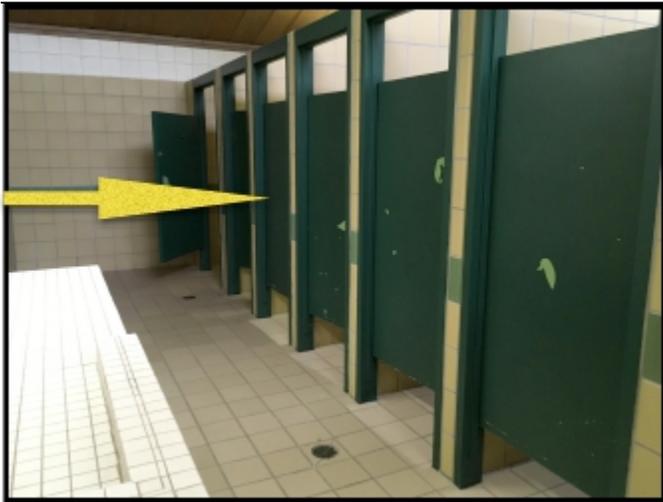
**#8 - Create ambulatory stall**

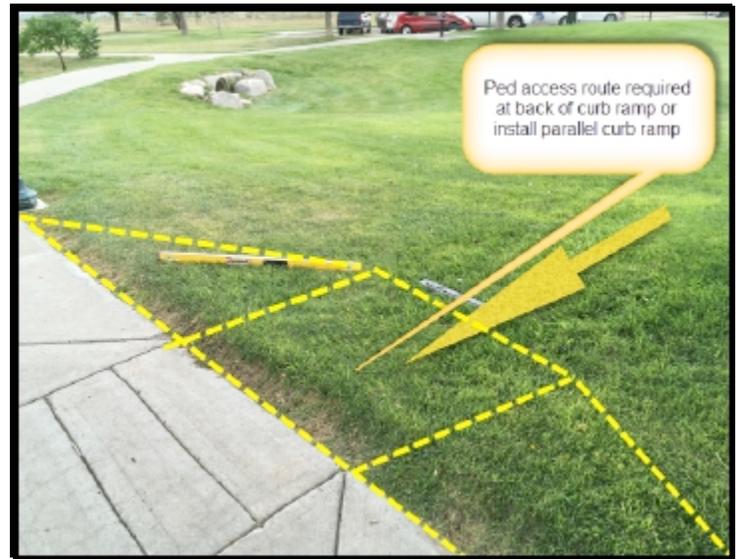
**#9 - landing area needed**

Create a 48" wide landing on top of curb cut from RV/Truck parking area (photo #9)

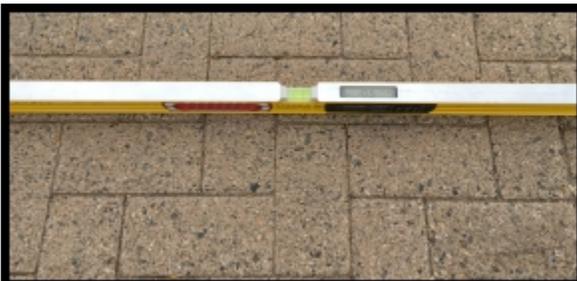
**Surface OK**

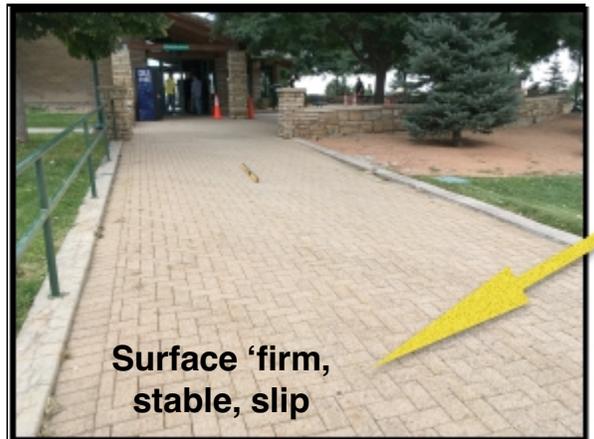
The surface of the brick pavers for the two ramps to the building are ADA acceptable as they are 'firm, stable, and slip resistant.' The brick pavers do have small gaps, but they are not excessive and there are not any vertical edges in excess of 1/2".

**Surface 'firm,  
stable, slip**

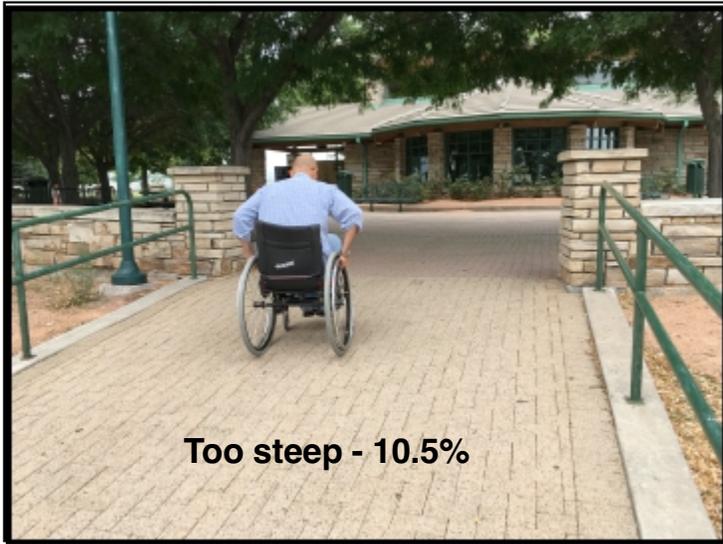
Too steep - 10.5%

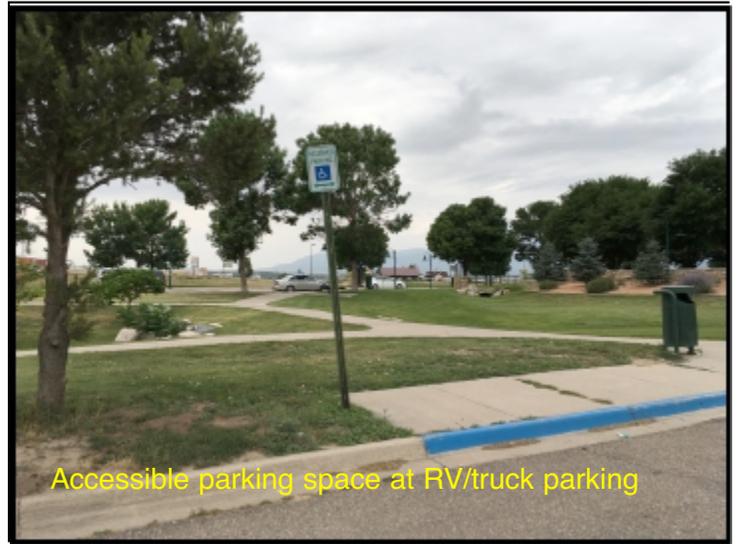
There is a separate parking area for RV's and trucks. There is a designated accessible parking space with proper signage for a truck. This space is adjacent to a curb cut for access to a path-of-travel to building. See last picture.

Accessible parking space at RV/truck parking
