Report No. CDOH-DTD-R-90-3

**COLD-RECYCLING OF
ASPHALT PAVEMENT - U.S. 24
PROJECT CX-04-0024-25**

Donna S. Harmelink
Colorado Department of Highways
4201 E. Arkansas Avenue
Denver, Colorado 80222

Final report
June 1990

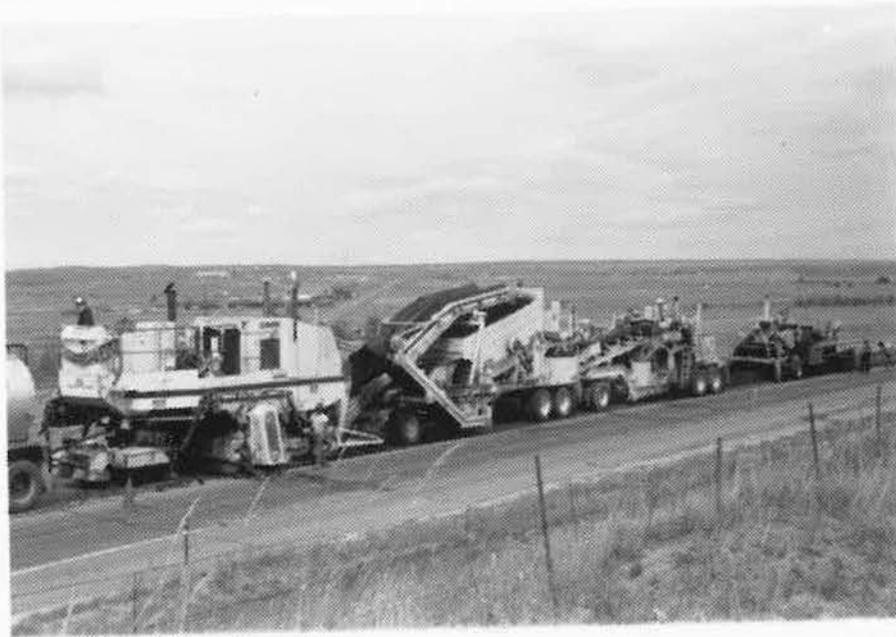
Photo 1

The paving train consisted of three units.

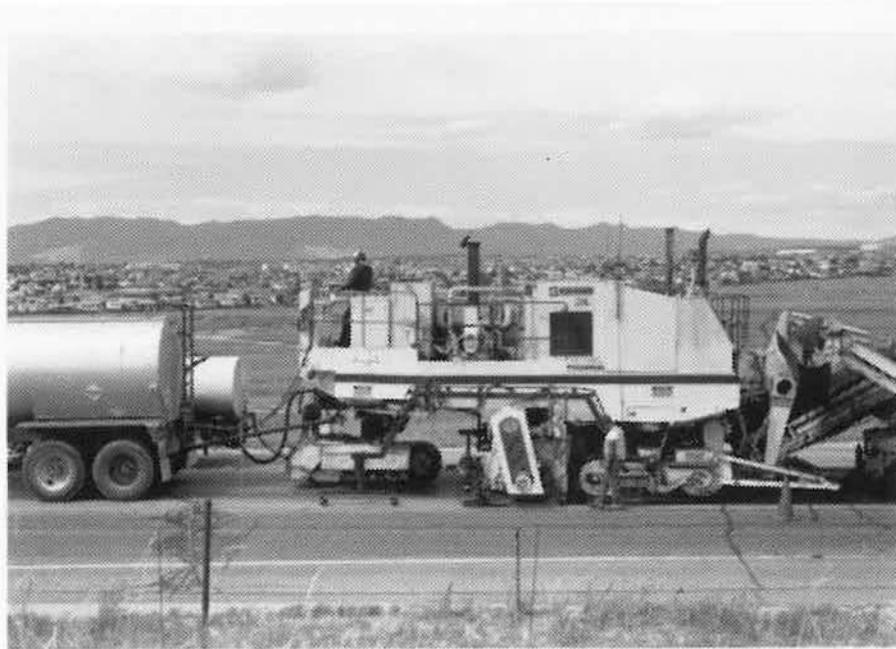
Photo 2

The first unit contained the milling chamber. The emulsion truck was attached to milling unit and pumped emulsion to the pugmill.

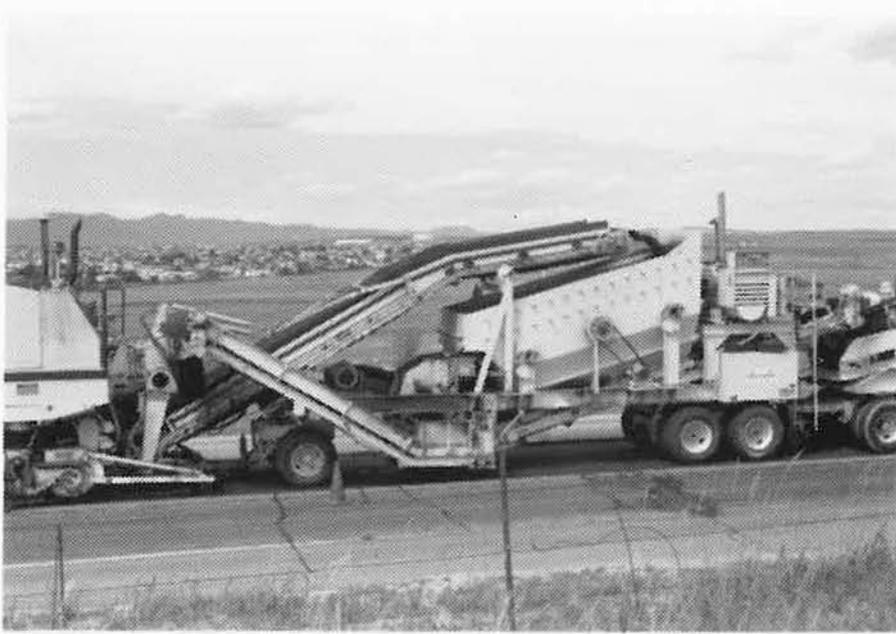
Photo 3

The second unit contained the screening and crushing system.

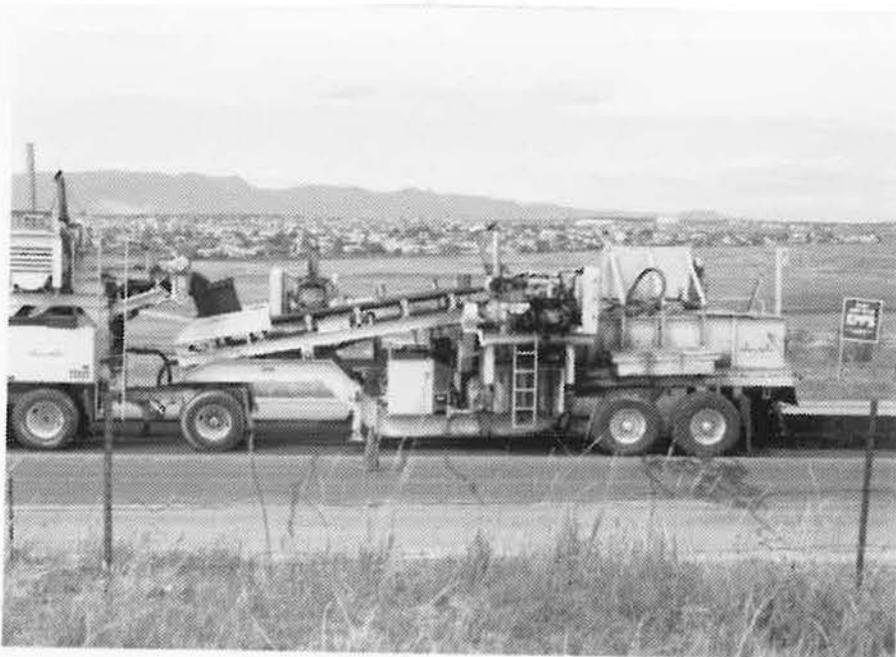
Photo 4

In the third unit the emulsion was added to the milled material and then placed on the roadway in a windrow.

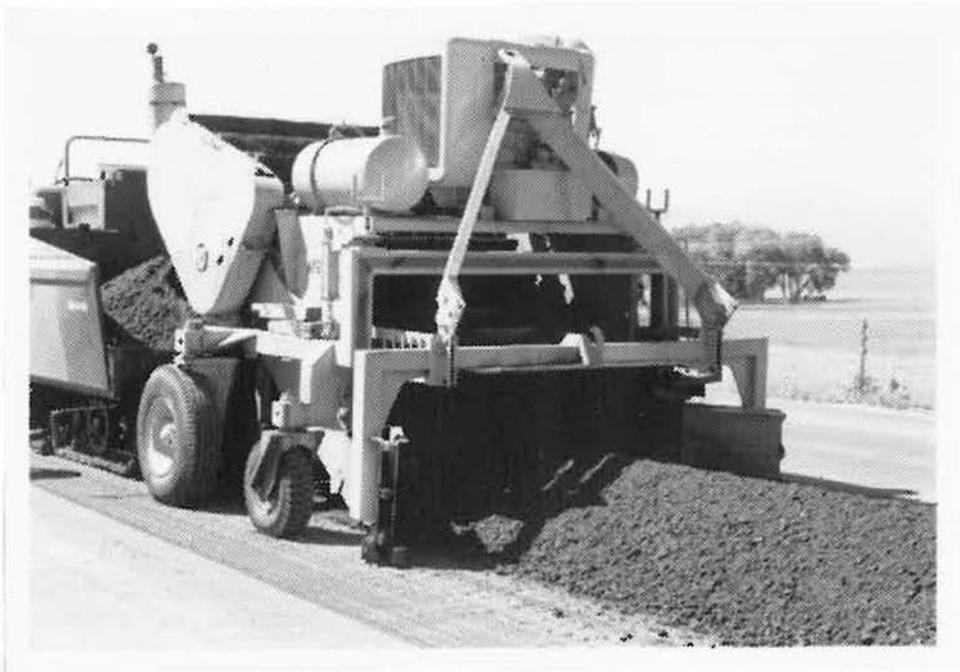
Photo 5

The windrow elevator picked the material up and placed it in a hopper.

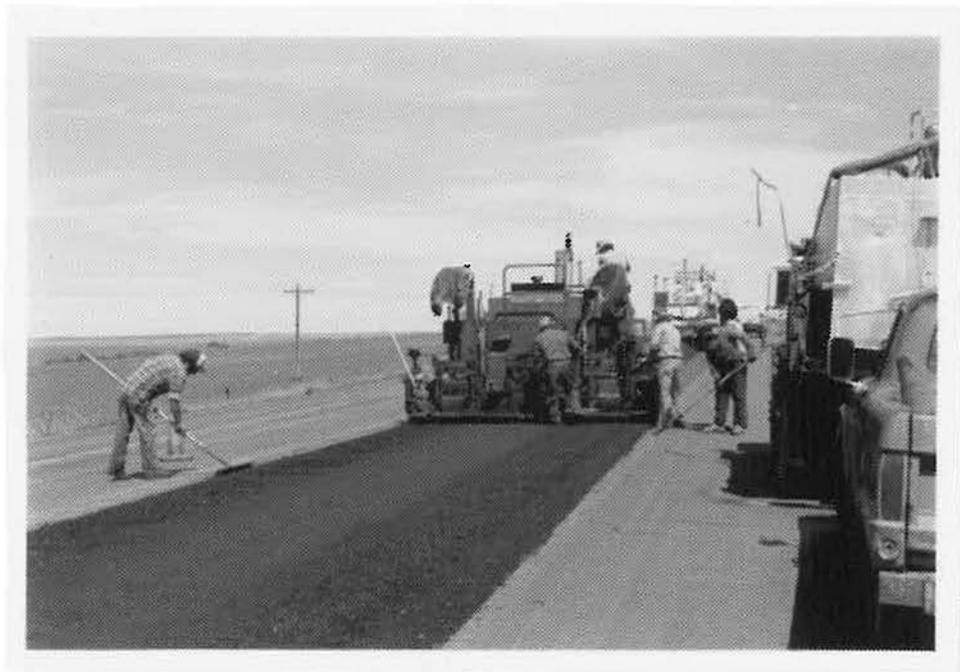
Photo 6

The lay-down machine followed directly behind the train.

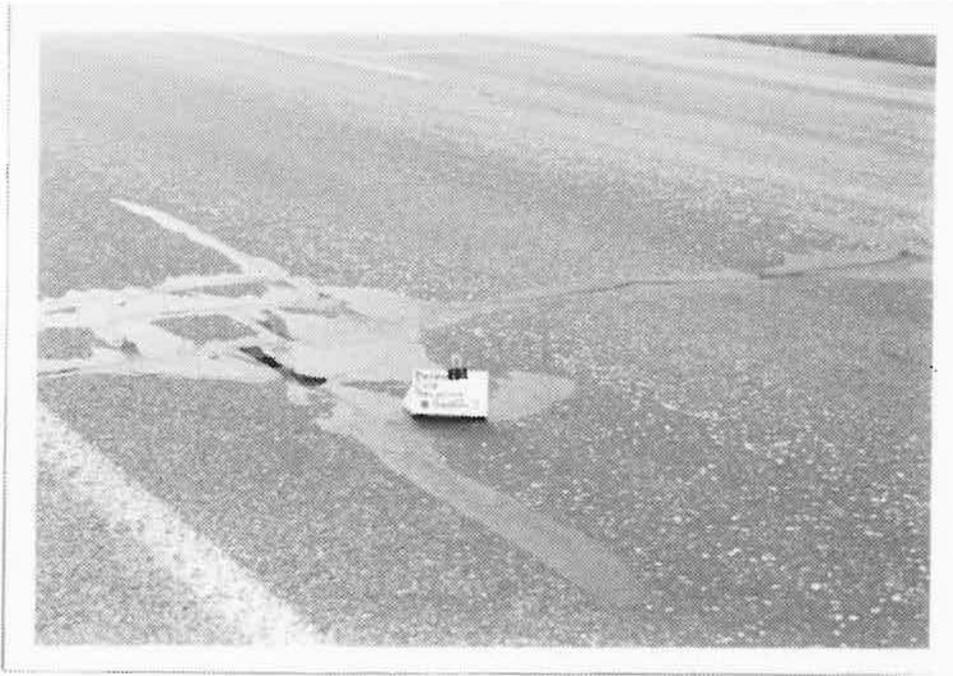
Photo 7

The original pavement on the west end of the project contained mostly transverse cracks with longitudinal cracking in the wheel paths. Most of the cracks had been sealed.

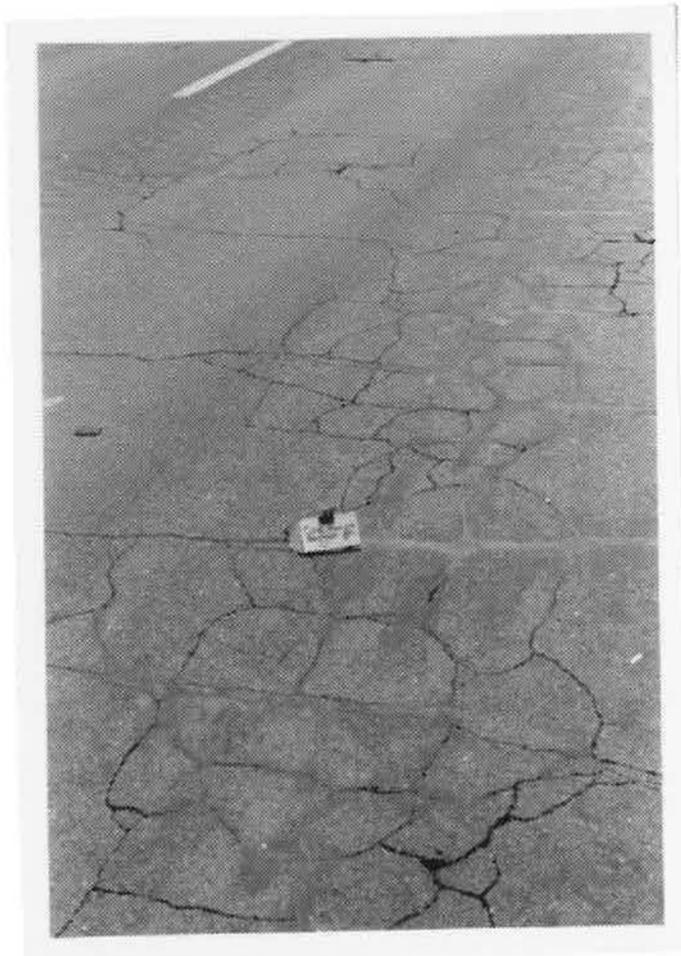
Photo 8

The original pavement on the east was severely block cracked. Very few of the cracks had been sealed.

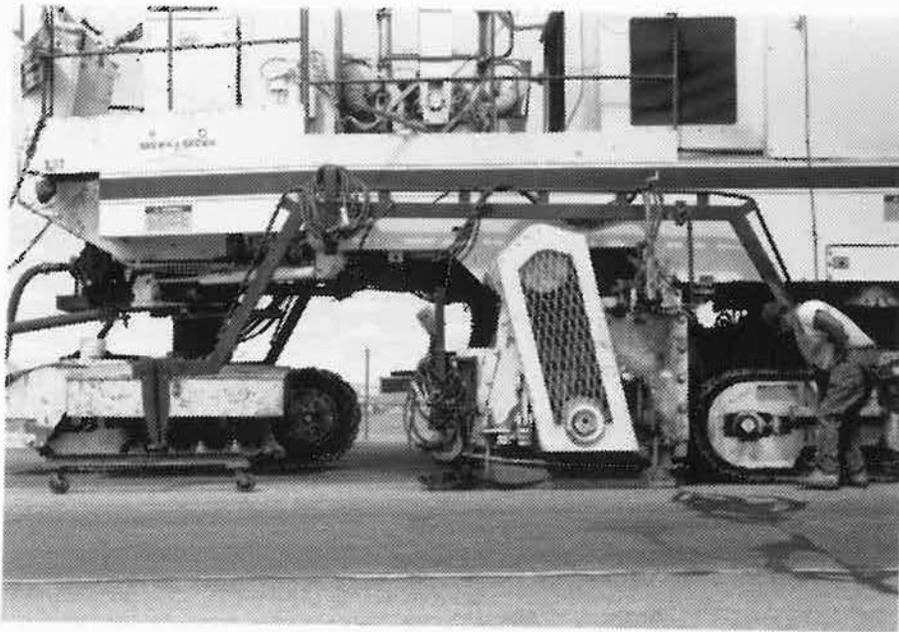
Photo 9

The depth of the cut was controlled by a pivoted four foot ski on wheels attached to a sensing device which measured changes in the grade of the roadway. The depth was checked manually every few feet and depths were adjusted according. The depth was controlled in the same manner on both sides of the milling machine. This is shown in Photo 9.

The depth of the cut was checked manually every few feet and adjusted accordingly on both sides of the milling unit.

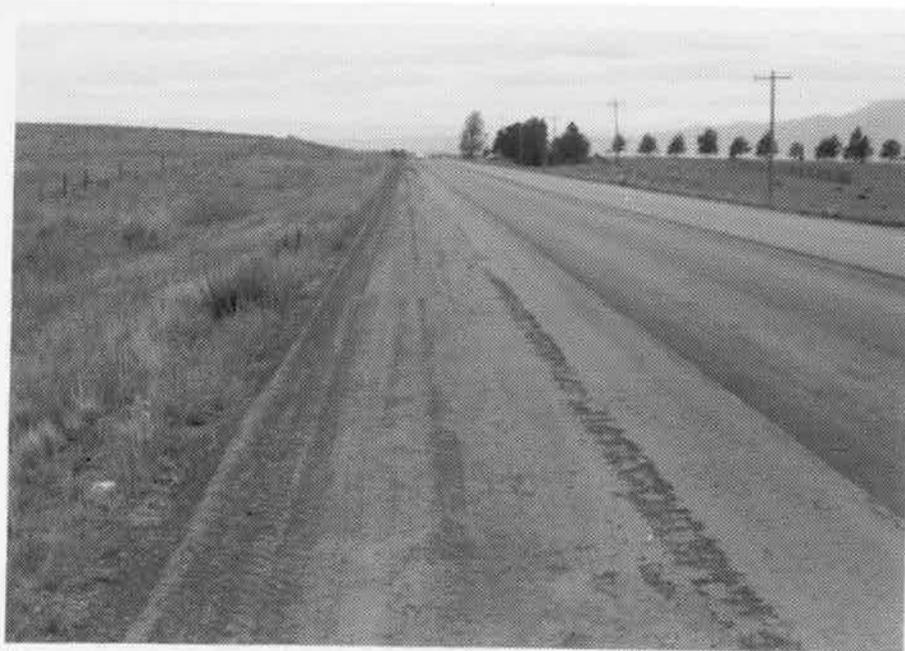
Photo 10

the recycled pavement appeared to be too "dry" and began to ravel under traffic. Raveling to some extent occurred on all of the test sections. This was apparent from the fines scattered on the shoulders and down the center of the roadway. This is shown in Photo 10. Raveled sections were covered with a fog seal of CSS-1h to prevent further raveling. A chip seal was placed on the recycled sections containing three types of emulsions used in the recycling process, CSS-1h modified, HFMS-2sP and Cyclogen ME. On the east end, a 1-inch HBP overlay was placed over the recycled sections. The recycled material contained two types of emulsions, HFMS-2sP and Cyclogen ME.

The rapid raveling of the new mat was shown by the fines scattered on the shoulder.

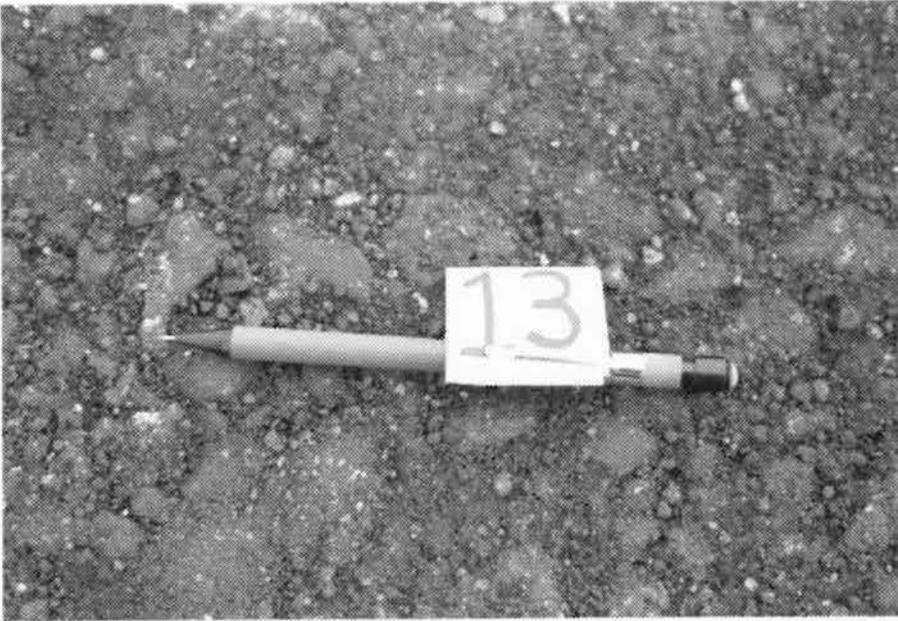
Photo 12

After the CSS-1h modified material was rolled the mat looked good. The condition of the mat can be seen in Photo 12. The following morning after traffic had driven on the recycled mat, the roadway began to ravel badly. Two fog coats of CSS-1h were applied to this section. The project engineer decided to overlay the entire CSS-1h modified section before it raveled out completely.

This is a photo of the CSS-1h modified immediately following the rolling process. The following day this section was overlaid because it began to ravel.

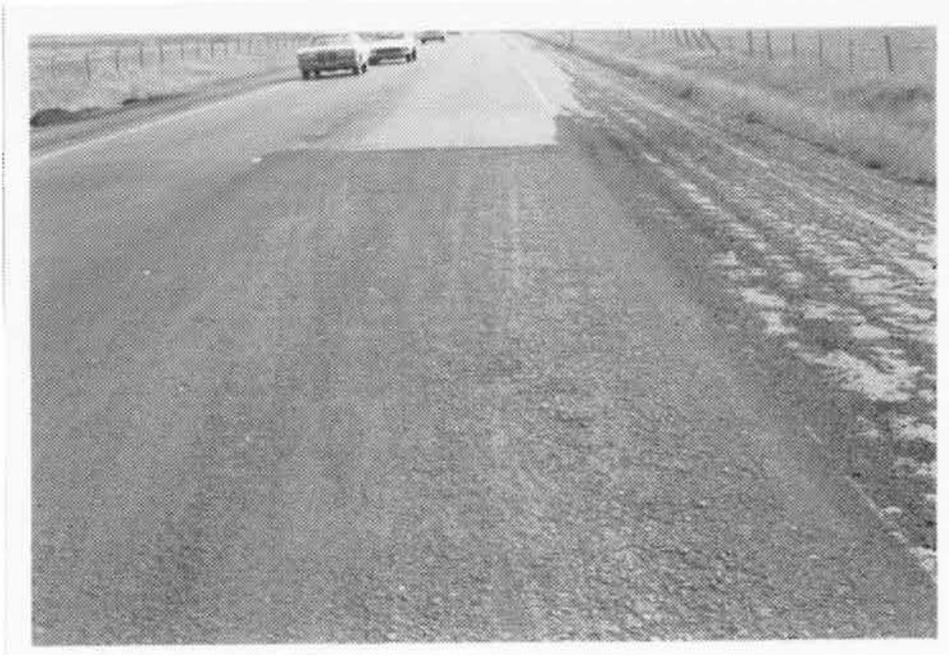
Photo 13

This photo shows the end of a section which raveled after traffic was allowed on it.

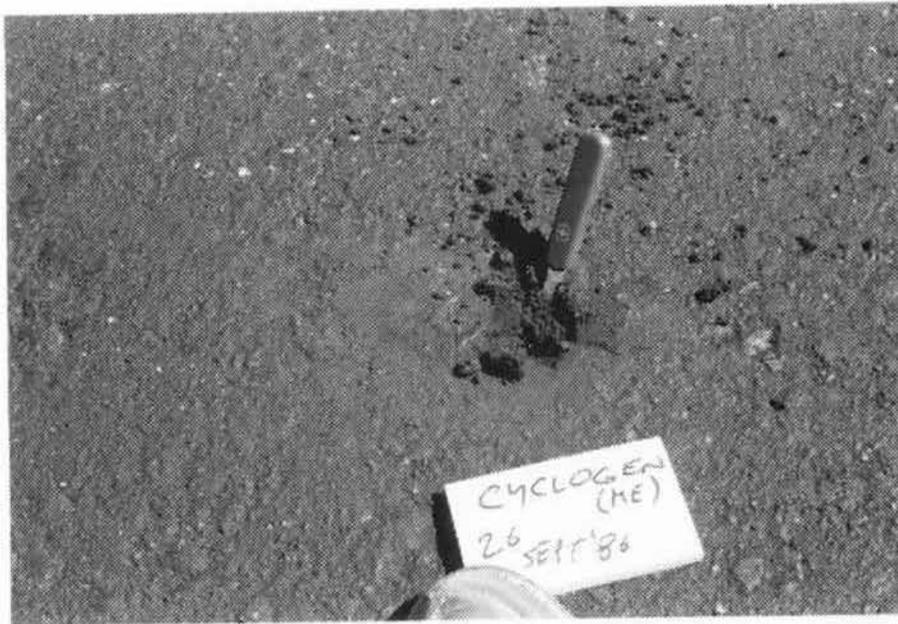
Once traffic was permitted on the recycled mat the sand pockets raveled out and caused circular depressions in the new pavement. These sand pockets occurred regardless of the binder used and are shown in Photo 14 and Photo 15.

This photo shows one of the oily sand pockets found throughout the project.

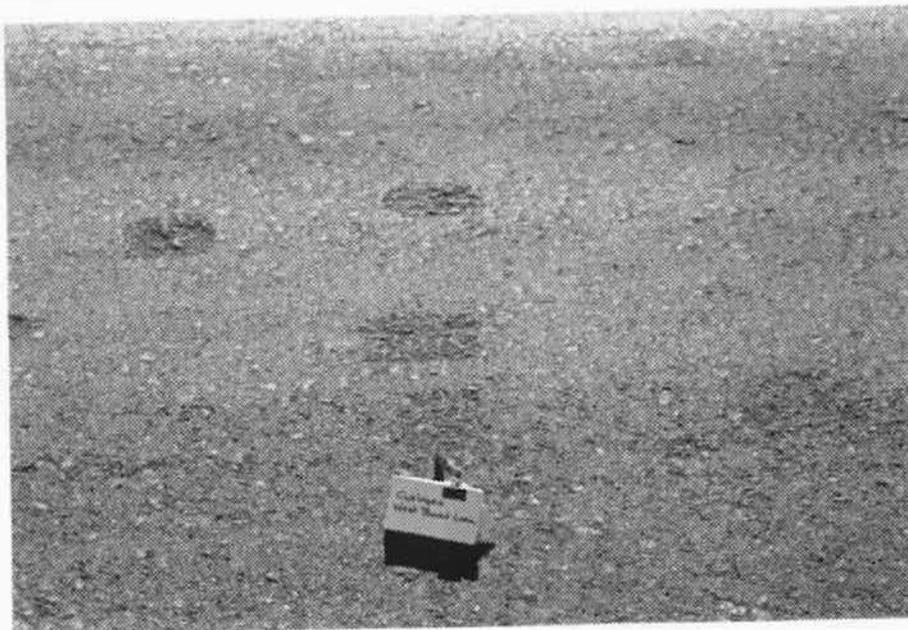
Photo 15

After traffic had driven on the cold recycled roadway the sand pockets raveled out leaving circular depressions in the pavement.

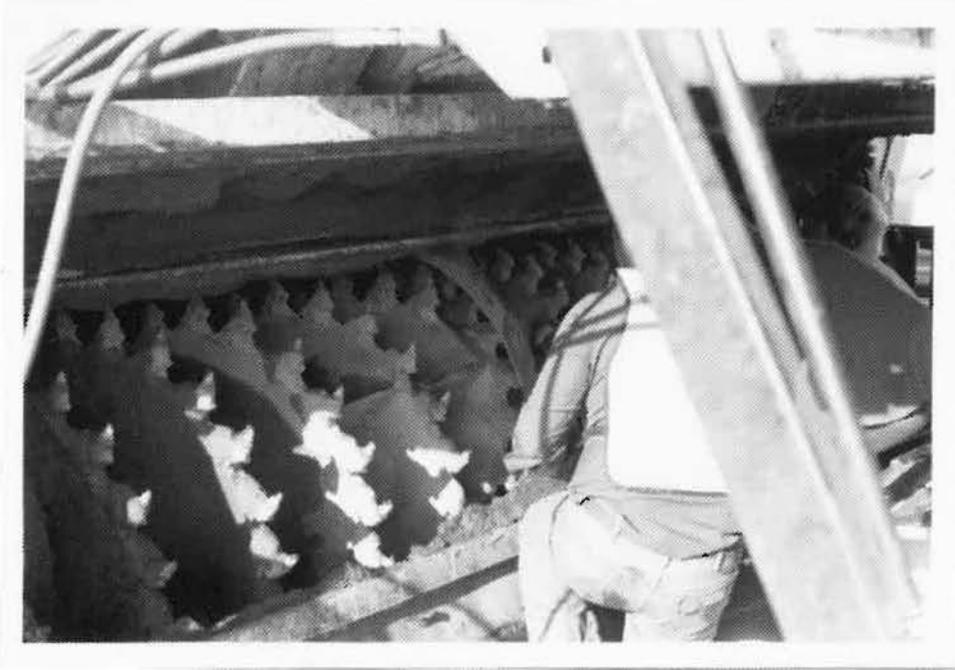
Photo 16

Delays caused by the paving train were minimal. Due to the abrasive aggregate in the pavement, and since the amount of water used to mill the material was limited to keep the water in the new mix low, the teeth needed to be changed approximately three times a day. This process

took between 30 minutes to 45 minutes depending on the number of teeth that needed to be replaced. Milling teeth are shown in Photo 16.

The teeth on the milling machine were changed three times a day.

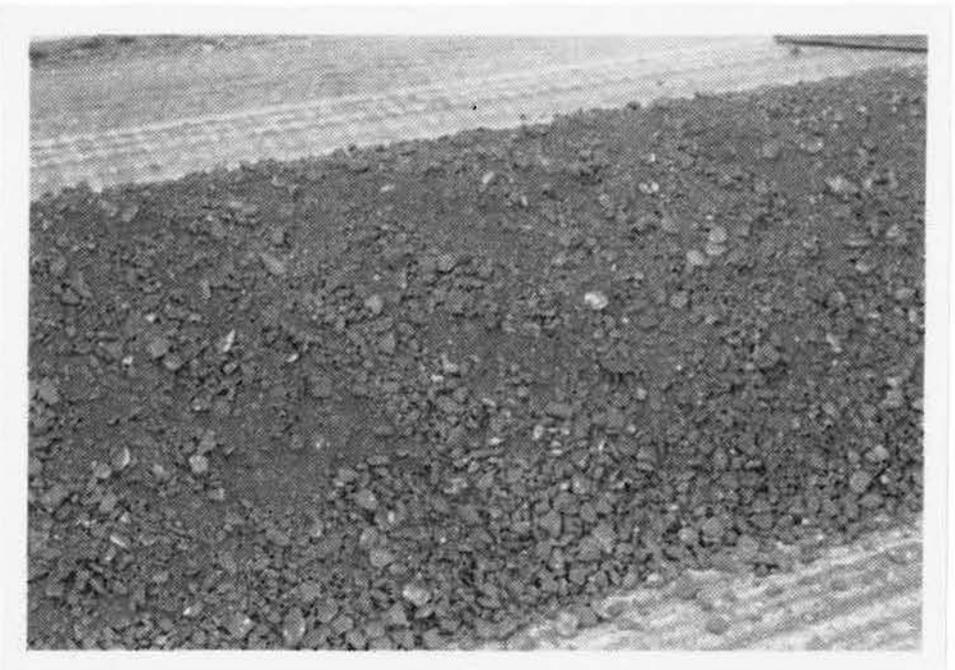
In addition, portions of the road were so badly cracked that the material was milled into large chunks causing the crushing section of the machine to clog up. Several times the milling was stopped to unclog the hammermill. The larger pieces of the milled material forced the hammermill to work extra hard when crushing the material into the proper size causing the speed of the paving train to be reduced. Even though the machine had difficulty with milling the large chunks, the size of the material in the windrow was within specification. The milled material is shown in Photo 17 and Photo 18.

The milled material in the windrow.

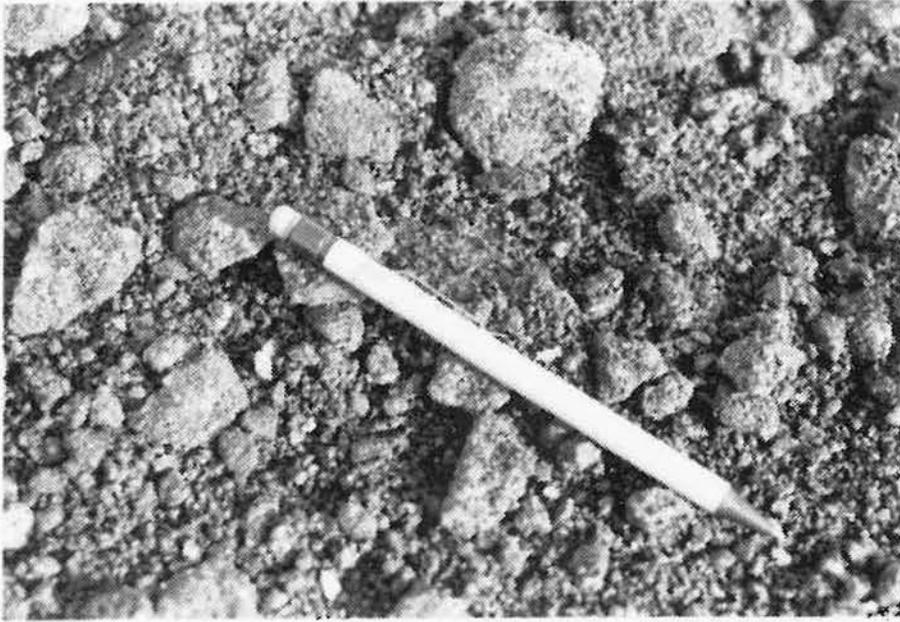
Photo 18

Texture of the
milled material.
This material
met the
specification
for gradation.

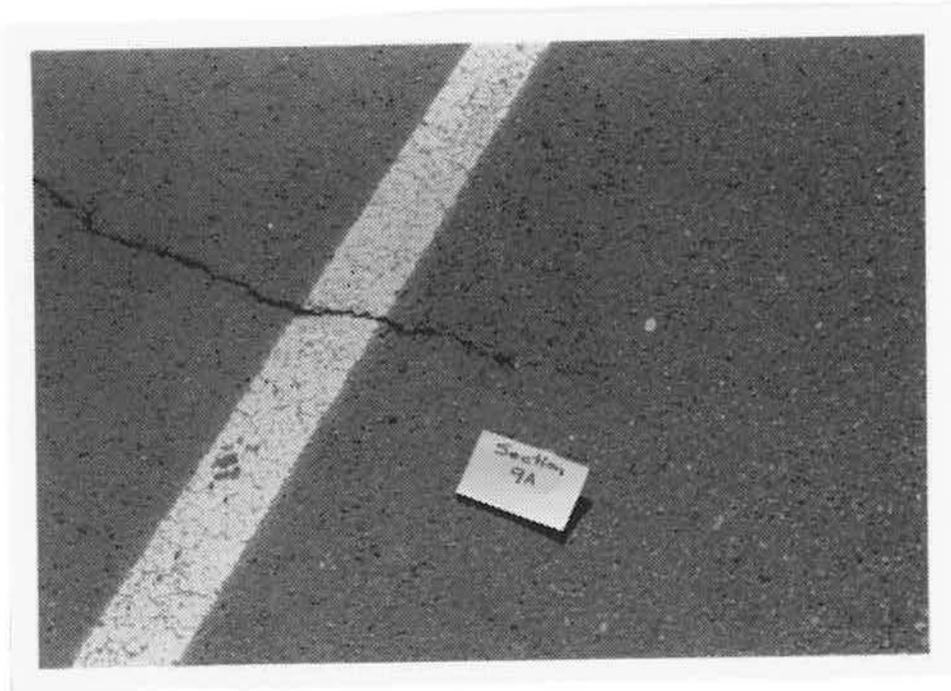
Photo 19

The amount of cracking during the evaluation showed a significant difference between the cold-recycled sections with a 1-inch HBP overlay and the section which received only the 1-inch HBP overlay. After the first winter, the cracking pattern appearing in the section which received only the 1-inch overlay was extensive and similar to the cracking found in the original mat. Cracking in the cold-recycled portion was minimal; however, cracks were reflecting through on the shoulders in this area (the shoulders were not recycled on this project). It was observed that the majority of the shoulder cracks either stopped at the driving lane where the recycled material began, or extended only a few inches into the recycled mat. This can be seen in Photo 19.

Following the first winter the majority of the transverse cracks either stopped at the driving lane where the recycled material began or extended only a few inches into the recycled mat.
