Report No. CDOT-DTD-94-5

Large-Stone Hot Mix Asphalt Pavements

**Final Report
April 1994**

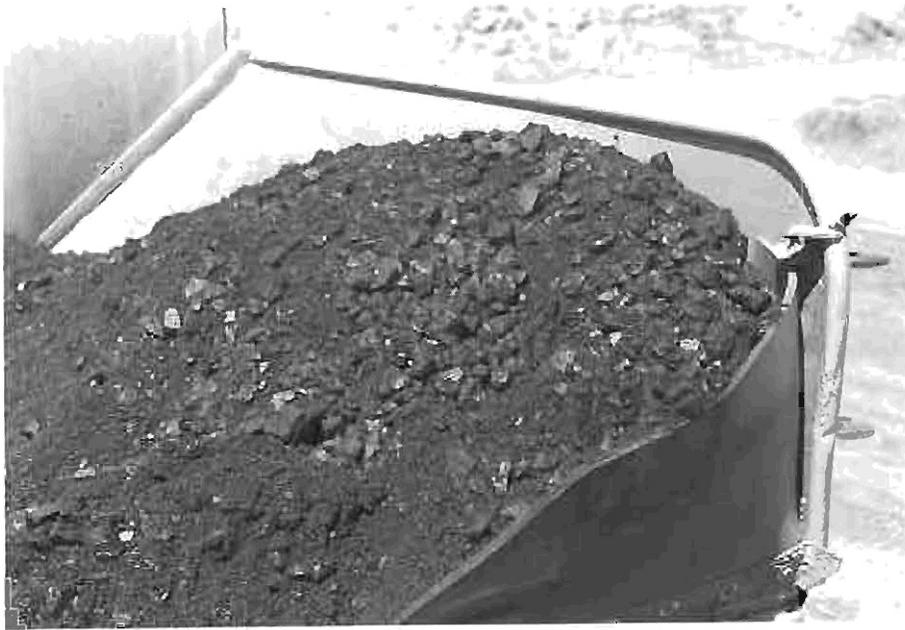
Paving operations began on the morning of April 27, 1990 with the drum mixer located at I-25 and Harmony Road in Ft. Collins approximately ten minutes travel time from the construction site. The contractor Western Mobile, Inc. chose to use end dumps for hauling the mix and placed the mix directly into the laydown machine's hopper. Early in the construction the segregation problem was severe. The majority of the problem appeared to be at the point where the mix was transferred from the haul truck to the laydown hopper. To help reduce segregation the contractor had the end dumps raise their beds to a point where the mix would slide against the tail gate before releasing the gate and thereby allowing the mix to drop uniformly into the hopper of the laydown machine. This appeared to help greatly in reducing the segregation occurring at the transfer point. The other method used to reduce segregation was for the laydown operator not to raise the wings on the hopper until the end of the day at which time the material was discarded. Figures 3 and 4 show the haul truck, laydown machine and how they were being used on this project. Figures 5 and 6 show the segregation occurring inside the laydown hopper at the edge of the wings.

Figure 5 - Segregation of large-stone mix can be seen at the edge of the paver hopper wings.

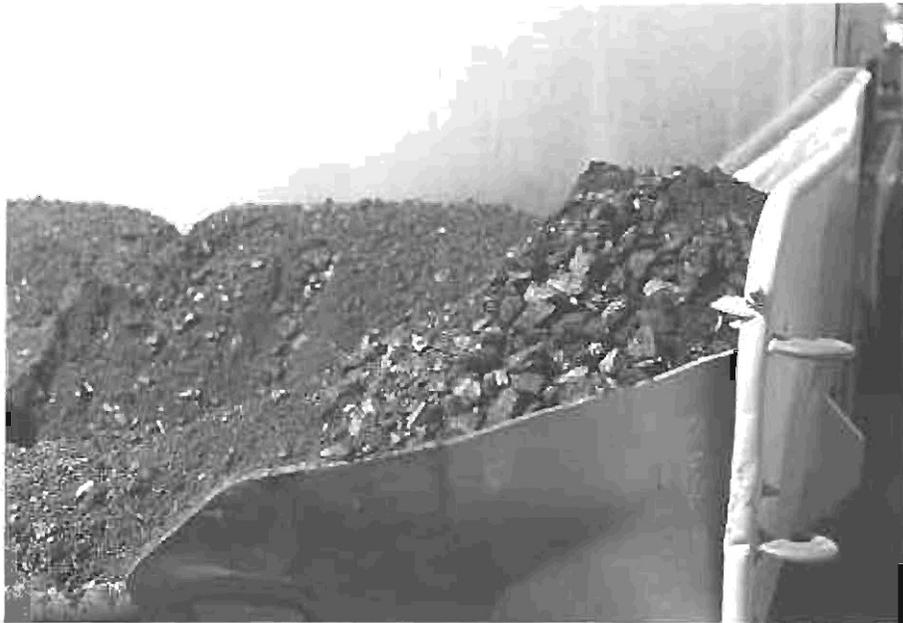
Figure 6 - Same as figure 5.

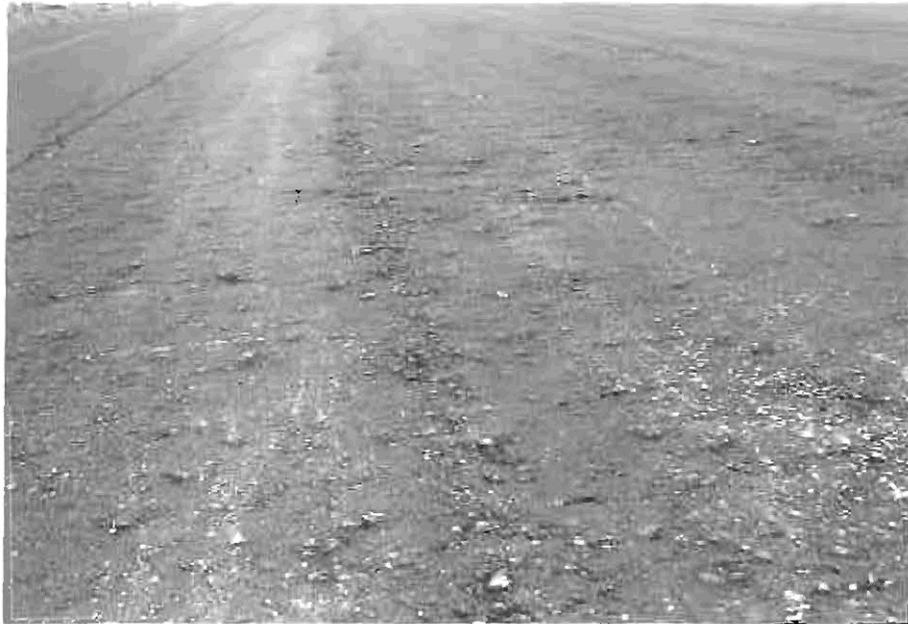
The overall appearance of this project showed several pockets of segregation. Many of these locations are where the laydown machine stopped to reload its hopper. Figures 7 and 8 show an area of heavy segregation mostly due to equipment problems with the laydown machine. The laydown machine placed too thin of a lift at this point and began to drag larger aggregate behind the laydown screed. Figure 9 shows a closeup of one of the large-stone segregated pockets seen on the project. Figure 10 shows the segregated pocket. A 38mm (1-1/2 inch) thick Grading E rubberized mix was placed over the top of the large-stone HMA, giving an overall appearance of a smoothly completed project.

Figure 7 - Segregated areas due to equipment problems and too thin of a lift causing aggregate to be dragged.

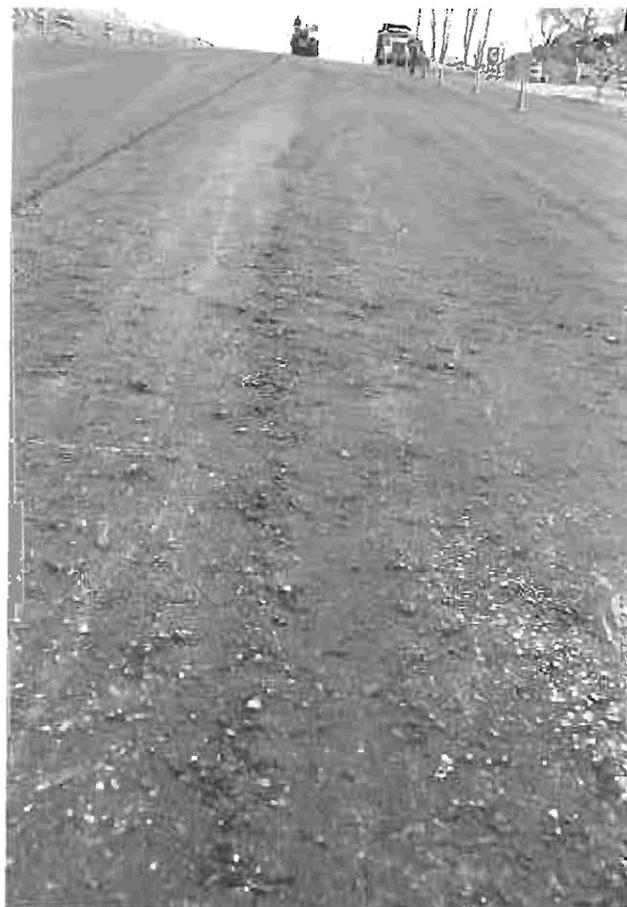
Figure 8 - Same as Figure 7.

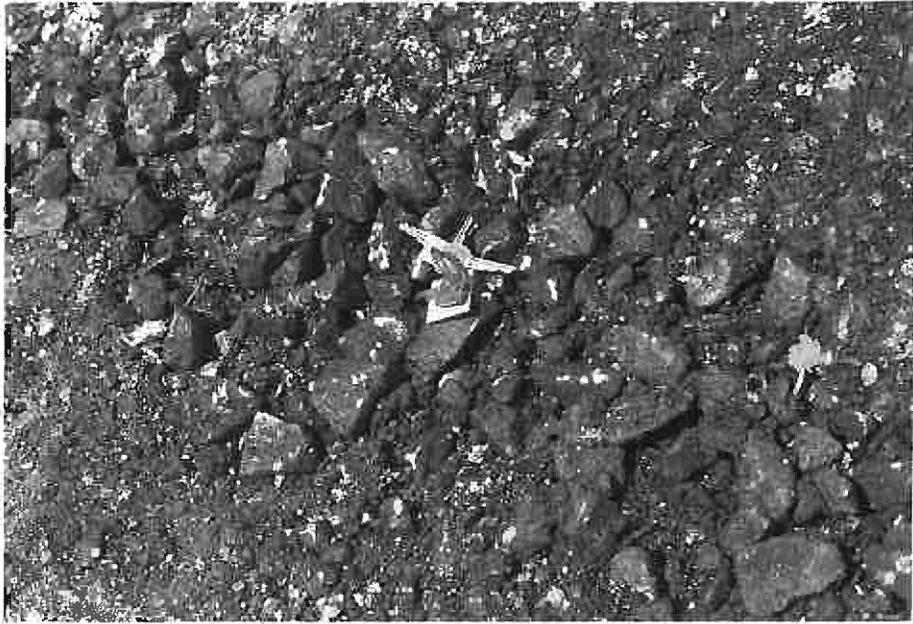
Figure 9 - Close-up of a segregated pocket on SH-14.

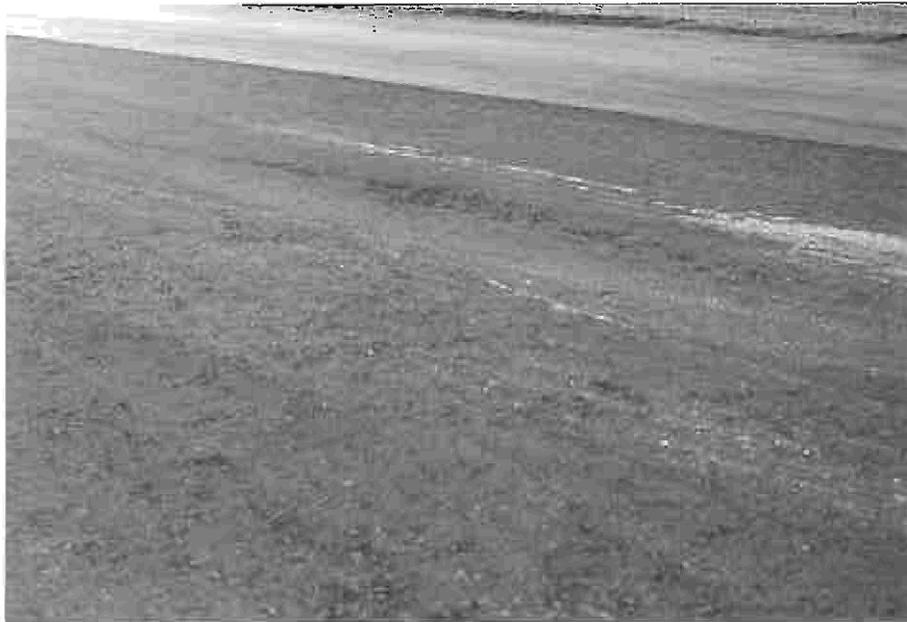
Figure 10 - Segregated pocket on SH-14.

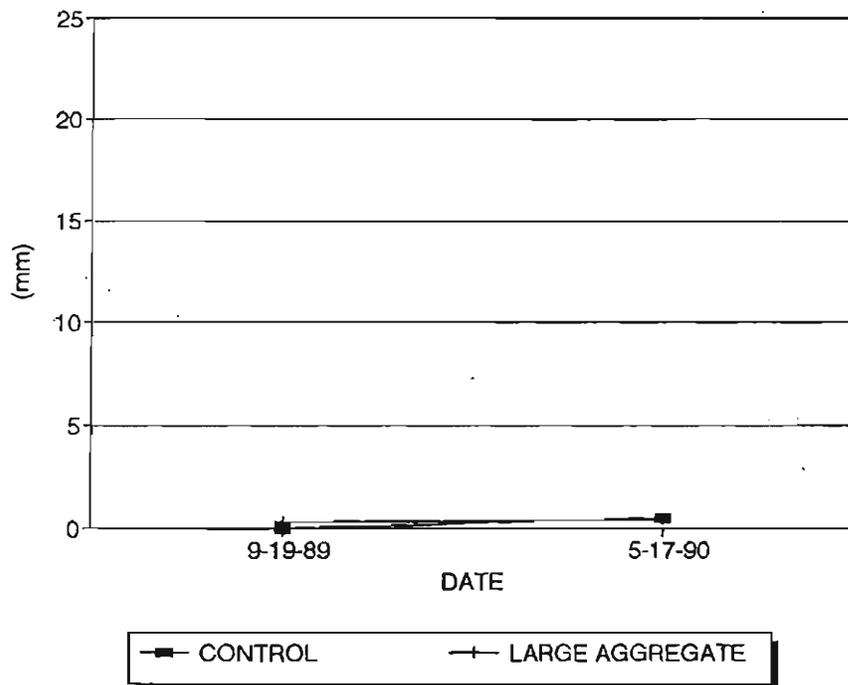
Figure 16 - I-70 Rut Depth Measurements

the Grading G test section with the PMSC. Maximum rutting showed 11mm (0.44 inches) with a minimum of 3.75mm (0.15 inches). At this time there was a minimum of rutting in the uncovered Grading G. This shows the possibility that the PMSC is causing stripping within this section. The rutting in the PMSC section was not continuous (pockets within the section), which also gives credence to the possibility of PMSC causing stripping to occur within the section below the PMSC. The problem discussed here is documented with data from other sites in CDOT Report No. CDOT-DTD-R-91-4, "Rut-Resistant Composite Pavement Design".

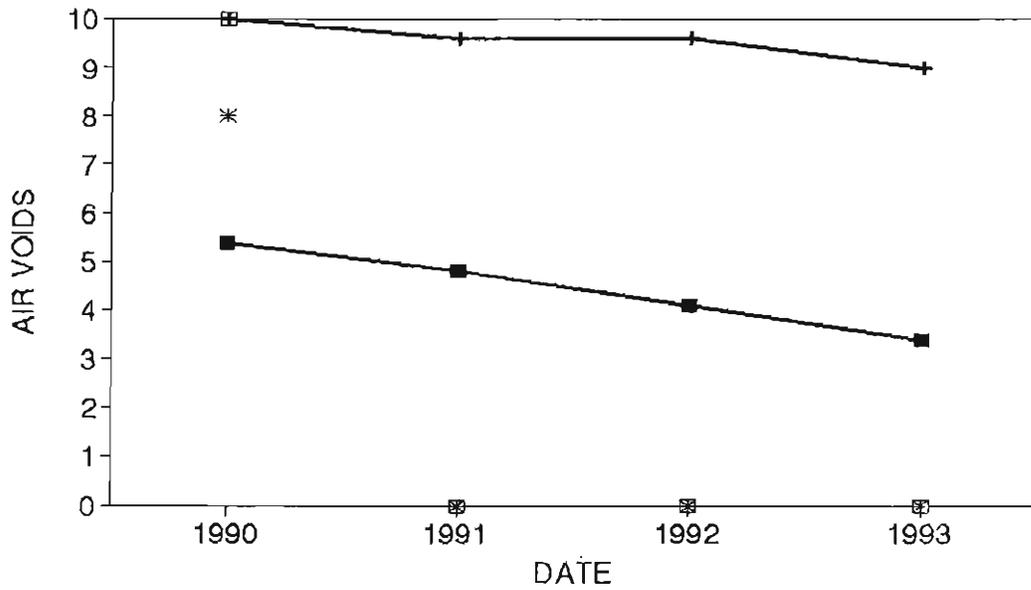
Figure 17 - I-70 Air Voids

Cores were taken for a period of four years in the Grading G section. Air voids in the pavement for these samples are shown in Figure 17. The Grading G section shows a decrease in air voids from 5.4% to 3.4%, a loss of 2% air voids over a three year period. This normal amount of consolidation taking place within this material is in direct relationship to the amount of rutting which occurred within the large-stone HMA section. The Grading C which is the control section was monitored for only one year, not allowing for good comparison with the Grading G.

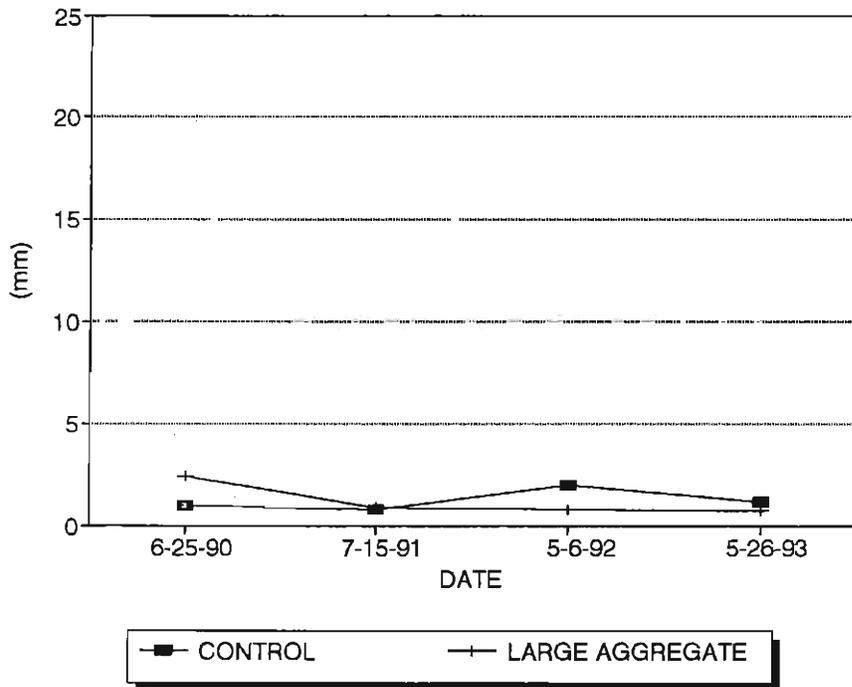
Figure 18 - SH-14 Rut Depth Measurements

Rut measurements were taken for a period of three years, showing very little change in pavement rutting in both the control and test sections. The control section showed basically the same rutting for the three year period (0.4mm). The test section also showed very little change (0.1mm). Both sections rutting results can be seen in Figure 18. The test and control sections are both rut resistant.

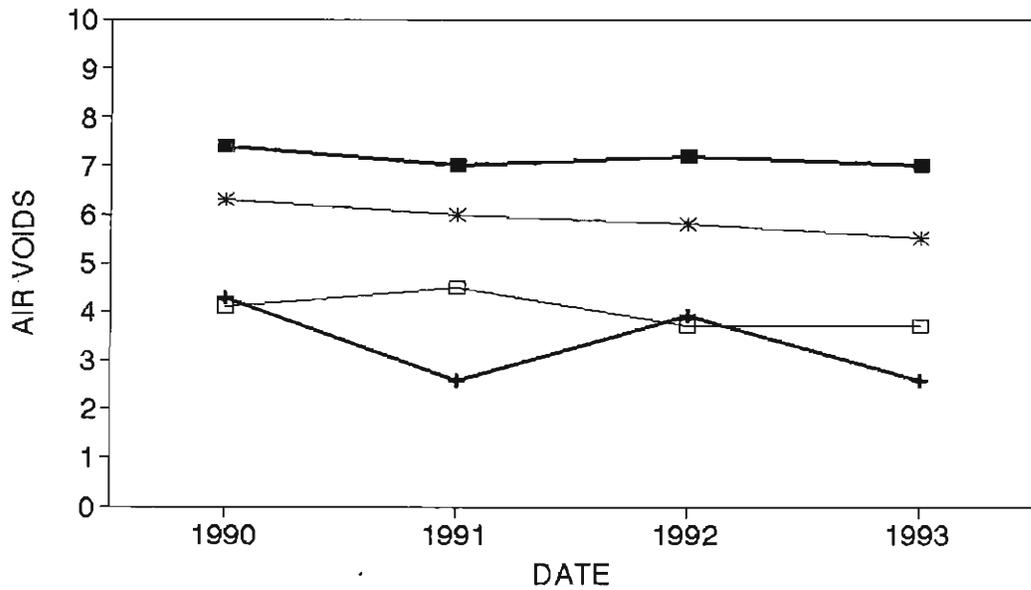
Figure 19 - SH-14 Air Voids

Cores were removed from the pavement and the results of lab tests for air voids are shown in Figure 19. This Figure shows similar results to the field rut testing. The Grading G showed a drop of 0.4% in air voids over the four year period. This section was constructed at a depth of 64mm. The change in air voids relates to approximately a 0.3mm rut. The measured rutting is virtually all due to traffic densification. The control section shows a 1.7% drop in air voids which relates to a 1.3mm rut in the 76mm thick Grading E. The rutting measured on this project is virtually all due to traffic densification.

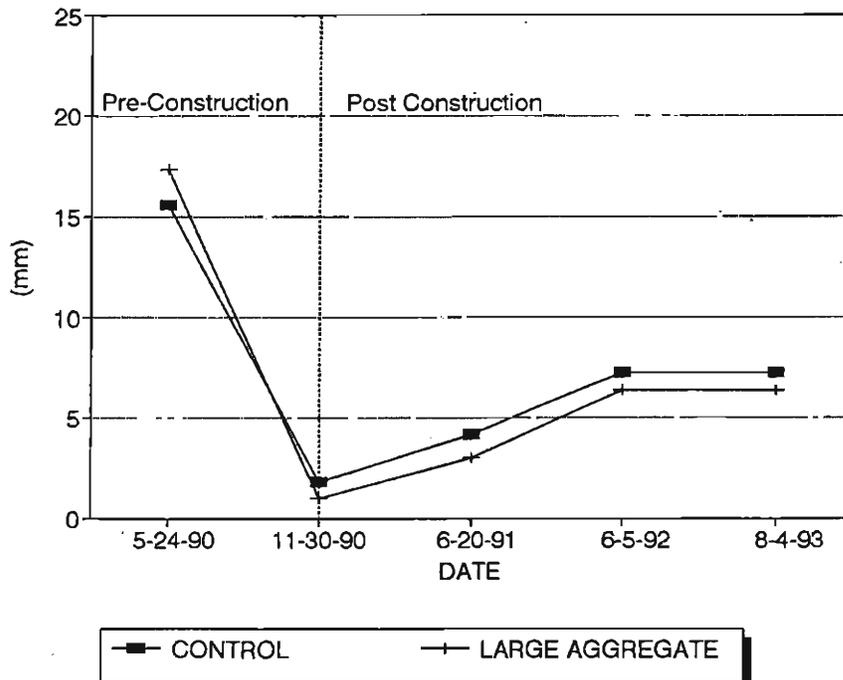
Figure 20 - SH-40 Rut Depth Measurements

Rut measurements were taken for a period of three years, once again showing little change in rutting in either test or control section. Both the control section and the test section both showed approximately the same amount of rutting at the same rate which can be seen in Figure 20. The amount of rutting approaches the maximum acceptable levels of 8mm.

The majority of the rutting appears to have occurred within the top surface mat and not in the test and control material below the surface. The rutting has been caused by traffic densification, not plastic flow. When comparing the two sections, both have equal ability to resist rutting.

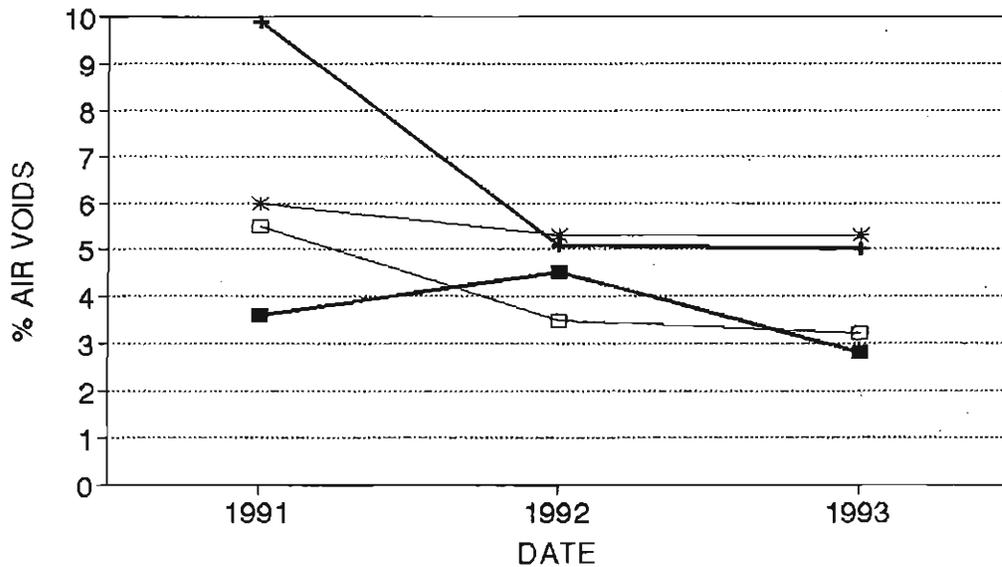
Figure 21 - SH-40 Air Voids

Cores were removed from the pavement and the results of the lab test for air voids are shown in Figure 21. This Figure shows similar results to the field rut measurements. The biggest change in air voids can be seen in the Grading G toplift. This lift is a 38mm lift of Grading C rubberized material. Air voids on this material dropped 4.9% over three years. This shows that a large part of the rutting occurring in this section may be caused due to the top 38mm lift densifying and not the large-stone HMA below. Looking at Figure 21 it can also be seen that this holds true on the control section. The control section showed a drop of 2.3% air voids over the three years.
