**Report No. CDOT-DTD-R-2001-20**

## **SHRP CHIP SEAL**

# **SHRP CHIP SEAL**

CDOT-DTD-R-2001-20

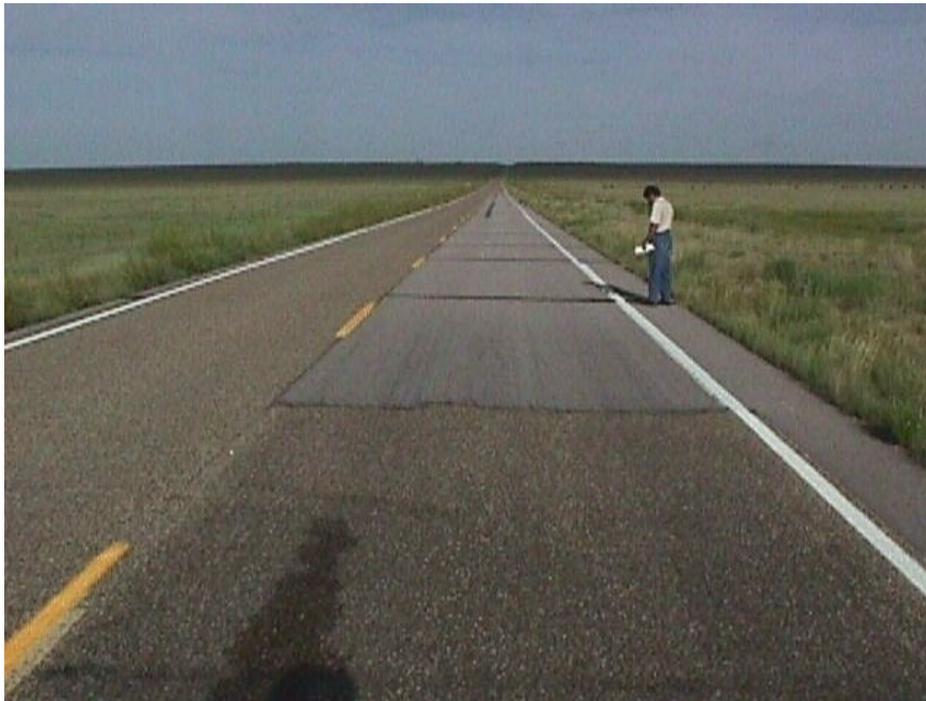
**Figure 1. Looking west from the fog sealed section into the control. The dark stripe next to the figure is a sealed crack. The dark patches in the left wheel path are water where the skid tester had just finished testing.**

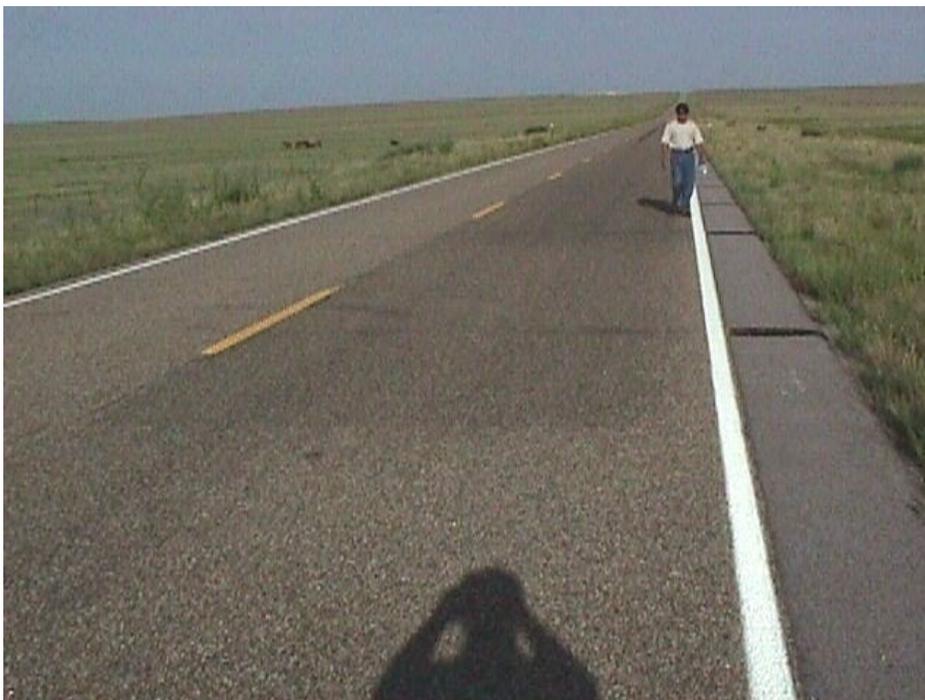
**Figure 2. The fog seal section starts where the pavement is darker. The dark stripes on the shoulder are seals applied to transverse cracks before the chip seals were placed.**

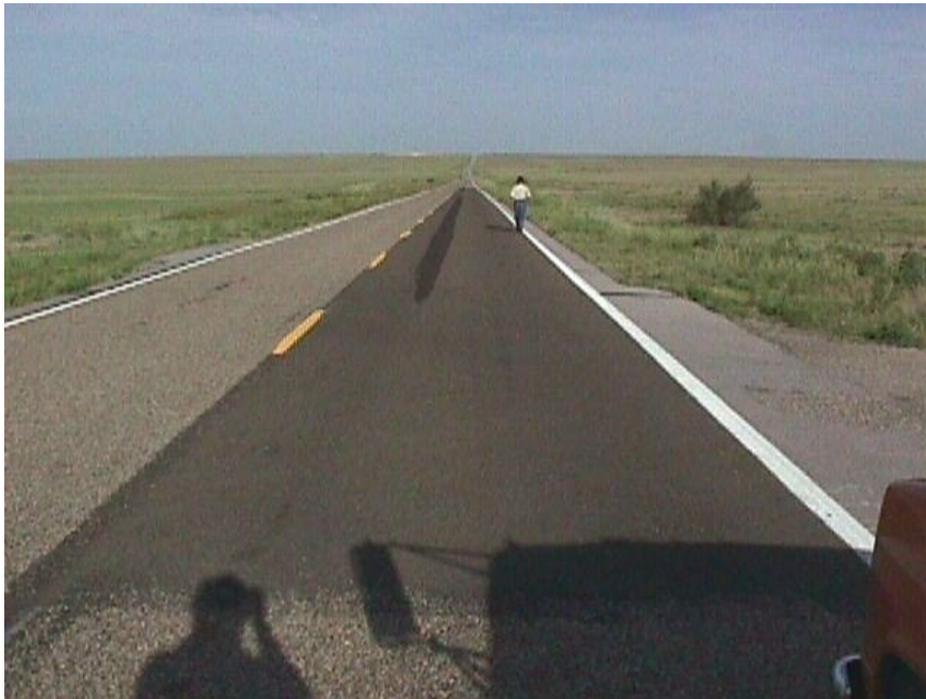
**Figure 3. The light weight chip section at the east end of the site. The right lane is the light weight chip seal. The dark patch in the left wheel path is water left by the skid testing equipment.**

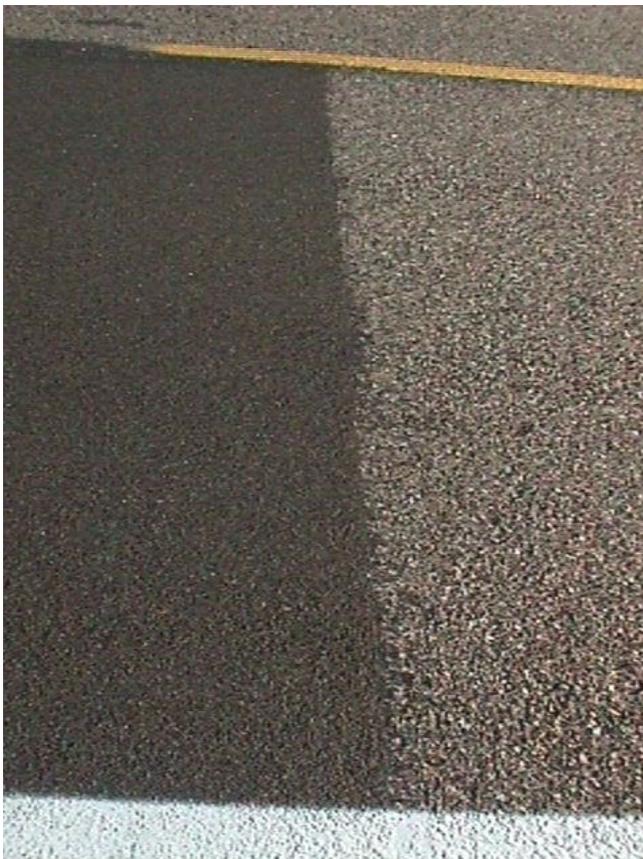
**Figure 4. The transition from light weight to standard weight chips. Light weight chips are the dark area on the left of the picture. To the right side and in the far lane are standard chips.**

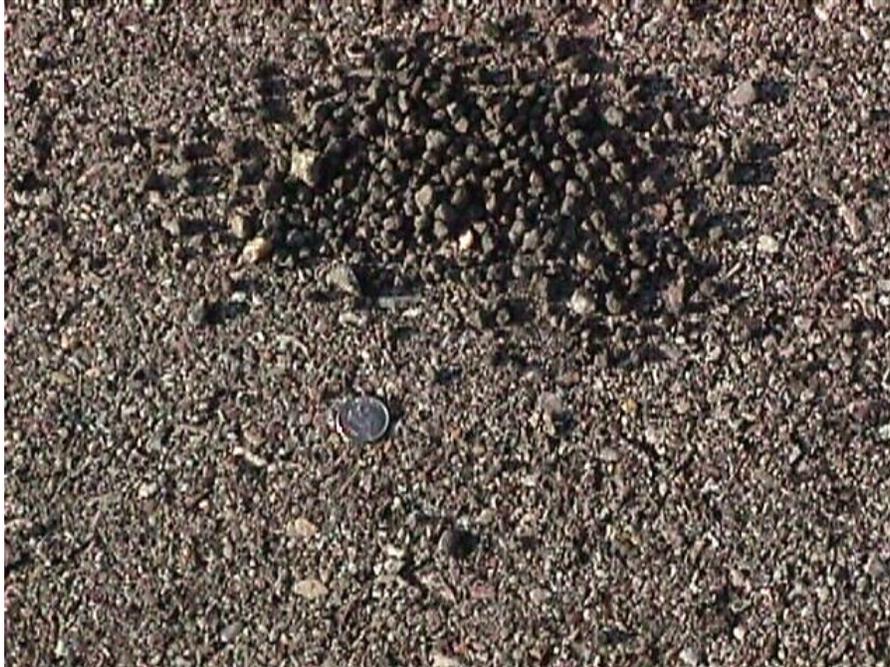
**Figure 5. A handful of the light weight chips.**

**These are loose chips piled on the old pavement surface with a dime to show their size.**

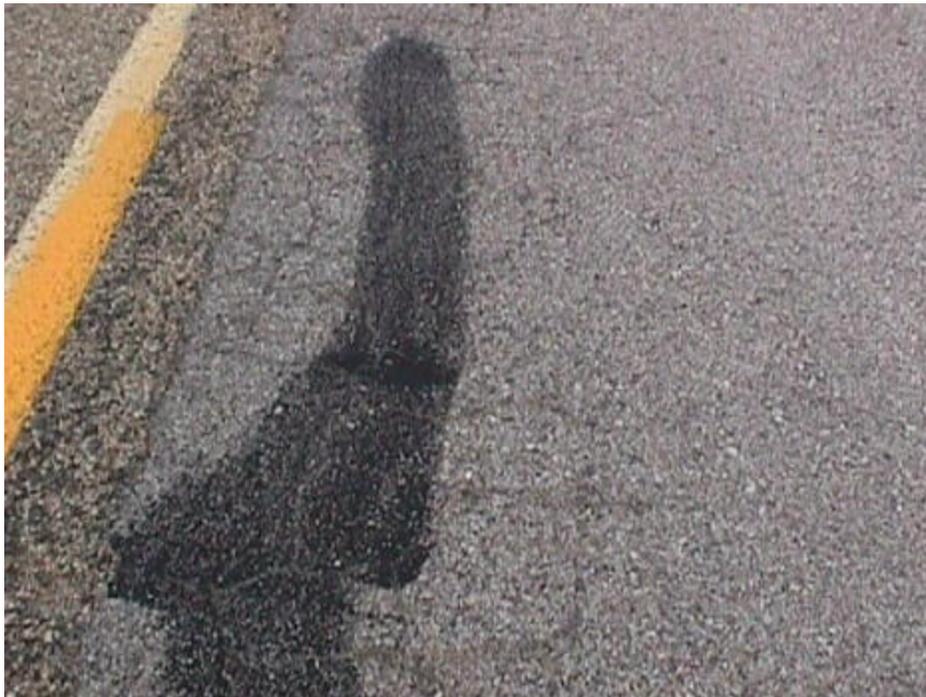
Before construction, the condition of the pavement at the site was visually evaluated and crack maps were made for each section showing the length and location of all visible cracks. The cracks were sealed with a rubberized sealer using an over-band method before the chip seals were applied. Since the chip seal was applied only in the lane, on the shoulder it was easy to see where the cracks had been sealed before the chip seal was applied. During post-construction evaluations those cracks that had not opened through the chip seal were not listed on the crack maps. However, if a crack had opened through the chip seal it was listed on the map at the date of the evaluation. At the time of the June '98 visit, portions of cracks that were seen and recorded during the March '98 visit had closed, probably due to the action of traffic during hot weather (the closed areas were mostly in the wheel paths). Table 1 shows the total amount of cracks measured during each visit. By the final evaluation in August of 2001, the control section had

developed some block cracking along the longitudinal cracks near the centerline. No additional crack sealing had been done in the control section since the chip seal was applied.

**Figure 6. Block cracking is developing in the control section near the skip stripe.**

**The longitudinal crack just to the right of the yellow stripe appears to be the construction joint. The dark patch is old crack seal material.**
