**Report No. CDOT-DTD-R-2003-1  
Final Report**

# **EVALUATION OF PREMATURE PCCP LONGITUDINAL CRACKING IN COLORADO**

**COLORADO DEPARTMENT OF TRANSPORTATION  
RESEARCH BRANCH**

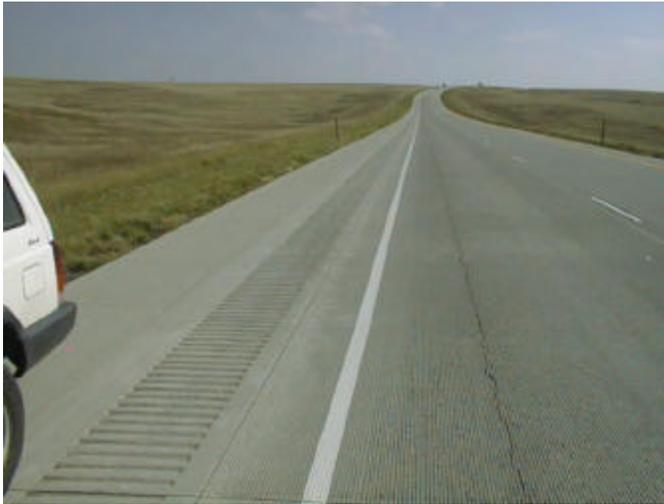
**Figure 1. Premature longitudinal crack on I-70 westbound near Agate.**

month of August 2001, distresses, mainly in the form of longitudinal cracks, were encountered at several locations in the westbound lanes (no distresses were reported in the eastbound lanes). The majority of the cracks were scattered between mileposts 340 and 346. Four cracks, each measuring approximately 200 feet in length, and located about four to five feet to the left of the shoulder paint stripe, appeared to be related to improper vibration practices. These cracks are very straight (**Figure 1**) and at a consistent distance from the edge of the pavement.

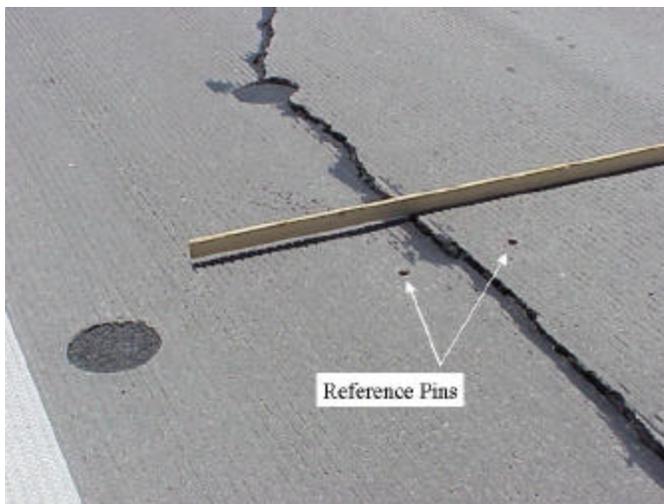
**Figure 2. Differential settlement on I-70 westbound near Agate.**

At some locations near Agate, cracks have developed with substantial differential settlement across the cracks. They tend to wander back and forth between the center of the lane and the right wheel path (**Figure 2**).

These cracks are probably due to under-compaction of the subgrade fill materials or to the high expansive potential of the of highly plastic clayey natural soils in the area (or to the combined effects of

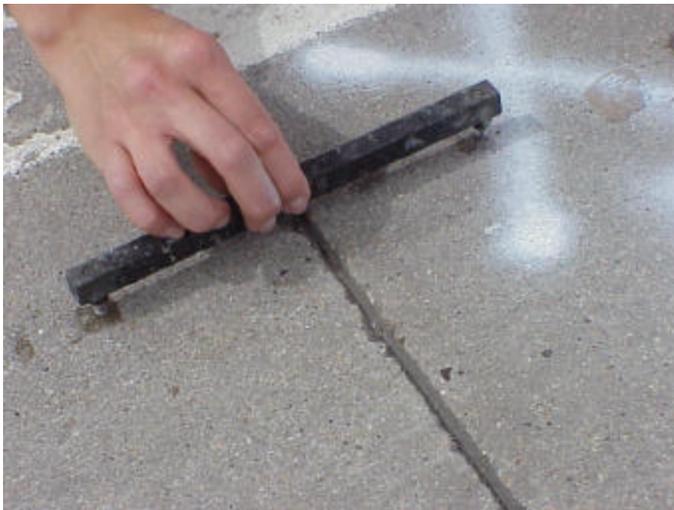
**Figure 3. Reference pins installed across a joint.**

Early in 2001, pairs of steel reference pins (**Figures 2 & 3**) were installed on either side of the longitudinal cracks to provide permanent reference points for monitoring changes in the crack widths and the differential settlement across the crack. Pins were installed at MP's 340.260, 340.453, 340.529, 340.751, 340.891, 341.059, 342.504, and 345.275. The crack widths were measured at 1-2 month intervals. The results are shown in Appendix A.

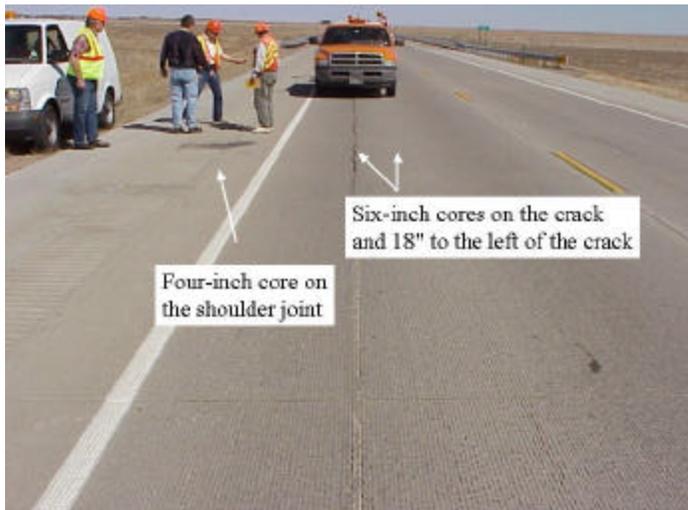
**Figure 5. Core locations on the vibrator trail - US-287 southbound.**

An overactive vibrator apparently created a vibrator trail which caused a weakened plane in the concrete. In some areas, longitudinal cracks developed along the vibrator trail even where the shoulder joint was working, i.e., the saw-cut was at a proper depth and the joint had cracked through.

Split tensile strength tests were performed on 6-inch-diameter cores extracted from the vibrator trail where the tining tracks were deeper, but no longitudinal crack was evident – see the foreground of Figure 5. Split tensile strength tests were also conducted on cores taken next to the vibrator trails

The southbound cracks occurred primarily in the vibrator trail and are a consistent distance from the edge of the pavement (**Figure 5**). In contrast, while most of the longitudinal cracks in the northbound lanes are in the right wheel path, they wander from side to side (**Figure 7**).

- It is strongly recommended that the paving contractors equip their paving machines with frequency monitoring devices for the vibrators. These monitoring devices provide the transportation agencies and the paving contractor a necessary tool to help achieve a quality concrete pavement that is long-lasting. CDOT recommends following Iowa DOT's specification for monitoring the frequencies of the vibrators. CDOT is in the process of fine-tuning Iowa's specification and plans to implement the results in the near future.
- Accurately recognizing and predicting the potential volume change of expansive soils and their treatment prior to construction plays a major role in overall longevity and performance of pavements. It is necessary to alleviate or eliminate the detrimental effects of expansive soils.

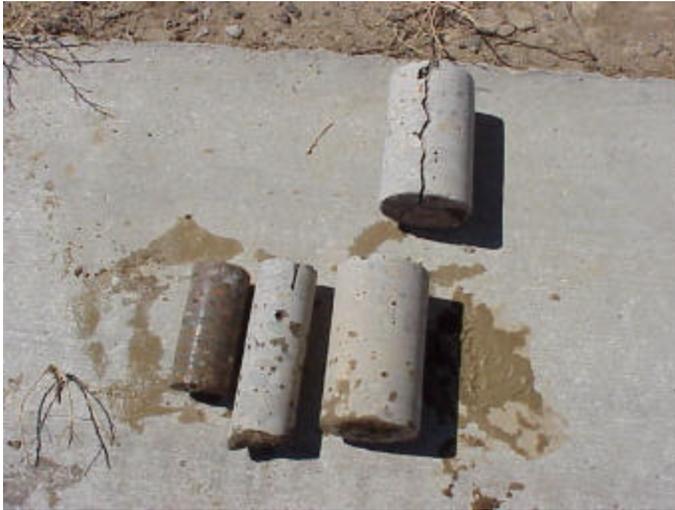
**Figure 6. Cores from US-287 southbound.**

A set of three core samples was taken at each of three different locations southbound through the project. A set consisted of a six-inch core on the longitudinal crack, a six-inch core about 18 inches to the left of the first core, and a four-inch core on the shoulder joint (**Figure 5**). The six-inch cores were sent to Construction Technology Laboratories (CTL) for petrographic analysis; the four-inch cores were used to determine if the shoulder joint had cracked through, as it should (**Figure 6**).

The results of CTL's testing showed the air content of the six-inch cores taken on the vibrator trails to be consistently lower than the air content of the cores taken from the center of the lane. This proved that vibrator operation at too high frequency or prolonged vibration at low paver

(Figure 6). The main purpose was to determine if the cores taken from the vibrator trials showed lower strength than cores taken next to them. This investigation was inconclusive. The results are shown in Table 1.

Examination of the four-inch cores taken on the shoulder joint revealed that the saw-cuts were not deep enough (less than 0.4 D for 14-foot slabs) to instigate a weakened plane. As a result, longitudinal cracks developed in the travel lanes to release the strength gain of the concrete.

- Premature longitudinal cracking due to improper depth of the longitudinal saw-cut can be prevented by adhering to CDOT's present specification, which requires saw-cut depth of

D/3 for 12-foot slabs and 0.4D for 14-foot slabs. It is recommended that project engineers in the field measure saw-cut depth at intervals of 1 per 1/10 of a mile (528 feet). This specification has already been incorporated into CDOT's Field Materials Manual.

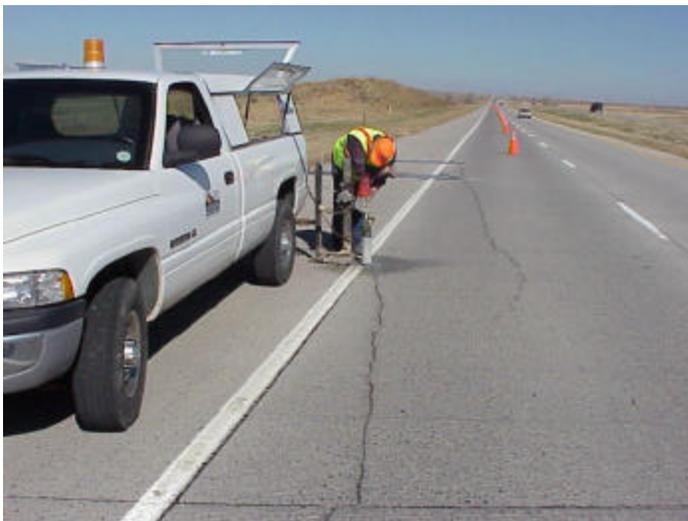
**Figure 8. Longitudinal cracks on 12' wide slabs - I-70 at Deer Trail.**

In April of 2002, CDOT's Research Branch, with the help of Maintenance Patrol 16 from Deer Trail, extracted 4 cores from the longitudinal shoulder joint on I-70 eastbound near Deer Trail between Mileposts 326-327 (**Figure 8**). The slab width in the driving lane, unlike those investigated previously on US-287 (14-foot slabs), was standard 12 feet. The longitudinal cracks at this location consistently began at the shoulder joint and wandered diagonally through the wheel path to about mid-

slab. Cracks were also noted on the shoulder parallel to the joint. I-70 at this location was built in 1987 with lower cement content (565 lb. total cementitious, including 455 lb. of cement and 110 lb. of fly ash) and with skewed transverse joints on 18' spacing.

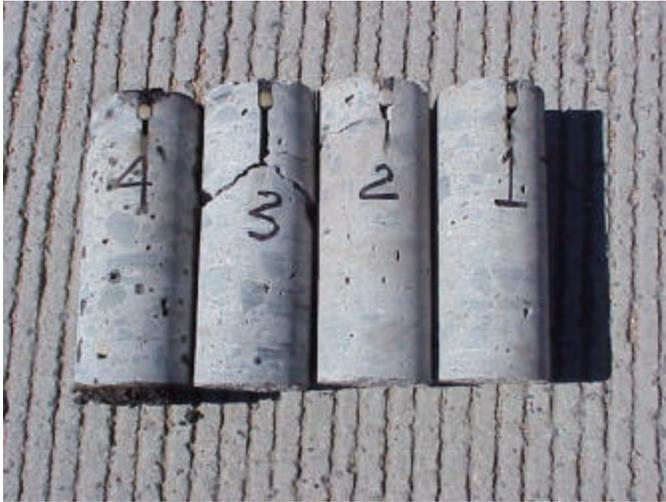
**Figure 9. Cores from the non-working shoulder joint on I-70 at Deer Trail.**

As shown in **Figure 9**, none of the saw-cuts at the shoulder joint were working. The pavement depth was 10.25 inches; the saw-cut measured between 2 and 2.25 inches (35% shallower than  $D/3$ ). This proves, once more, that the longitudinal cracks are due to shallow saw-cut depth at the shoulder joint.

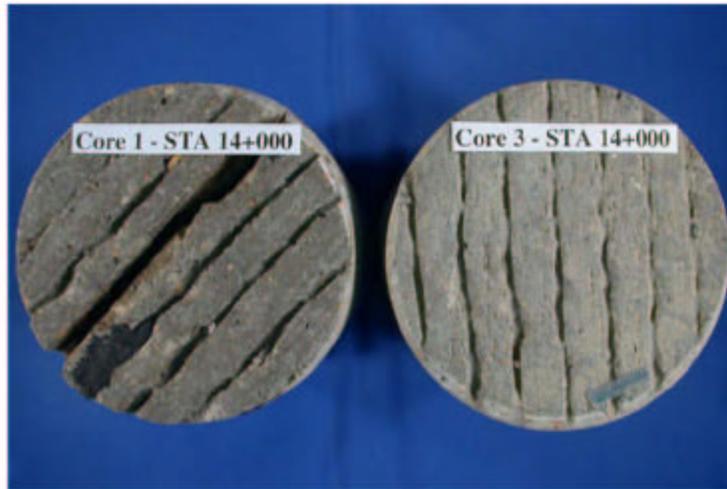
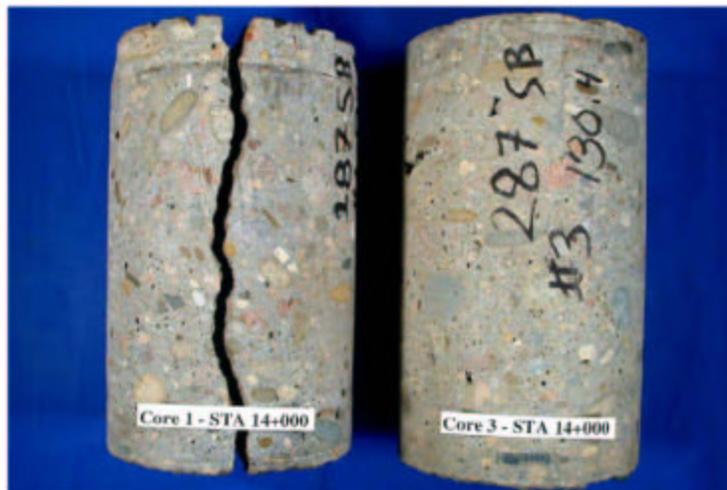
Fig. 1 (a & b) Concrete Cores 1 and 3, as received for analysis. Core 1 is from the cracked portion of the pavement and Core 3 is from the center of the lane.

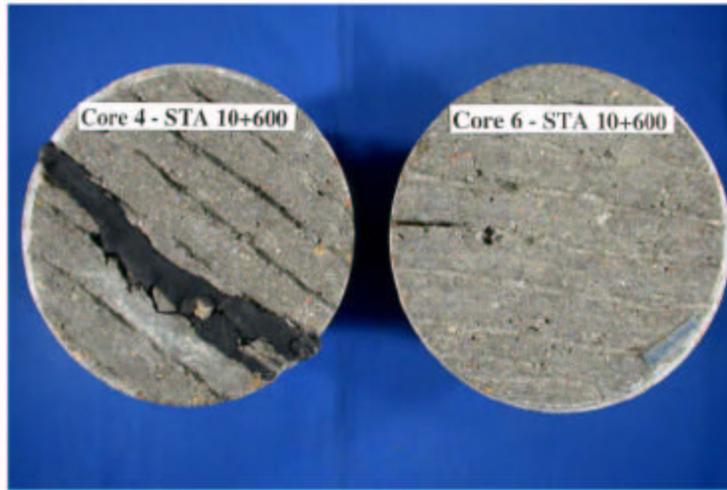
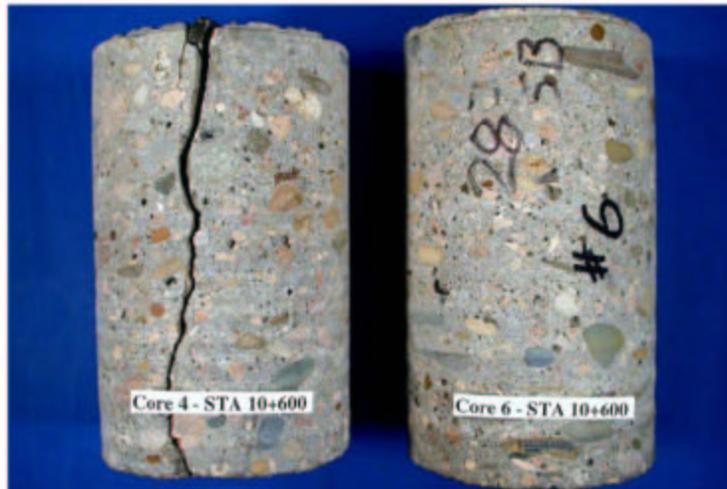
Fig. 2 (a & b) Concrete Cores 4 and 6, as received for analysis. Core 4 is from the cracked portion of the pavement and Core 6 is from the center of the lane.

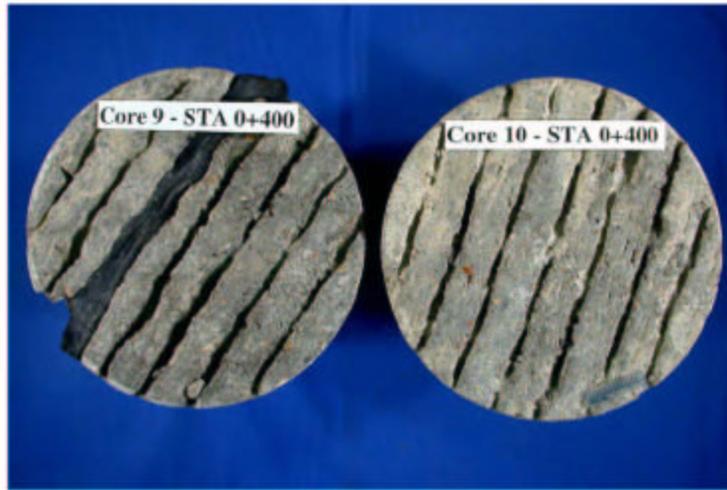
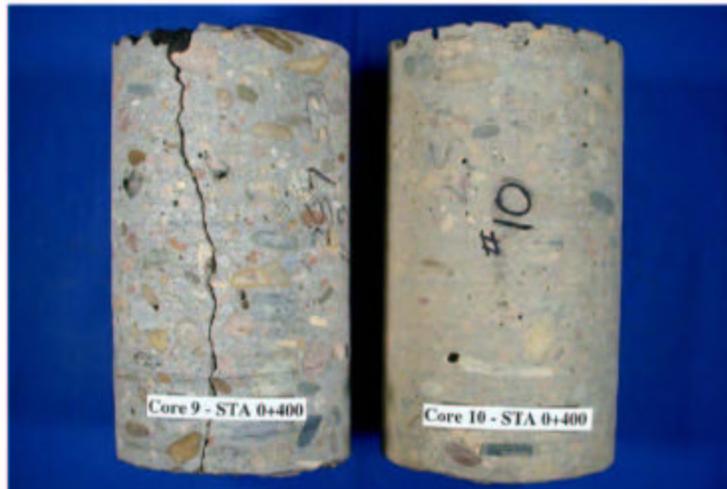
Fig. 3 (a & b) Concrete Cores 9 and 10, as received for analysis. Core 9 is from the cracked portion of the pavement and Core 10 is from the center of the lane.

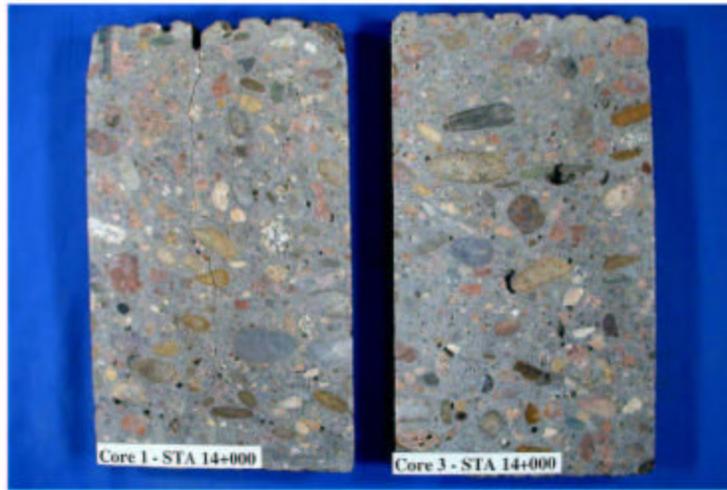
**Fig. 10** Cut cross section of Cores 1 and 3 showing the longitudinal crack in Core 1.

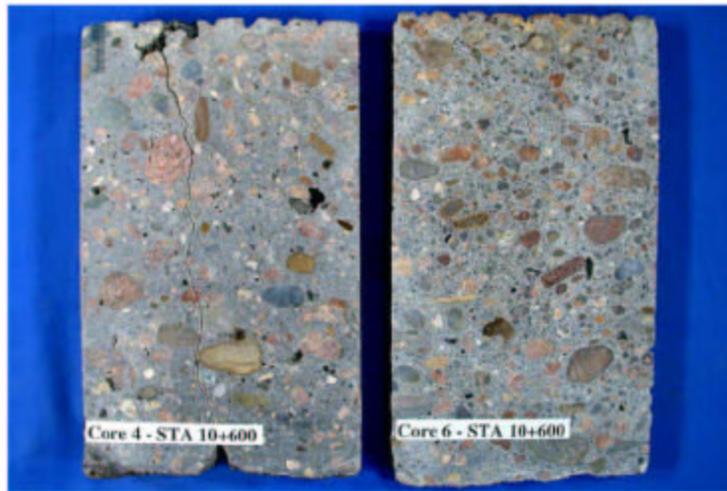
**Fig. 11** Cut cross section of Cores 4 and 6 showing the longitudinal crack in Core 4.

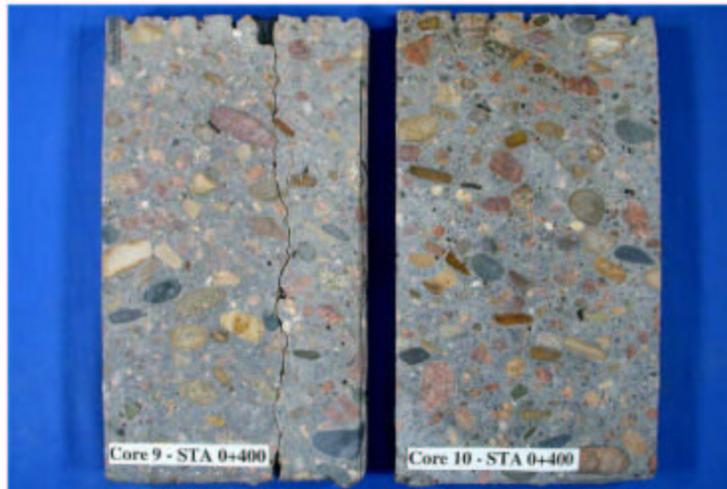
**Fig. 12** Cut cross section of Cores 9 and 10 showing the longitudinal crack in Core 9.
