**Report No. CDOT-DTD-R-2004-10
Interim Report**

CABLE GUARDRAIL

June 2004

**COLORADO DEPARTMENT OF TRANSPORTATION
RESEARCH BRANCH**

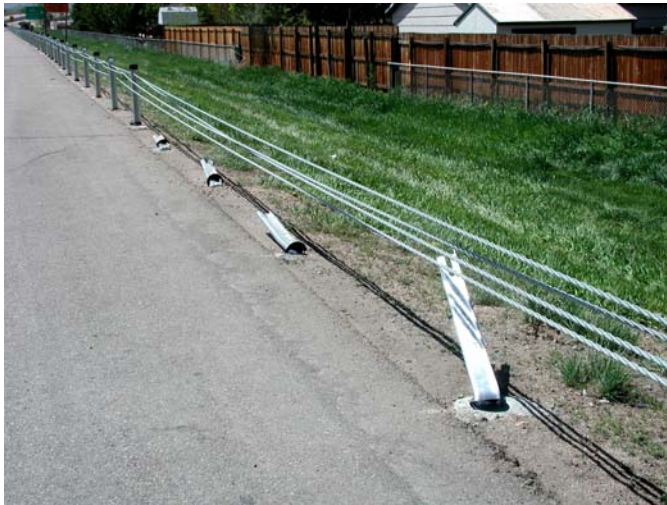
Figure 2. Only four posts were bent in this drive-away accident on US-285 at Kipling.

US-285 at Kipling Parkway: In early May of 2003, the system on southbound US-285 (**Figure 2**) was hit once requiring replacement of 4 posts. This appears to

have been another drive-away situation; there is no record of a report to law enforcement, and there have been no reports of any additional hits on the system.
