**Background:**

**Geometric Deficiencies**

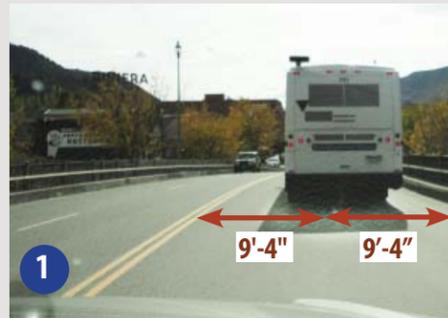
**1** The bridge is too narrow.\*

- 1** The existing lane widths are 9'-4", compared to 11'-0" wide approach lanes south of the bridge. Standard highway lanes are 12'-0". In addition, there are no shoulders on the bridge. The appraisal rating for bridge width is 2 out of 9.

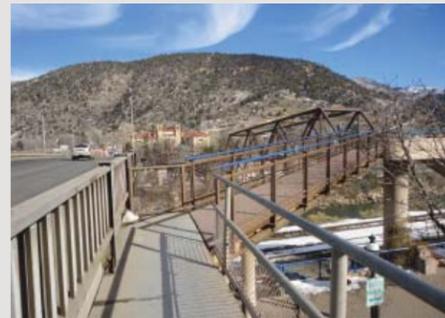
**2** Poor ADA and bike access to pedestrian bridge.

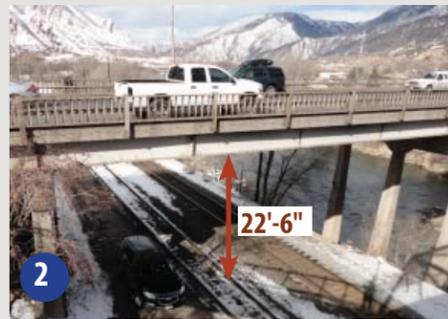
**2** Vertical clearance to railroad.\*

- 2** Currently, the vertical clearance from the railroad tracks to the bottom of the bridge girders is 22'-6". The current railroad standards require 23'-6" clearance over railroads.

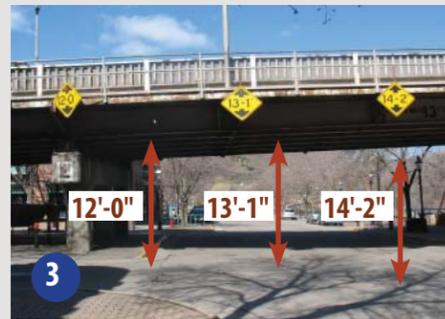
**3** Substandard vertical clearance at 7th Street.\*

- 3** Currently, the vertical clearance from 7th Street to the bottom of the bridge girders varies from 12'-0" to 14'-2". This low clearance results in an appraisal rating of 3 out of 9. Current standards require 14'-6" clearance on local streets.

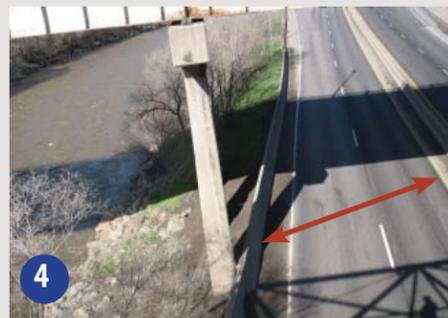
**4** Substandard horizontal clearance at I-70.\*

- 4** Piers are located less than 6' from the edge of traveled roadway on I-70, resulting in an appraisal rating of 3 out of 9. This close pier location does not allow for proper impact protection of the piers with guardrail, and existing piers were not designed for an impact load.

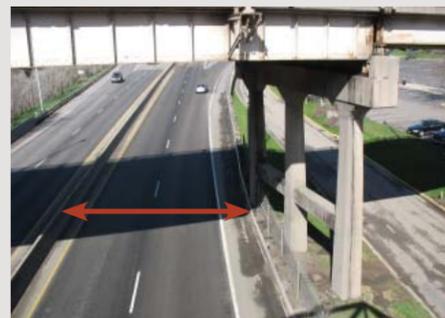
**4** Piers force I-70 to have narrow shoulders.\*

The existing piers supporting the Grand Avenue Bridge pinch the width of I-70 below. The location of the piers adjacent to the east bound I-70 shoulder limit the length of the ramp as it merges onto I-70, not allowing for sufficient acceleration distance for traffic merging onto I-70 eastbound.

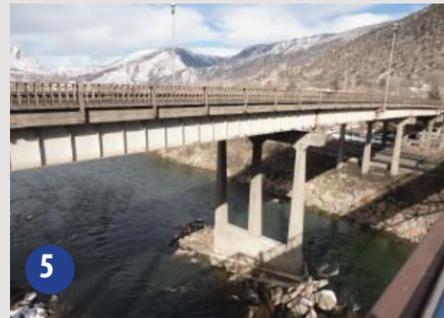
**5** Existing bridge piers are supported on shallow spread footings that are susceptible to erosion.

- 5** The existing bridge piers are supported on spread footings that rest 7' below the river bed. An underwater inspection in 1992 found that the river had caused erosion around the footing to a depth of 2' below a portion of the footing. (Scour hole depth equals 9' below river bottom.) This erosion was repaired at the time by filling the hole and placing rock around the footing to provide some erosion protection. Records show that this repair was intended to last eight years.

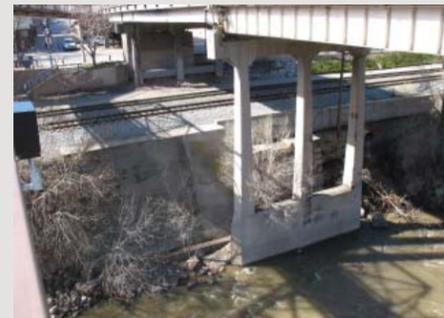
**6** Based on the 2010 bridge inspection, the bridge condition has the following ratings:

- Bridge Deck 6 out of 9
- Superstructure (girders) 6 out of 9
- Substructure (piers and abutments) 6 out of 9
- Bridge Rail substandard

- 6** The condition rating indicates that the bridge is in satisfactory condition, but shows minor deterioration such as:
  - Deterioration of the concrete curbs and piers

- Exposed reinforcing steel on the curbs and piers
  - Corrosion on the railing
  - Peeling paint that has led to girder corrosion
  - Corrosion of the girders

- Damage to girders over 7th Street due to vehicular impact
  - Corrosion on the bridge supports
