APPENDIX F

I-25 Bridge Over the Arkansas River

Colorado Department of Transportation
Structure Inspection and Inventory Report (English Units)

Bridge Name: K-18-AJ Inspection Date: 12/11/2012 Sufficiency Rating: 62.3 Not Eligible

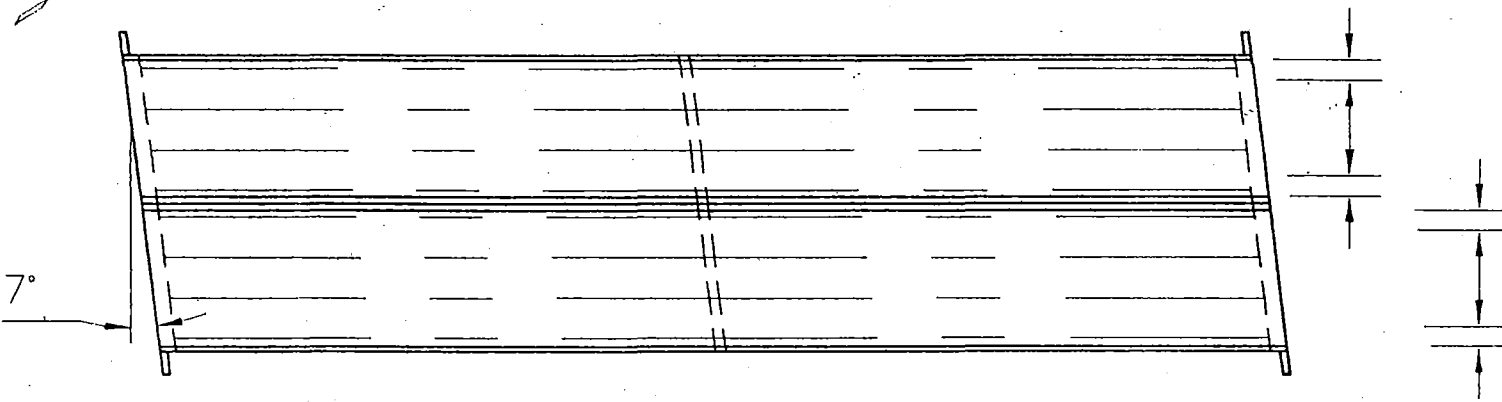
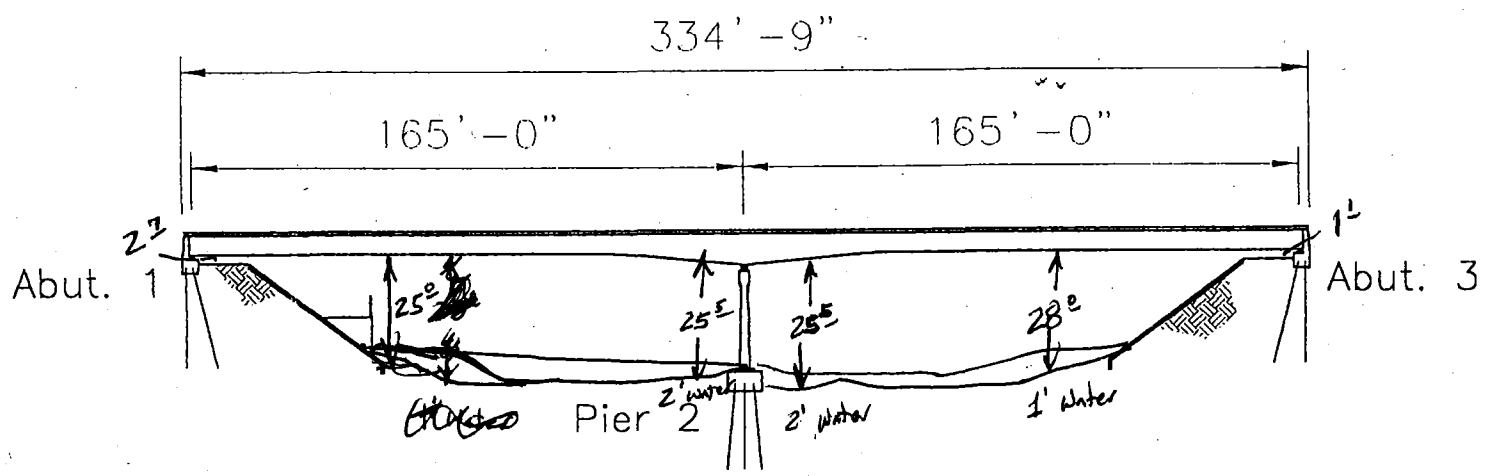
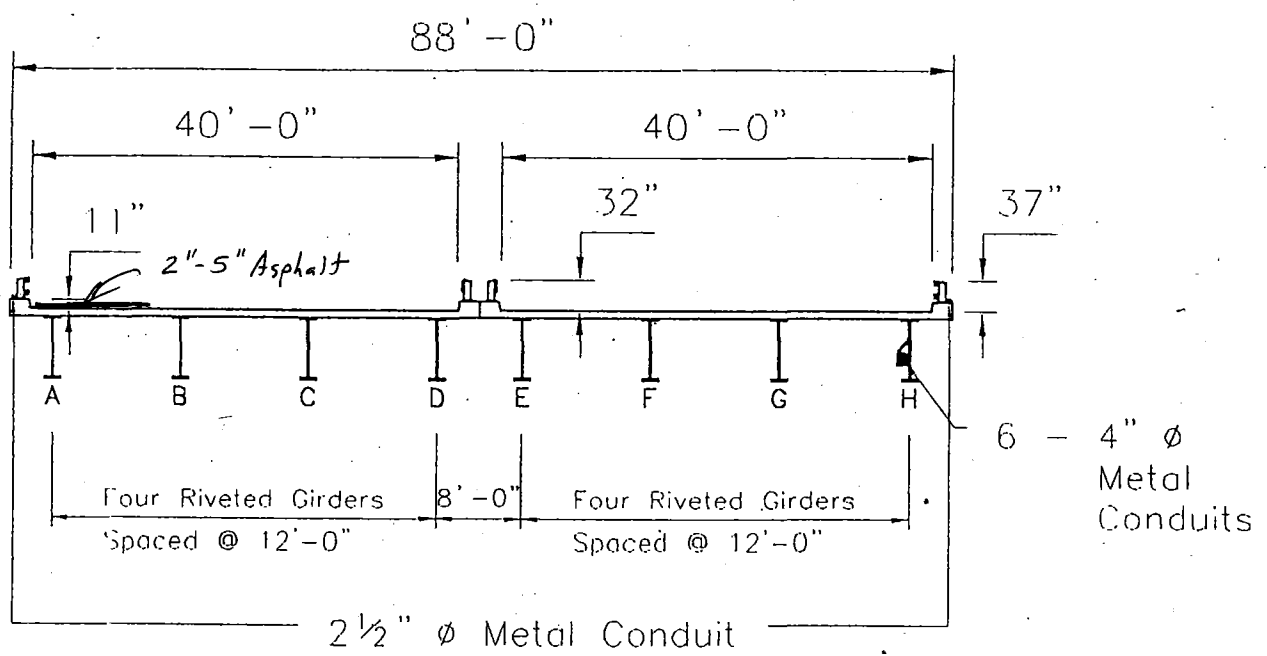
Structure K-18.AJ

- Change Item 91 to 12 months
- Include Jeff Anderson + John Deland in next inspection.
- I discussed this structure with Mark Leonard on 6/11/09. We are concerned with the exterior girders in the negative moment region, specifically regarding the lateral support of compression flange. DOT may want to replace the cross framing of the exterior girders that are cracked in the negative moment region. Due to the girder connection at the pier a critical inspection finding memo is not warranted at this time. Particular attention will be paid to the cracked diaphragm connections near the pier as well as the bearing conditions at all substructure supports.

Structure was inspected 8/12/09. I do not have any concerns at this time
