Genessee Buffalo Herd/Pull-Out - I-70 MM 254
Elevation \approx 7650'

CDOT Region #1

Summary Observations

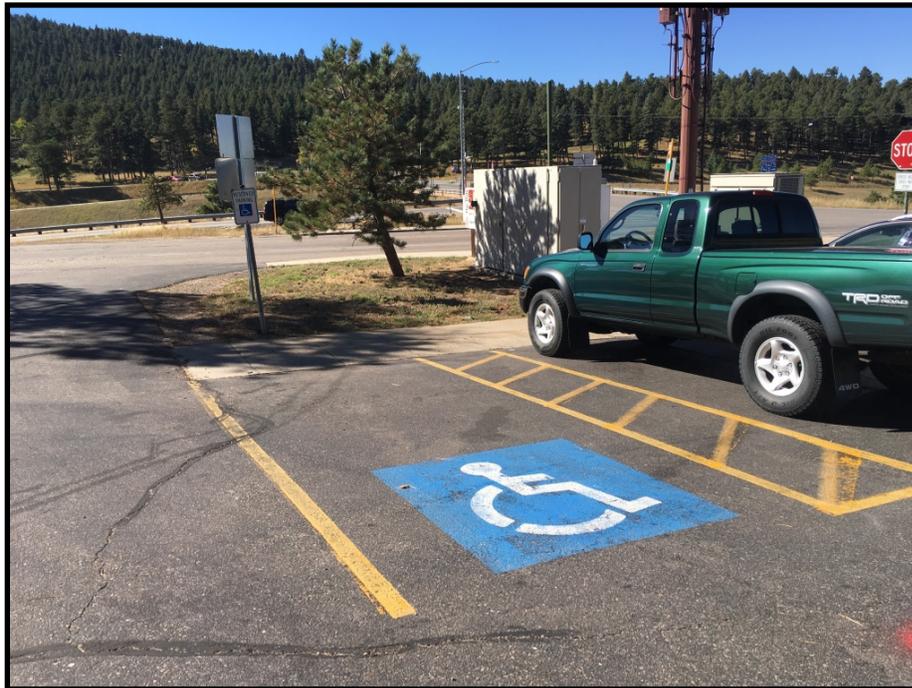
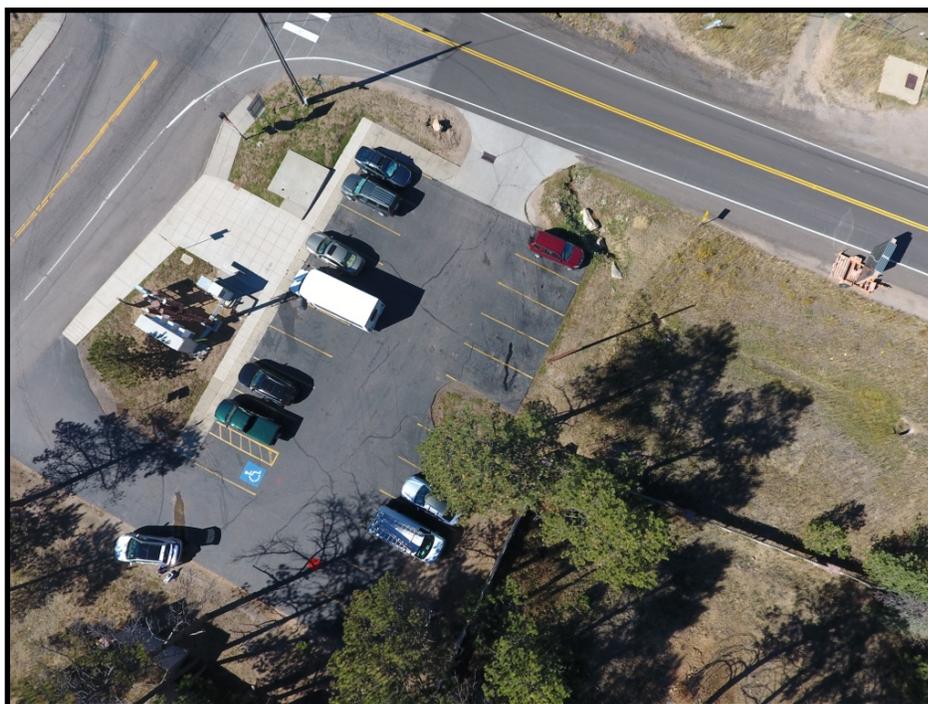
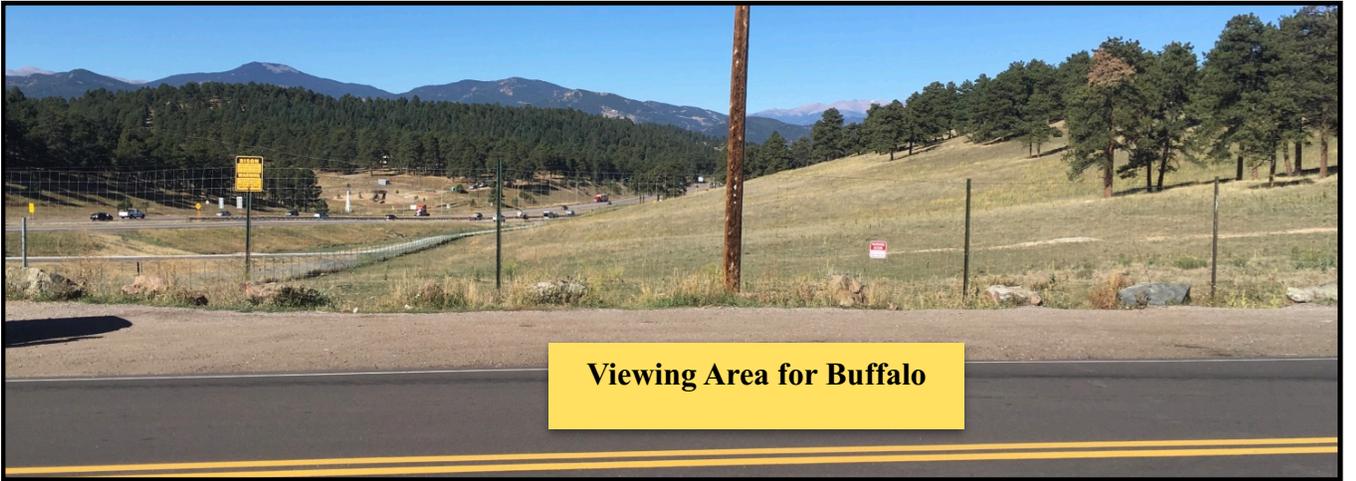
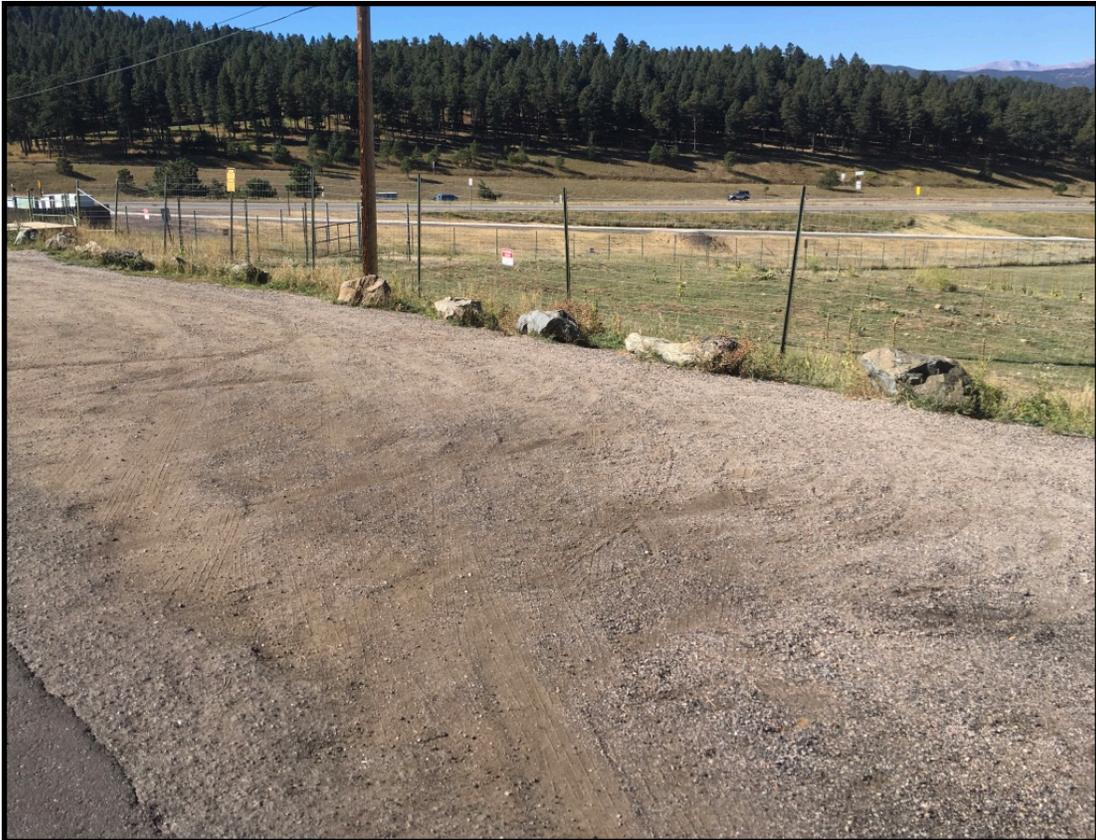
There are 20 parking spaces with one designated accessible parking spot with a vertical sign and access aisle. This lot is not designed for trucks or large RVs.

The path from the open parking to the visitor sign and overlook is not accessible for a person using a wheelchair. The path to the viewing fence is gravel/dirt.

Description	Priority
ADA requires at least one van accessible parking space (§208.2.4). Expand existing access aisle to 8' wide to accommodate vans or cars.	Soon
Raise accessible parking sign to 60"	Immediate
