**SOUTH PLATTE RIVER,  
GLOBEVILLE  
PHASE III DESIGN  
DOCUMENTATION REPORT**

**“HYDRAULIC MODEL STUDY  
OF THE SOUTH PLATTE RIVER  
AT THE FRANKLIN STREET BRIDGE”**

**HYDRAULIC MODEL STUDY OF THE  
SOUTH PLATTE RIVER AT  
THE FRANKLIN STREET BRIDGE**

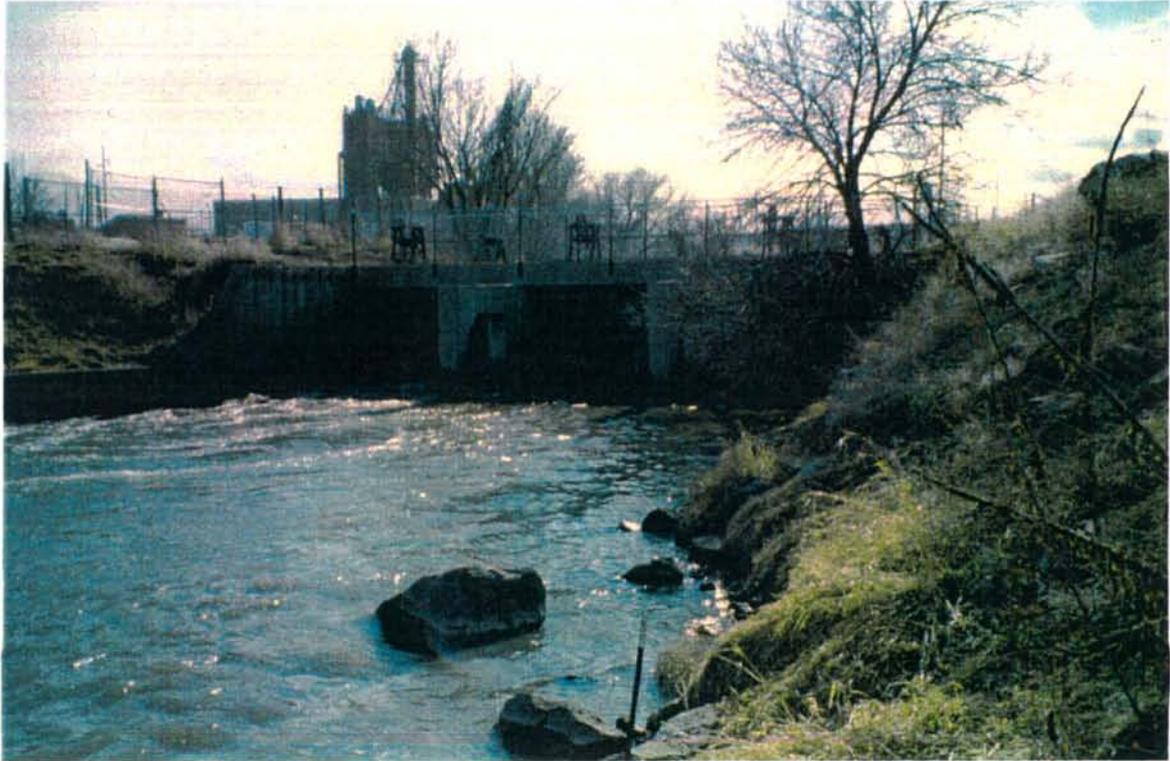
Figure 1. View of the existing head gates at the Burlington, O'Brien and Farmers Canal on the South Platte River.

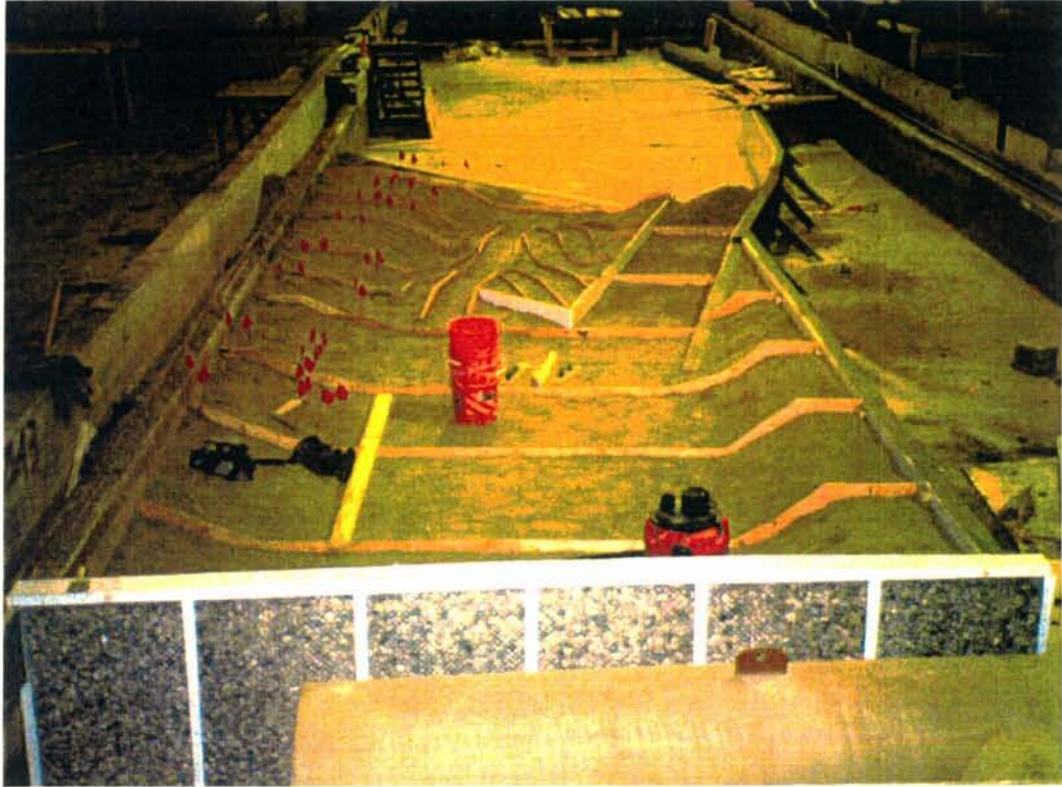
Figure 2. Model construction showing the cross section templates and sand fill before the concrete cap is applied.

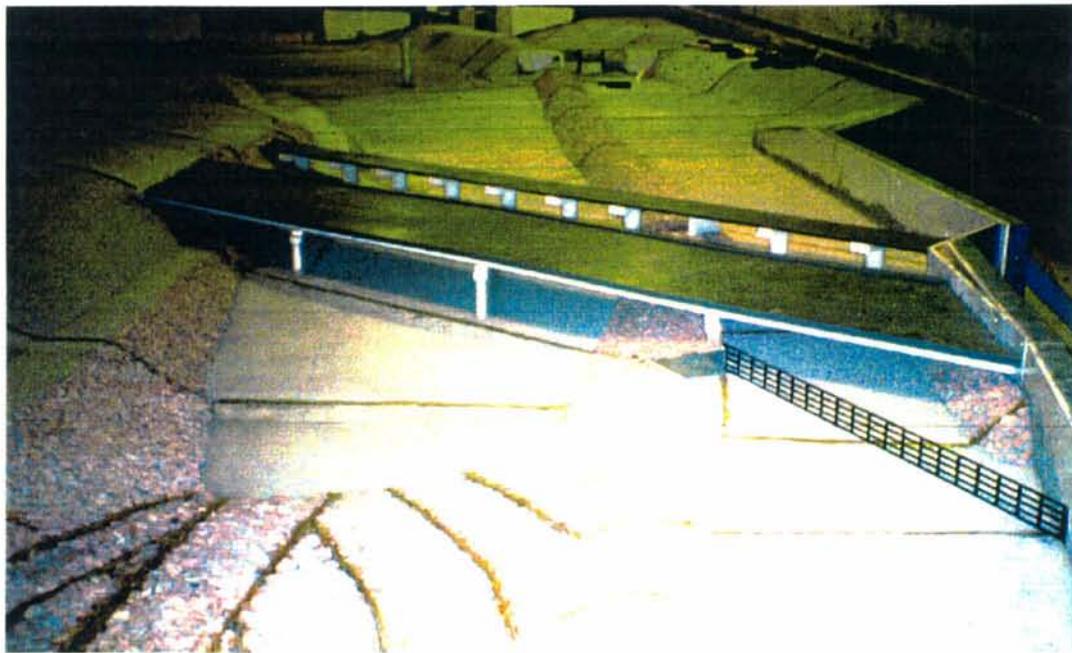
Figure 3. View of the completed model looking downstream to the Franklin Street Bridge and the Union Pacific Railroad Bridge.

The piers and deck of the Franklin Street Bridge were modeled with wood painted with an epoxy waterproof paint as shown in Figure 3. The bridge stringers and underside of the deck were modeled to provide the same flow restriction to flood waters as the prototype. The UPRR Bridge immediately downstream of the Franklin Street Bridge was modeled in a new design configuration, as directed by Love & Associates, Inc., to replace the old timber pilings presently in use. The UPRR Bridge will be removed and replaced as a part of the project. PVC pipe was used to simulate the circular cross section single pilings for the new bridge with a wooden bridge deck and supports. The elevated water pipeline located between the two bridges was not modeled as the pipeline is also scheduled for burial in the river bottom as part of this project.

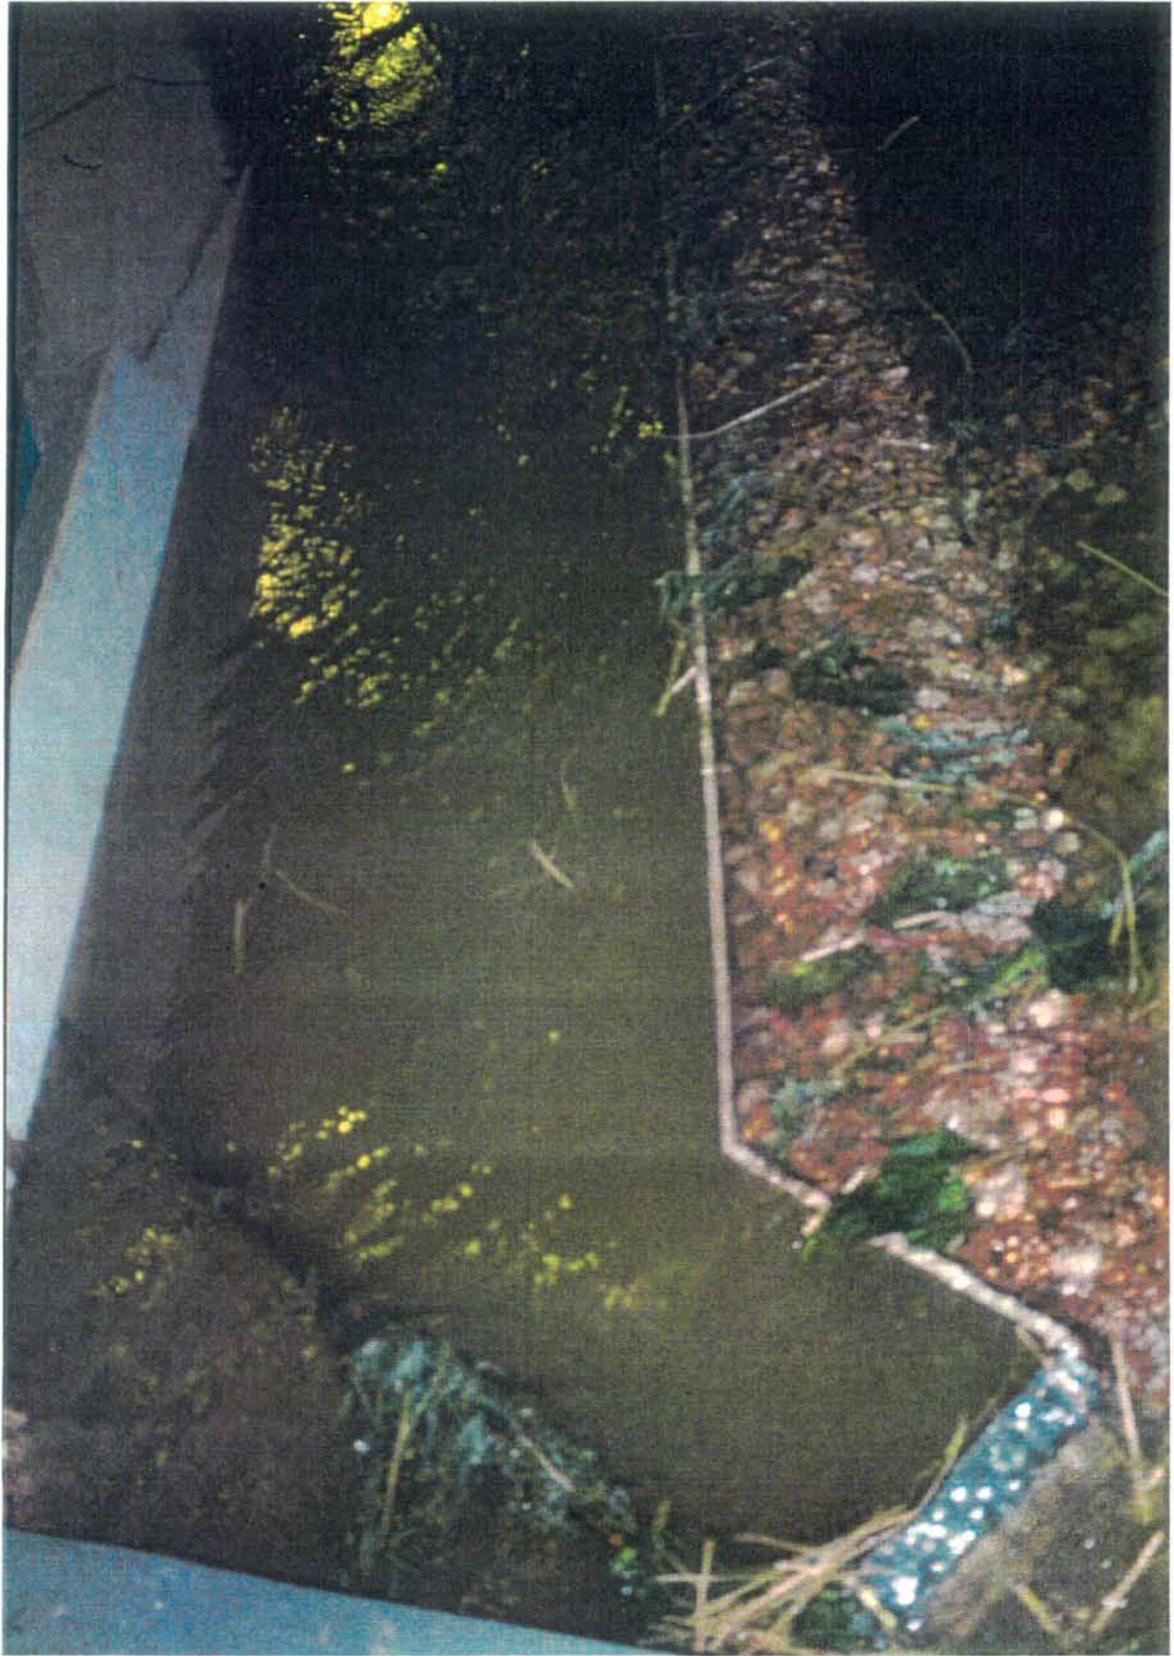
Figure 8. Debris and trash trapped on trash rack and weir top, 2-year flood event.

A series of tests was performed focusing on how debris will be transported through the study reach during 2-year and 10-year flood events. Figure 8 portrays a typical debris buildup on the trash rack resulting from a 2-year flood event. The tests indicated that of the total debris load entering the reach, approximately 80 percent of the debris entered the diversion approach channel with 20 percent remaining in the river channel. Of the debris transported down the diversion approach channel, approximately half was washed/flushed over the separation weir and returned to the main river channel upstream of the Franklin Street Bridge trash rack. Of the debris remaining in the diversion channel, 15 to 30 percent was trapped on the Franklin Street Bridge trash rack. The remaining debris was either trapped on the separation weir downstream of the Franklin Street Bridge or at the trash rack at the regulation head gates.

The model results indicate that the separation weir and Franklin Street Bridge trash rack are efficient in trapping debris and will significantly reduce the amount of debris approaching the regulation head gates. Further, the sluice gate adjacent to the Franklin Street Bridge will enhance returning the debris entrapped on the trash rack. However, the sluicing operation will not eliminate the need for periodic maintenance. It was observed that the Franklin Street Bridge trash rack will not trap all debris in the diversion approach channel. Based upon the model test results, the expected debris load at the regulation head gates should not exceed current (pre-construction) levels and, most probably, will be reduced in future operations.

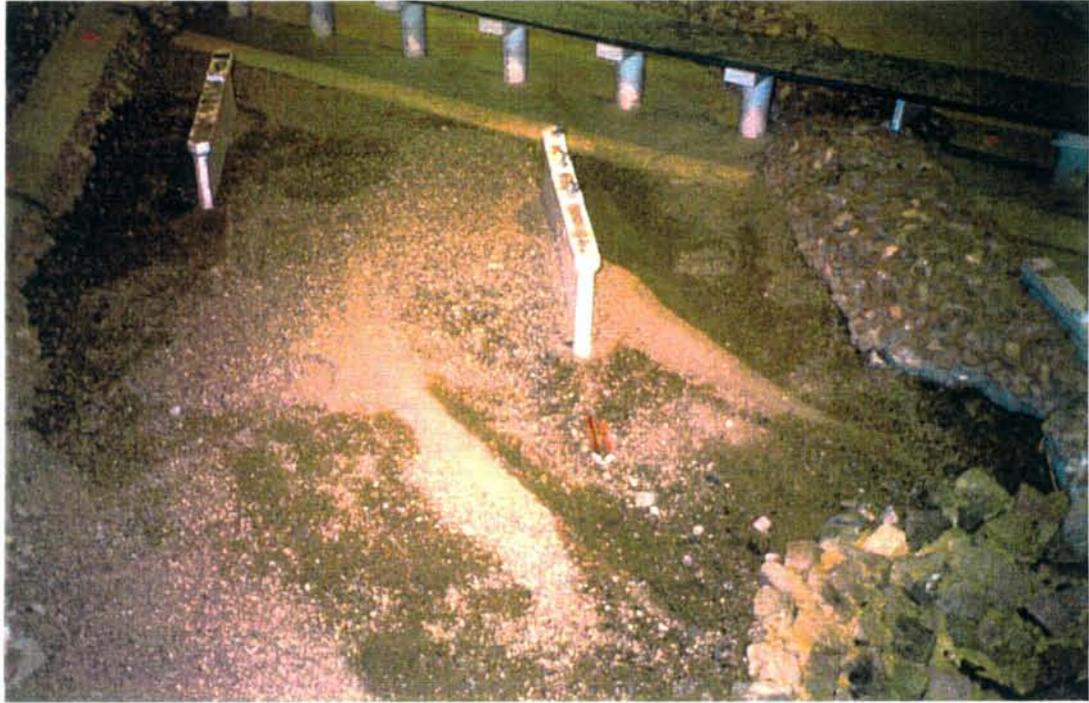
Figure 10. Pier scour with the 2-year flood event, sluice gate at Franklin Street wide open, 300 cfs flow in the canal. Piers are shortened by 20 feet.

The 2-year flood event created a scour hole that was considerably larger than observed after the 1,000 cfs event as observed in Figures 10 and 11. The scour hole extended from the edge of the hard boundary to the nose of the pier. This hole was 4- to 5-feet deep and approximately 20-feet wide extending to the nose of the pier. Scour

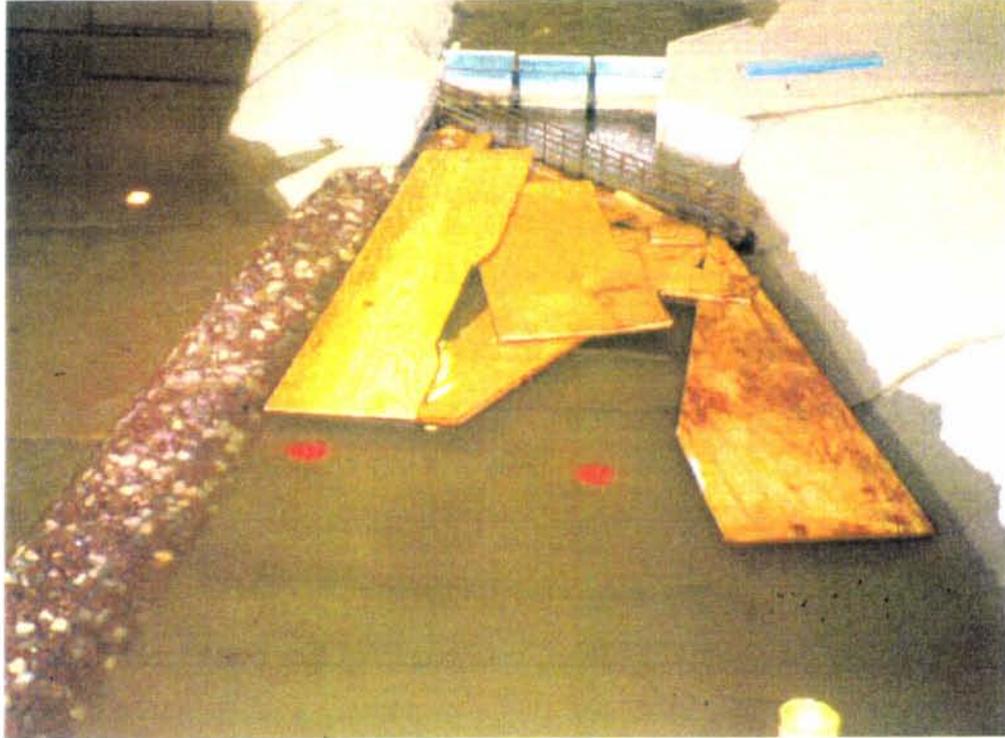
Figure 13. Plywood sheets to simulate ice buildup against the canal head gates trash rack.

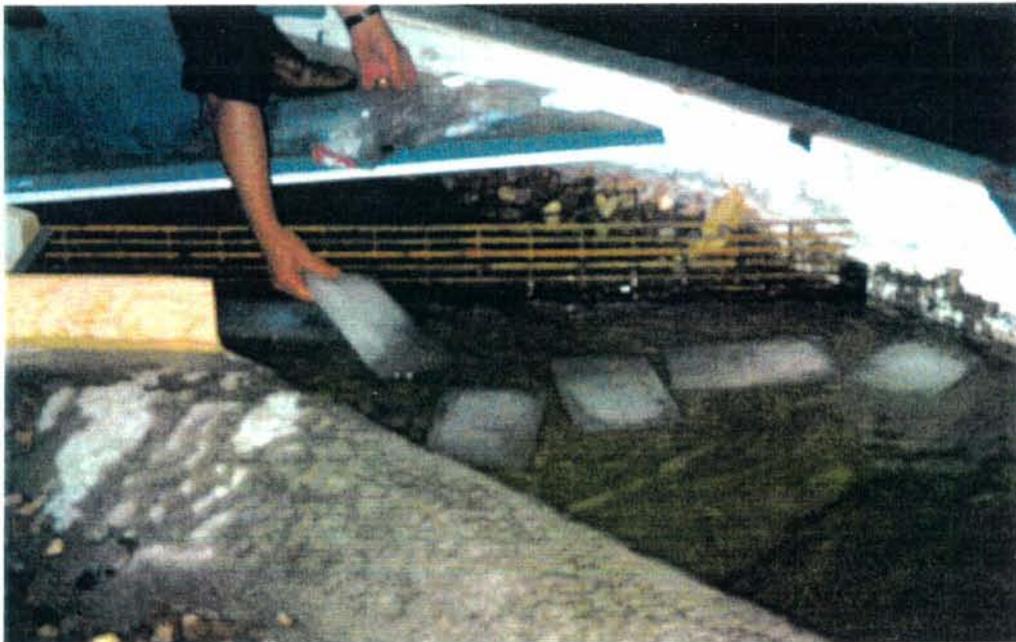
Figure 14. Using thin ice sheets to simulate ice buildup at the Franklin Street trash rack.

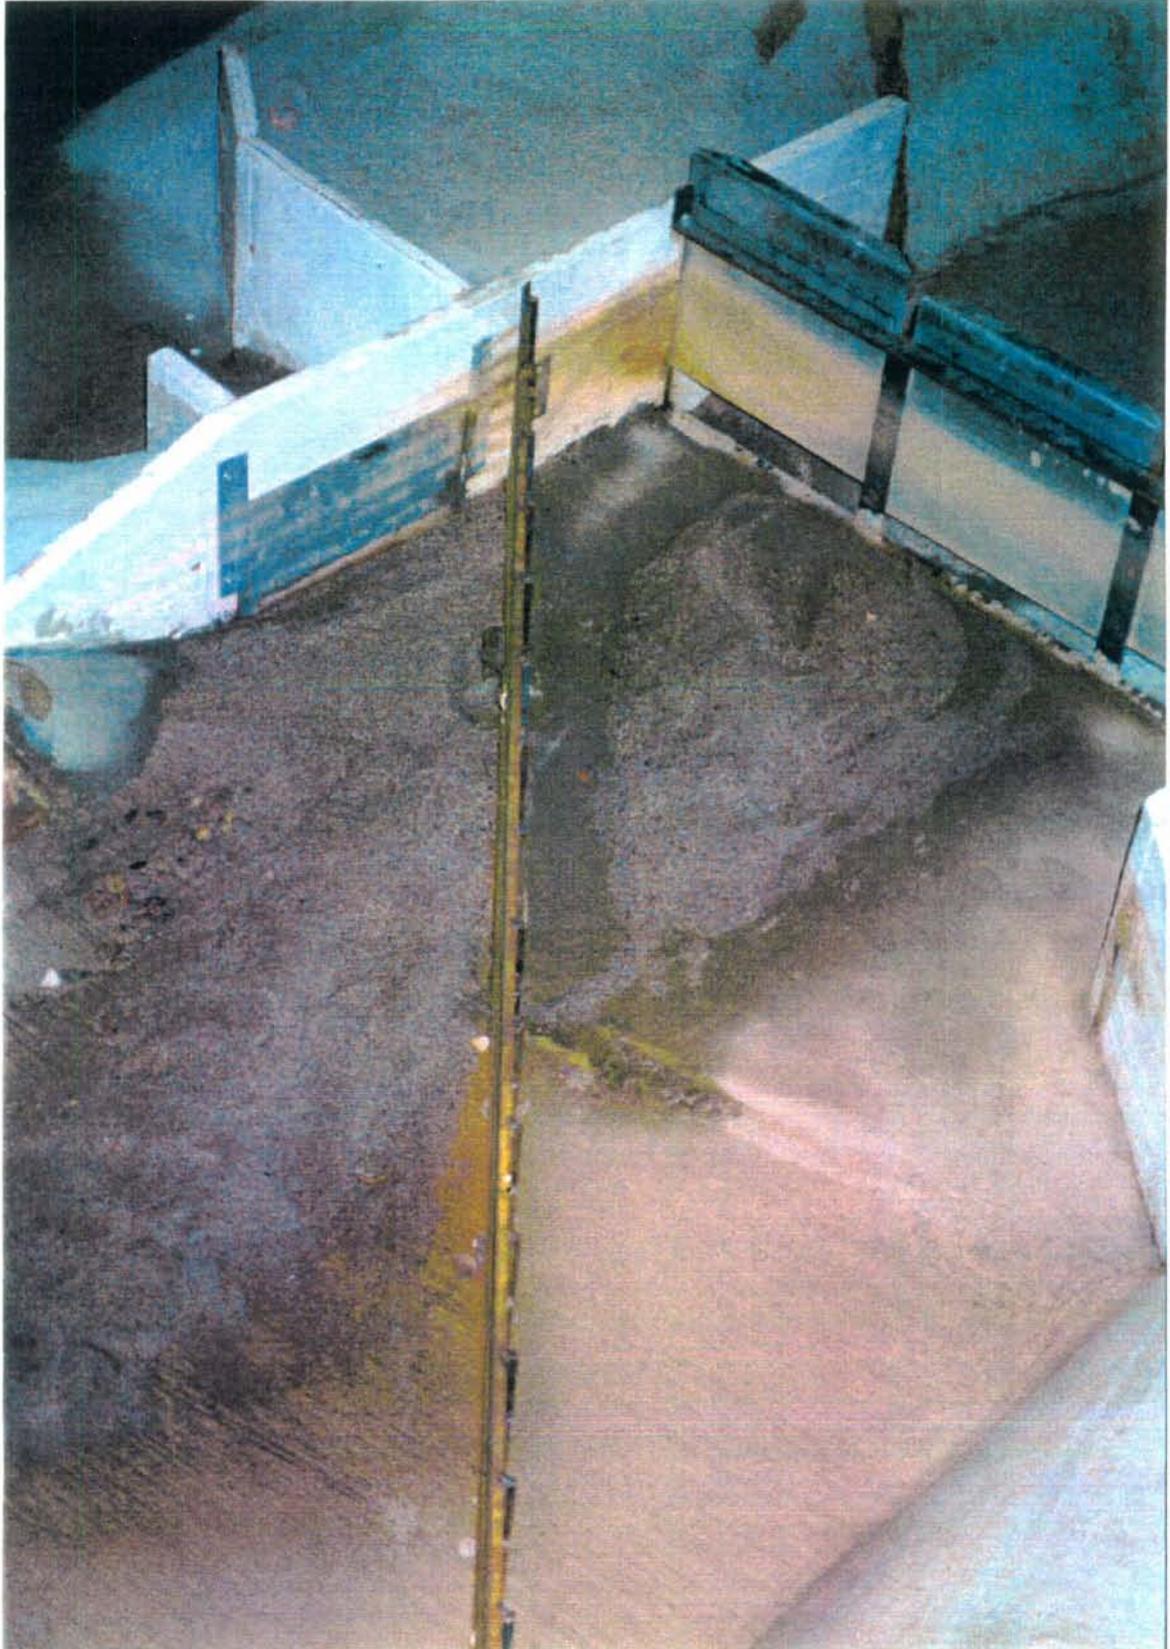
Figure 16. Sediment deposition at canal regulation head gates for 2-year flood event.

Sediments were injected into the model during the 2-year flood event in a manner similar to that described for the 1,000-cfs condition. Sediments were observed to be transported through both the river channel and the diversion approach channel. It is estimated that approximately 40 percent of the sediment migrated through the river channel while the remaining sediments were transported through the diversion approach channel. After several hours of operation, sediments were observed to deposit throughout the diversion approach channel as observed in Figure 15. Sediment deposits were observed adjacent to the Franklin Street Bridge trash rack and sluice gate, adjacent to the UPRR Bridge, and in the diversion approach channel upstream of the regulation head gates as portrayed in Figure 16.

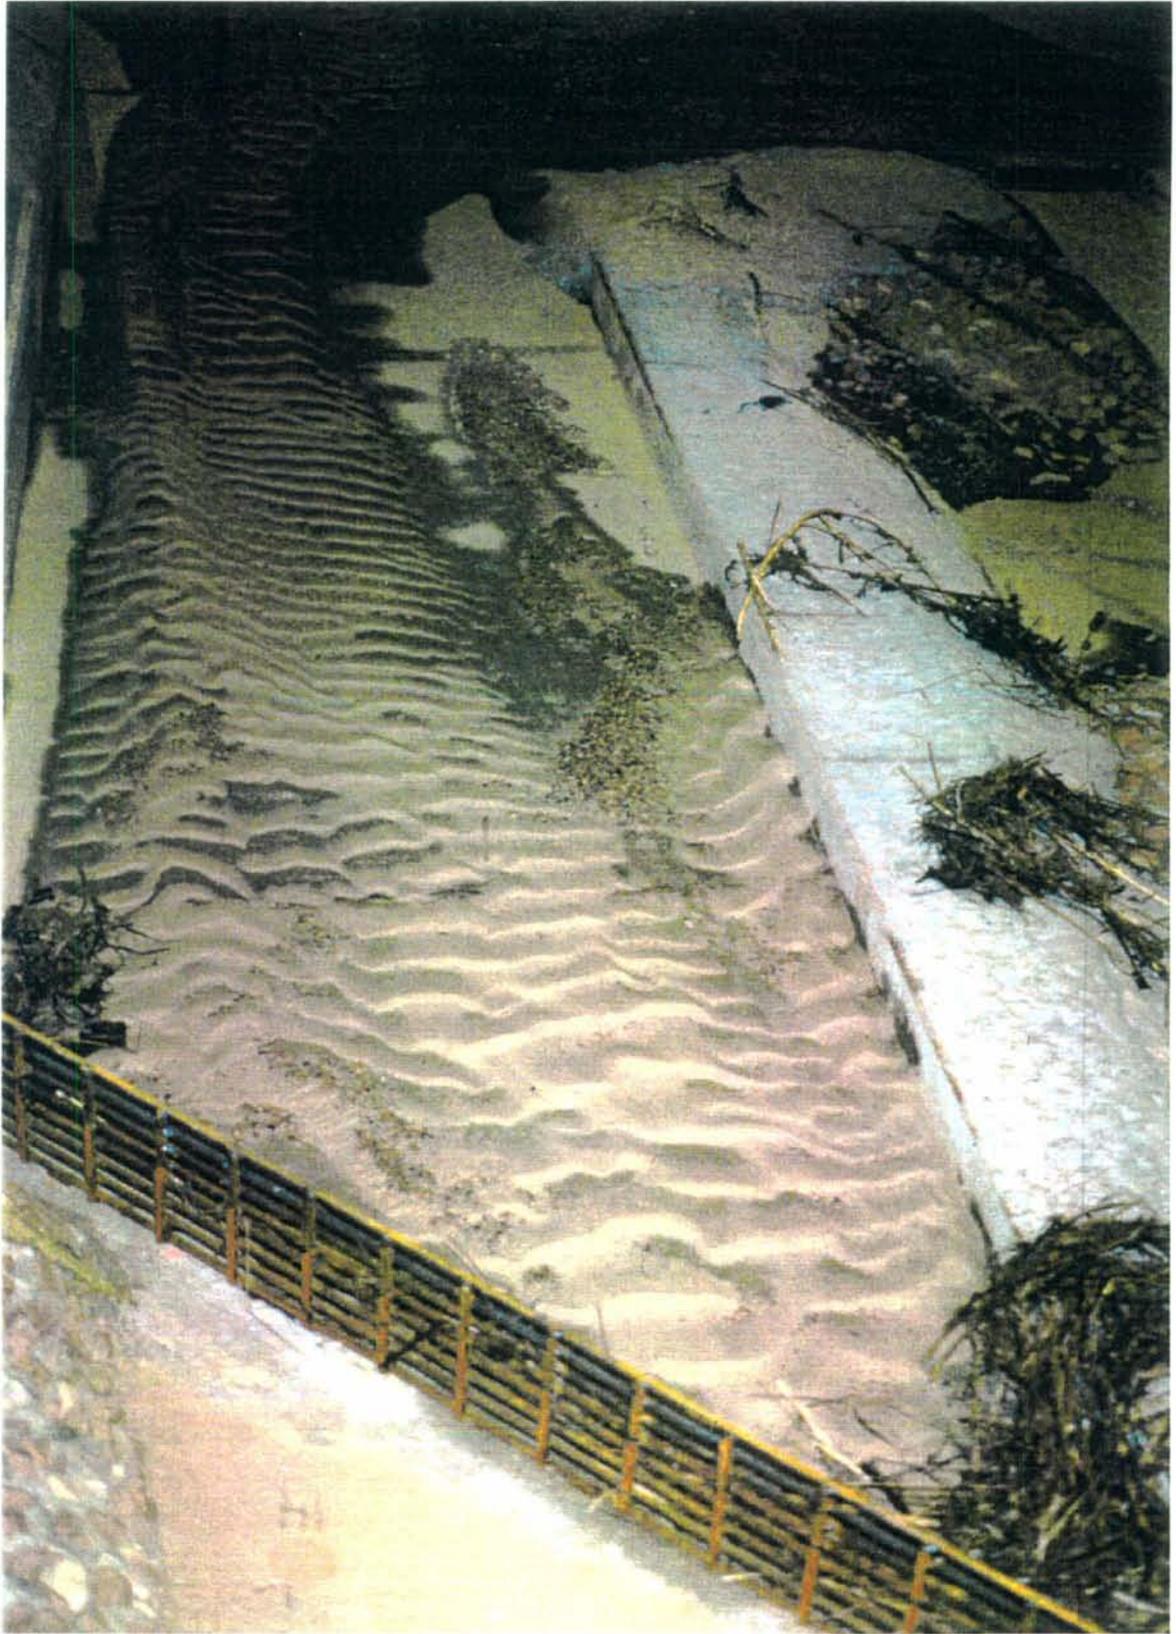
Figure 18. Siltation in the diversion approach channel with the 10-year flood event.

The 10-year flood event was routed through the model while sediments were injected similar to the 1,000 cfs and 2-year flood events. Sediment deposition occurred in the same areas described for the 2-year flood condition. However, the sediment transport split between the river channel and the diversion approach channel was observed to be approximately 60 percent and 40 percent, respectively. The higher velocities and flow depths upstream of the diversion approach channel entrance transported a greater portion of the sediment through the river channel, the river flow was not as strongly influenced by the diversion as observed at the lower flood events. Further, the relatively high velocities in the diversion approach channel overtopped the separation weir returning a portion of

the transported sediments to the river channel. Therefore, sediment deposits were significantly smaller than those observed for the 1,000 cfs and 2-year flood events as presented in Figures 17 and 18.
