**Report No. CDOT-DTD-R-00-1**  
**Final Report**

## **PCCP Texturing Methods**

**COLORADO DEPARTMENT OF TRANSPORTATION  
RESEARCH BRANCH**

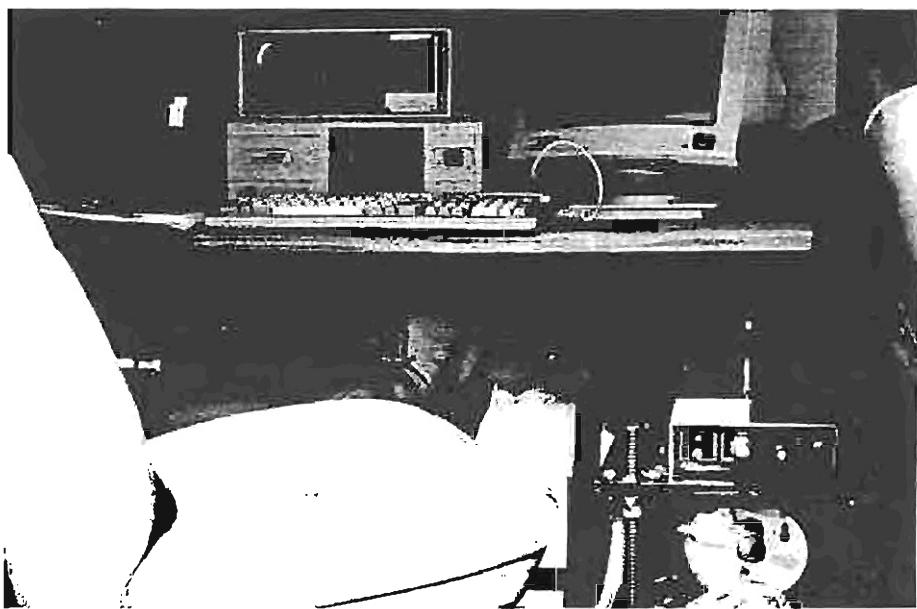
Photo 19: Inside of a texture measuring van

The texture van equipment (Photograph 19) can measure texture at travel speeds and does not interfere with normal traffic. It uses a television camera to take snapshots of a small pavement section in the wheel track (about 4 inches long). It takes a pre-selected number of exposures spaced about 50 feet apart at 50 miles per hour. To assure image sharpness the exposure time is given by a strobe light, and an infrared sensor assures that the field of view is in focus. A slit mask forms the images over the lens, giving two profile edges at every exposure.

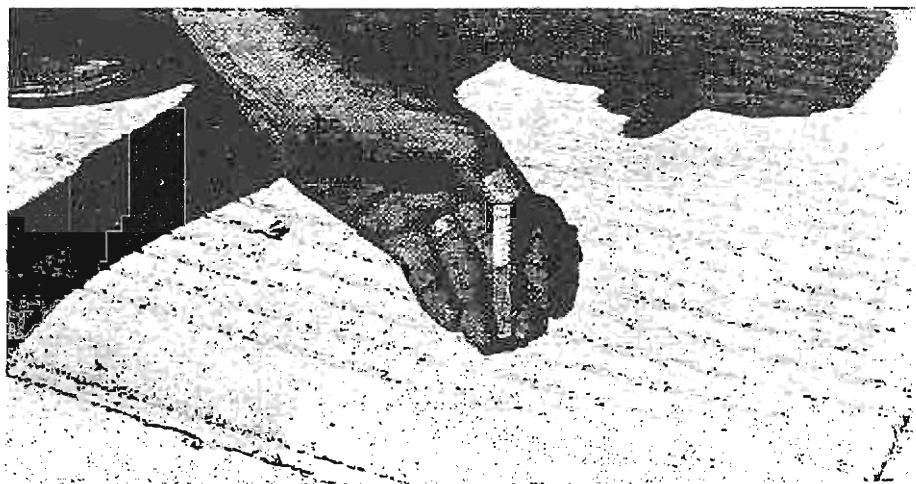
Photo 23: Texture depth measurement using a tire tread depth gauge
