Report No. CDOT-DTD-R-2000-10
Final Report

**Effects of De-Icing Agents
(Magnesium Chloride and Sodium Chloride)
on Corrosion of Truck Components**

**COLORADO DEPARTMENT OF TRANSPORTATION
RESEARCH BRANCH**

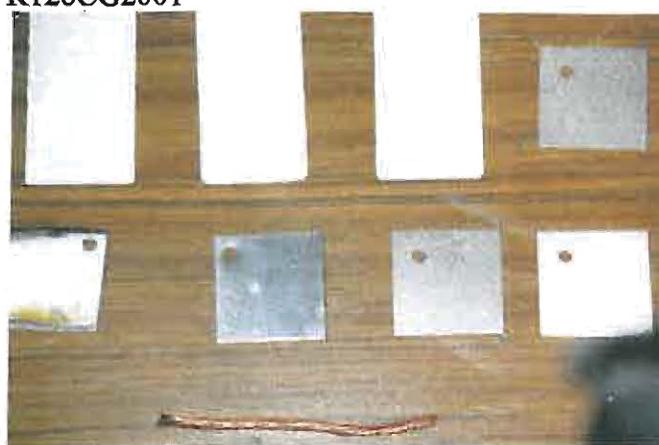
Figure 3: A photograph of the coupons.

All three ACT coupons (Type e, f, and g) have the same coating system:

Ecoat: U32AD400
Primer: G27AD258 Powder
Basecoat: R164WE936 Stone white
Clearcoat: R126CG2001

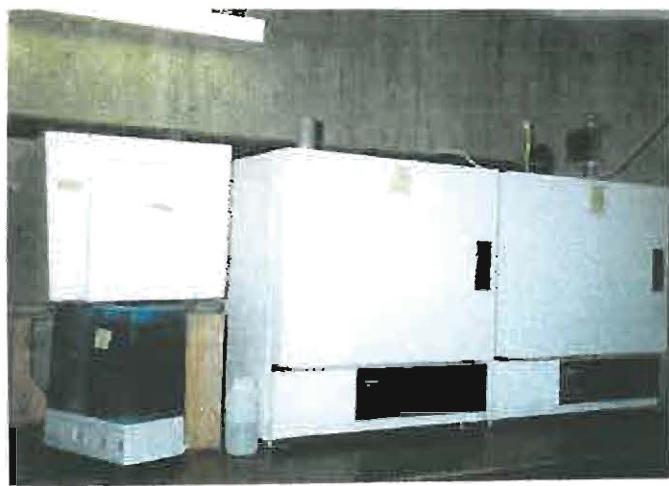
Figure 4: Experimental setups.

- a. Two environmental chambers (see Figure4), with a range in temperature from ambient to 65°C, and a humidity range from ambient to 100% RH;
- b. Precision balance, $210 \pm 0.001\text{g}$;
- c. Continuously spray unit (see Figure4), $38^\circ\text{C} \pm 1^\circ\text{C}$;
- d. Optical microscope of 200x with a CCD camera connected to a PC with an image grabber;
- e. Digital Multimeter, Model Bel Merit DX360T;
- f. Microcomputer pH meter, Model HI 8424.

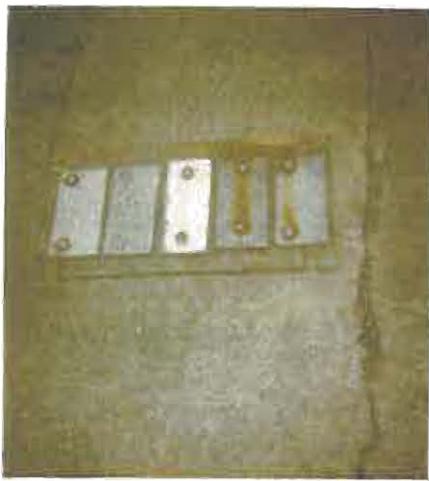
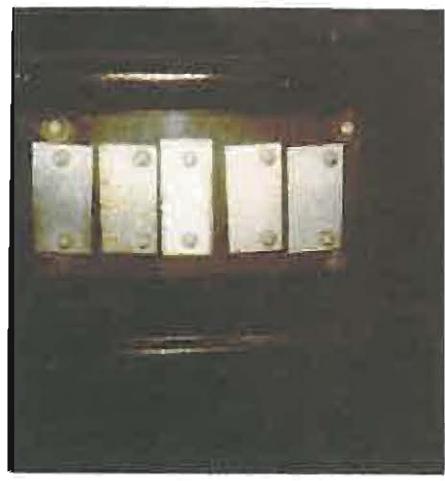
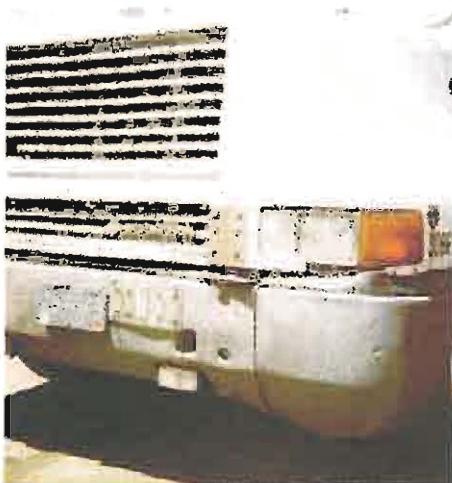
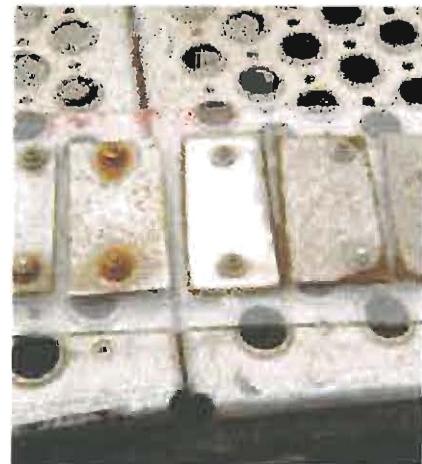
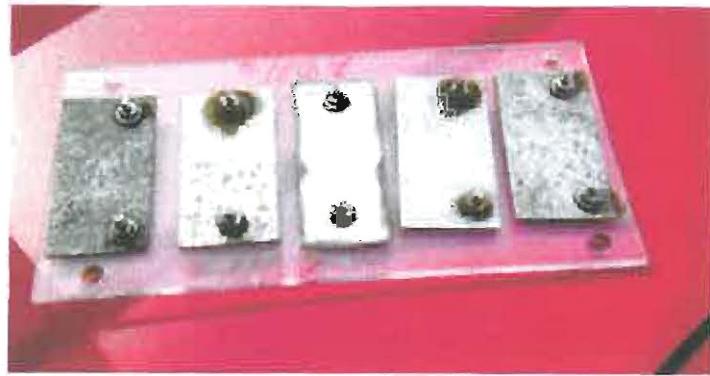
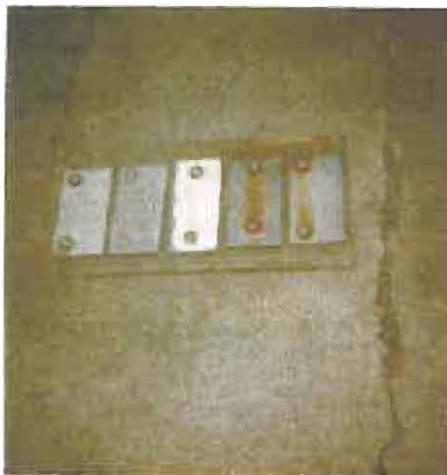
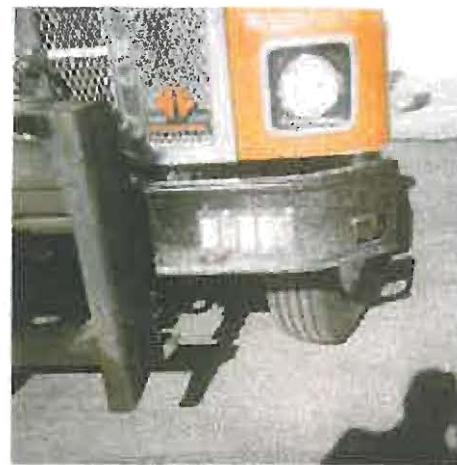
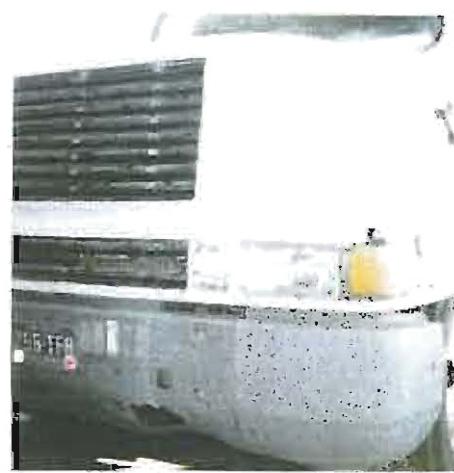
Figure 5a: coupons on CDOT truck immediately prior to removal

Figure 5b: coupons on CDOT truck immediately prior to removal

Figure 5c: coupons on HVH truck immediately prior to removal

Figure 5d: coupons removed from CAST truck

Figure 5E: Coupons from Cast truck

Figure 5g: Coupons on CDOT truck

Figure 5f: Coupons on CDOT truck

Figure 5h: Coupons on HVH truck

Maintenance trucks. While both CAST and HVH have interstate operations, the participating carriers were asked to mount the plates on trucks that ran miles only in Colorado to guard against exposure to other state's deicing chemicals.

- HVH Transportation is a large for-hire trucking company that operates primarily in Colorado. Test plates were installed on two trucks that operate between Denver and Grand Junction, and one truck that operates between Pueblo and Denver.
- CAST Transportation is a large for-hire trucking company that operates primarily in Colorado. Test plates were installed on four trucks that operate mainly on the I-70 and I-25 corridors.
- Colorado Department of Transportation Region 6 Maintenance Department is responsible for Highway Maintenance along the Front Range and in the Denver metropolitan area, including C-470 and parts of I-25. Test plates were installed on two vehicles that apply magnesium chloride and one vehicle utilized by the Road Maintenance Supervisor.

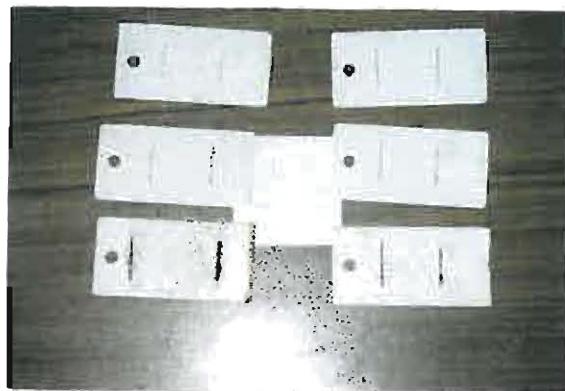
Figure 9: Coupons Corroded by NaCl and MgCl₂

For ACT coupons (i.e. ACT cold roll sheets, ACT Zn/Fe A45, and ACT E60 EZG), different chlorides used in the cyclic tests did not lead to any significant difference in the corrosion damage, as shown in Figure 9. The cold roll sheet was corroded by both NaCl and MgCl₂ to the same extent. However, no corrosion occurred to the other two ACT sheet materials, (ACT Zn/Fe

A45 and ACT E60 EZG) even after the cyclic tests were extended from two months to four months. One should notice that a scratch which penetrated the coating layer was made on every ACT coupon. Previous research showed that the scratches help accelerate the corrosion of the metals. The tests indicate that the treatments of electroplating or the hot-dip alloying during the manufacturing of the coupons enable the two ACT coupons to withstand cyclic chloride corrosion.

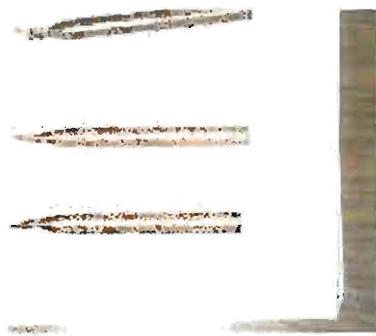
Figure 14a: Copper coupons prior to the test of SAE J2334

The corrosion test for copper tubes by SAE J2334 lasted one month. Two different chloride solutions were used in the test with the same concentration (3.0 wt.%). Different corrosion damages were observed. The results are given in Figures 14a and 14b. Copper wire specimens experienced same test and the corroded wires are seen as in Figure 14c. All these photos indicate that $MgCl_2$ causes more severe corrosion to the copper specimens than $NaCl$.
