**Report No. CDOT-DTD-R-2001-10
Final Report**

Forensic Investigation of Early Cracking on I-25 in Denver, Colorado

**Prepared for
Colorado Department of Transportation**

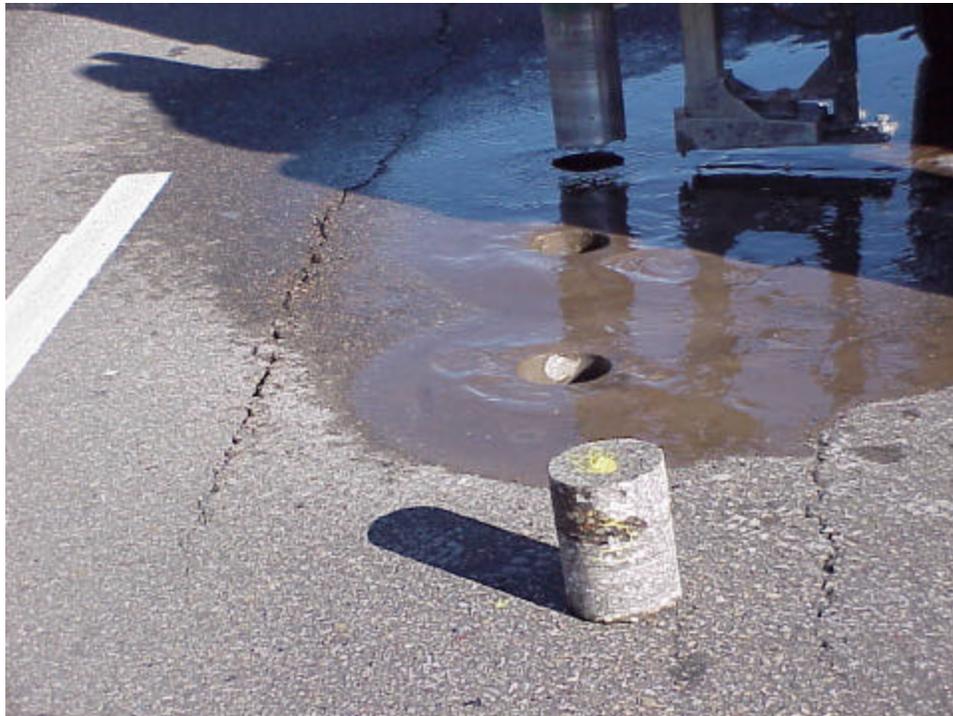
Figure 2 Coring in the Wheelpath of the Site with Distress

Figure 2 shows the coring in progress.

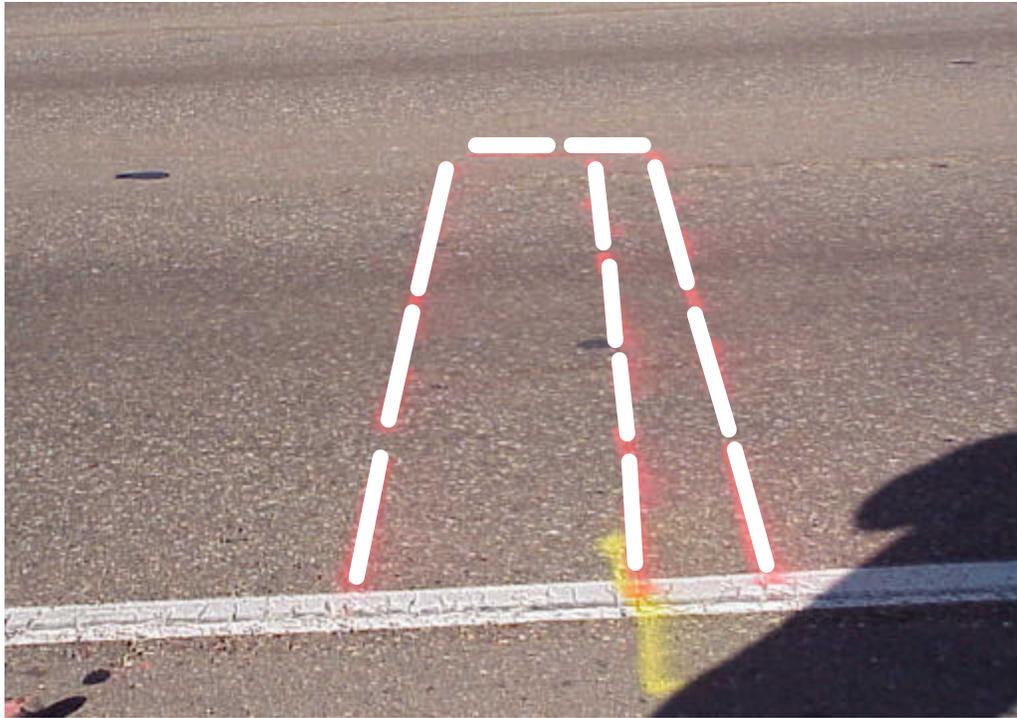
Figure 4 Layout for Cutting Slab

Figure 4 shows the pavement as marked for cutting.

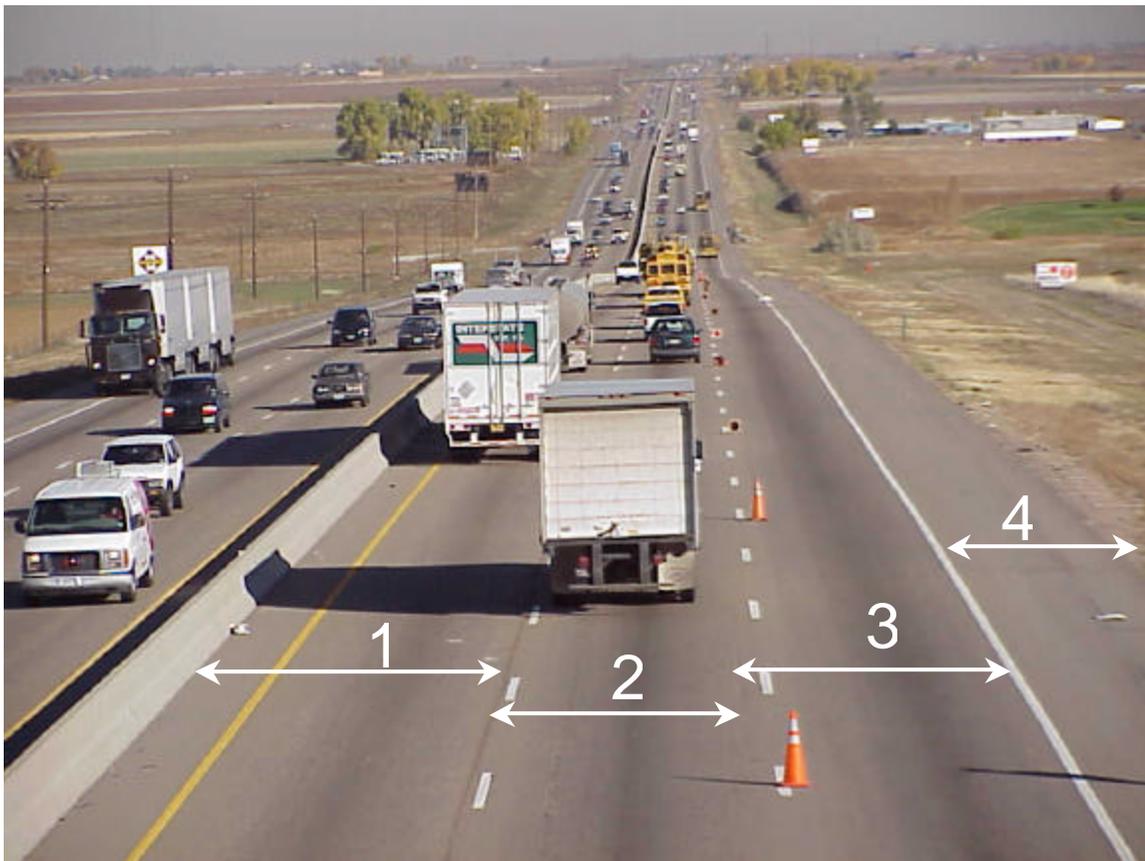
Figure 6 Paving Construction Sequence

- The pavement was originally built of hot mix asphalt in 1956.
- The roadway was widened to 6 lanes with hot mix asphalt in 1975.
- The roadway was overlaid with 3 inches of hot mix asphalt in 1984. A paving fabric was placed before the overlay.
- In 1997 the road was milled and overlaid with 3 inches of hot bituminous pavement.

In the 1997 construction, a milling machine was used to establish a new cross-slope. Hence, the thickness remaining of the 1984 overlay varies from $\frac{1}{2}$ inch to about 2 inches. The paving sequence is as follows:

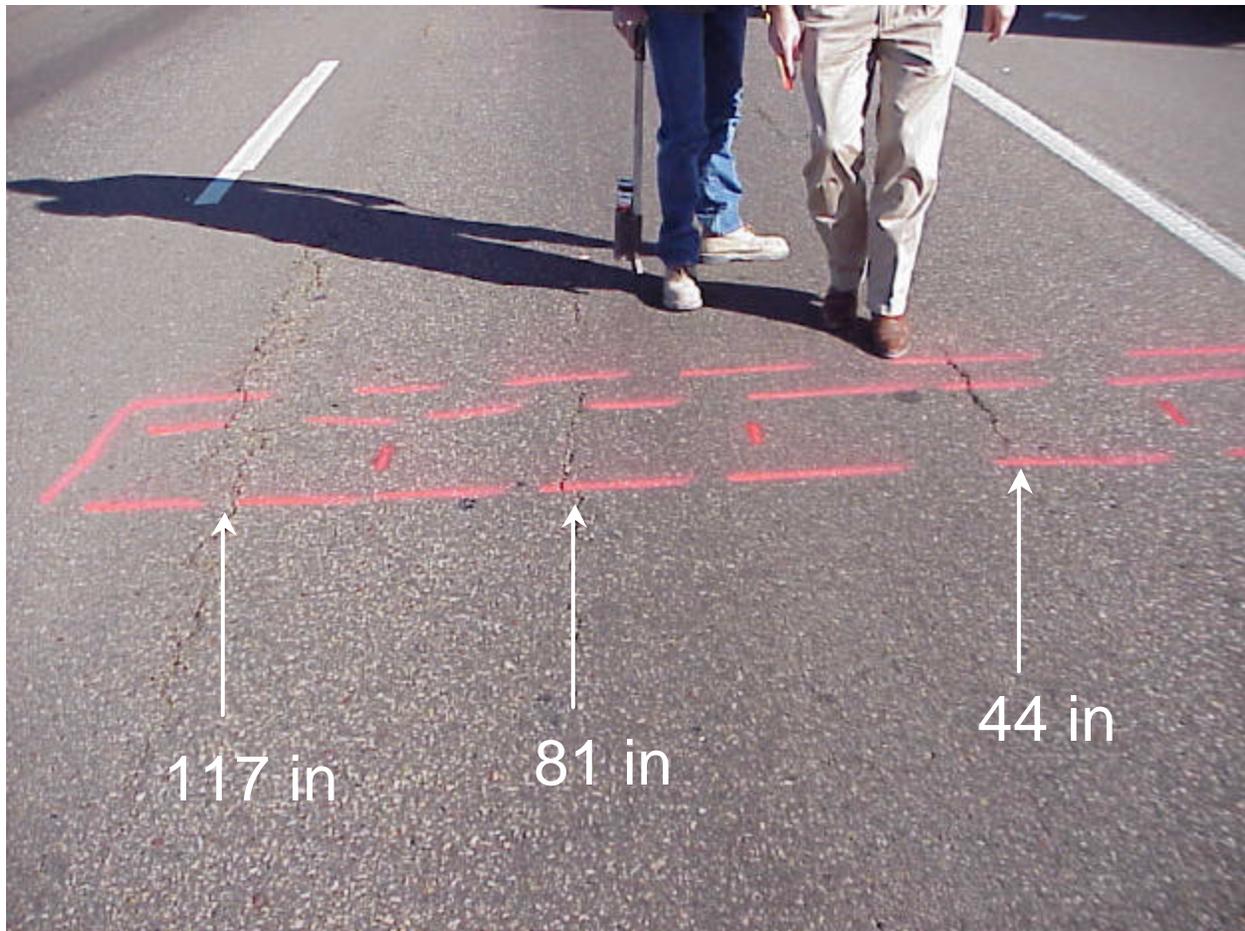
Figure 7 Location of the Cross Section Slab Prior to Removal

Figure 7 shows the location of the slab removal before sawing. There are two cracks adjacent to the left wheel path and one on the inside of the right wheel path.

Three saw cuts were made across the lane. The width of the lane was broken into four pieces as marked by the short dashes. The larger pieces were discarded. The narrower sections were retained.

of rocks near the surface so no segregation is visible from the surface. Close inspection of Figure 7 before sawing also confirms that no segregation is visible at the surface.

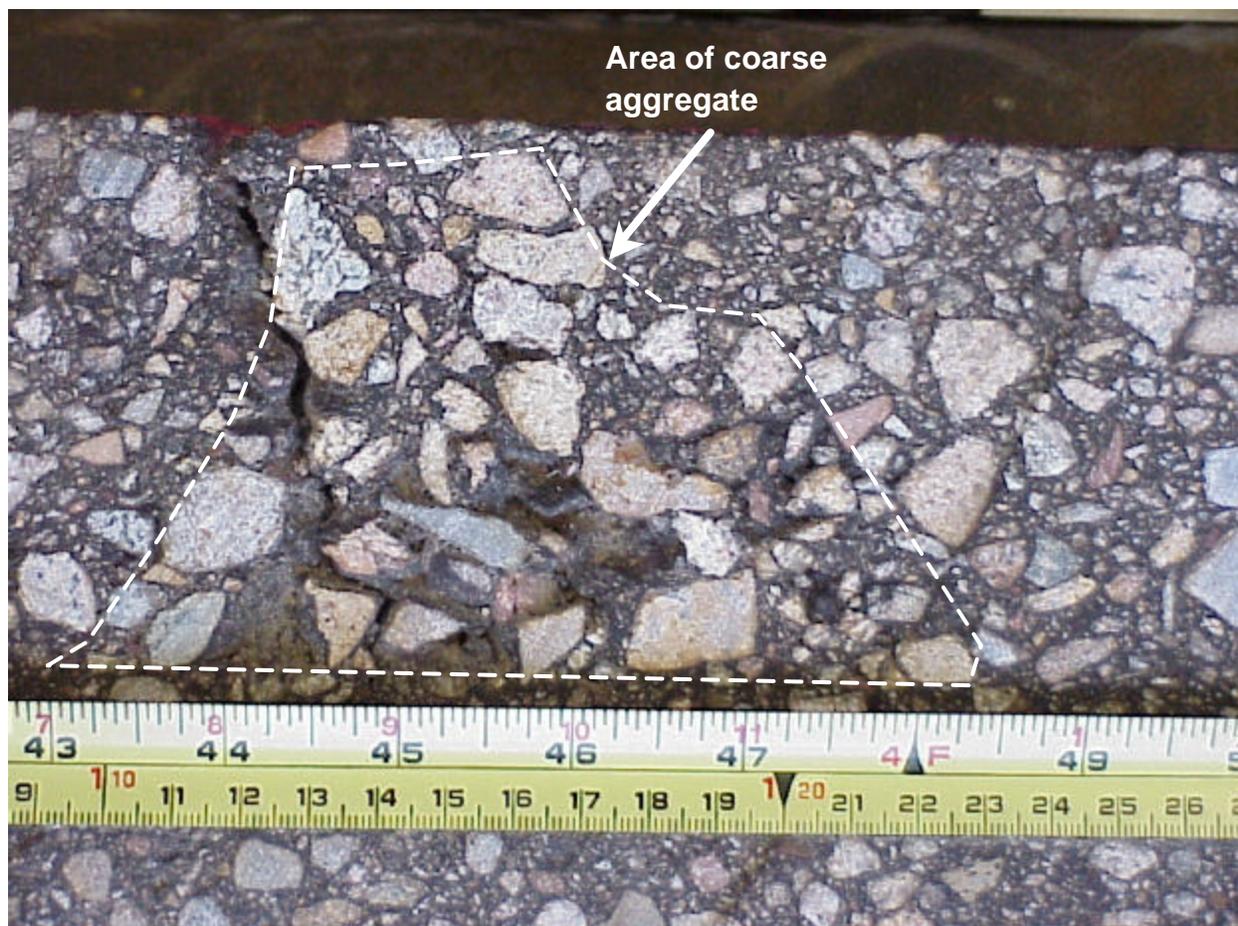
Figure 8 Close-up Cross Section at Crack Beside Right Wheelpath

The photo showing the crack at 44 inches is shown in Figure 8. Note that the photo is from the point of view of the observers in Figure 7. The photo clearly shows there is a pocket of segregation at the bottom of the lift. Interestingly, there is not a concentration

The area of segregation has lower density and higher air voids. Water can permeate and saturate this area. The presence of water was clearly visible after the slabs were removed and the face had begun to dry. Areas with water soaked into the mixture remained damp. Figure 9 shows the outside half of the cross section. There is a wet spot in the vicinity of the crack at 44 inches. Figure 10 shows the other half of the lane. The wet spots are more localized. They are concentrated at the crack at 81 inches and 117 inches.

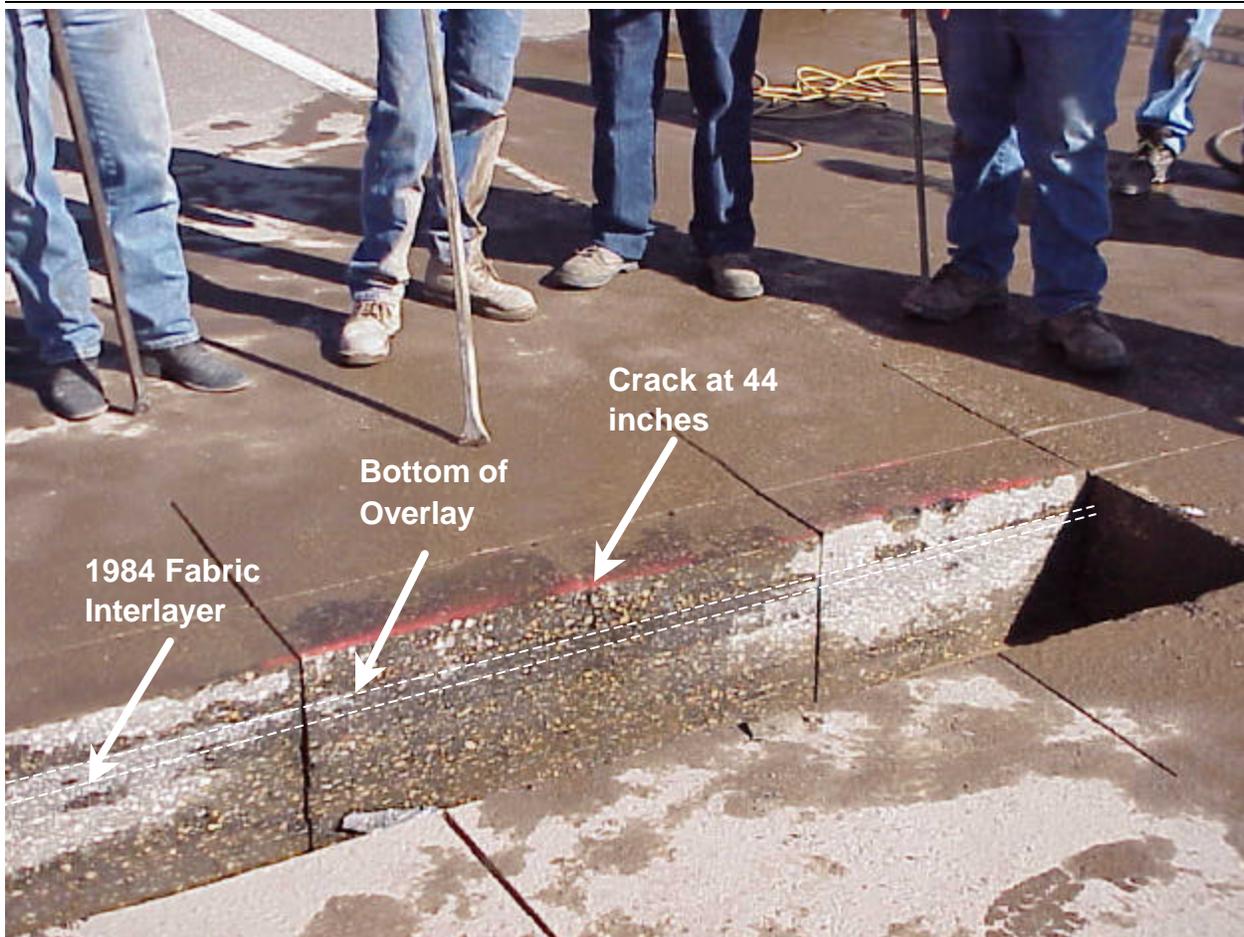
Figure 9 Cross Sectional View of Outside Half of Lane Shortly After Sawing

It is interesting to note that most of the 1997 overlay has a wet area along the bottom of the lift suggesting the density is low.

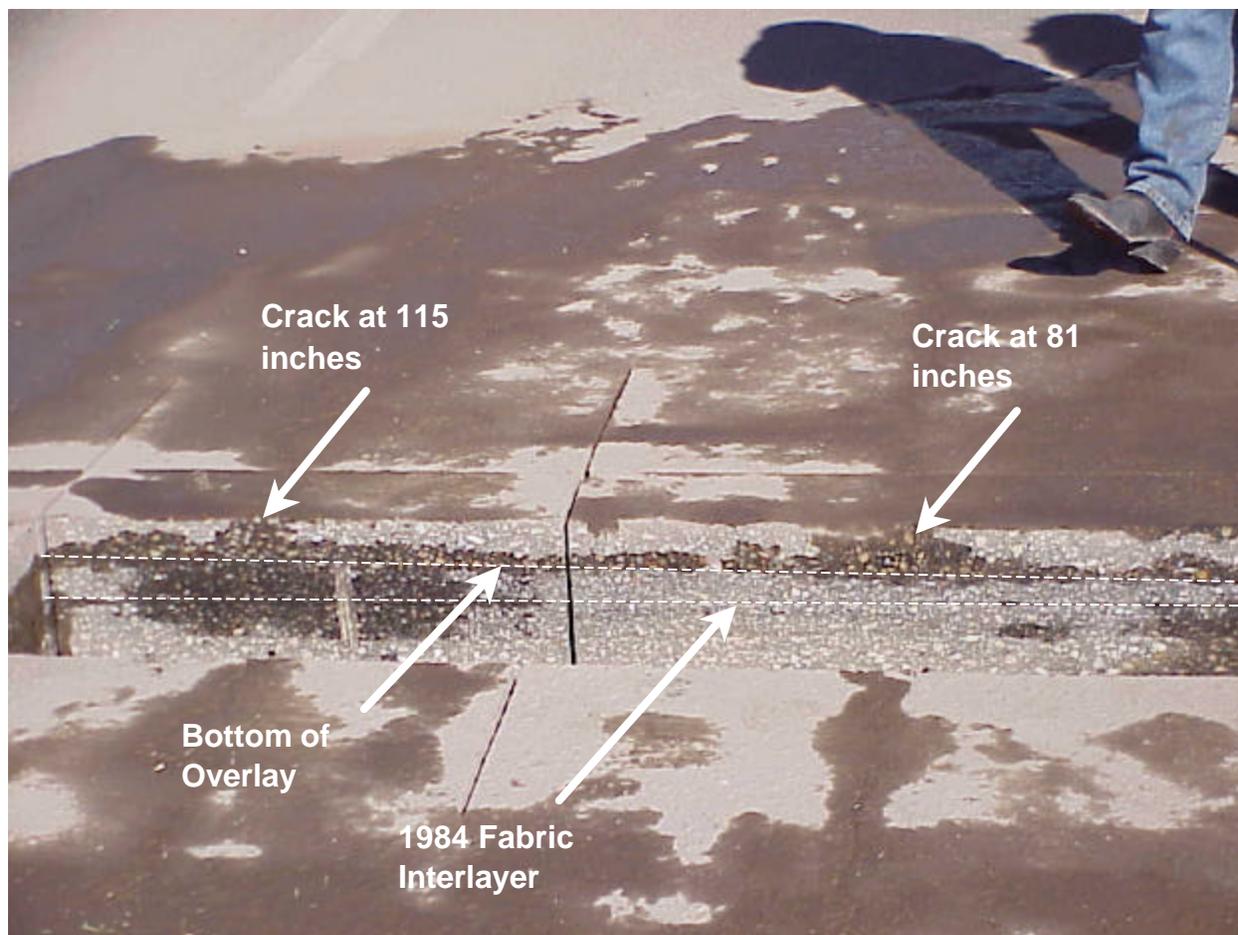
Figure 10 Cross Sectional View of Inside Half of Lane Shortly After Sawing

The 1984 and older hot mix is showing signs of holding water in the areas directly underneath the wheelpaths. The slowness to dry indicates the presence of water in the mixture and possibly the beginning of stripping. The location of these areas directly under the wheelpaths correlates with documented histories of stripping in which the pulsating wheel loads combine with moisture in the mixture to cause stripping. Once again, there were no signs of severe stripping or mixture disintegration.

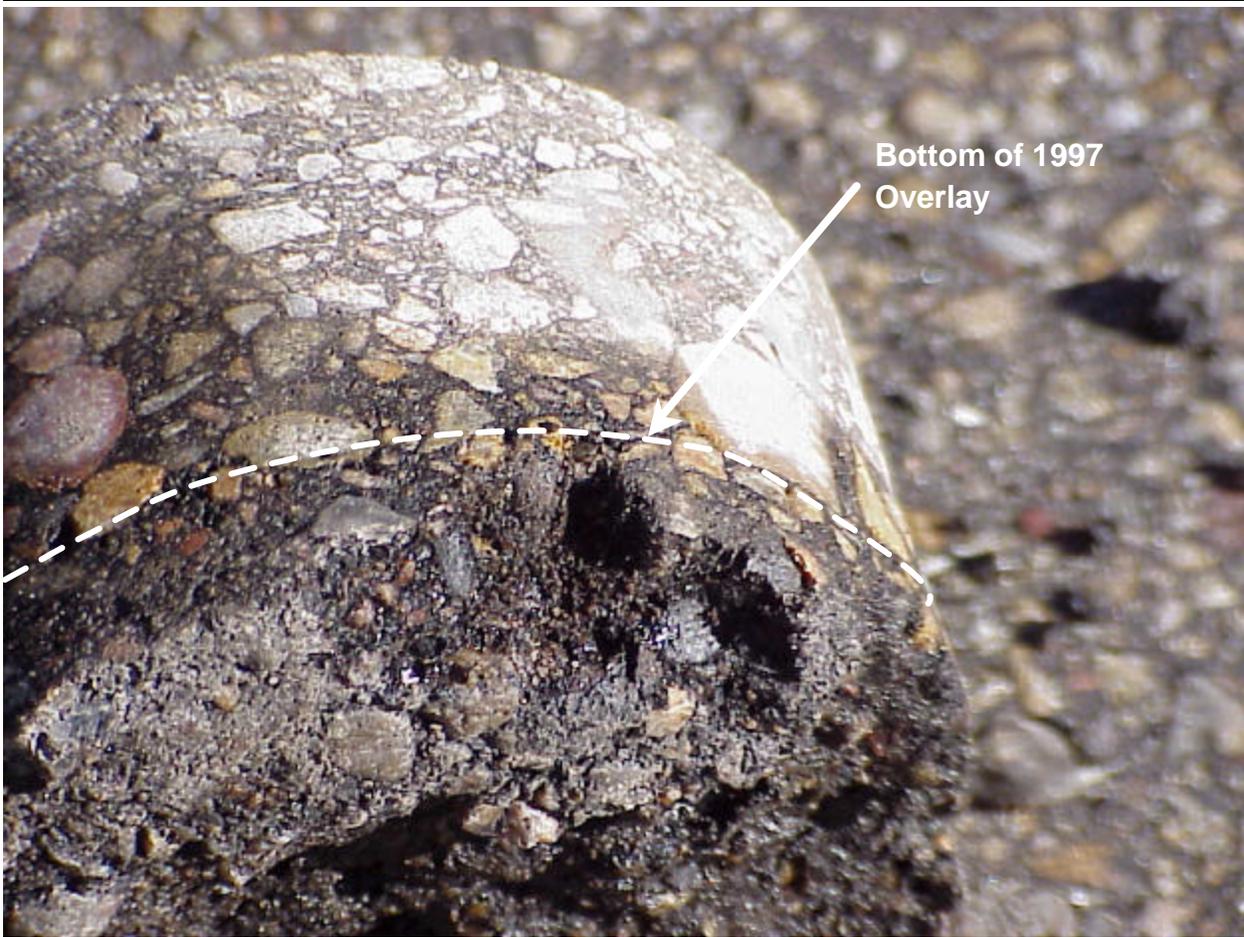
Figure 11 Bottom of Core Showing Signs of Stripping in 1984 Overlay Mixture

There were some signs of moisture damage in the old hot mix asphalt under the overlay. Figure 11 shows the bottom of a core which broke off at the fabric interlayer. The 1984 mixture below the overlay shows some stripping. The stripping has not advanced to the point of total mixture disintegration.

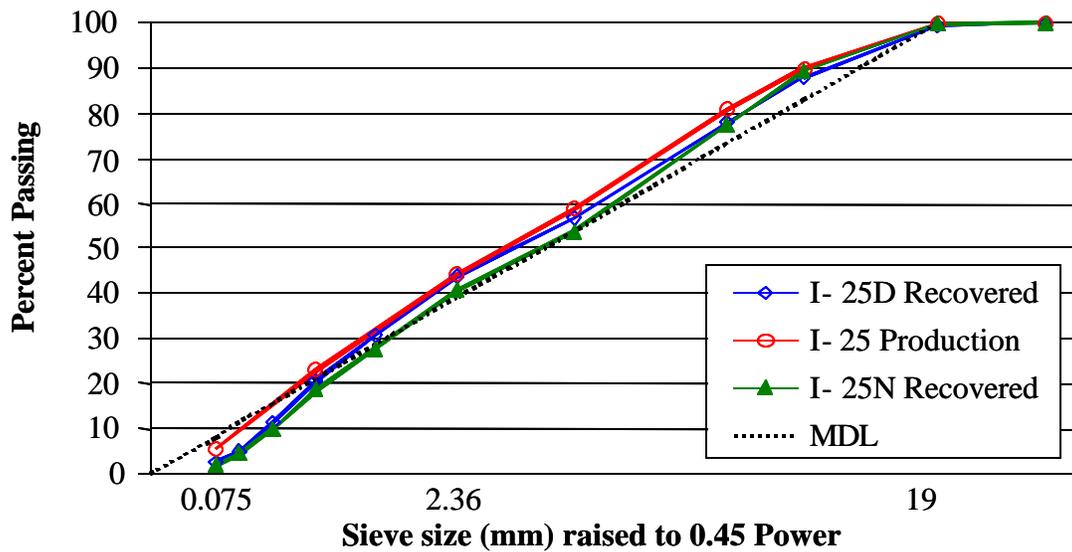
Figure 12 Recovered Aggregate Gradations for I-25D and I-25N Surface Mixtures

The data in Table 5 indicates that the recovered aggregate gradations of the **I-25D** and **I-25N** surface mixtures are very similar. In general, the recovered aggregate gradation is close to the average production values, but is slightly coarser.

As shown previously in Figure 12, the gradation at 100 inches from the shoulder closely matched the average quality control gradation. As shown in Figure 23 the cores at 44 inches are considerably coarser and cores at 20 inches are considerably finer than the quality control gradation. On the 4.75 mm sieve the gradation at 20 inches is 7 percent finer (65 Vs 58%) and the gradation at 44 inches is 9 percent coarser (49 Vs 58%).

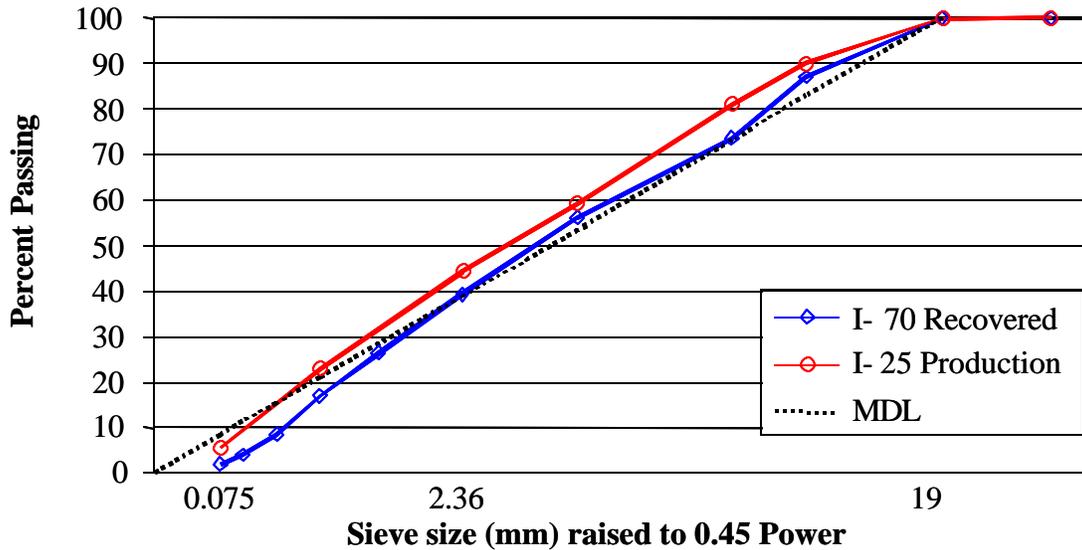
Figure 13 Comparison of Gradations for I-70 and I-25 Surface Mixtures

The data in Table 6 indicates that the recovered aggregate gradation of the **I-70** surface mixture is slightly more coarse than the I-25 average production values, but is similar to the recovered aggregate gradation from the **I-25D** and **I-25N** surface mixtures. As with the data in Table 5, the percent passing the #200 (0.075-mm) sieve is relatively low (2.2%). It should also be noted that the measured asphalt binder content is significantly higher (4.8%) than for the **I-25D** and **I-25N** surface mixtures (4.1%).

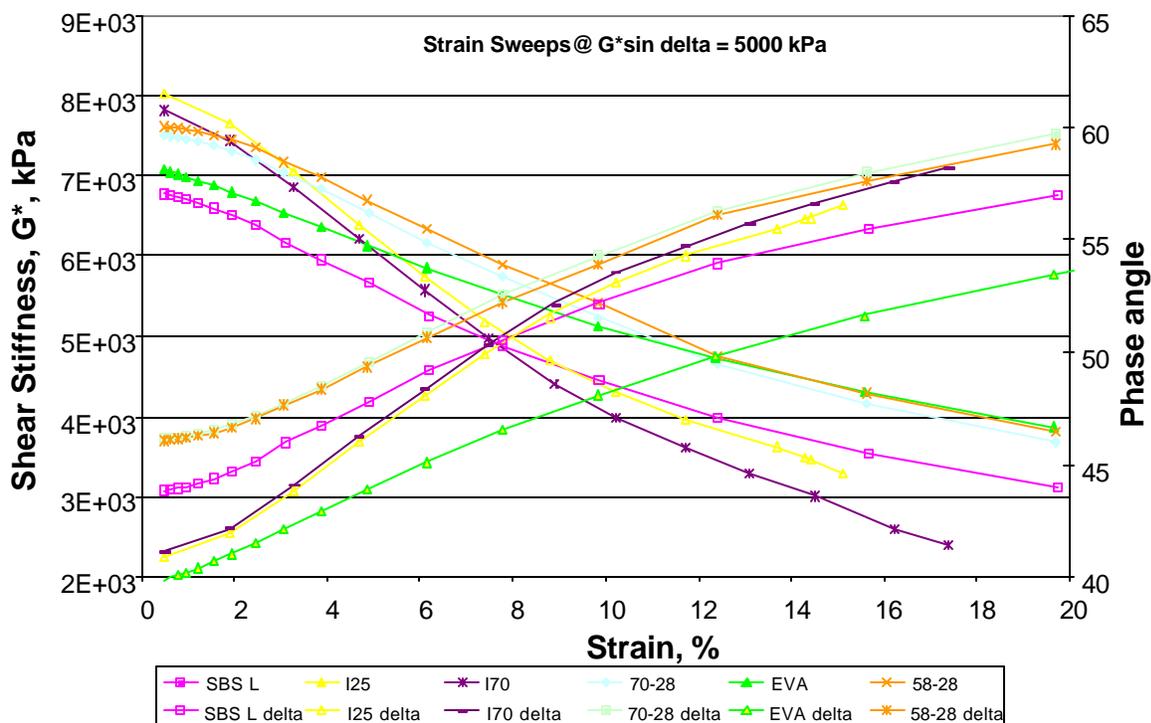
Figure 14 DSR Strain Sweep – I-25N and I-70 Recovered Asphalt Binders

Figure 14 illustrates DSR strain sweep for the **I-25N** and **I-70** recovered asphalt binders in addition to several other modified and unmodified binders. The phase angle response to shear strain is identical for the **I-25N** and **I-70** asphalt binders. The phase angle is an indicator of the molecular structure of the binder. The I-25N and I-70 binders have the same molecular structure. The initial phase angle (approximately 41°) for the Colorado binders indicates that they are similar to other modified binders such as the 74-28 EVA and the 75-28 SBS shown in Figure 3. The 70-28 and the 58-28 are unmodified binders and have higher phase angles than the modified systems. The slope of the Colorado binders is different than the other binders; however, that is because a different base asphalt binder was used.

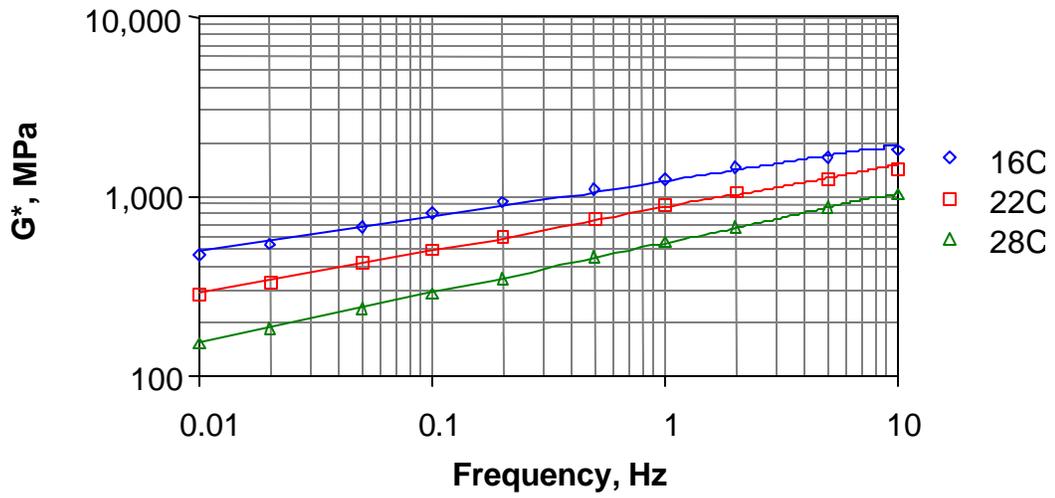
Figure 15 Shear Stiffness of the I-25D Surface Mixture

Figures 15, 16 and 17 illustrate the average response of the shear modulus to frequency for each of the three mixtures. Figure 18 compares the average response of the three mixtures at 22°C. Figure 19 indicates the average response of the three mixtures at a loading frequency of 10 Hz.

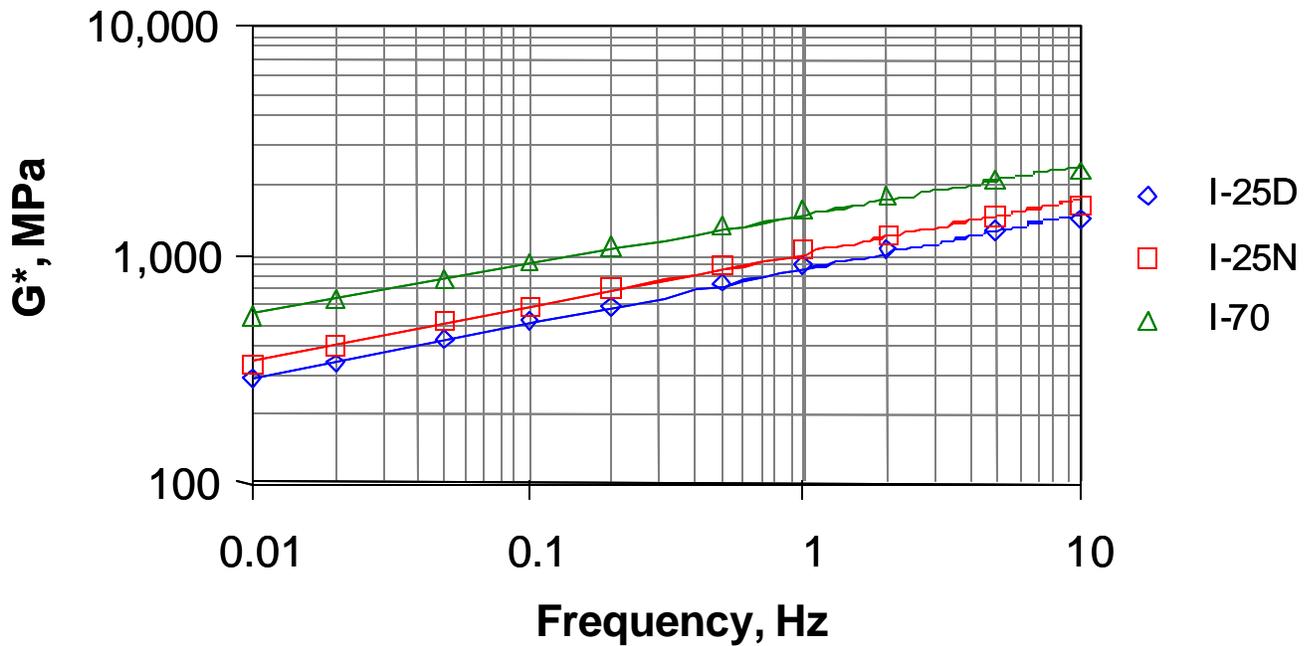
Figure 18 Average Shear Stiffness at 22° C – All Surface Mixtures

The data in Figure 18 indicates that the **I-70** surface mixture has a higher shear stiffness than the **I-25N** and **I-25D** mixtures at 22°C for all loading frequencies. At a loading frequency of 10 Hz (selected to simulate highway traffic speed), the **I-70** mixture has higher shear stiffness at all three temperatures (Figure 19) than the **I-25N** and **I-25D** mixtures. A statistical analysis performed on the shear stiffness values at 10 Hz ($G^*_{10\text{Hz}}$) indicates that the **I-70** surface mixture is significantly stiffer ($\alpha = 0.05$) than the **I-25N** and **I-25D** surface mixtures at 16°C and 22°C. At 28°C, the **I-70** mixture is significantly stiffer than the **I-25D** mixture, but statistically equal to the **I-25N** mixture. The **I-25D** and **I-25N** mixtures are statistically equal at all three temperatures.

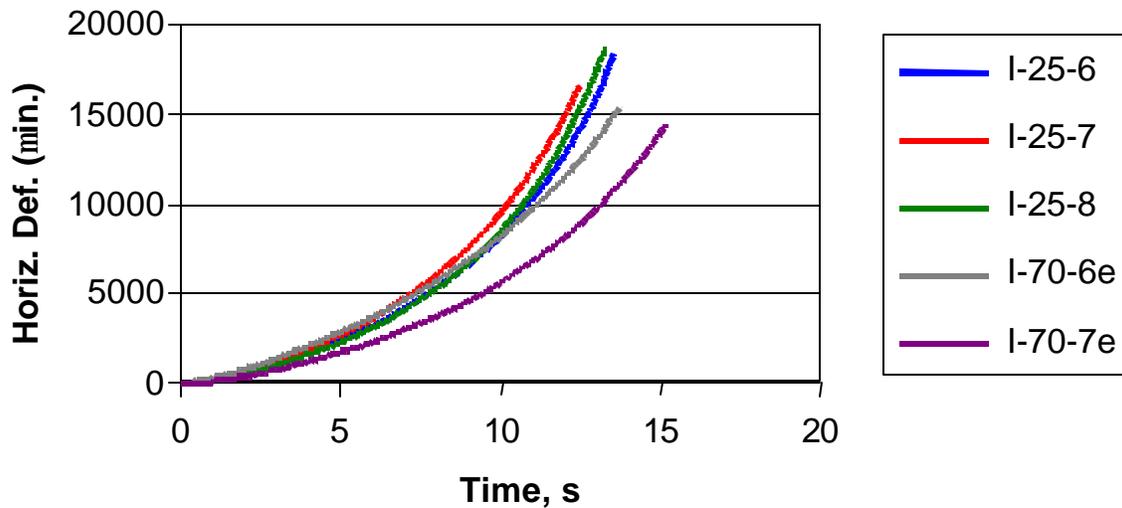
Figure 20 Horizontal Deformation from IDT Tests (22°C, 12.5 mm/min.)

As a further illustration, the horizontal and vertical deformations for the test specimens are shown in Figures 20 and 21.

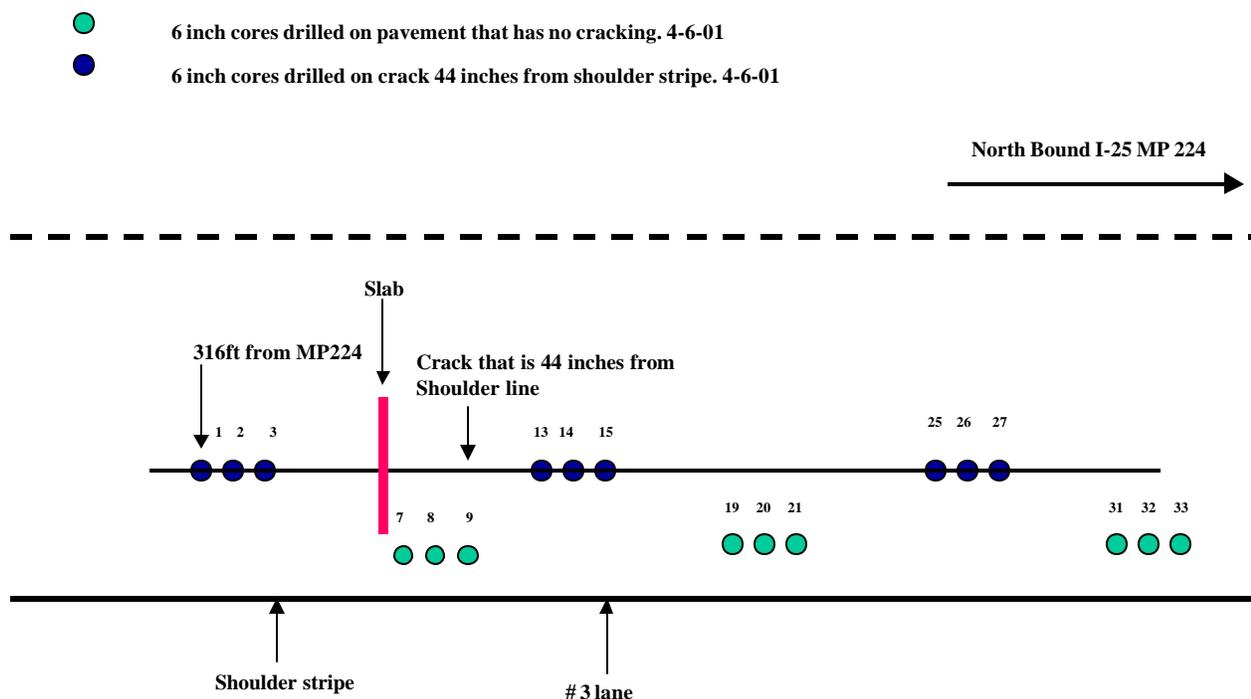
Figure 22 Layout of Cores Taken to Investigate Segregation

Cores Taken From I-25, 120th to Hwy 7 (Northbound)

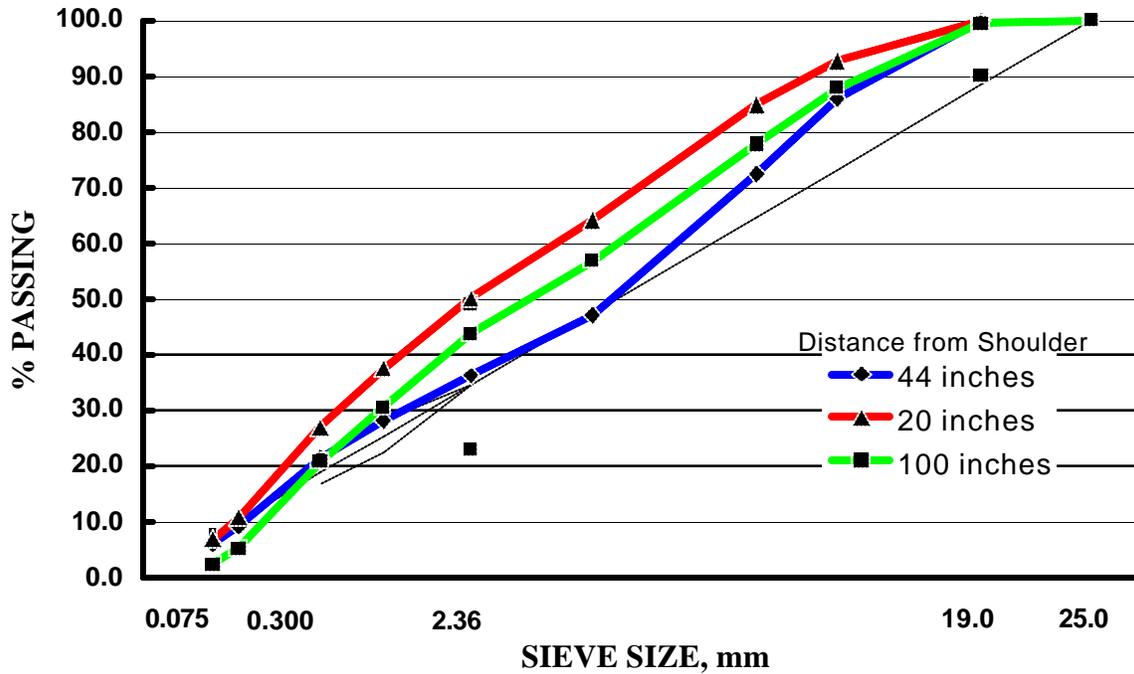
Figure 23 Gradations from Colorado DOT Cores

Figure 23 shows the gradation obtained from the cores. Gradation of the cores from atop the crack is labeled as 44 inches from the shoulder. The gradation of cores from between the crack and the shoulder is labeled as 20 inches from the shoulder. Also shown is the gradation of cores taken in the forensic study. They were taken approximately 100 inches from the shoulder.

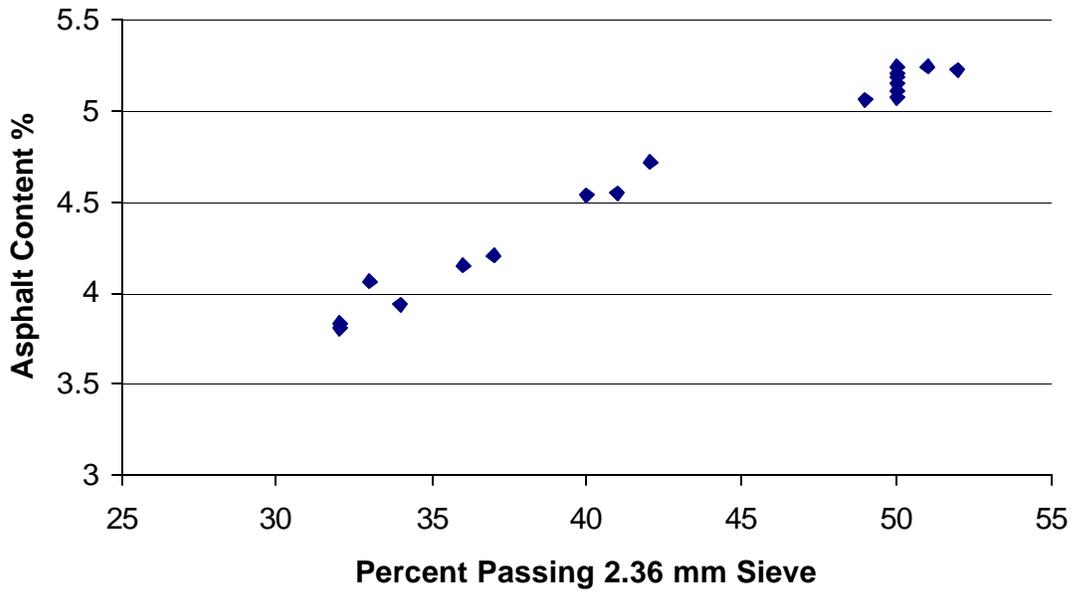
Figure 24 Plot of Asphalt Content Vs Percent Passing 2.36 mm Sieve for CDOT Cores

The asphalt content was considerably different for the 44 inch and 20 inch cores, 4.2% compared to 5.2%. Figure 24 shows a plot of asphalt content for the individual cores

taken at 44 and 20 inches and the percent passing the 2.36 mm sieve. There is clearly a relationship between the measured asphalt content and the gradation, indicating the mixture was segregated after it left the hot mix plant.

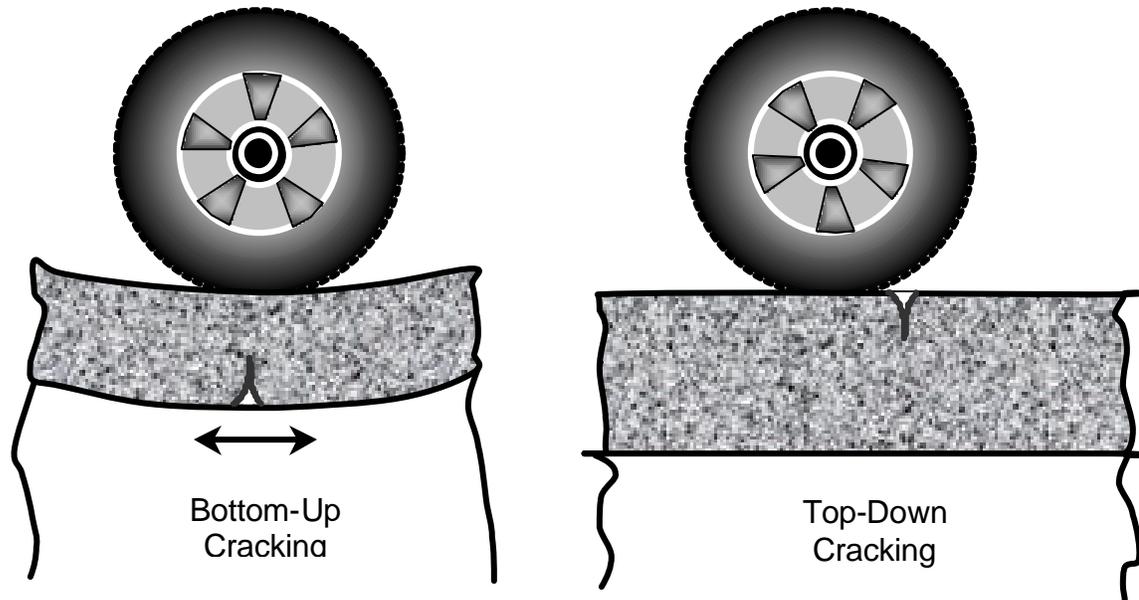
Figure 25 Development of Fatigue Cracking In Asphalt Pavements

Fatigue cracking is classically thought to be a crack that begins at the bottom of a structural layer and progresses upward. Top-down fatigue cracking is a phenomena where pavement cracking begins at the pavement surface and progresses downward. Bottom-up and top-down cracking is shown in Figure 25.

Bottom-up fatigue cracking occurs when the asphalt allows enough flexing such that critical tensile strains are generated at the bottom of the asphalt layer. If the pavement is sufficiently thick, strains at the bottom of the asphalt layer are sufficiently small that bottom-up fatigue cracking is delayed nearly indefinitely. Slight bending and deflection at the surface of the pavement will cause cracks to begin developing at the road surface and begin to move downward. Surface-initiated cracks can be either transverse across the wheelpath or longitudinal along the edge of the wheelpath.

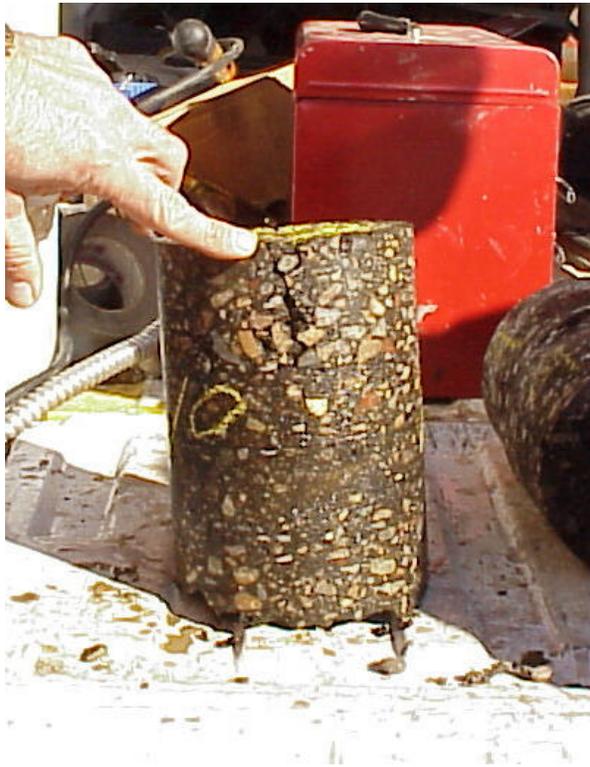
Commonly, surface-initiated cracking does not occur until later in the life of the pavement. Surface strains are usually small enough and the pavement is resilient enough that surface cracking does not initiate. If surface cracking does begin, it will not propagate through the entire pavement layer. Instead it will progress downward and stop partway through the layer. Figure 26 shows a core taken on top of a longitudinal crack on I-25. It is clear that the crack has started at the pavement surface and has propagated downwards.

Figure 26 Core taken on top of a longitudinal crack on I-25. The cracking is clearly contained only within the top layer of the pavement.

Top-down cracking would be expected in the later life of a pavement because earlier in the pavement life the surface layer would be sufficiently resilient to accommodate the strains imposed on it. If the surface layer is unable to accommodate the strains, the layer could begin to crack early in the pavement life. Low asphalt content or unusually aged asphalt binder could make the surface layer intolerant of strain. Segregation can also make the pavement layer intolerant of strain because asphalt content is low in areas of coarse aggregate concentration.

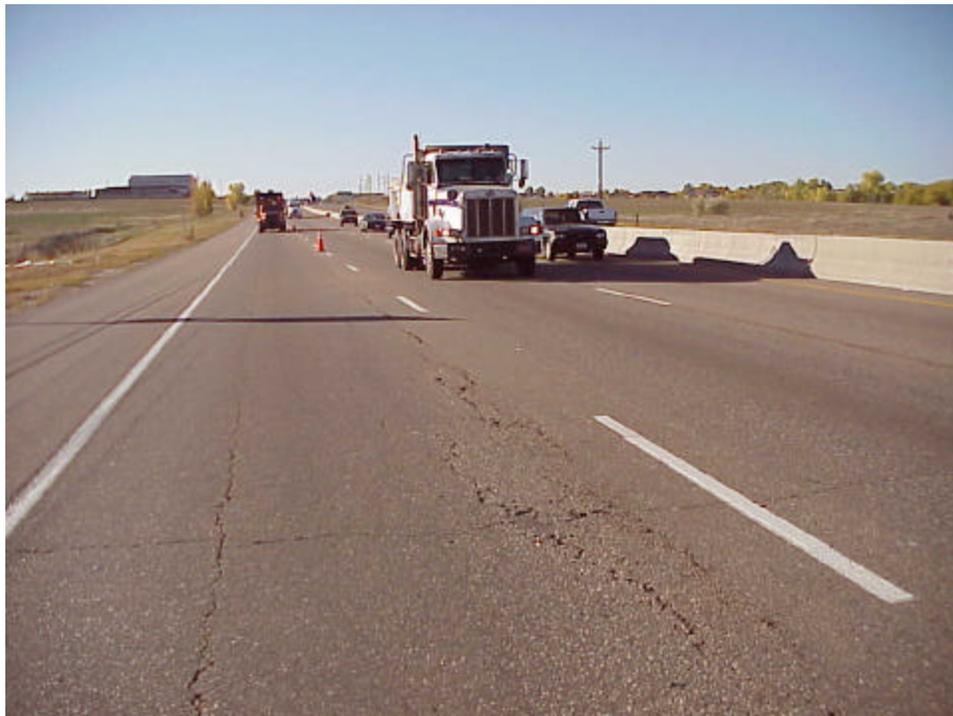
Condition of I-25 in the vicinity where the cores were taken in the distressed site.

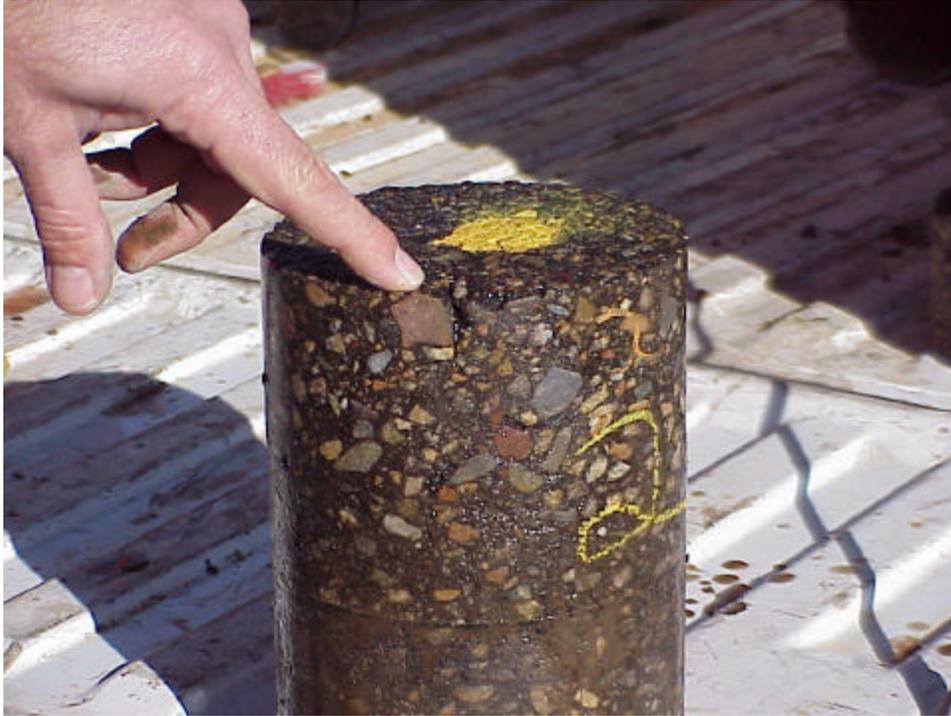
Freshly cut, wet core showing aggregate skeleton. This is Core # 2 shown in the core location figure. It was taken at the end of a short longitudinal crack.

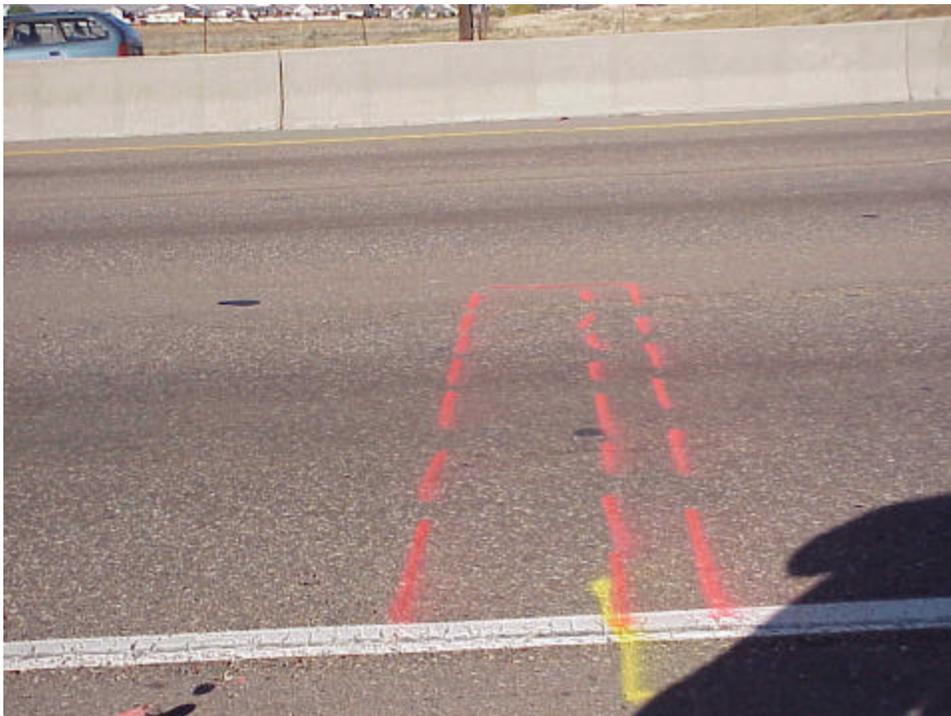
Location of the cross section slab before sawing.
From this angle the longitudinal cracks are not readily visible.

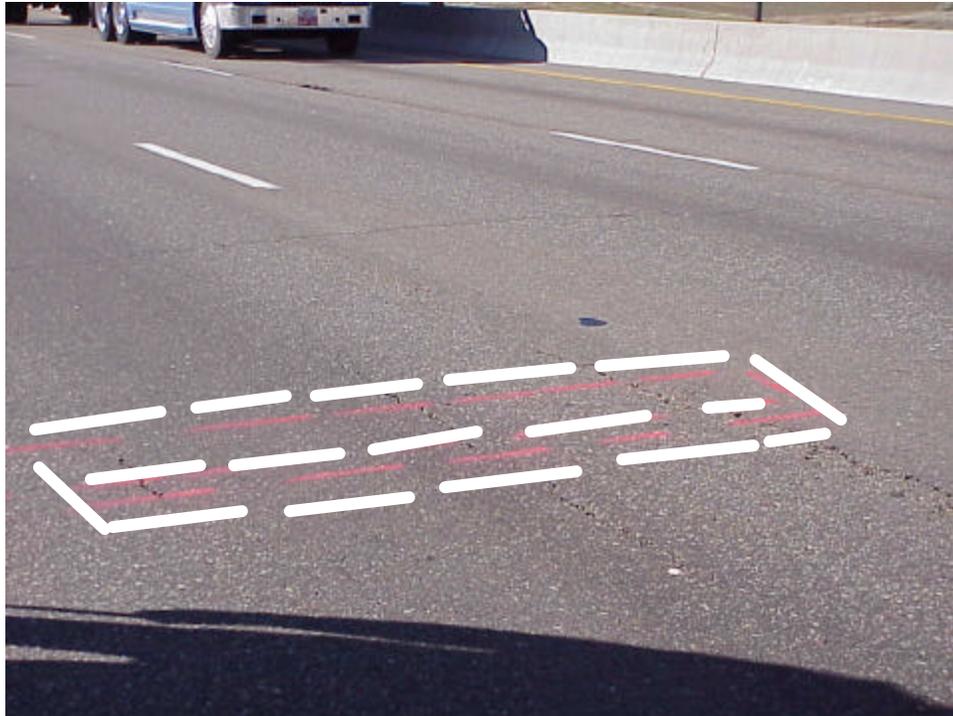
Location of the cross-section slab before sawing.
From this angle the longitudinal cracks are clearly visible.

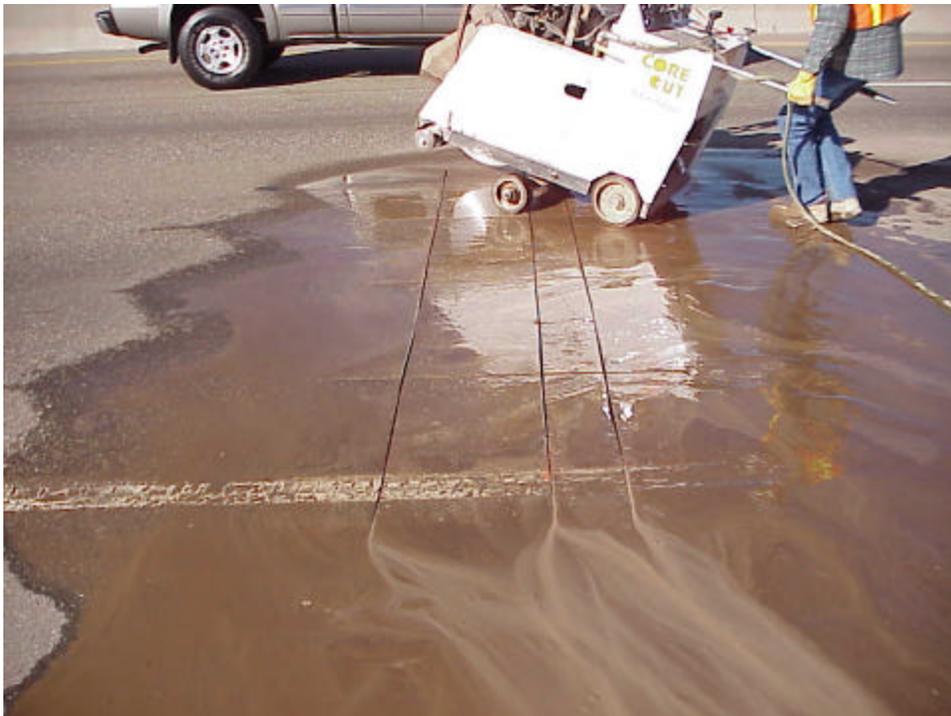
Sawing of the cross section slab. Three saw cuts were made across the lane width. Cross cuts were made to break the slab into four pieces.

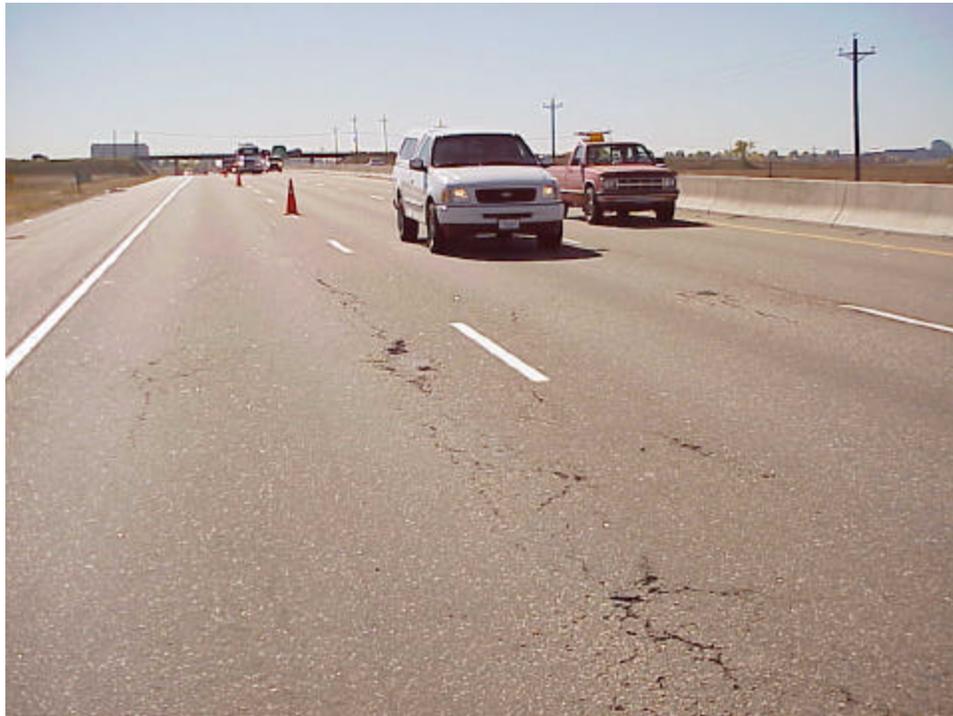
View looking south of distresses occurring on I-25. This location is about 0.3 miles north of where the cross section slab was cut. Just north of here is the no-distress site where cores were taken. Surface conditions could change very rapidly along the road. It was difficult to find sections that were not showing distress.
