Report No. CDOT-DTD-R-2004-13
Final Report

RECESSED STRIPING IN CONCRETE PAVEMENT

August 2004

**COLORADO DEPARTMENT OF TRANSPORTATION
RESEARCH BRANCH**

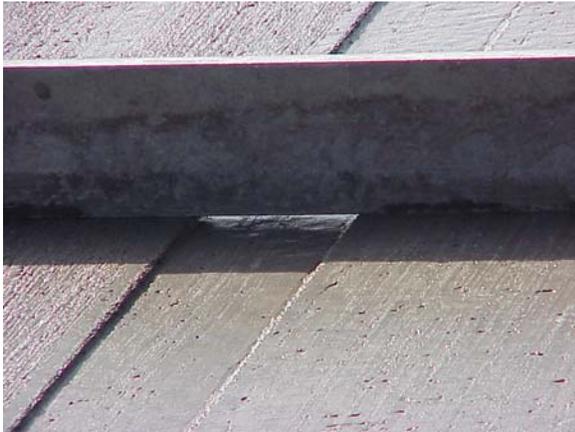
Figure 1. Shoulder stripe groove formed in plastic concrete.

reduced and their useful lives considerably increased by placing them in shallow grooves in the surface of the pavement. In the past, the grooves (1/8" – 1/4" deep) have been cut with diamond grinding equipment – a relatively slow and costly process. Now there is another way – on concrete at least.

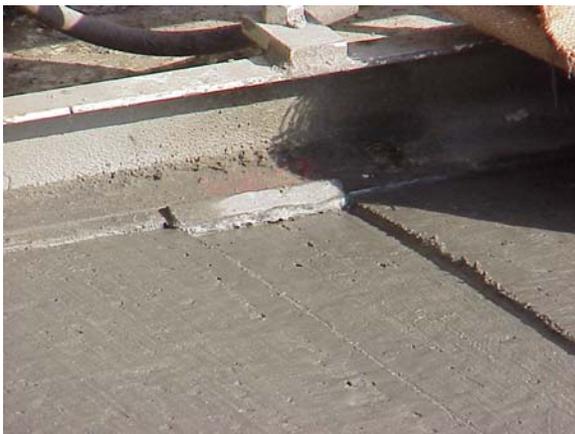
Figure 2. Small pieces of steel welded to the screed formed the grooves.

the paving machine in the appropriate locations, formed three continuous grooves – one for each shoulder stripe and one for the skip stripe – as the pavement was being placed. The two shoulder grooves were formed 4-1/2 inches wide and the skip stripe groove was formed 8 inches wide to accommodate hi-visibility black-edged tape. The only other changes that had to be made in the paving operation were: 1. At the groove locations, cut gaps in the texturing drag behind

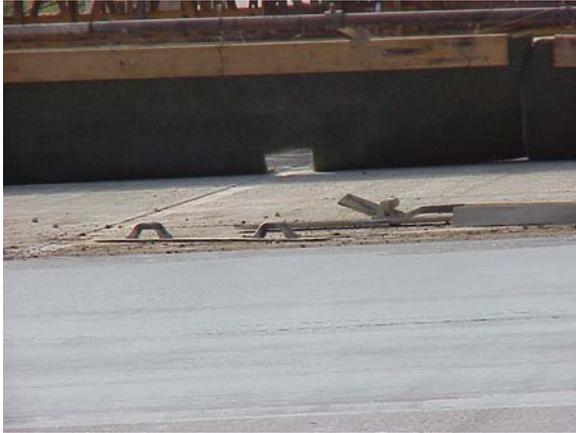
Figure 3. Gaps were cut in the drag to keep the groove smooth.

the paver so the drag didn't round the edges of the grooves. 2. At the grooves, remove the tines from the tining machine so the bottoms of the grooves would provide a smooth surface for paint and tape.

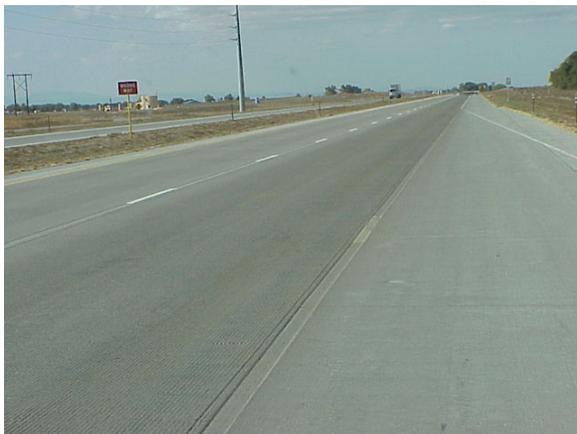
Figure 4. At accel/decel lanes the stripes were placed outside the grooves.

When an extra lane is added for a short distance to serve as an accel/decel lane at an intersection, the shoulder stripe curves outward to a new position nearer the outside edge of the pavement. Since the positions of all of the grooves are permanently set at a fixed distance from the edge of the pavement by their welded locations on the screed, there is no way to adjust the position of the shoulder stripe groove to allow for the extra

lane. At these locations, whether they are on the left or right shoulder, the groove continues at its fixed location relative to the edge of the concrete. The painted stripe leaves the groove at the beginning of the new lane and is painted on the surface of the concrete for the length of the additional lane. The shoulder stripe then bends back toward the center of the concrete at the end of the acceleration lane and rejoins the shoulder stripe groove when the lane ends.

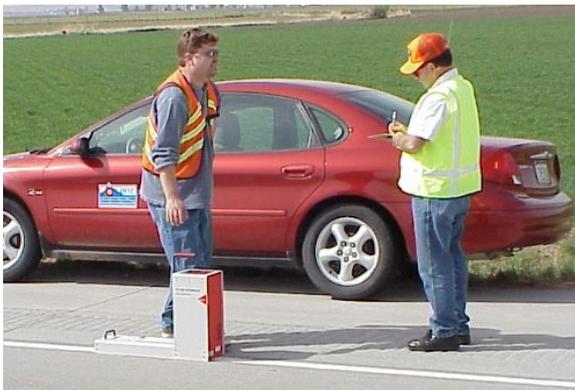
Figure 5. The Delta LTL2000 measures retroreflectance in any light condition.

Both types of pavement markings went through several winters with no noticeable wear from traffic or snowplows. Retroreflectance measurements were taken using a Delta LTL2000 Retrometer. This description is on the first page of the Delta Retrometer manual: “The LTL2000 Retrometer is a portable field instrument, intended for measuring the retroreflection properties of road markings in car headlight illumination, the value R1 (coefficient of retro reflected luminance)

is used. R1 is a measure of the lightness of the road marking as seen by drivers of motorized

vehicles in car headlight illumination. The road is illuminated at an angle of 1.24° and the reflected light is measured at an angle of 2.29°. which corresponds to an observation distance of 30 meters. Thus relevant for a motorist viewing situation under normal conditions.” The retroreflectance numbers generated by the LTL2000 are milli-candellas per lux per square meter. Typically, when marking tape is applied to the surface of the pavement, the tops of the raised

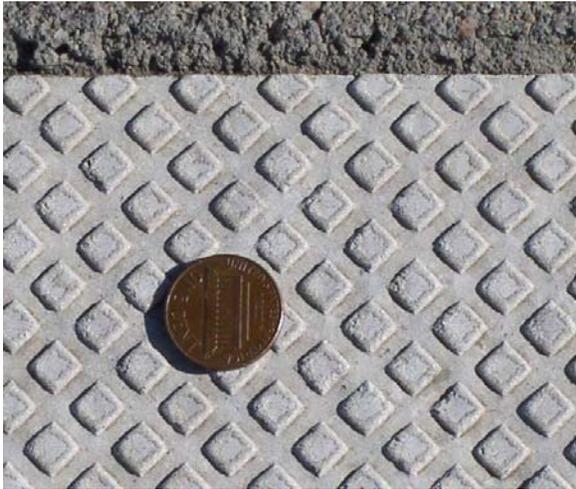
Figure 6. Even after 3 years, the tape was still bright.

diamonds are quickly damaged by snowplows. In the eastbound lanes, the tape in the grooves remained in excellent condition with no plow damage to the raised diamonds. **Figure 6** shows the right shoulder tape after three winters. There is no visible wear; however, the surface appeared slightly less bright than when it was new, possibly due to the tape being a little dirty – it had been exposed to the elements for three years. After three winters, retrometer readings averaged 514 for the white tape in the right shoulder and 479

After three winters all of the tape in the eastbound lanes remained in very good condition. There was only one very small – about six inches long – piece that had been damaged by something being dragged over the tape and tearing it. As **Figure 6** shows, the reflective tape was slightly dirty; however, the retroreflectance numbers for the three-year-old tape were higher than those for new epoxy paint.

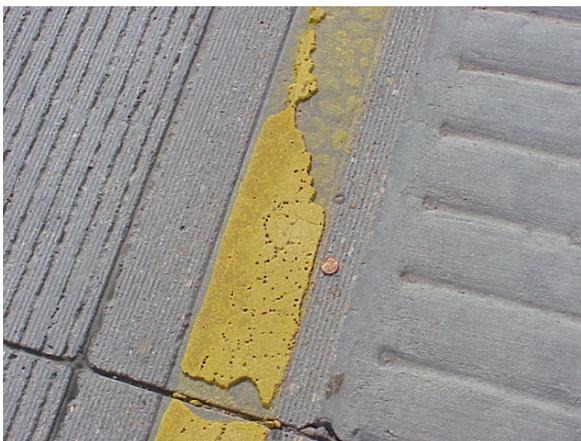
Figure 7. The thermoplastic failed due to adhesion loss.

The thermoplastic markings in the grooves in the westbound lanes had good retroreflectivity readings, 299 to 378 for white and 154 to 209 for yellow, and showed no traffic or snowplow damage. However, the thermoplastic material, which was between 1/8th inch and 3/16th inches thick, was extensively cracked and had started to separate from the surface of the pavement.

Postage stamp-sized pieces were easily picked

up off the pavement. There were extensive areas of the skip stripe where the wind blast from passing traffic had removed nearly all of the thermoplastic material.

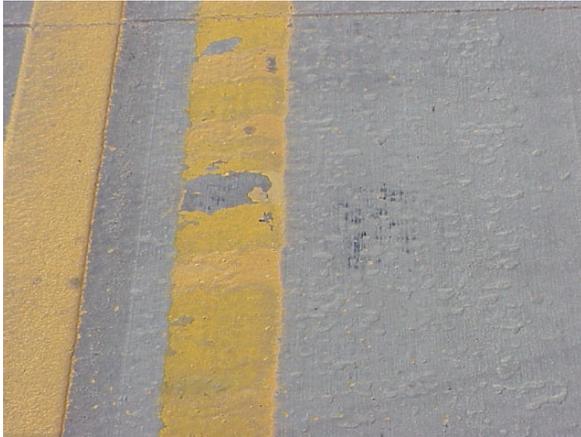
Figure 8. Epoxy paint in a groove in perfect condition next to damaged paint on the surface.

At about mp 123.5 in the eastbound lanes, the left shoulder stripe is a double yellow of epoxy paint. The left stripe in **Figure 8** is in a groove; the right stripe is on the surface of the pavement.

Retroreflectivity readings for the two stripes are nearly the same – the one in the groove averaged 69.8 for five readings; the one on the surface

averaged 70 for five readings. However, as can be seen in the photo, the paint on the surface of the pavement has begun to come off of the concrete.

The areas of the surface stripe (the one on the right) that appear brighter yellow are where the stripe was scraped by snowplows. The places where the paint is gone seem to be part of the scraped areas. However, it is impossible to say whether the snowplows directly caused the missing paint or simply removed paint that was already loose. Most of the paint that shows evidence of scraping was still firmly stuck to the concrete. It is not known whether the same method was used to clean the surface for both stripes before the epoxy was installed; however, the paint and beads in the stripe in the groove were completely undamaged after repeated plowing operations and showed no signs of losing adhesion to the concrete.
