**Report No. CDOT-DTD-R-2006-9  
Final Report**

# **IMPLEMENTATION OF PROVEN PCCP PRACTICES IN COLORADO**

**Ahmad Ardani, P.E**

**COLORADO DEPARTMENT OF TRANSPORTATION  
RESEARCH BRANCH**

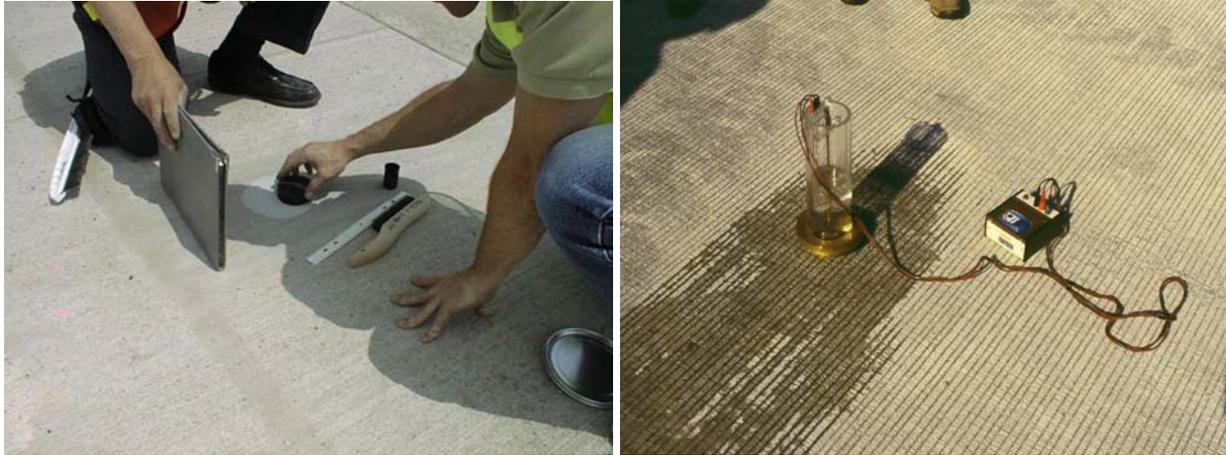
Figures 5 and 6: Sand Patch and Outflow Meter Testing

This method is a volumetric measurement using the ASTM procedure E-965. A given amount of fine sand or glass beads particles (1.5 cubic inches) are spread in a circular motion to form a circle. By knowing the volume of the sand and the Diameter of the circle one can measure the depth of the texture as shown below.

This is an indirect measure of texture as shown below. A cylinder with rubber seals on its lower end is placed on the surface and loaded by weights to assure good contact. An electric timer is connected to probes inside the cylinder. The cylinder is filled with water. To start the test, the plunger sealing of the outlet is lifted and the water escapes between the rubber seals and the pavement surface. The time for the water to escape is a measure of texture. Deep textured surfaces will allow fast escape of water; i.e., the outflow time for deep textured surfaces is shorter than the outflow time for shallow textured surfaces.

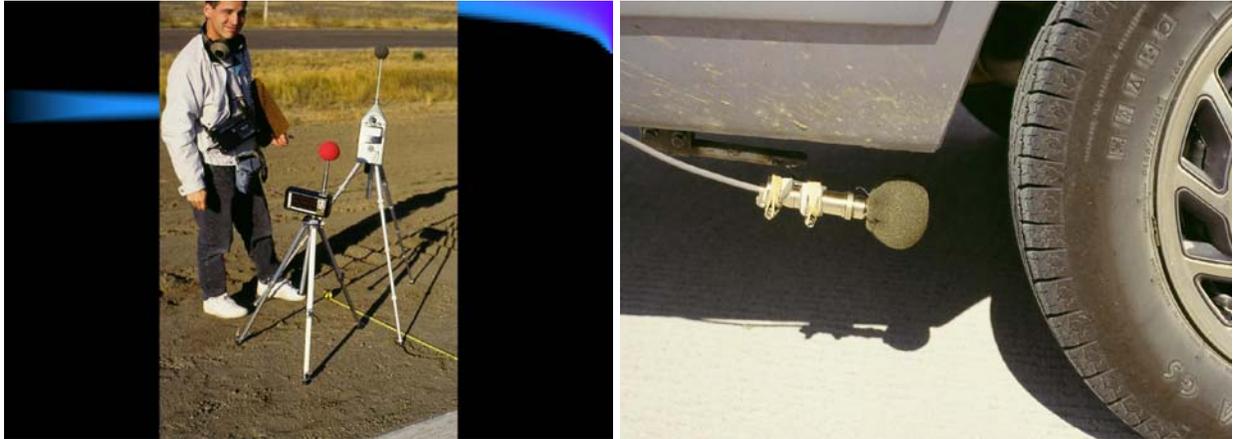
Figure 9: SPL Measurements at Roadside and Behind the Rear Tire

Noise measurements were acquired using a test vehicle, a 1994 Oldsmobile Cutlass station wagon provided by CDOT. Sound pressure level (SPL) measurements were recorded through a sound level meter to a digital tape recorder at three different locations:

- Inside the test vehicle
- 25 feet from the center line (3 feet away from the right shoulder)
- Near the right rear tire of the test vehicle, away from the exhaust pipe

The data extracted from the recordings were A-weighted sound levels, as well as 1/3-octave SPL with frequencies between 100 and 5000 Hz.

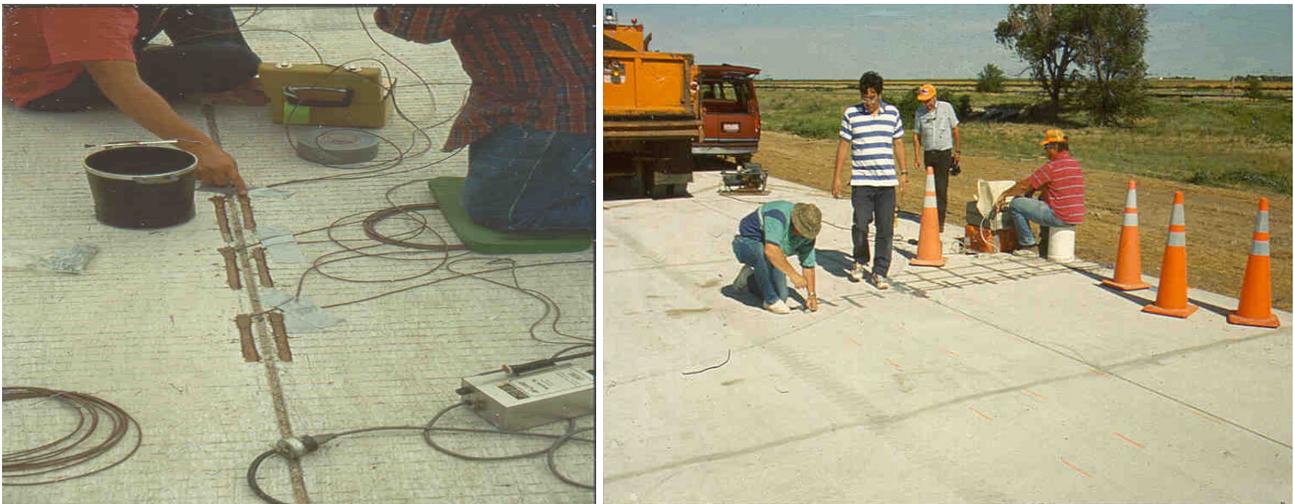
Figures 19 and 20: Surface Mounted Strain Gauges

Surface-mounted strain gauges were installed at selected locations to measure load-induced strains at the free edge (shoulder edge), at longitudinal edges of lane-shoulder joint (for the 12 ft tied, 14 ft tied, and 14 ft untied) as shown in the instrumentation layout above.

A loaded truck of 18-kip rear axle was used to acquire static and creep strains throughout the day to evaluate the effects of temperature variations on load-induced strains. The strain data were obtained using an automated data acquisition system capable of sampling data at 20,000 times per second. In general, the analysis of the load strains data revealed no appreciable difference for different temperature gradients. Strains were much higher for the free edge.

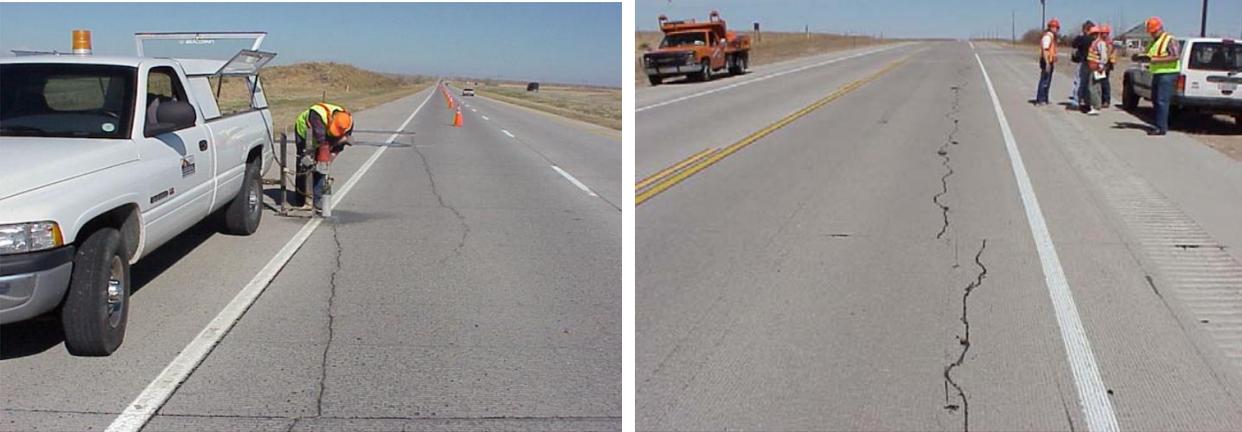
Figures 22 and 23: Longitudinal Cracks Due to Improper Depth of Saw Cut

Examination of cores from several locations on US-287 and I-70 revealed longitudinal joints with sawcut depth that were less than 1/3 of the thickness of the pavement, i.e., not deep enough to instigate the weakened plane cracking. As a result, longitudinal cracks developed to relieve the internal stresses in the concrete. This discovery eliminated the 14-foot-wide slabs as a possible cause of these longitudinal cracks.

- Premature longitudinal cracking due to improper depth of the longitudinal saw-cut can be prevented by adhering to CDOT's present specification, which requires saw-cut depth of  $D/3$  for 12-foot slabs and  $0.4D$  for 14-foot slabs. It is recommended that project engineers in the field measure saw-cut depth at intervals of 1 per 1/10 of a mile (528 feet). This specification has already been incorporated into CDOT's Field Materials Manual.

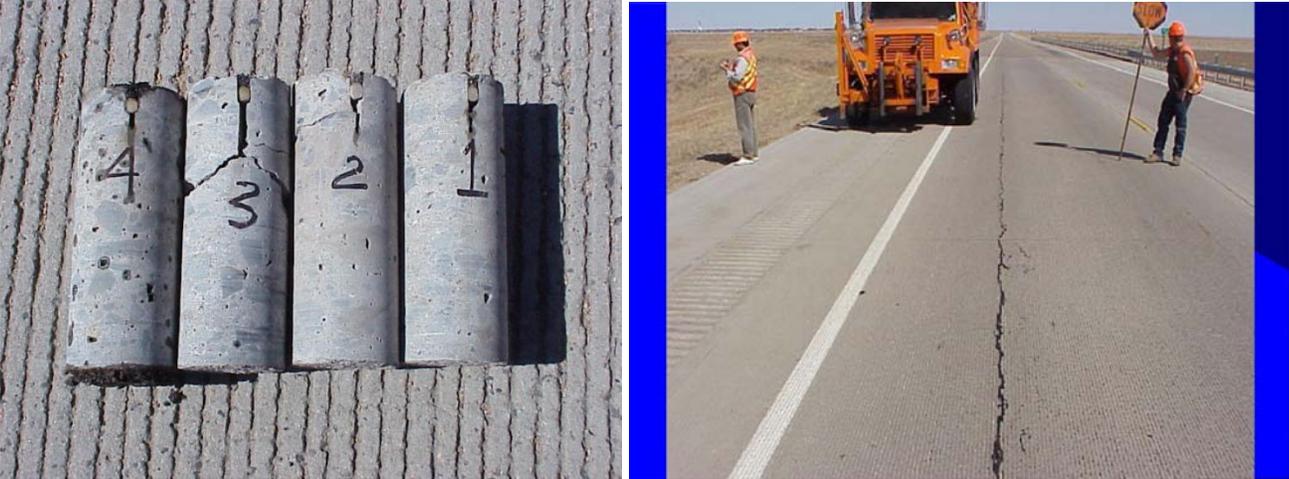
Figure 24: Cores Showing Non-Working Joints

Some of the longitudinal cracks on US-287 were assumed to be due to vibrator trails created by malfunctioning of paver vibrators. Laboratory testing revealed a definite relationship between

improper vibration practices and longitudinal cracking in the path of the vibrators. Cores taken from three different locations on and next to the vibrator trails were sent to Construction Technology Laboratories (CTL) for petrographic analysis. Air-void system analysis was performed in accordance with the modified point-count method of ASTM C 457-98, “Standard Test Method for Microscopical Determination of Parameters of the Air-Void System in Hardened Concrete.” The cores were cut longitudinally and one of the resulting surfaces was finely lapped (polished) and analyzed using a computerized apparatus.

The results showed the air content of the cores taken on the vibrator trails to be consistently lower (30-60 percent lower) than the air content of the cores taken next to the vibrator trails. Visual examination of the cores taken on the vibrator trails revealed non-uniform dispersion of the aggregate, indicating segregation of the mix caused by malfunctioning of the vibrators. High vibrator frequencies and/or prolonged vibrations at lower paver speed were determined to be the main factors that caused segregation and eventually longitudinal cracking along the vibrator trails.

- It is strongly recommended that the paving contractors equip their paving machines with frequency monitoring devices for the vibrators. These monitoring devices provide the transportation agencies and the paving contractor a necessary tool to help achieve a quality concrete pavement that is long-lasting. CDOT has already adopted and fine tuned the Iowa DOT's specification for monitoring the frequencies of the vibrators. This specification was fully implemented at the completion of this study. To view this specification visit CDOT's website.
