**Report No. CDOT-2010-8  
Final Report**

# **OPTIMIZATION OF STABILIZATION OF HIGHWAY EMBANKMENT SLOPES USING DRIVEN PILES – PHASE I**

**December 2010**

**COLORADO DEPARTMENT OF TRANSPORTATION  
DTD APPLIED RESEARCH AND INNOVATION BRANCH**

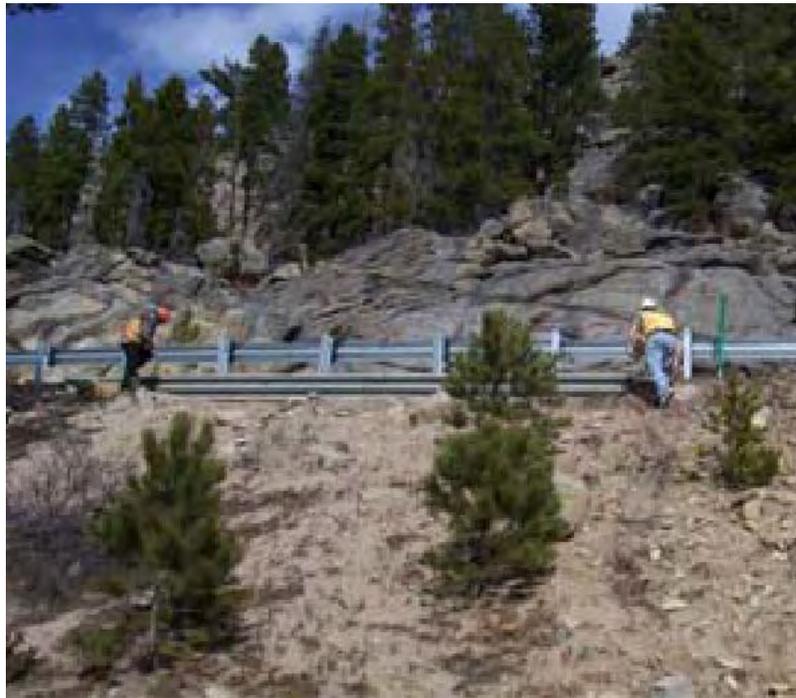
The site visit was performed March 6, 2009 near mile marker 25 along State Highway 72 (Steve Laudeman, Aziz Khan, Russel Cox, Alan Lisowy, John Hart, Panos D. Kioussis, Jared Stewart). The slide had been previously stabilized using steel guard rail sections. Type 3 guardrail posts were used as piles spaced at six ft and three inches in this case, a typical section is shown in Figure 5. Additionally, guardrail railing was used to provide lagging between the piles, Figure 6. This slide did not show any signs of recent movement.

**Figure 6. Guardrail stabilization system along SH-72.**

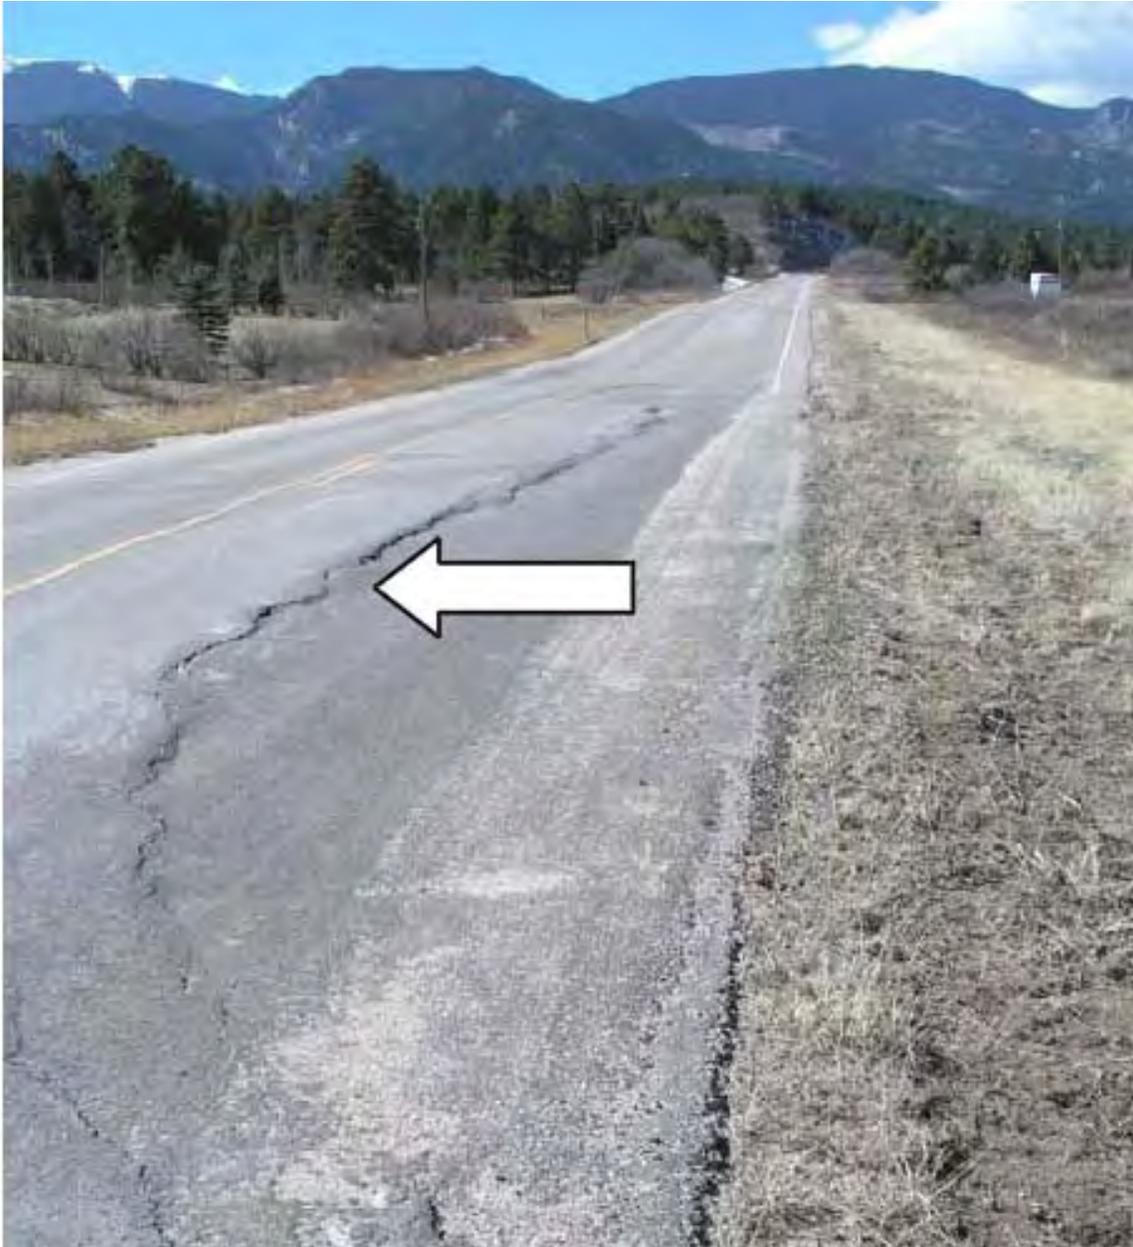
Two main areas of distress were identified at the Rye slide (State Highway 165, mile marker 26) during the visit (Aziz Khan and Panos D. Kioussis) on May 11, 2009. The first area is identified in the 2006 report (Figure 7) and again during the May 11, 2009 visit (Figure 7 white arrow). This distress appears to be the result of a deep seated slip failure, which, according to the 2006 report, had its toe 50 to 100 ft within the private property that borders the northern “right-of-way” boundary. This is verified by close examination of Figures 1 and 4 of the 2006 “Rye Slide Interim Report” [14] and the inclinometer data of borehole I103 (up to 3-4-2008) provided by Mr. Laudeman, where a shear band at a depth between 34 and 36 ft (at the interface of clay and claystone layers) has been developed.

**Figure 7. Pavement distress at Rye (2006).**

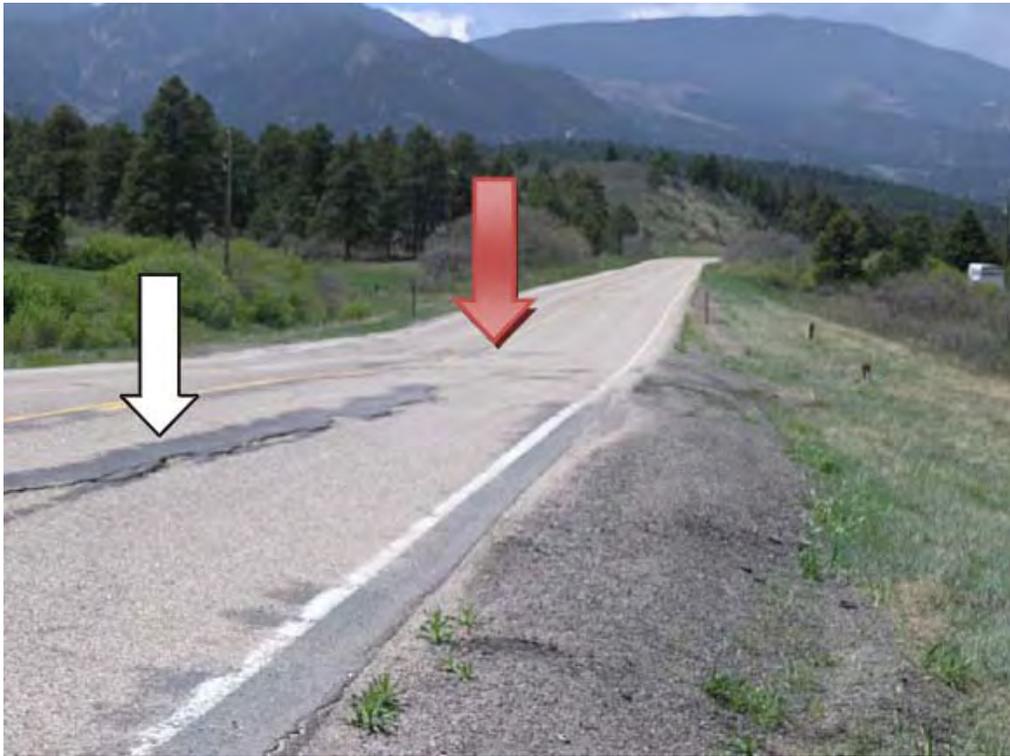
**Figure 8. Pavement distress at Rye (2009).**

The second area of distress is approximately 100 ft west of the aforementioned area (Figure 8 – red arrow) and it appears to be one where the predominant movement is settlement. Directly underneath this area, at the base of the embankment, there is a 24 inch diameter culvert which clearly sags approximately 9 inches in the area under the pavement (Figure 9 – the opening at the opposite end is barely visible due to sag). This indicates that a significant part of the settlement occurs below the fill, into the organic clay and/or clay layer beneath it. The inclinometers of boreholes I101 and I104 are located in this area, on the south and north sides of the road respectively. No shear failure is indicated in these inclinometers. Instead, a gradual displacement, almost linearly outwards (with respect to the road) in the case of I104 is observed. It is not clear if the displacements recorded by the inclinometer in borehole I101 are inward or outward with respect to the road.

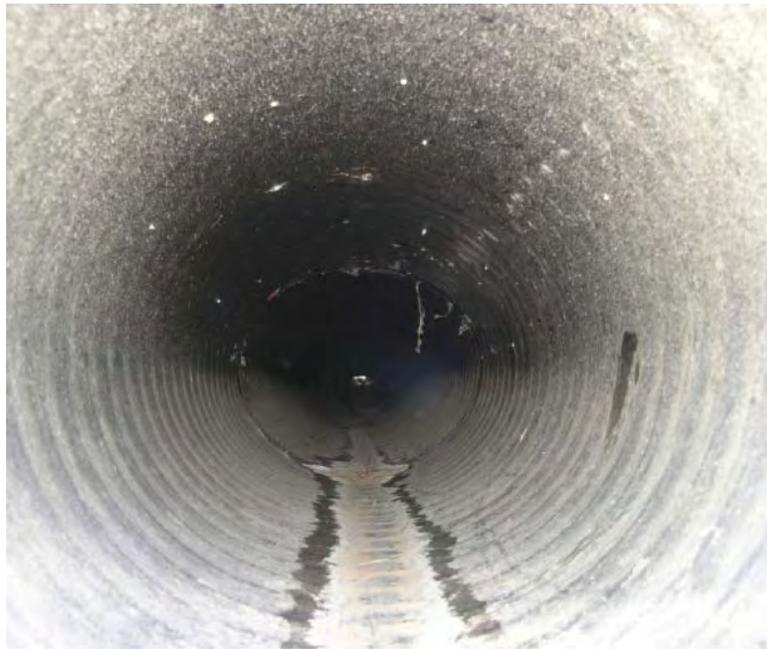
**Figure 9. Photo through culvert showing sag.**

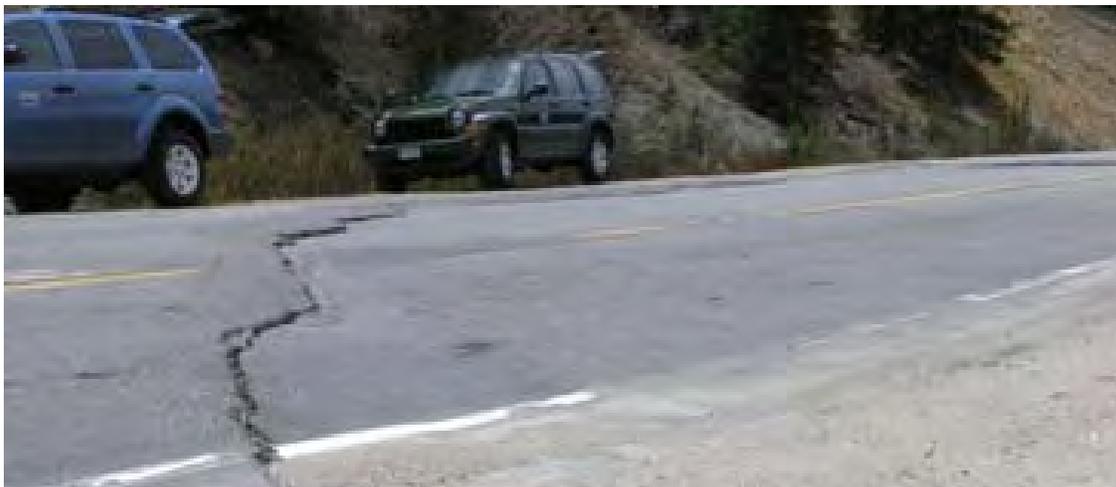
A slide occurring at Hoosier Pass on State Highway 9 at mile marker 74.8 was inspected June 8, 2009 (Steve Laudeman, Aziz Khan, Alan Lisowy, John Hart, D. V. Griffiths, Panos D. Kiouisis, Xiaoxia Zhou, Jared Stewart). The tension cracks at this slide cross the entire width of the roadway and the toe was found approximately 250 ft below the crest of the slope as shown in Figure 11. This slide presented a deep failure over a sloped underlying base.

**Figure 11. Pavement distress at Hoosier Pass.**

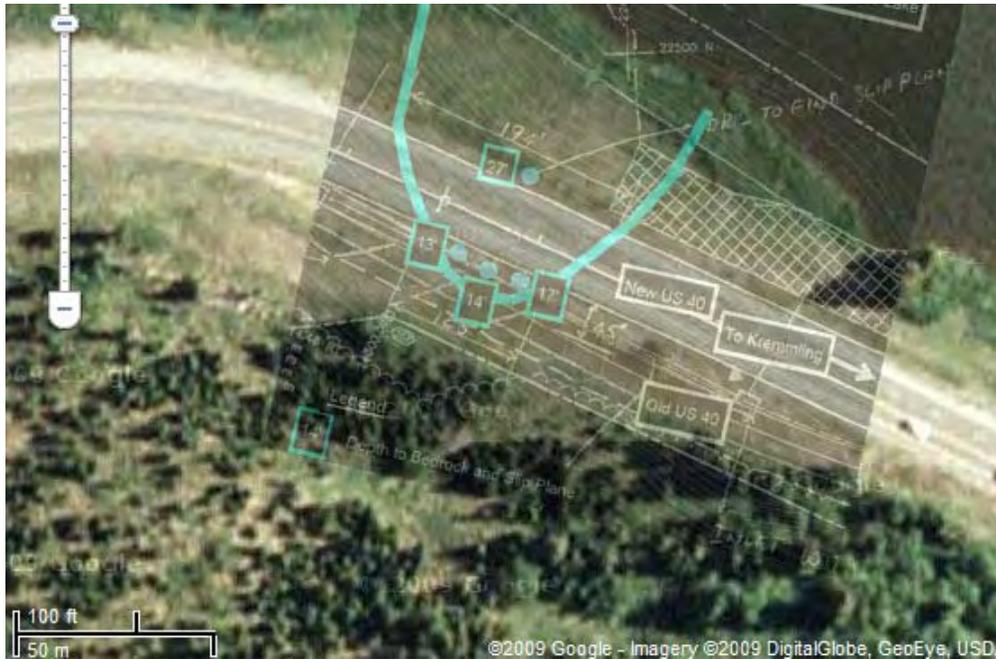
**Figure 12. Aerial extents of the Muddy Pass slide.**

shoulder, as shown in Figure 12. The toe is not apparent; it is believed to be near, or in, Muddy Pass Lake. Signs of distress were observed on the north side of the highway where the ground appears to have sunken as much as two ft in some locations. Tension cracks were found surrounding the slide mass and descending towards the lake.

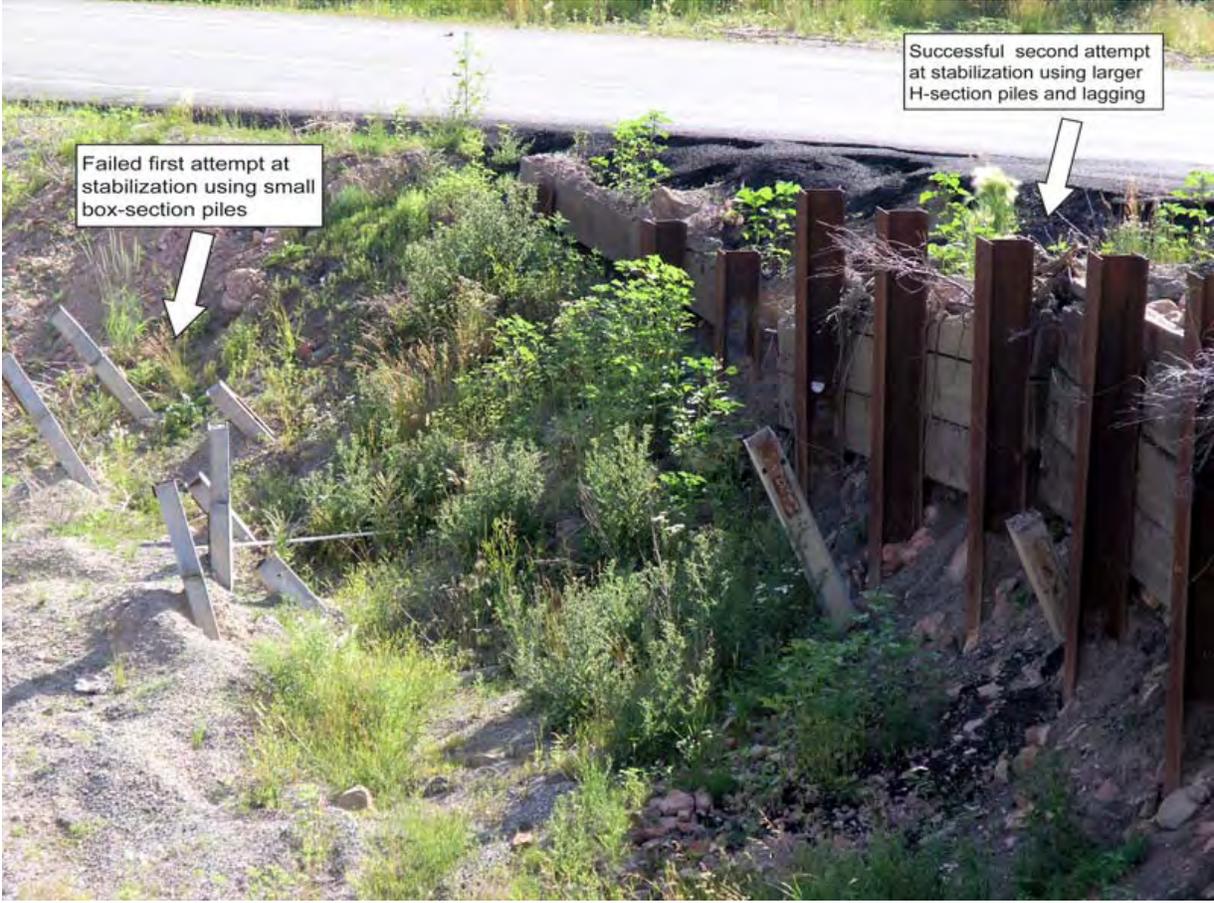
Three sites were visited along State Highway 139 going south from Rangely towards Grand Junction. The first site visited here (located at approximately mile marker 36) had previously been stabilized unsuccessfully before using driven piles. The first attempt used small box-section piles that were driven into the failing slope, but later failed (Figure 14). The second attempt made use of 12 inch deep H-Piles spaced at 6 ft. Lagging, composed of guardrail posts, was also

installed to a depth of 10 ft as shown in the same figure. The piles were installed in 2004 and appear to be working well. The stiffness of the lagging is sufficient to provide support even at 12 foot spacing as is shown in Figure 15 where it is clear that the lagging support by the H-piles does not occur at the intended 6 foot interval. Nevertheless, it appears that the runoff has caused significant washout behind the lagging and piles, and may soon become a problem at this site.

**Figure 14. Stabilized site at Douglas Pass, showing failed first attempt.**
