## Draft FIR Hydraulic Report

CDOT Project 23010  
Replacement of  
Existing Structure  
F-20-J  
US Highway 40

**Draft FIR Hydraulic Report Replacement of  
Existing Structure F-20-J**

**CDOT Project 23010  
Replacement of Existing Structure F-20-J  
US Highway 40**

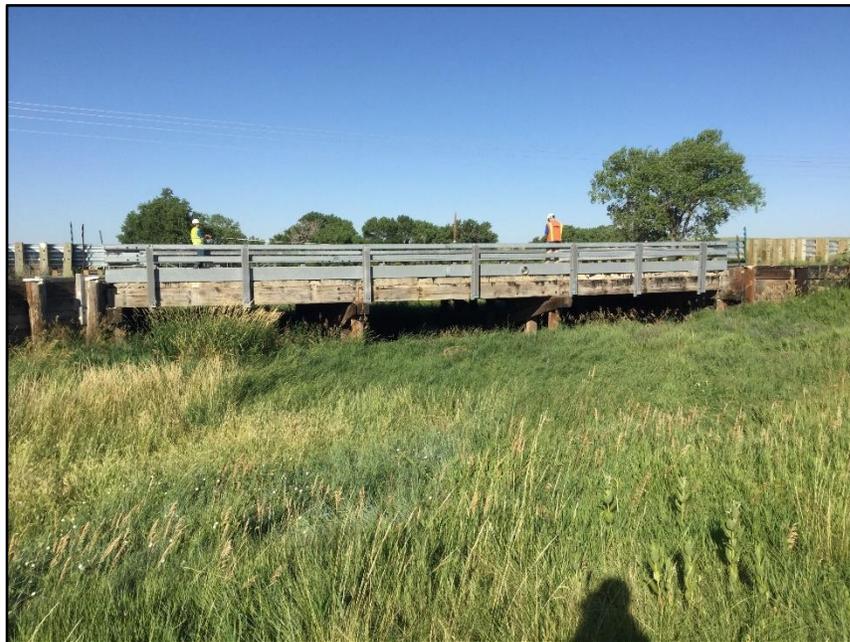
**Figure 2: Upstream face of Bridge F-20-J**

The existing F-20-J structure is an 89-year-old bridge constructed by the State Highway Department in 1931. The bridge has 3 spans of about 18 feet each supported by two rows of 1-foot diameter cross-braced timber pile bents and abutments. **Figure 2**, **Figure 3**, and **Figure 4** show the downstream face, upstream face, and roadway of the existing structure, respectively.

A field reconnaissance was performed by Ayres engineers on July 24, 2019, and the Olsson geomorphologists on July 30, 2019 to evaluate the existing bridge, document the study site, assess geomorphic conditions, obtain soil samples, identify hydraulically significant features, and estimate Manning roughness coefficients. This evaluation, which is indicated in Olson's geomorphic report indicates that the unnamed drainage is not highly dynamic over engineering time scales, and that no significant long-term degradation is expected. Conditions at the bridge suggest relatively infrequent flows with flows rarely exceeding 1.5 to 2 feet deep.

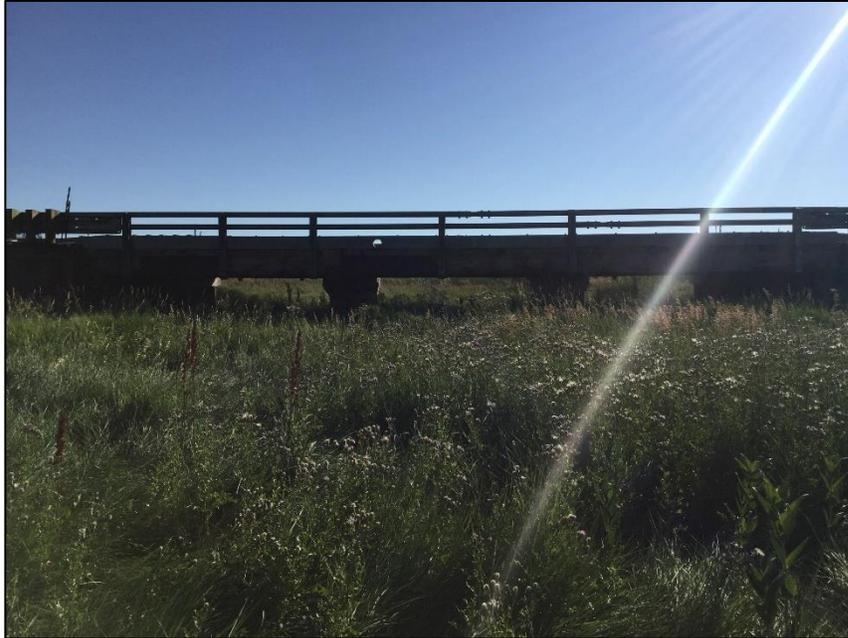
**Figure 3: Downstream face of Bridge F-20-J**

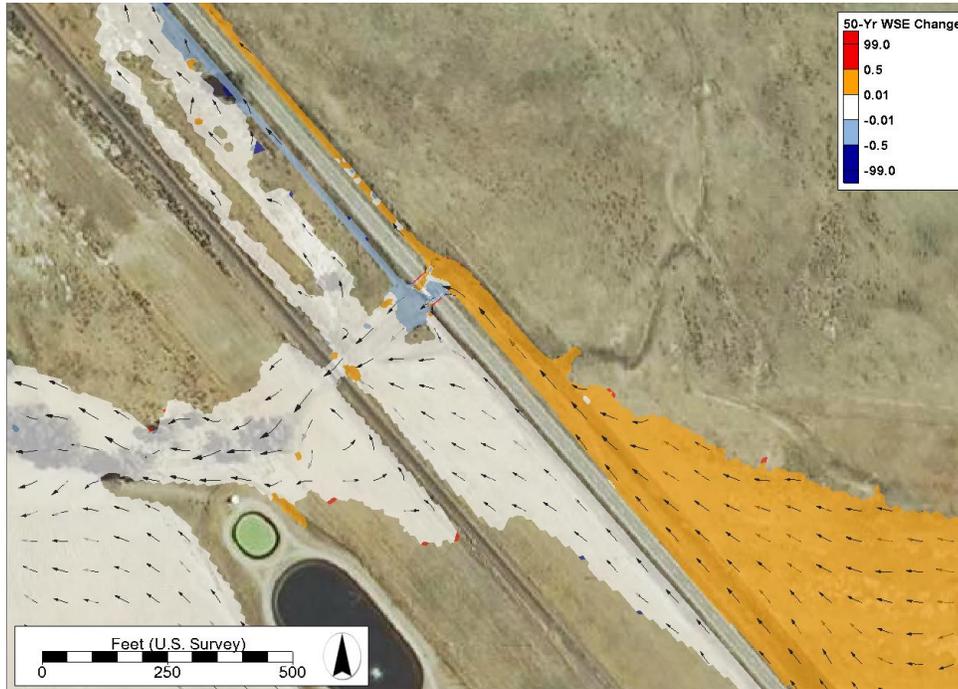
**Figure 7: Proposed vs existing velocity change (orange and red indicate an increase in velocity) during the 50-year event**

**Figure 7, Figure 8, and Figure 9** display a comparison of existing to proposed velocity values during the 50-, 100-, and 500-year events. During all events the velocity increases through more than half of the

bridge, starting from the north abutment by less than 2 ft/s during proposed conditions. The flow must make a sharp bend, and the flow is guided less abruptly during existing conditions due to wingwalls protecting the abutments. The proposed condition abutments are protected by riprap, creating a more abrupt turn through the bridge, resulting in a larger diameter eddy on the inside of the bend (near the south abutment) than during existing conditions. This leads to lower velocities on the inside of the bend, but a narrower vena contracta creating larger velocities during proposed conditions, outside of the eddy.

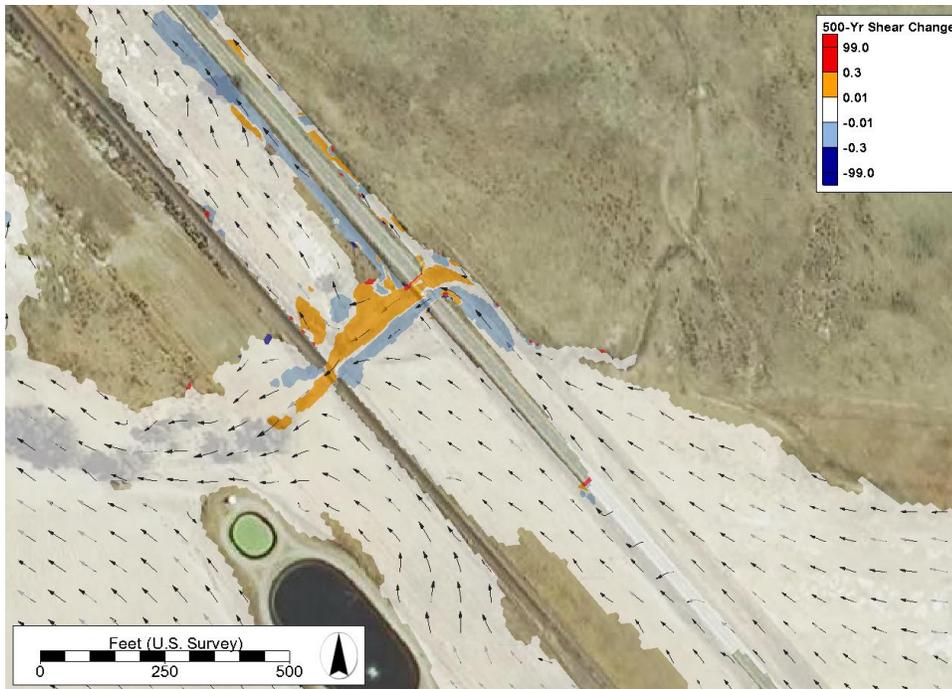
**Figure 12: Proposed vs existing bed shear stress change (orange and red indicate an increase in shear stress) during the 500-year event**

**Figure 10, Figure 11, and Figure 12** display a comparison of existing to proposed bed shear stress values during the 50-, 100-, and 500-year events. During all events, and similar to the velocity comparison above, the proposed conditions bed shear stress increases compared to the existing bed

shear stress from the north abutment to more than half of the bridge span. This is due to the increase of velocity during the proposed conditions caused by the more abrupt change in flow direction than existing conditions, explained previously.

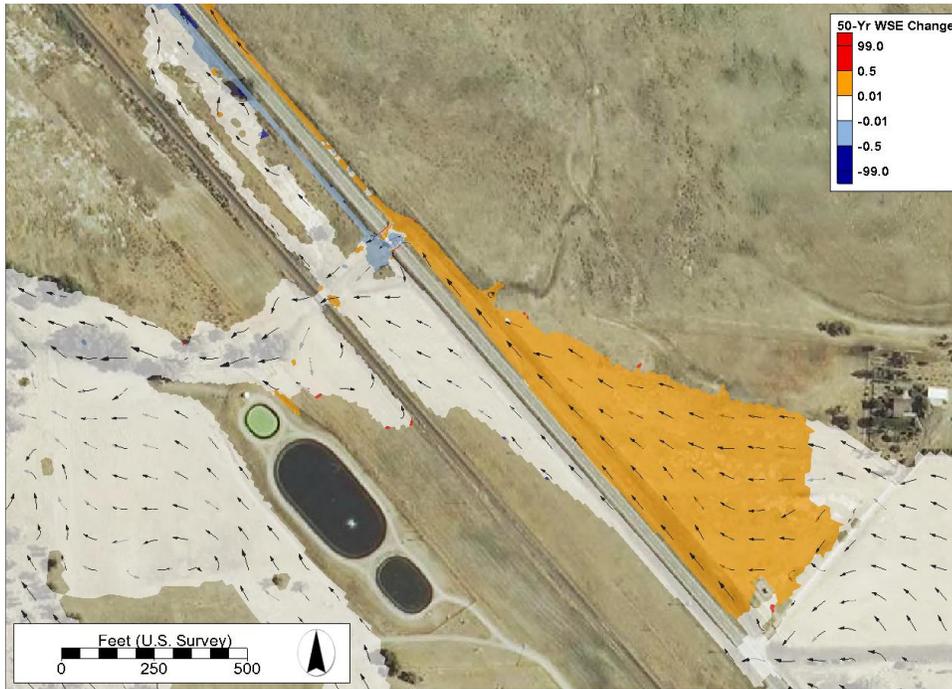
**Figure 13: Proposed vs existing WSEL change (orange and red indicate an increase in WSEL) during the 50-year event**

Analysis was performed using the Dataset Calculator within SMS to ensure no-adverse impact and improved hydraulic conditions of the proposed condition versus the existing condition. **Figure 13**, **Figure 14**, and **Figure 15** show a comparison of the 50-, 100-, and 500-year event water surface elevations around the bridge. Outside of the immediate vicinity of the proposed structure there is no WSEL rise greater than 0.5-foot, and no rises on insurable structures. In **Figure 14**, and **Figure 15** increases in WSEL are shown as shades of red, while decreases in WSEL are shown as shades of blue. White indicates WSEL changes less than  $\pm 0.01$  foot. Notice that the hydraulic impacts of the proposed bridge are limited to the areas immediately upstream and downstream of the bridge, with a small area of increase upstream of the bridge. No insurable structures are impacted by WSEL changes associated with the proposed bridge design. Note that in **Figure 15**, which compares existing to proposed water surface elevations during the 500-year event, there is less impacted upstream of the bridge during proposed conditions due to the roadway overtopping.

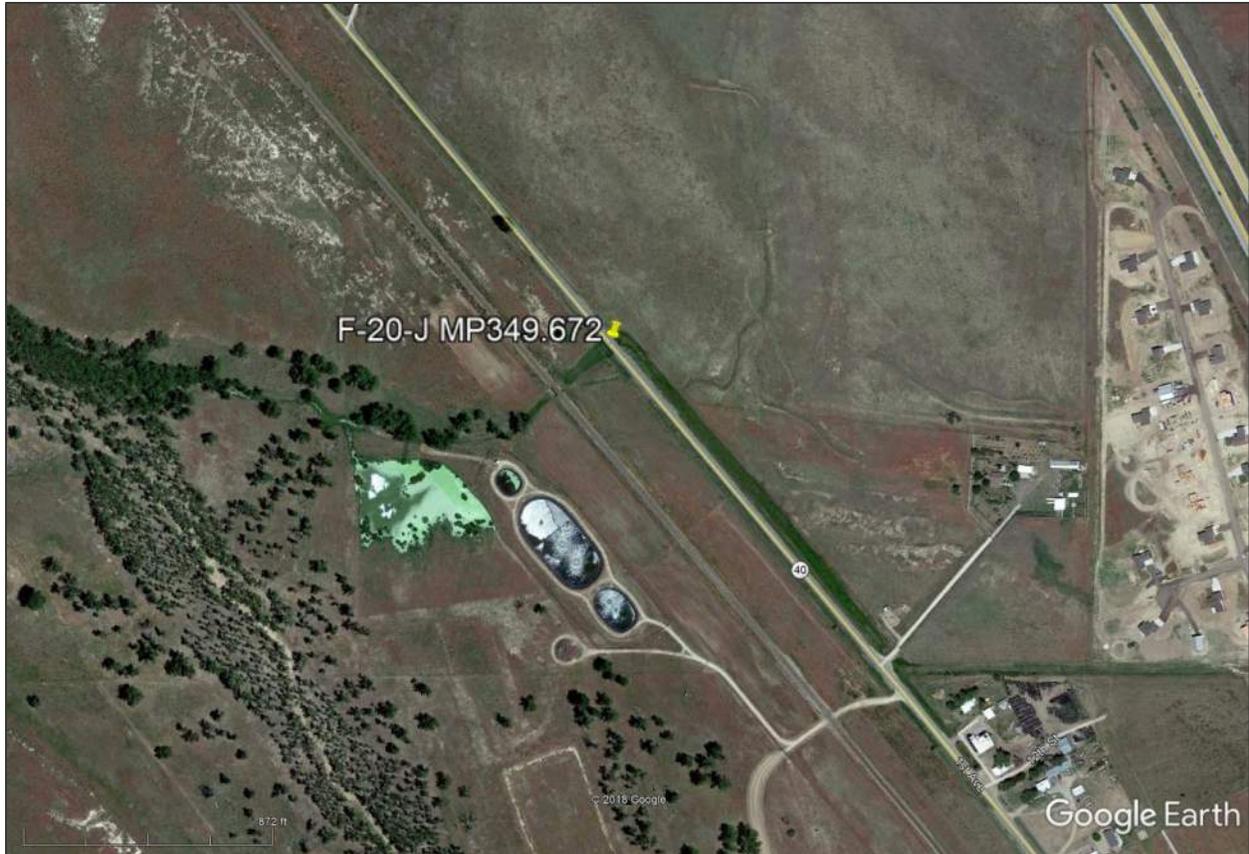
Figure 1. Location of US36 Bridge F-20-J over an unnamed drainage channel near Deer Trail, Colorado.

The following memo describes the geomorphic assessment of the stability of the unnamed drainage channel and the US36 (SH40) crossing of the channel by the Bridge Enterprise (BE) Bridge F-20-J, which is located in Arapahoe County about a quarter mile north of Deer Trail, Colorado at Mile Post 349.672 (**Figure 1**). The unnamed drainage channel flows from the southeast to the northwest and is tributary to East Bijou Creek, which is located to the west of the highway. The confluence of the channel with East Bijou Creek is located about 1,700 feet west of the bridge site. The bridge site and US36 are bound by hills to the east and railroad tracks/embankment about 225 feet to the west. Upstream of the bridge, the channel is located on the east side of US36 and parallels the highway for about 1,500 feet where it splits into 2 different stormwater drainage channels. At the bridge, the upstream channel makes a 90° turn to the southwest as it passes under the bridge. Downstream of the bridge the channel is straight and is bound by US36 and the railroad tracks.

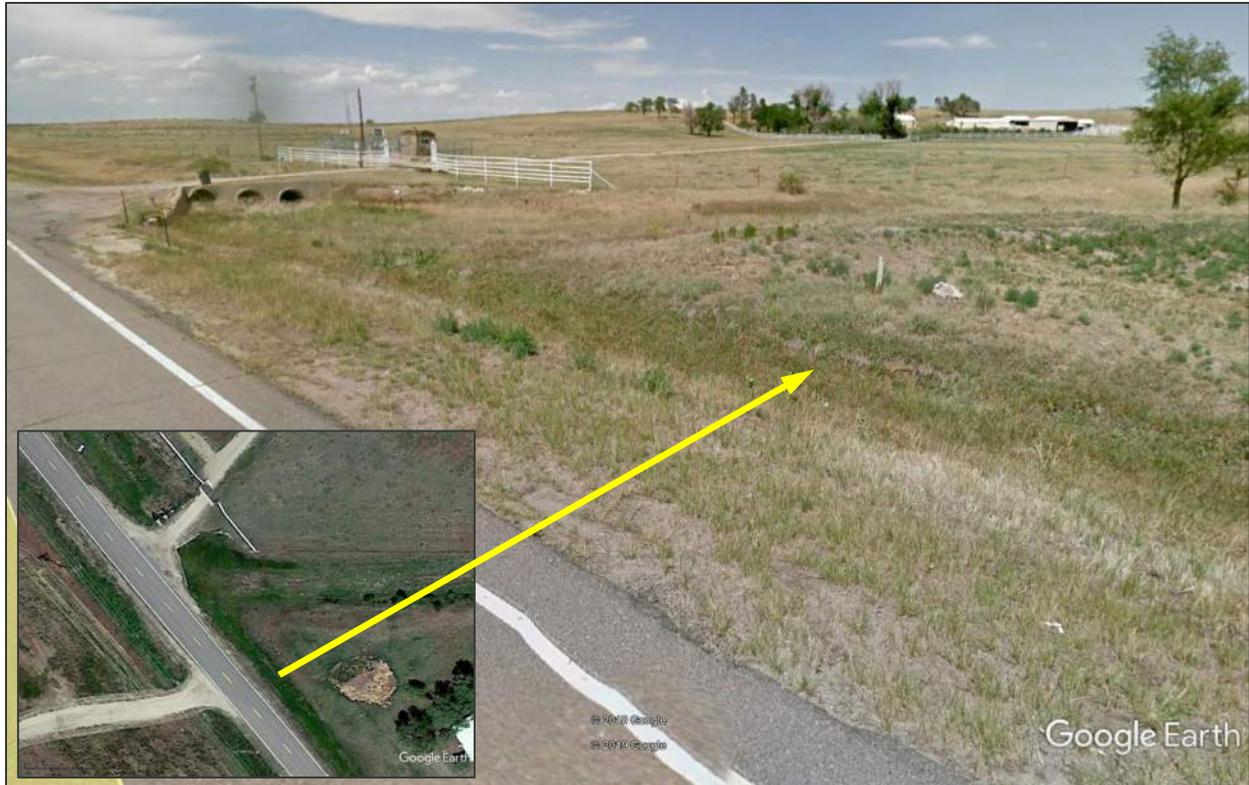
Figure 3. Google Earth Street View of stormwater channel along US36 and confluence with main unnamed channel.

As noted above, the drainage area and the peak flow values may be slightly incorrect since the drainage area delineated by StreamStats does not include a part of the north end of the town of Deer Trail. However, an examination of the current aerial photography shows a 1,450 foot long stormwater drainage channel that is present along the east side of US36 that appears to collect stormwater from the northwest end of town and connects up with the main channel about 1,500 feet southeast of the bridge (**Figure 3**).

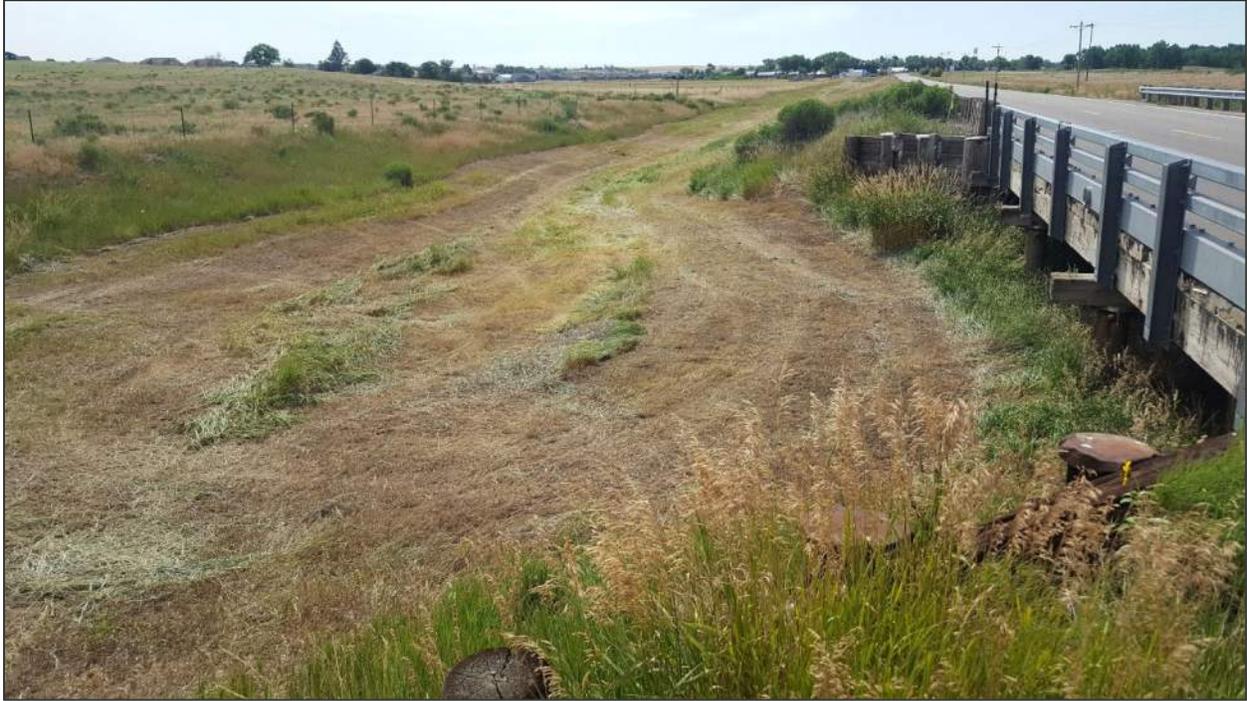
Figure 4. View looking upstream (south) toward Deer Trail along the unnamed channel southeast of US36 Bridge F-20-J.

Bridge F-20-J, which is 60 feet wide, consists of vertical timber retaining wall abutments with timber wingwalls. The bridge sits on 3 pile bents each of which contains 7 wood piles that are 12 inches in diameter. Wood cross braces are present on each pier bent. The pier bents are not skewed but the channel just upstream makes a 90° turn into the bridge opening (**Figure 4**). **Figure 5** shows the configuration of the bridge.

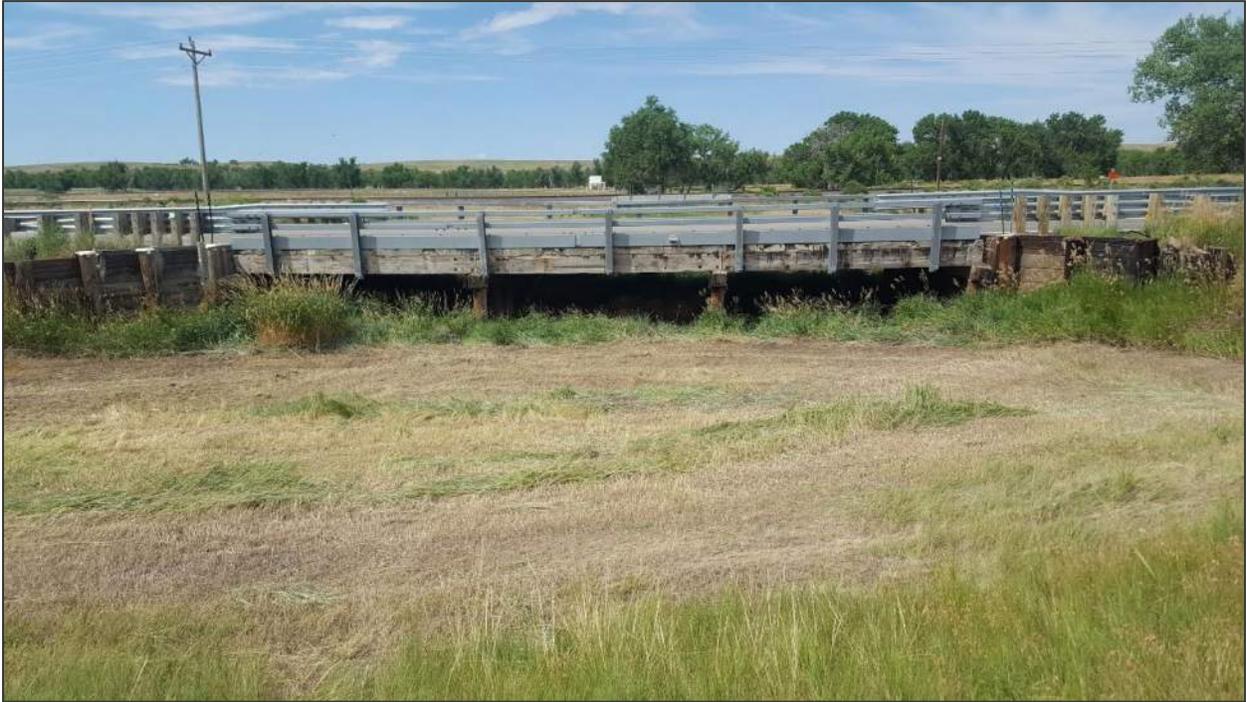
Figure 5. View looking downstream at US36 Bridge F-20-J over unnamed drainage channel near Deer Trail.
