Draft FIR Hydraulic Report

CDOT Project 23014
Replacement of
Existing Structure
G-21-A
US Highway 40

**Draft FIR Hydraulic Report Replacement of
Existing Structure G-21-A**

**CDOT Project 23014
Replacement of Existing Structure G-21-A
US Highway 40**

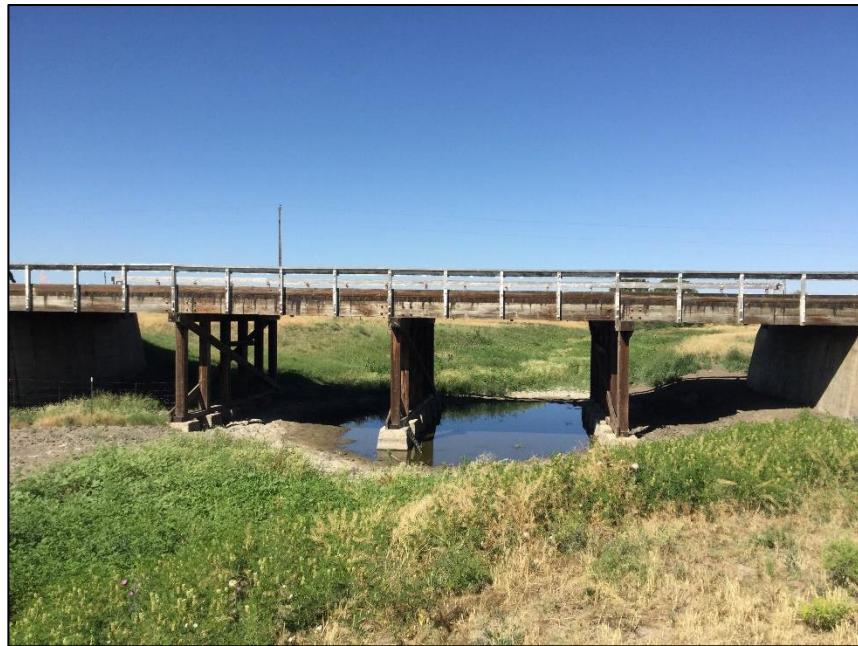
Figure 2: Upstream face of Bridge G-21-A

The existing G-21-A structure is an 89-year-old bridge constructed by the State Highway Department in 1931. The bridge has 4 spans, each 23 feet in length, supported by three rows of 1-foot diameter cross-braced timber pile bents and concrete abutments. The existing bridge width is 26 feet, out to out. **Figure 2**, **Figure 3**, and **Figure 4** show the downstream face, upstream face, and roadway of the existing structure, respectively.

Field reconnaissance was performed by Ayres engineers on July 24, 2019, and the Olsson geomorphologist on July 30, 2019 to evaluate the existing bridge, document the study site, assess geomorphic conditions, obtain soil samples, identify hydraulically significant features, and estimate Manning roughness coefficients. This evaluation, which is outlined in Olsson's geomorphic report, indicates that Agate Creek is not highly dynamic over engineering time scales, and that no significant long-term degradation is expected. Conditions at and around the bridge suggest relatively infrequent flows.

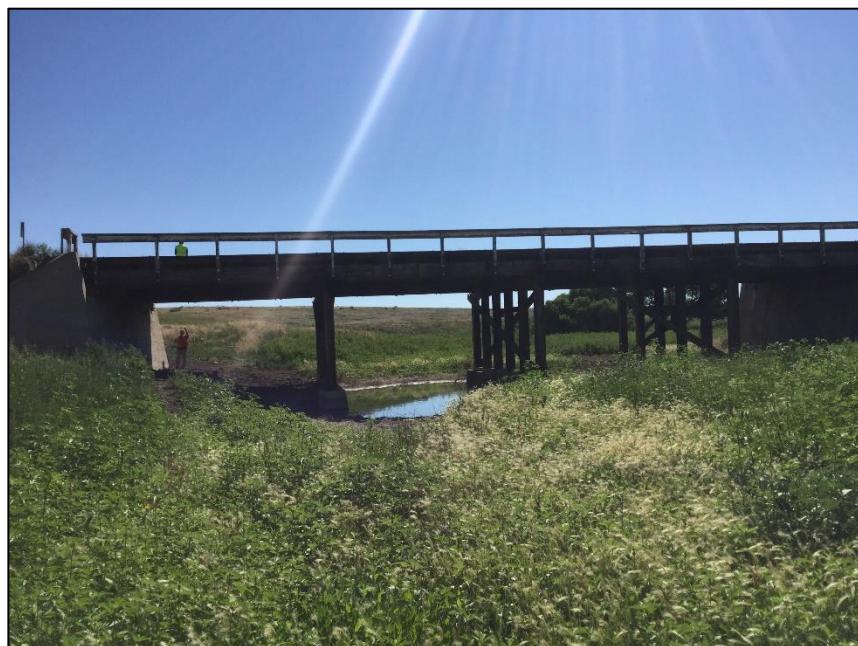
Figure 3: Downstream face of Bridge G-21-A

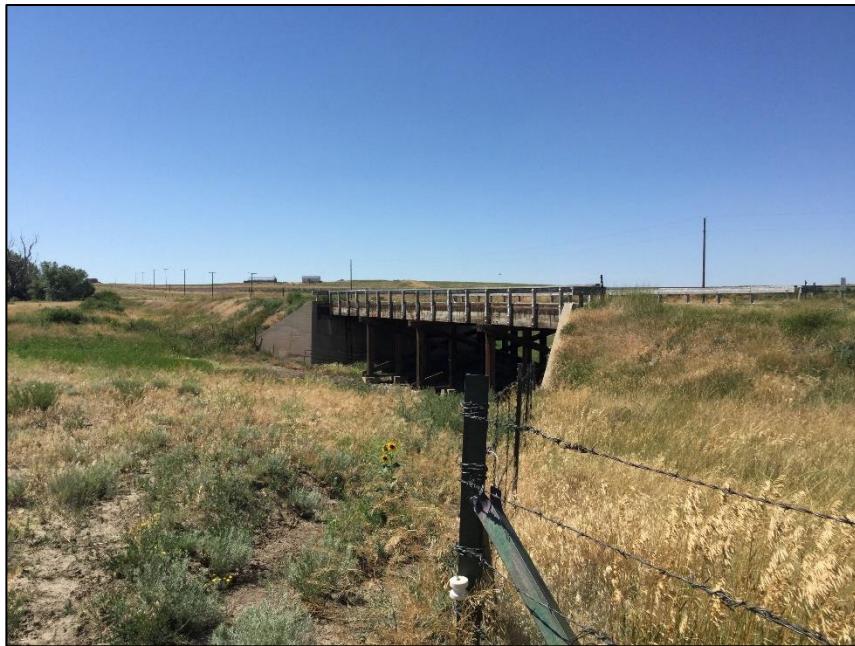
Figure 4: Upstream face of Bridge G-21-A, looking south along roadway

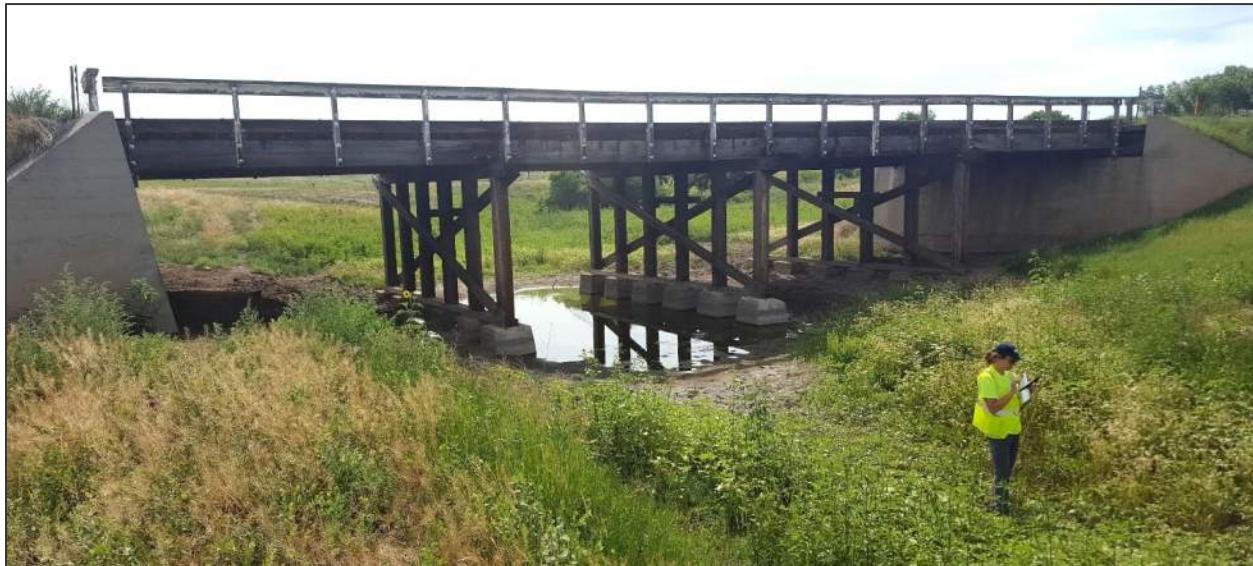
Bridge G-21-A, which is 95 feet wide, consists of 2 steeply sloping concrete spill-through abutments with concrete wingwalls. The bridge sits on 3 pier bents each of which contains 6 wood piers sitting on a single wood cross beam resting on square concrete footers located under each pier. Wood cross braces are present on each pier bent. The pier bents are skewed about 10° to the channel alignment. **Figure 3** shows the configuration of the bridge.

Figure 3. View looking downstream at US36 Bridge G-21-A over Agate Creek.

Besides the impounded area upstream of the bridge, the area under the bridge also appears to be used by livestock for shade and to transit between the upstream and downstream areas. Thus, the area under the bridge has become well trampled, forming a wide, shallow depression (see Figure 3) that has the appearance of a scour hole, which it is not. High water stains on the left abutment and the concrete pier footings suggest that water levels rarely get above the top of the footings.

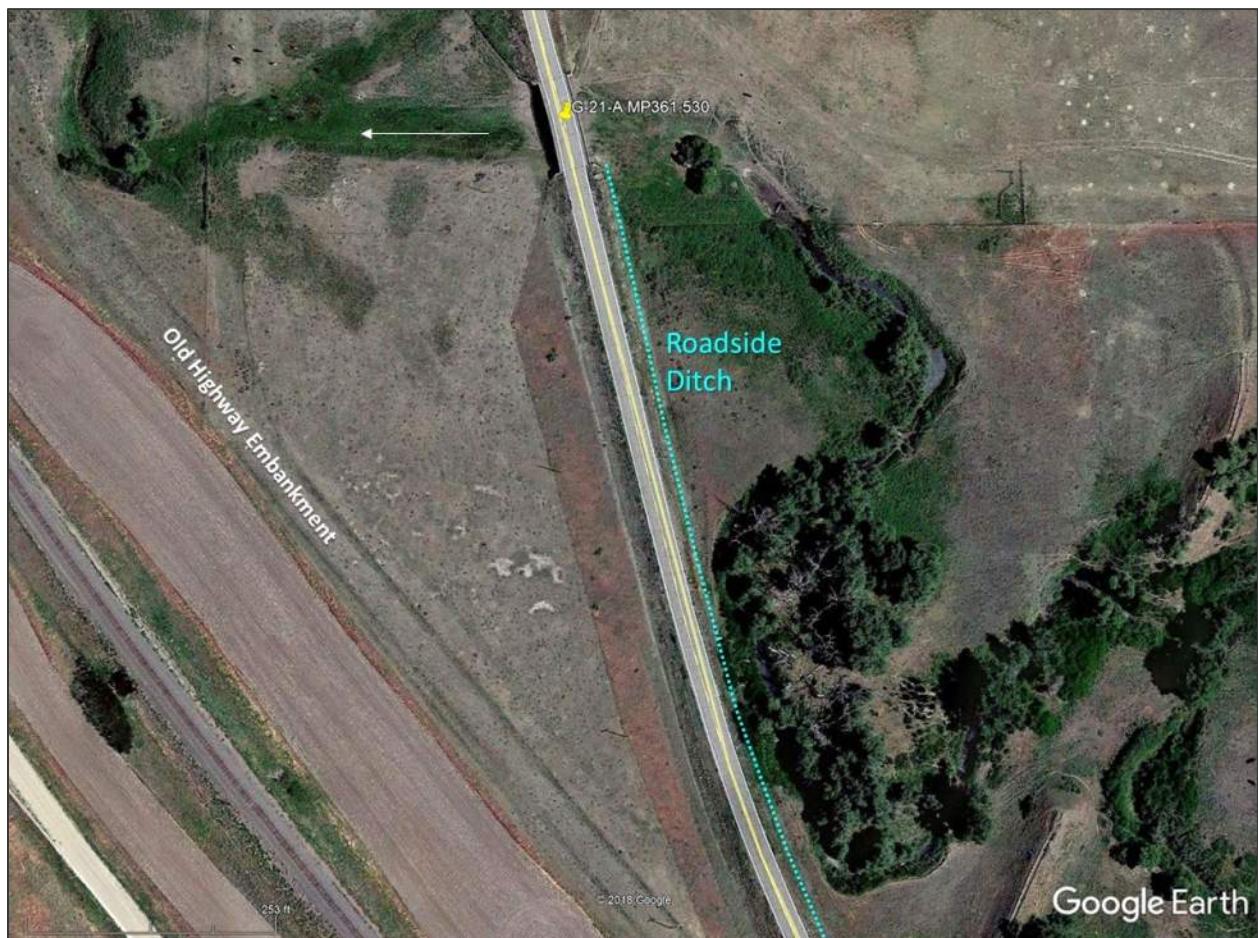
proximity to the highway embankment about 500 feet to the south (**Figure 4**). The ditch could potentially accommodate flood flows and develop into an avulsion if flood flows are sufficiently significant. If this were to occur, the left bridge abutment could be threatened by scour and undermining. Survey data and hydraulic modeling should be able to determine if this is possible.

Figure 4. View of US34 bridge G-21-A across Agate Creek and upstream channel and ditch.

A roadside ditch along the east side of the highway upstream (south) of the bridge could potentially be a conduit for flood flows that break out of Agate Creek where it comes in close

A short, discontinuous channel on the north side of the bridge that intersects the main channel about 200 feet downstream of the bridge appears to be a relic of the original channel of Agate Creek prior to the construction of the current US36 alignment. This relic channel may be the downstream remnant of a pair of small meander bends that might have been located in the path of the current US36 alignment. The bends were likely cut off and filled in when the current embankment for US36 was constructed and the current channel alignment was probably constructed as part of the meander cutoffs for a better alignment with the downstream channel. The original highway embankment is still visible west of the current highway and bridge as seen in Figure 4.
