APPENDIX B

I-70/32nd Avenue Interchange Project Wetland Photos

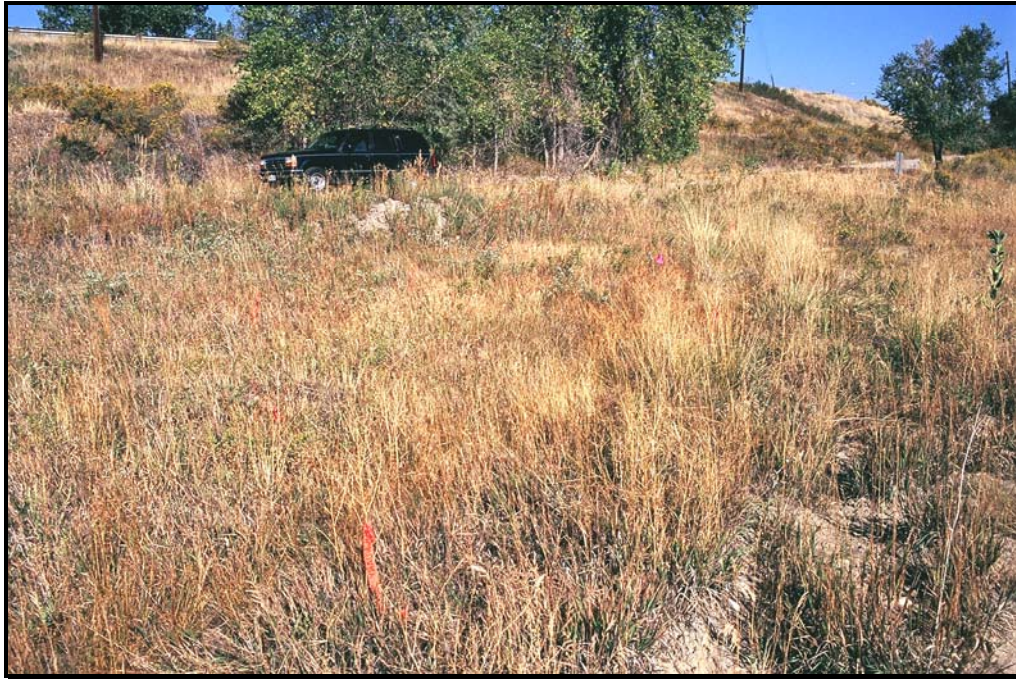
Photo 1. Data Plot A-1a looking northwest on September 21, 2005. The McIntyre Street roadway berm is in the background. Hydrology is from a roadside stormwater drain outflow. Determined not to be a wetland. The majority of the predominant vegetation was not facultative or wetter.

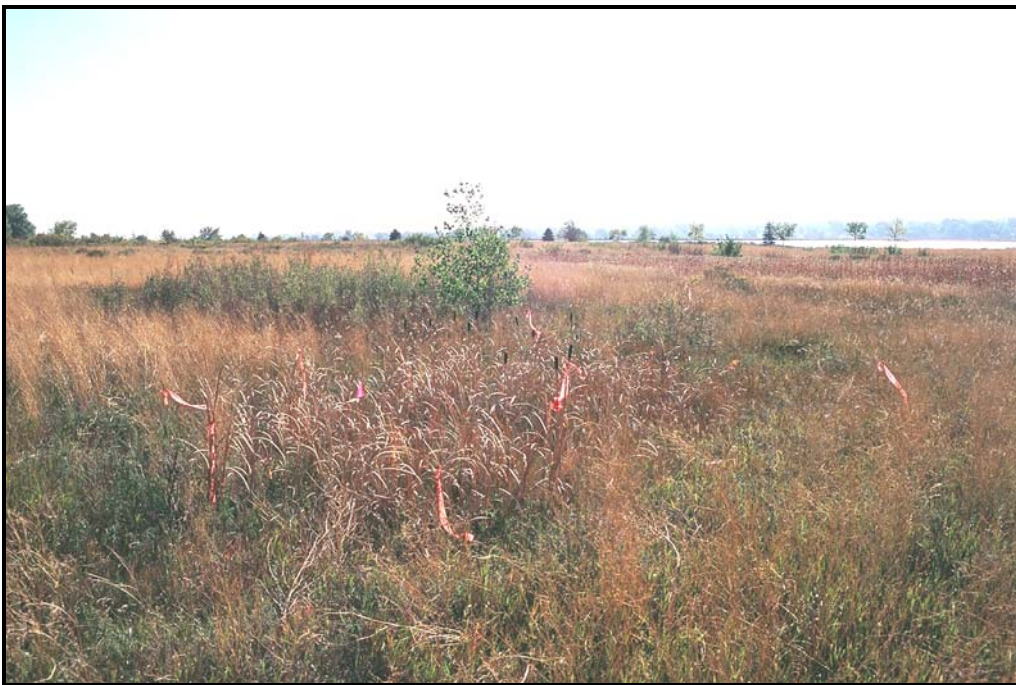
Photo 2. Wetland A-2, Data Plot A-2a. Looking east on September 21, 2005. Small isolated depression.

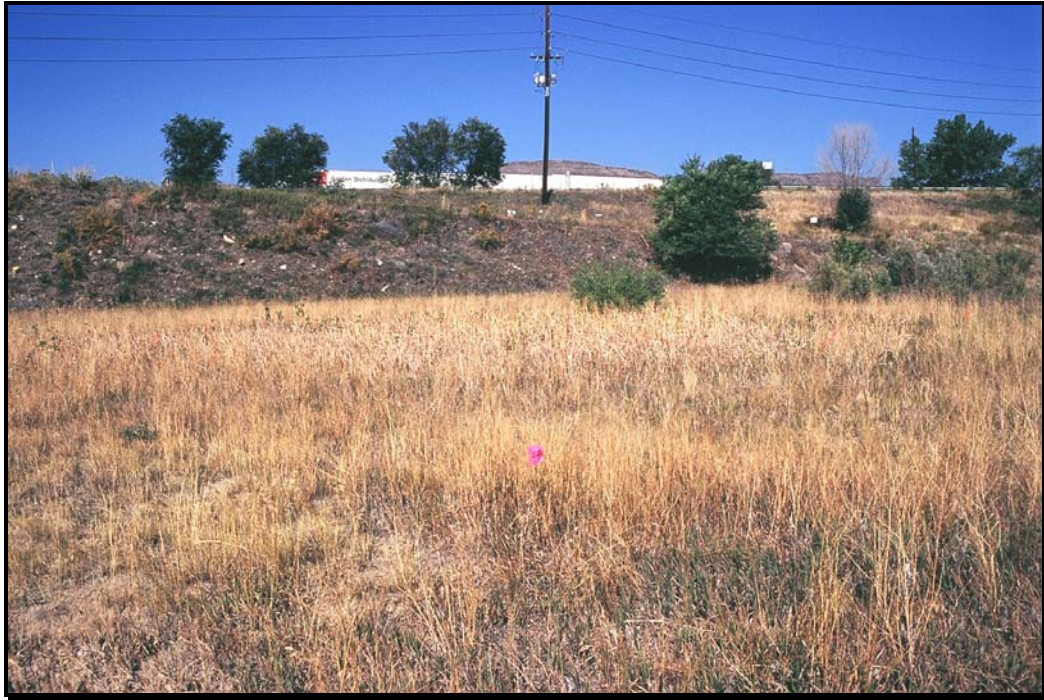
Photo 3. Wetland A-3, Data Plot A-3a in the background with pin flag at Data Plot A-4c (upland plot) in the foreground. Looking northwest on September 21, 2005. Isolated depression.

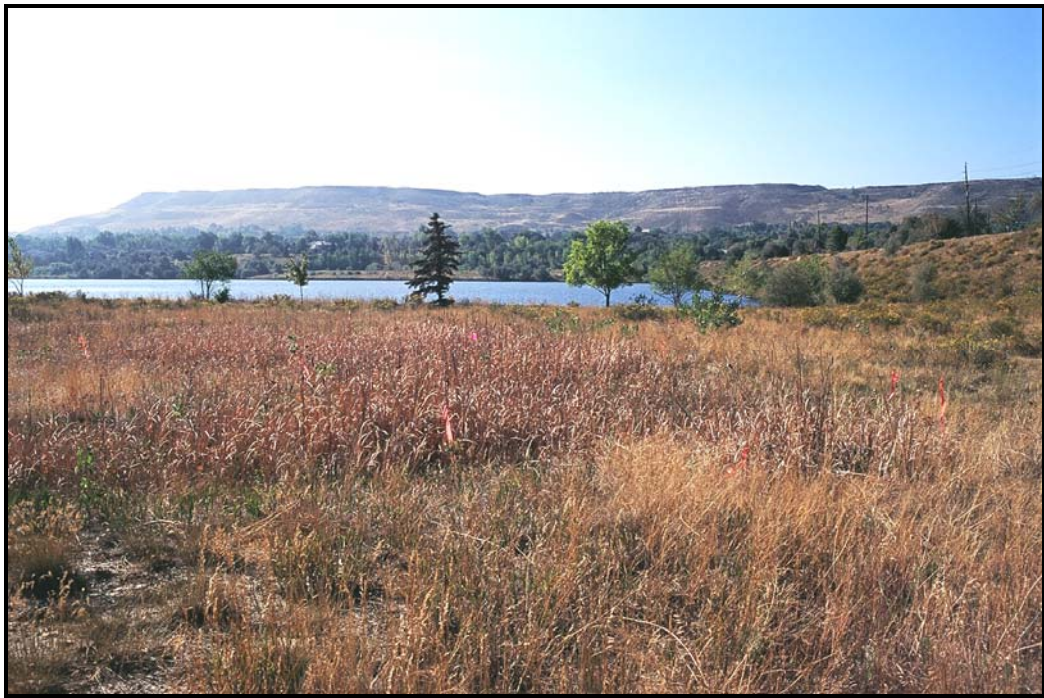
Photo 4. Wetland A-4, Data Plot A-4a. Looking south from Wetland A-2 on September 21, 2005. The berm for McIntyre Street is in the right background. A-4 is an isolated depression complex.

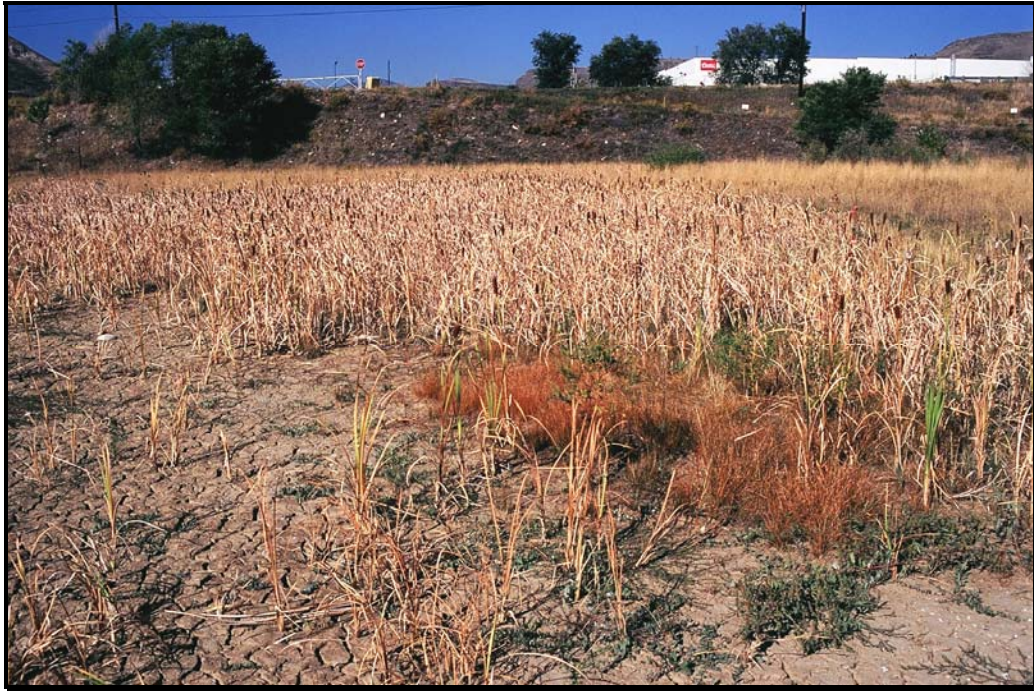
Photo 5. Wetland A-4. Data Plot A-4b on September 21, 2005. Looking west. McIntyre Street is in the background. Isolated depression complex.

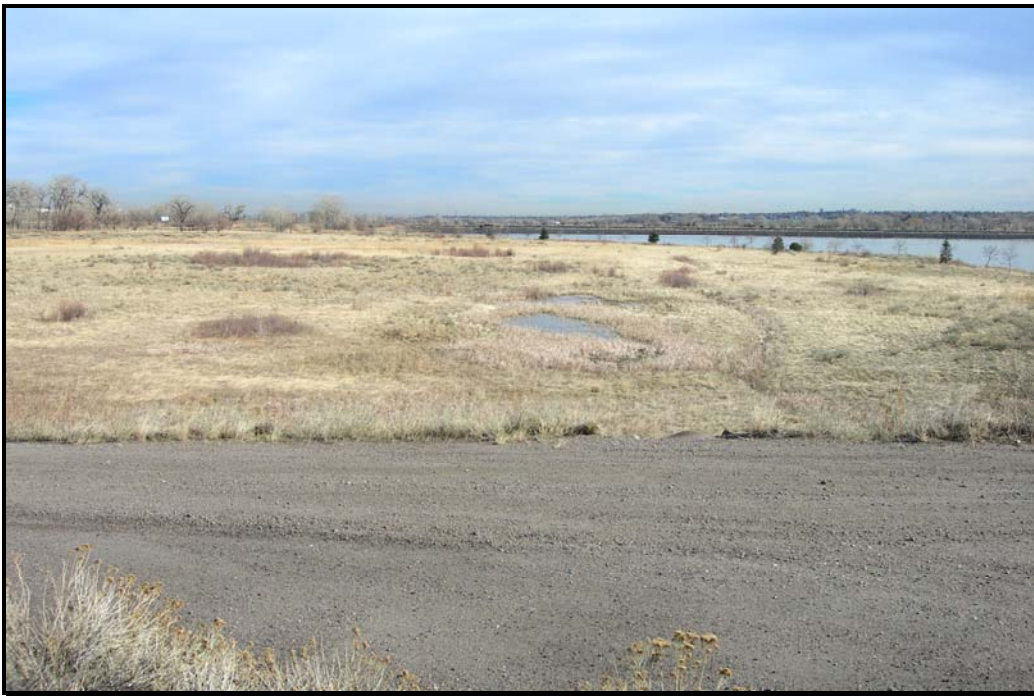
Photo 6. Wetland A-3 and A-4. Looking east on January 14, 2006 from McIntyre Street. Coors water storage reservoir in the background. Wetland A-3 and A-4 are inundated with standing water.

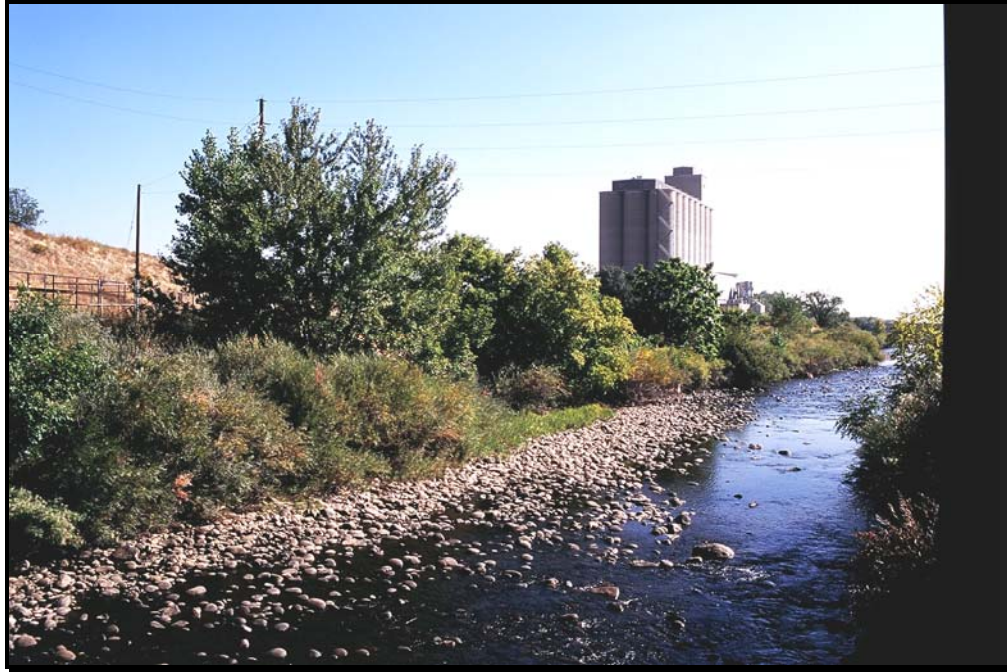
Photo 7. Wetland B-1, looking east on September 26, 2005. Data Plot B-1a is located in the foreground on the north side of Clear Creek. The photo was taken from beneath the McIntyre Street bridge over Clear Creek. The Coors Brewing Company grain elevator is in the background.

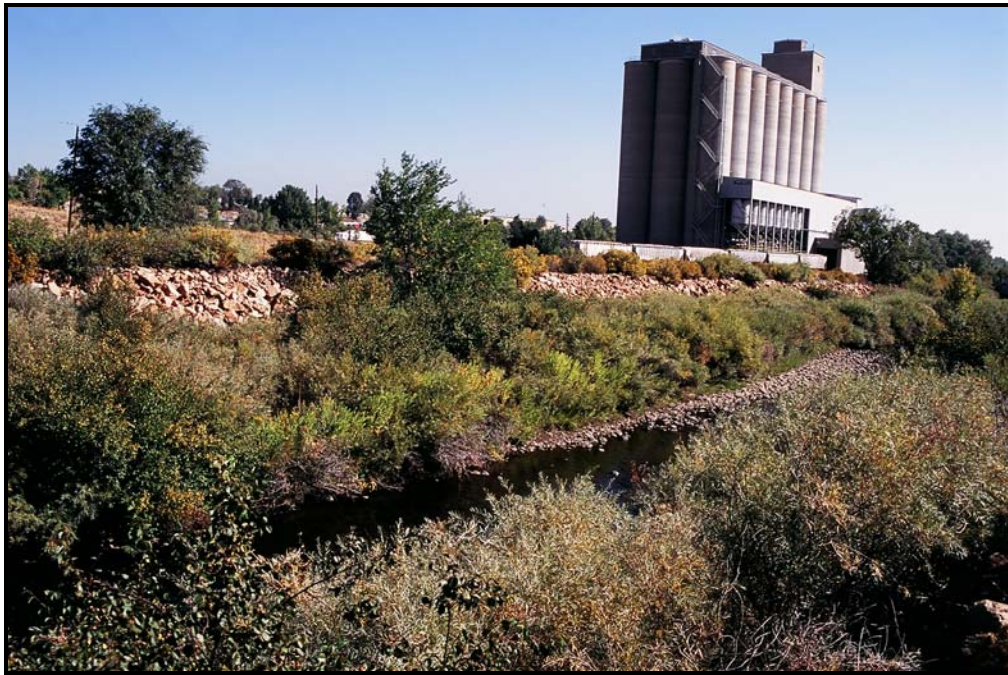
Photo 8. Wetland B-1, looking east on September 26, 2005. Data Plot B-1b is in the center of the photo on the north bank of Clear Creek. The Coors Brewing Company grain elevator is in the background.

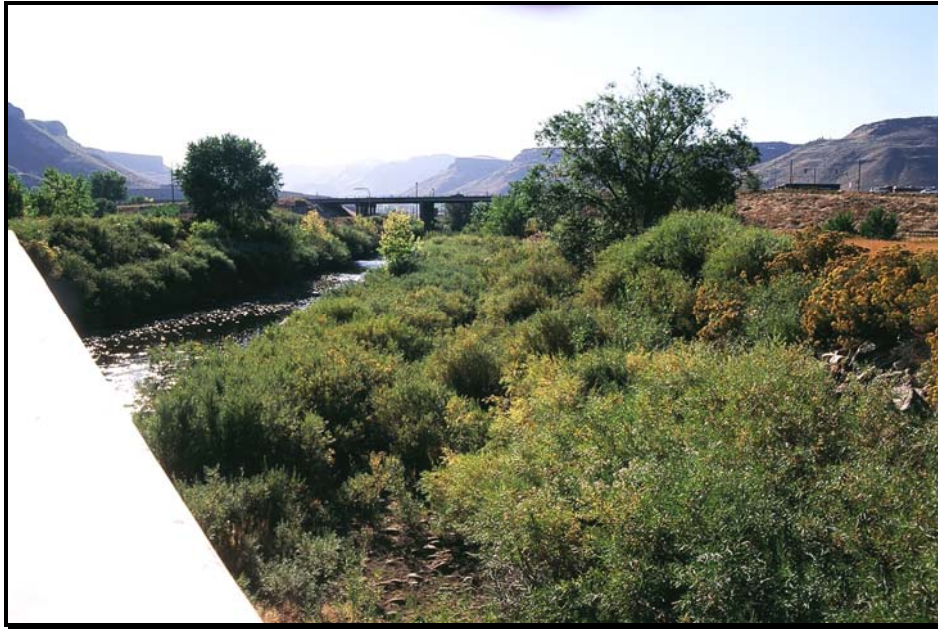
Photo 9. Wetland B-1, looking west on September 26, 2005. Data Plot B-1c is in the foreground on the north bank of Clear Creek. The photo was taken from the railroad bridge over Clear Creek just south of the Coors Brewing Company grain elevator. The McIntyre Street bridge over Clear Creek is in the background.

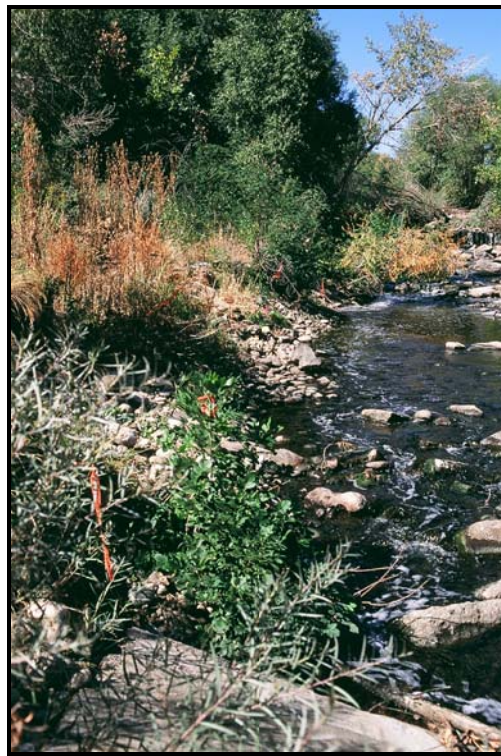
Photo 10. Wetland C-1, looking west on September 26, 2005. Data Plot C-1a is in the center of the photo on the south bank of Clear Creek.

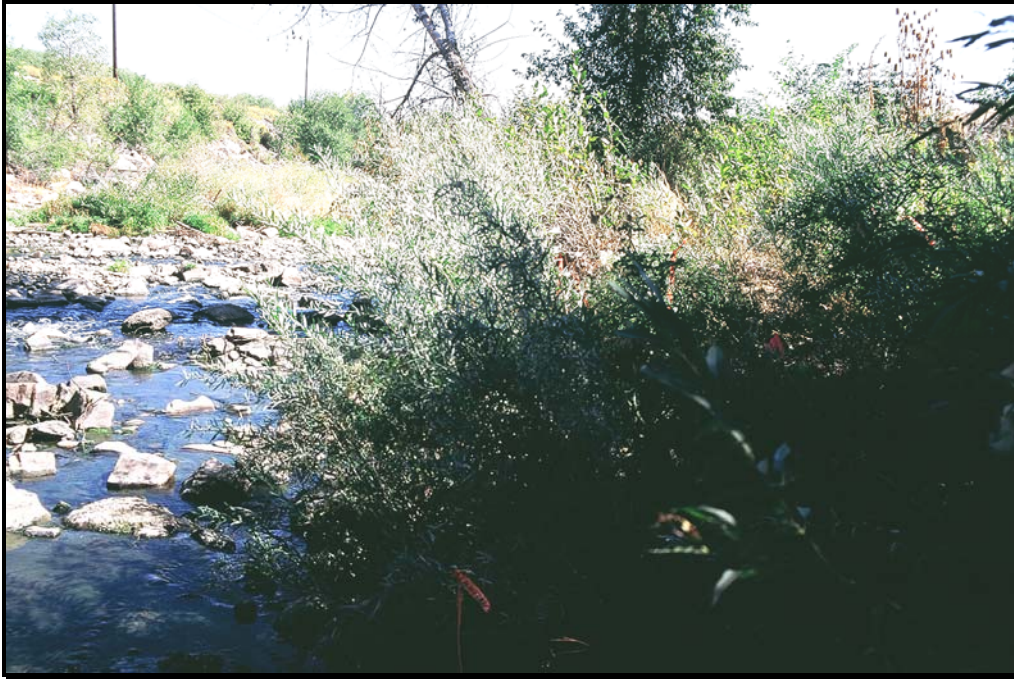
Photo 11. Wetland C-2, looking east on September 26, 2005. Data Plot C-2a is in the foreground on the south bank of Clear Creek.

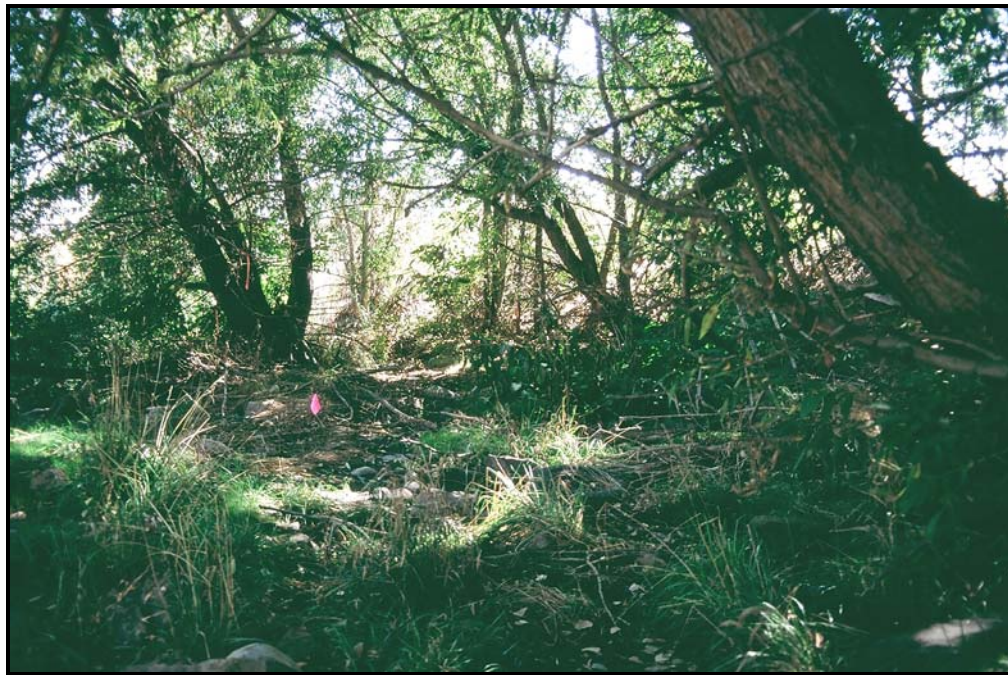
Photo 12. Wetland C-3, Data Plot C-3a, looking southeast on September 26, 2005. Wetland is within a forested floodplain area on the south bank of Clear Creek.

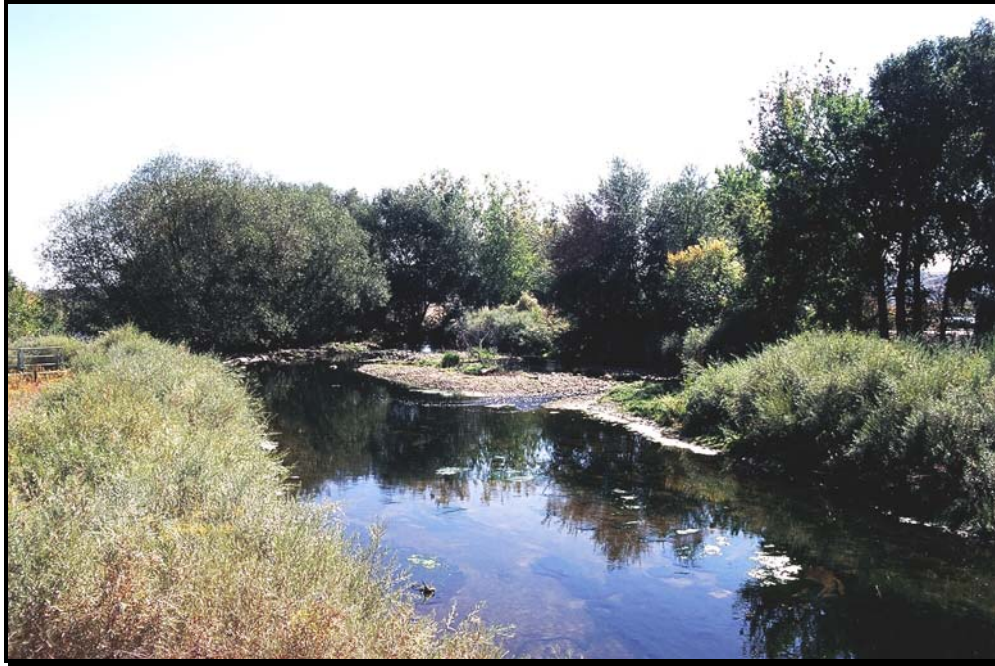
Photo 13. Clear Creek looking east on September 26, 2005. Wetland C-4 is on the right side of the photo (south bank) and Wetland C-5 is on the left side (north bank) of the photo. Wetland C-3 is the forested area in center background.

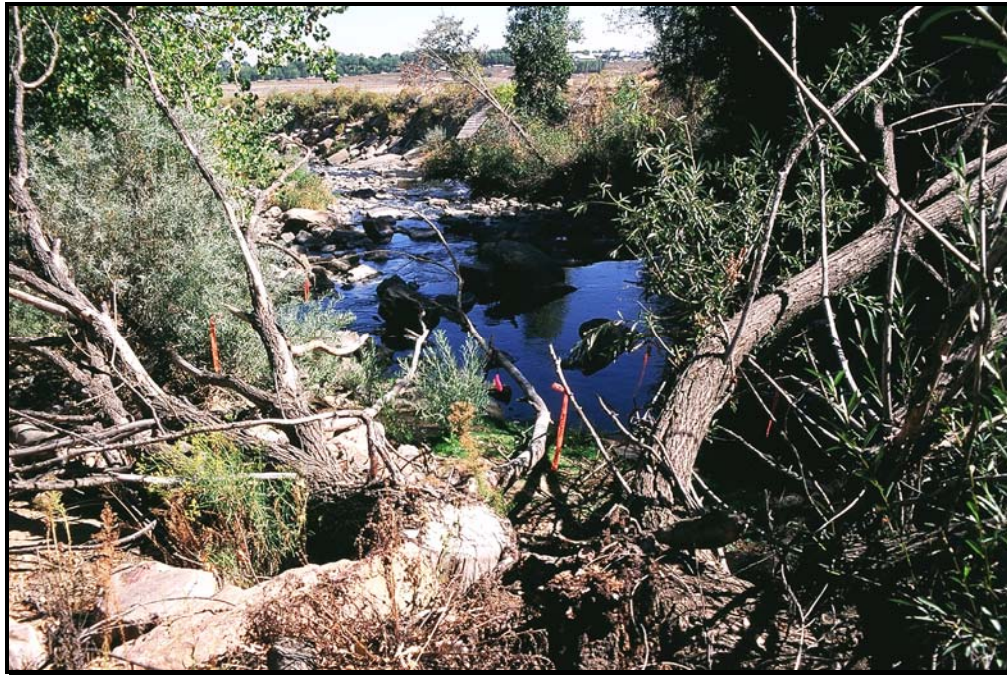
Photo 14. Wetland C-6, Data Plot C-6a, looking east on September 26, 2005. Wetland C-6 is on the north bank of Clear Creek in photo center. Wetlands C-1 and C-2 are in the background along the south bank of Clear Creek. Wetland C-3 is on the south bank of Clear Creek at the extreme right of the photo.

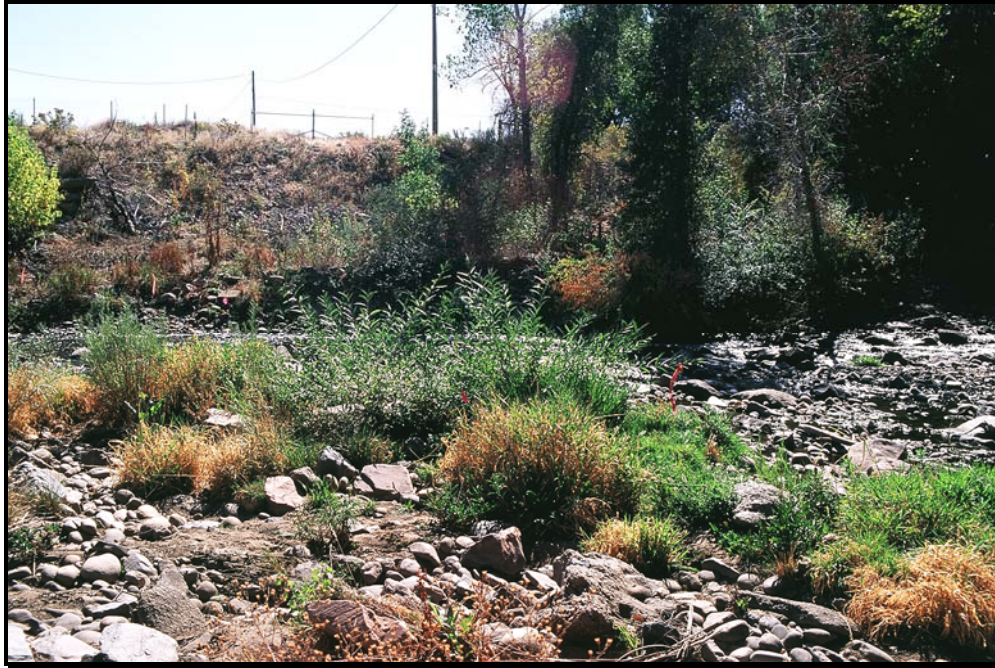
Photo 15. Wetland C-7, Data Plot C-7a, looking south from the north bank of Clear Creek on September 26, 2005. Wetland C-2 is shown in the background on the south bank of Clear Creek.

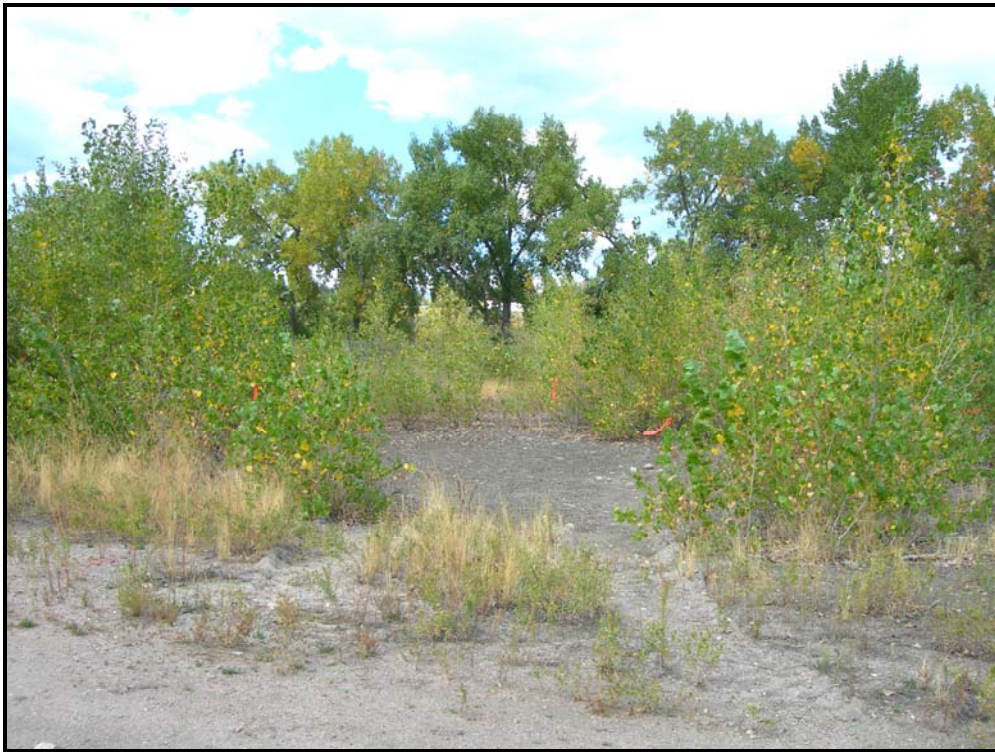
Photo 16. Wetland D-1, Data Plot D-1a, looking north on September 27, 2005. Isolated depression.

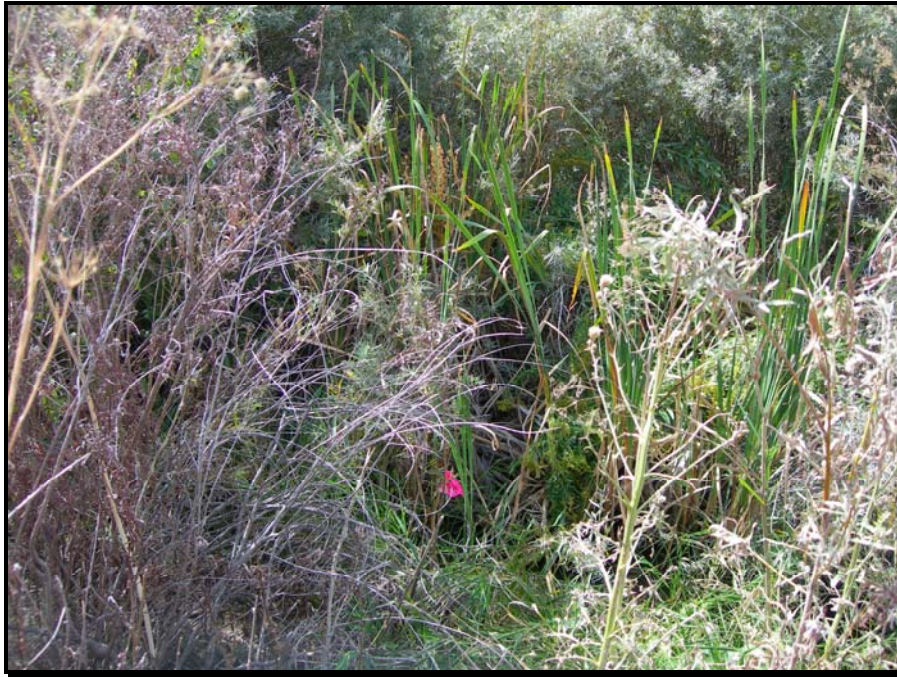
Photo 17. Wetland E-1, Data Plot E-1a, looking west on September 27, 2005. The wetland connected two drainage pipes carrying water from roadside drainage ditches associated with State Highway 58 and its frontage road to the Juchem Ditch.

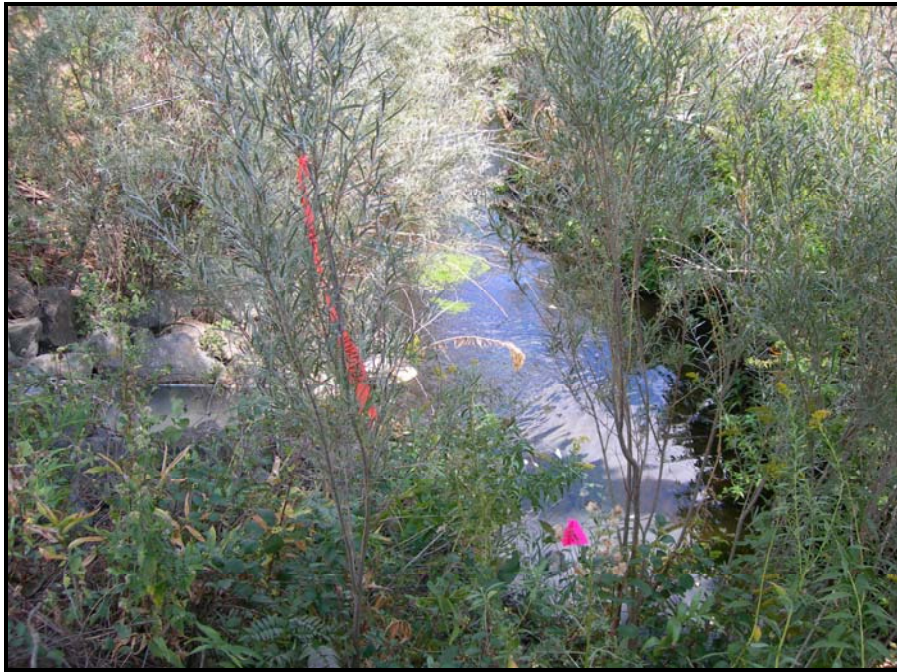
Photo 18. Wetland E-2, Data Plot E-2a, looking northeast on September 27, 2005. The wetland was associated with the outflow from a small culvert carrying water from roadside drainage ditches associated with State Highway 58 and its frontage road into the Juchem Ditch, an irrigation ditch originating at Clear Creek and flowing north. A segment of the Juchem Ditch (shown flowing from bottom to top of photo) was included in the wetland.

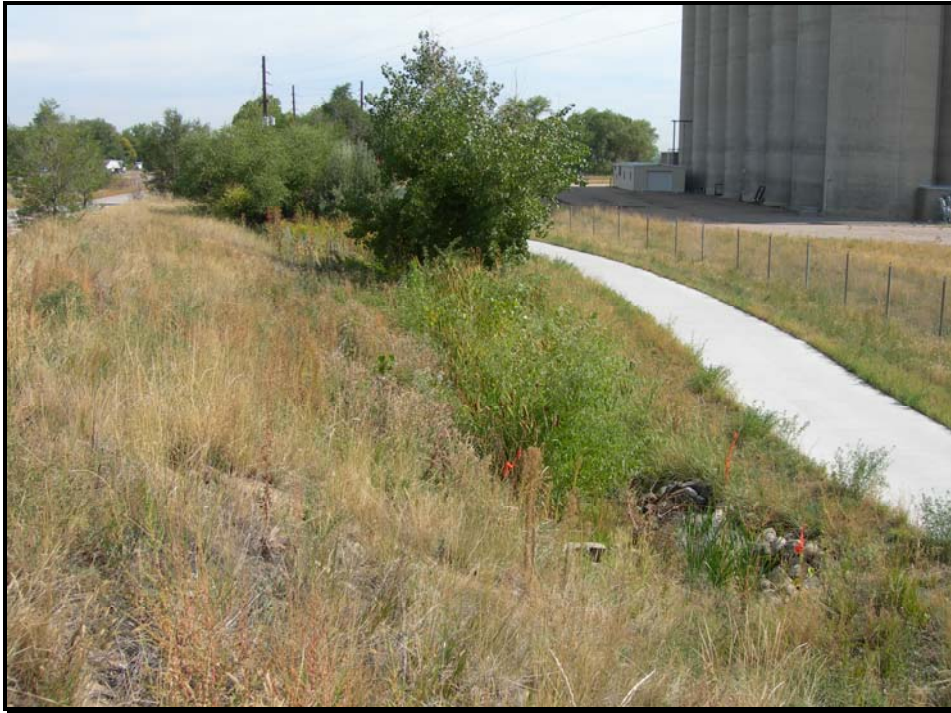
Photo 19. Wetland F-1, Data Plot F-1a, looking east on September 29, 2005. The Coors Brewing Company grain elevators are in the right background.

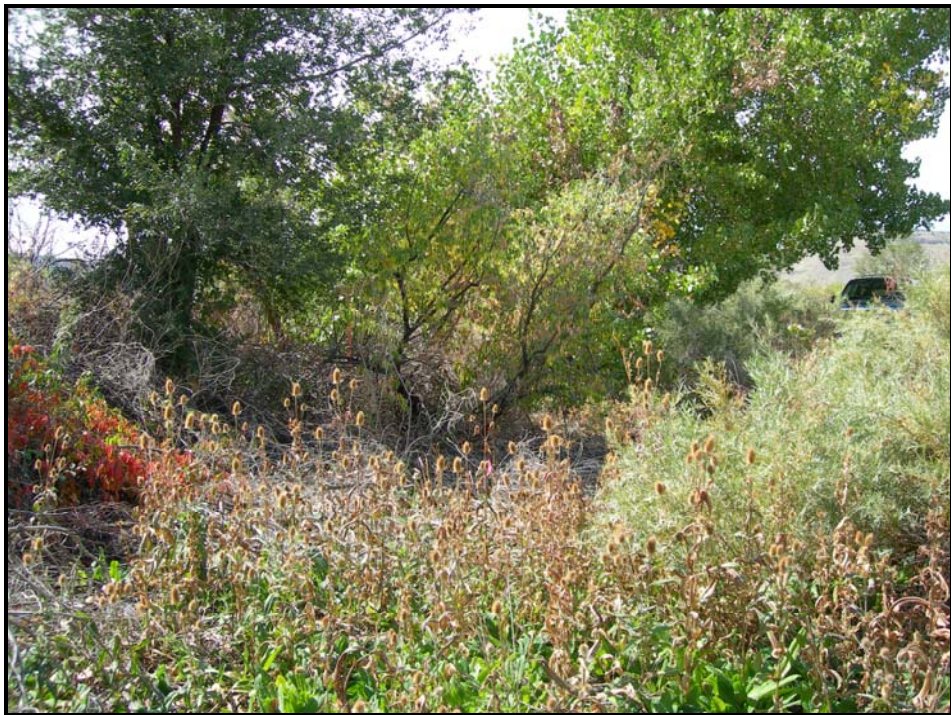
Photo 20. Wetland G-1, Data Plot G-1a, looking north from the Jefferson County Pedestrian Trail on September 29, 2005.

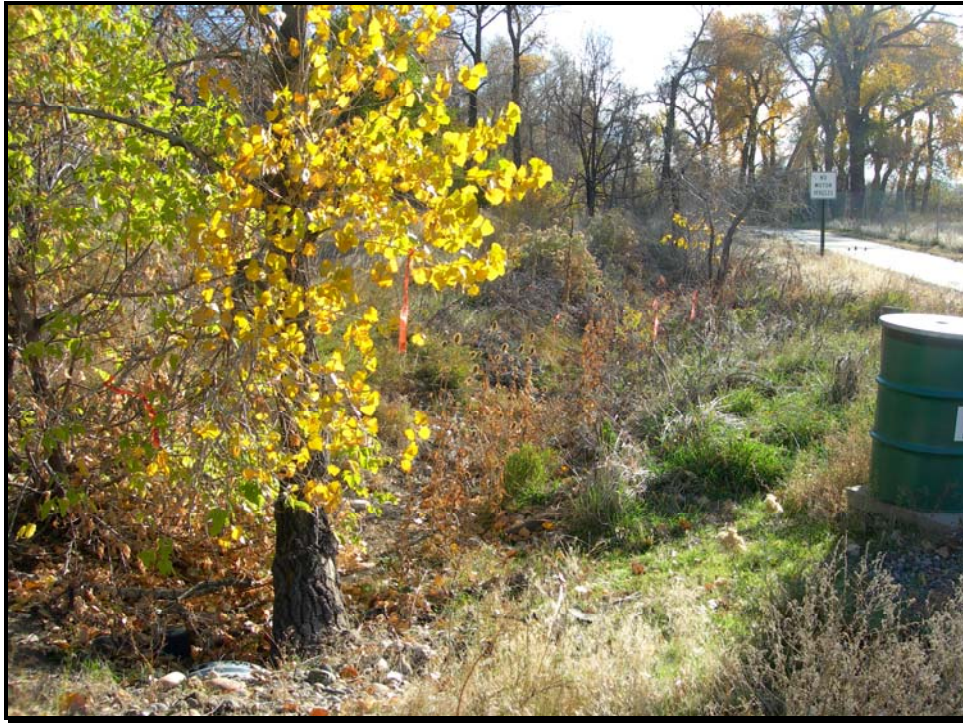
Photo 21. Wetland H-1, Data Plot H-1a, looking east on September 29, 2005. The Jefferson County Pedestrian Trail is at upper right.

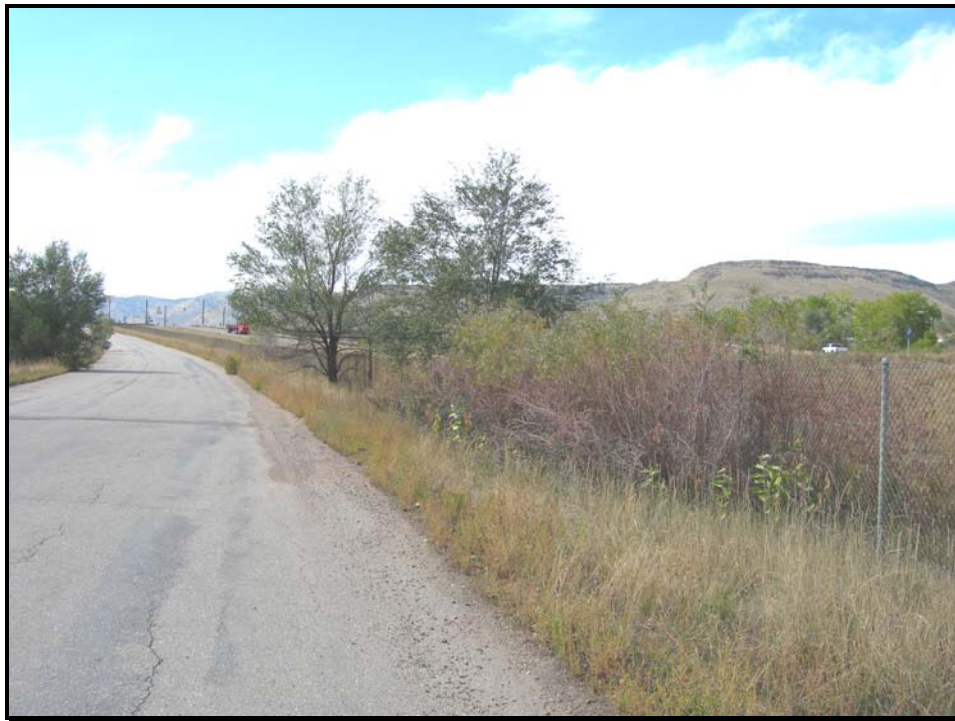
Photo 22. Wetland I-1, Data Plot I-1a, looking west on September 29, 2005. The SH 58 frontage road is on the left and SH 58 is on the right.

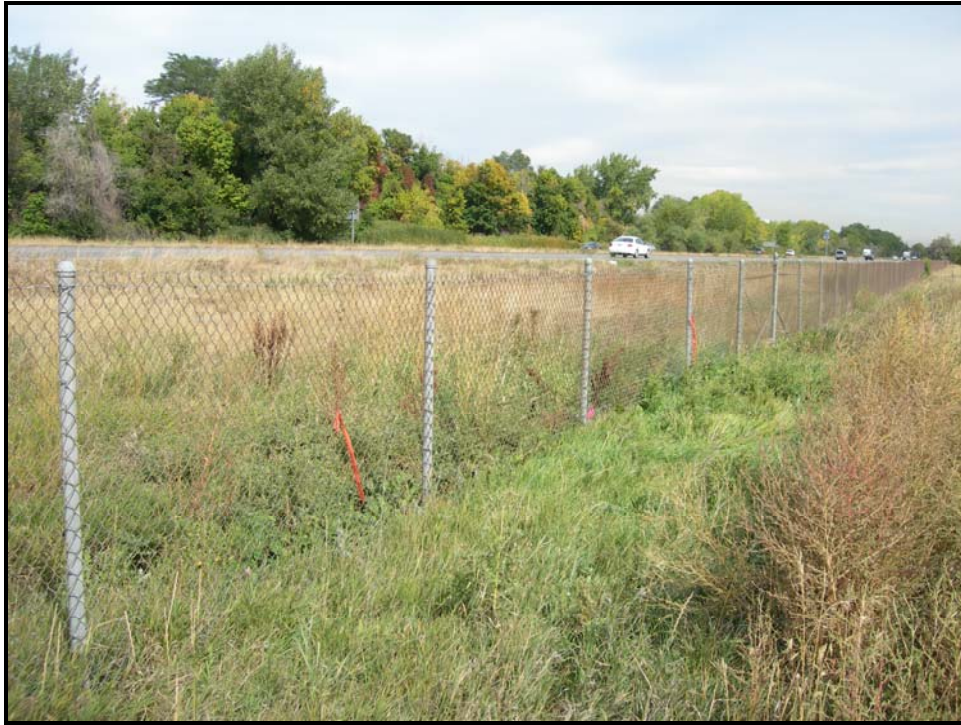
Photo 23. Wetland I-2, Data Plot I-2a, looking northeast on September 29, 2005. SH 58 is at the top of the photo.

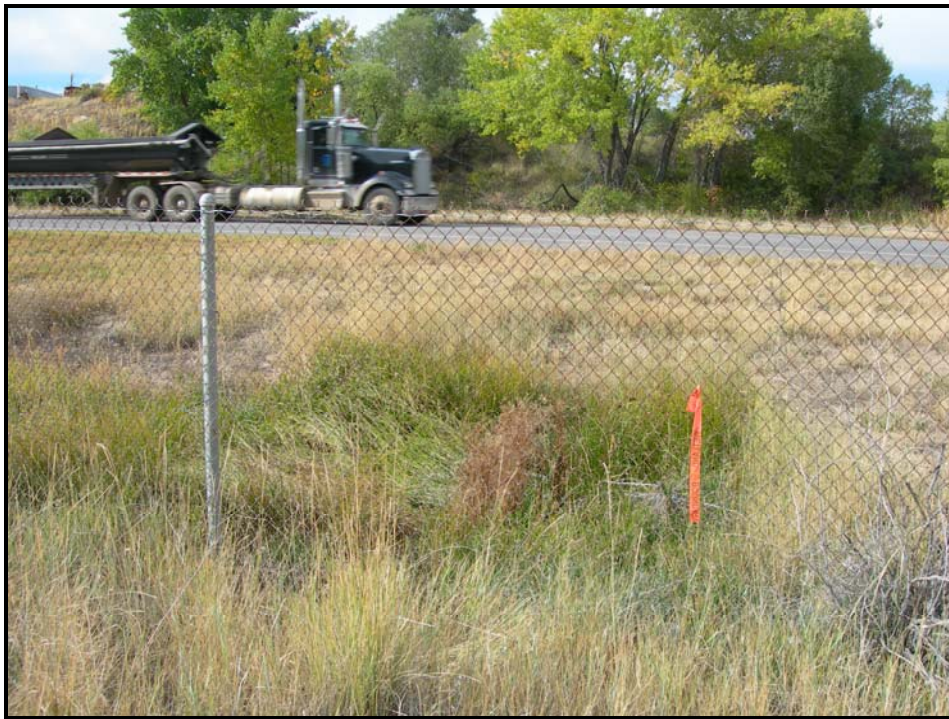
Photo 24. Wetland I-3, Data Plot I-3a, looking north on September 30, 2005. SH 58 is at the top of the photo.

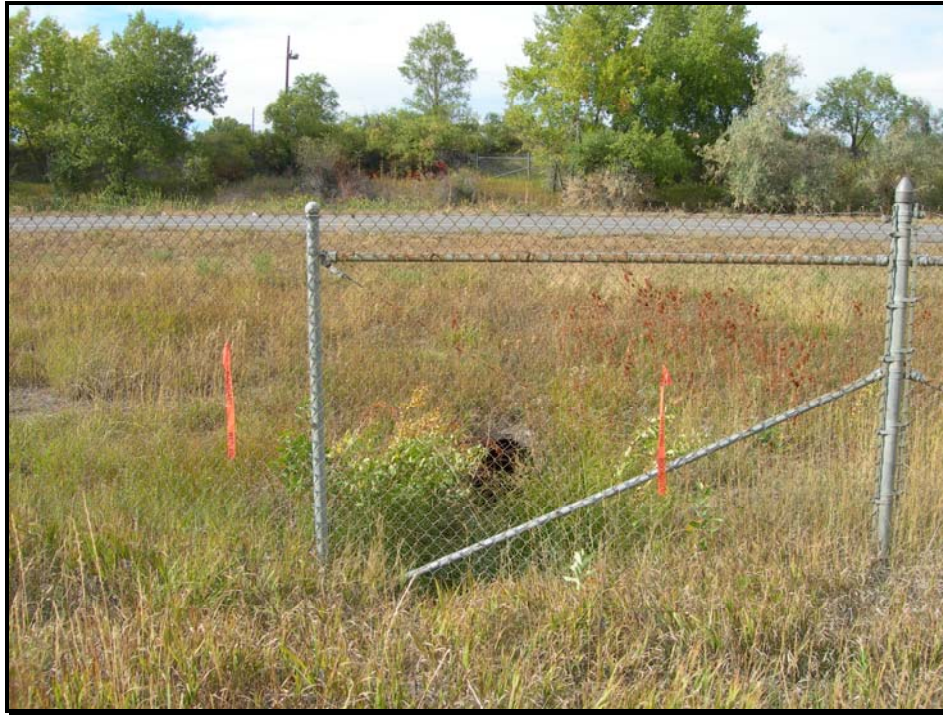
Photo 25. Wetland I-4, Data Plot I-4a, looking north on September 29, 2005. SH 58 is at the top of the photo.

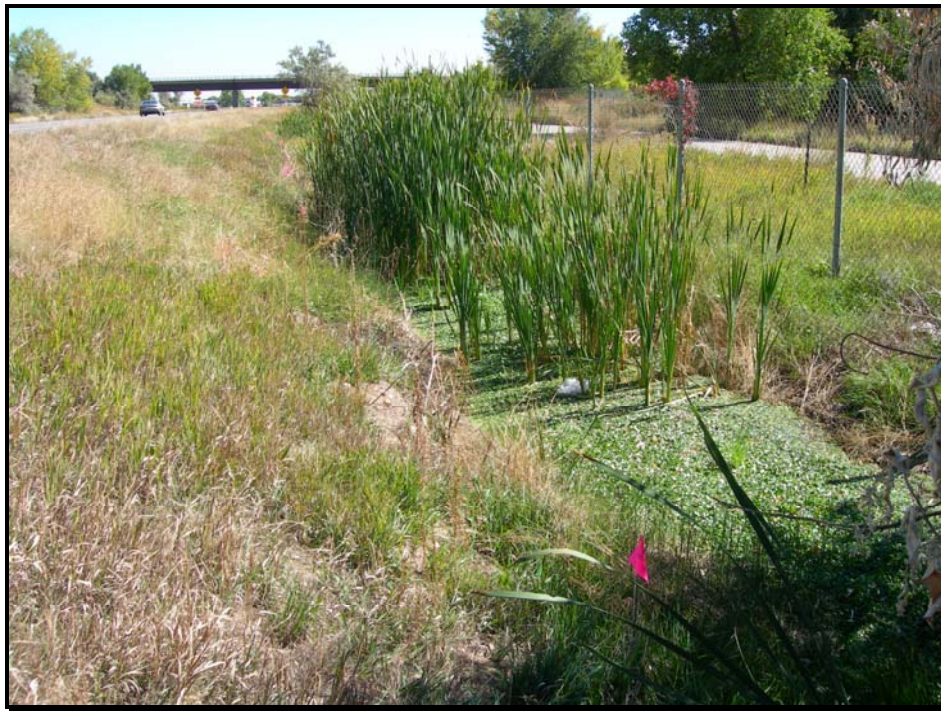
Photo 26. Wetland I-5, Data Plot I-5a, looking east on September 30, 2005. SH 58 is at the top left of the photo. The SH 58 frontage road is at the top right of the photo. The railroad overpass over SH 58 is evident in the distance at the top of the photo.

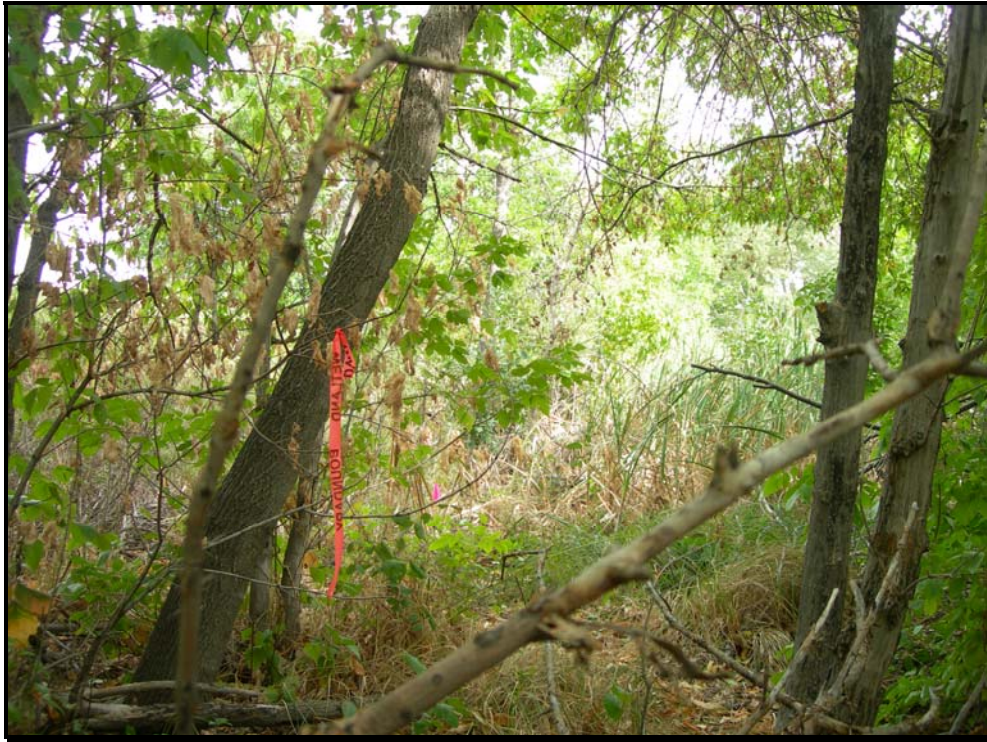
Photo 27. Wetland J-1, Data Plot J-1a, looking east on September 29, 2005.

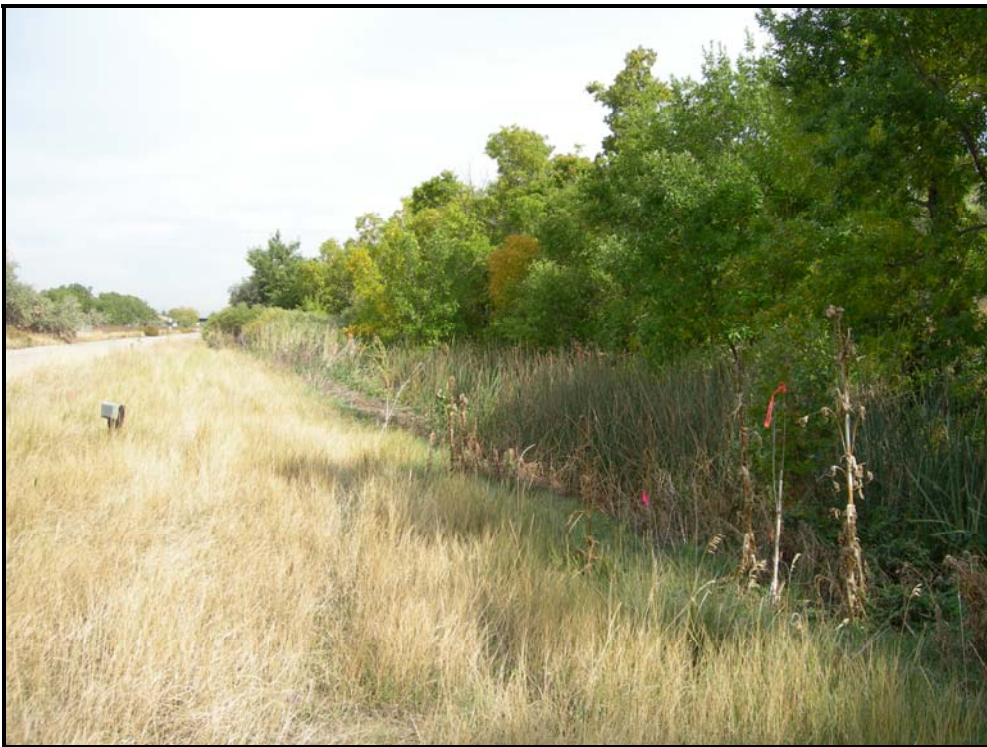
Photo 28. Wetland J-1, Data Plot J-1b, looking east on September 29, 2005. The SH 58 frontage road is evident at the upper left.

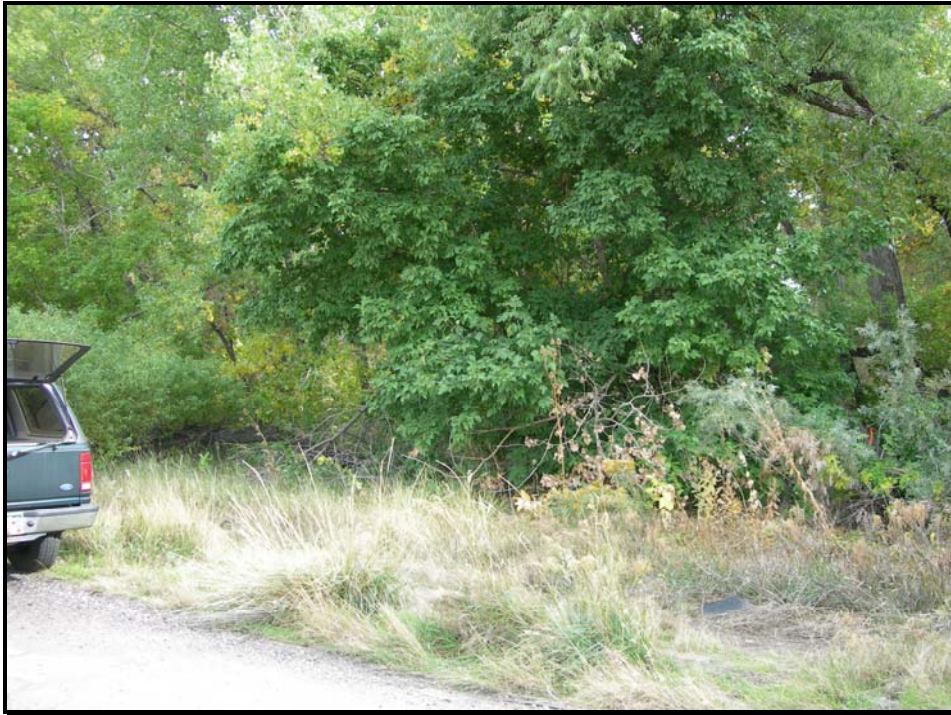
Photo 29. Wetland J-2, Data Plot J-2a, looking southeast on September 29, 2005 from the SH 58 frontage road.

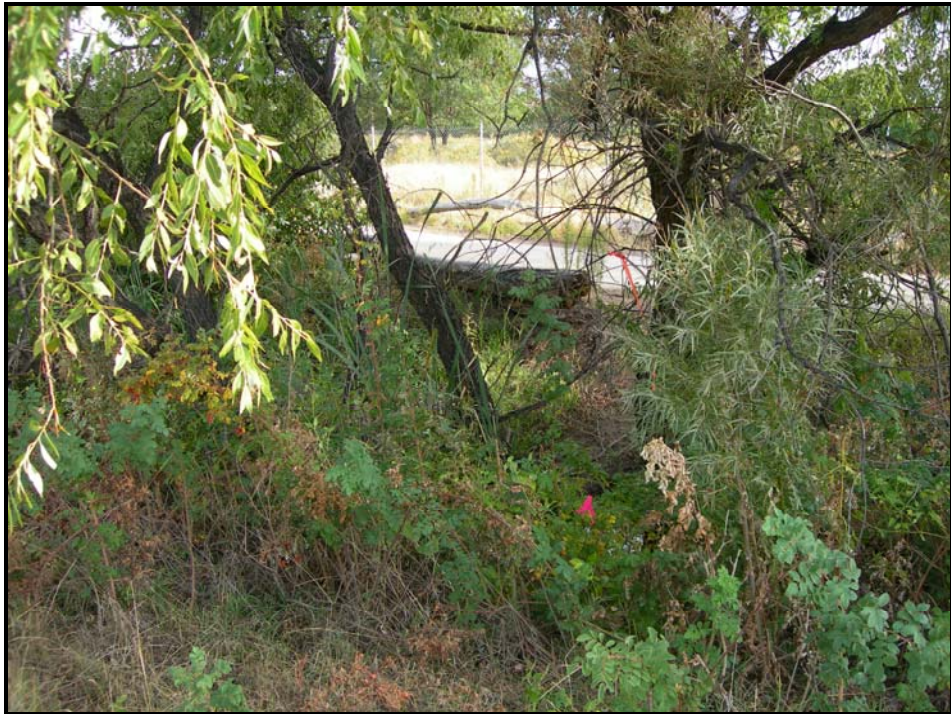
Photo 30. Wetland J-3, Data Plot J-3a, looking south on September 29, 2005 from the SH 58 frontage road. The Jefferson County Pedestrian Trail is visible in the background.

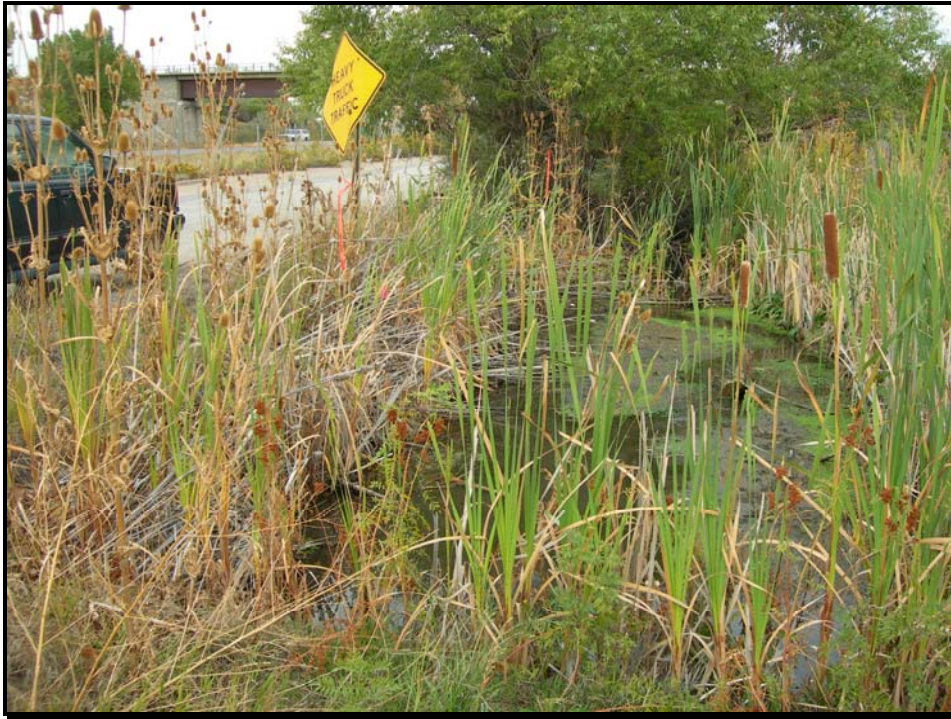
Photo 31. Wetland J-4, Data Plot J-4a, looking northeast on September 29, 2005. The SH 58 frontage road and the railroad overpass over SH 58 are visible in the background.

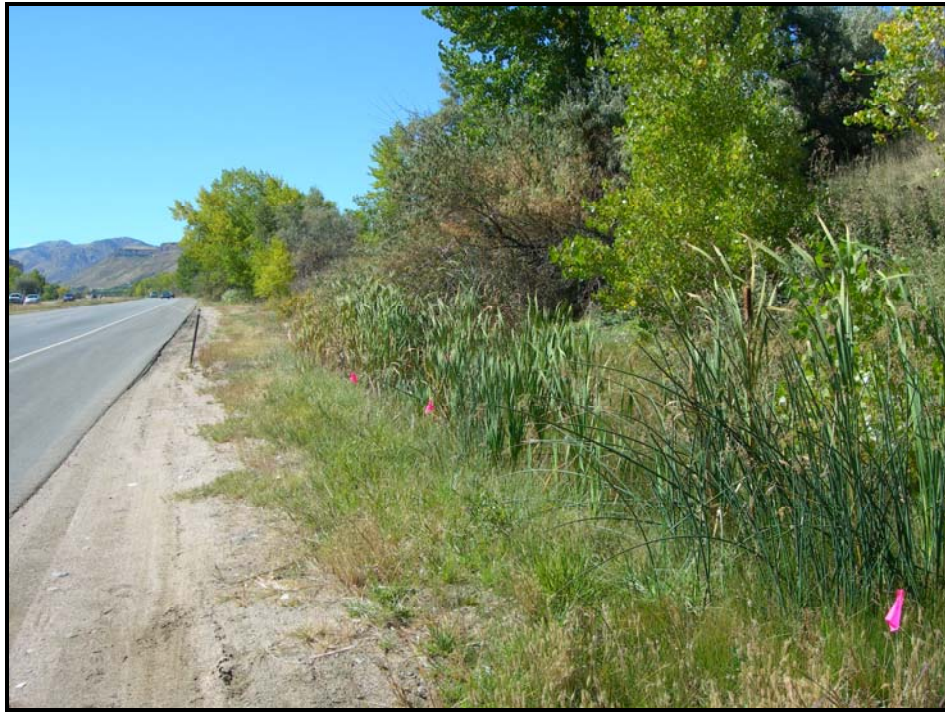
Photo 32. Wetland K-1, Data Point K-1a, looking west on September 30, 2005. SH 58 is shown at the left of the photo.
