APPENDIX B

I-70/32nd Avenue Interchange Project Wetland Photos

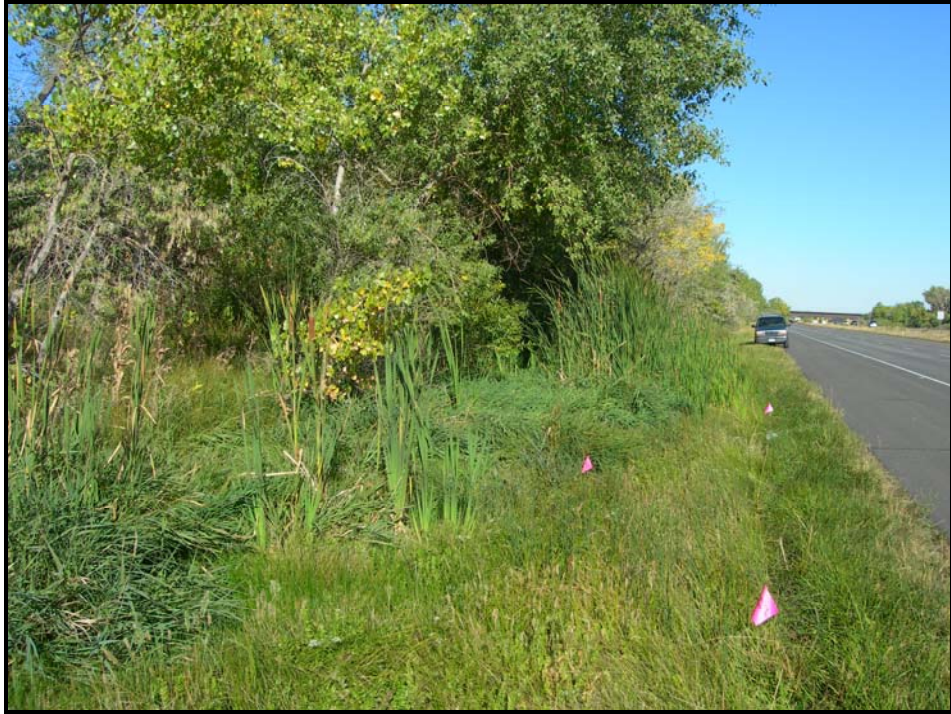
Photo 33. Wetland K-2, Data Plot K-2b, looking east on September 30, 2005. SH 58 is visible at right.

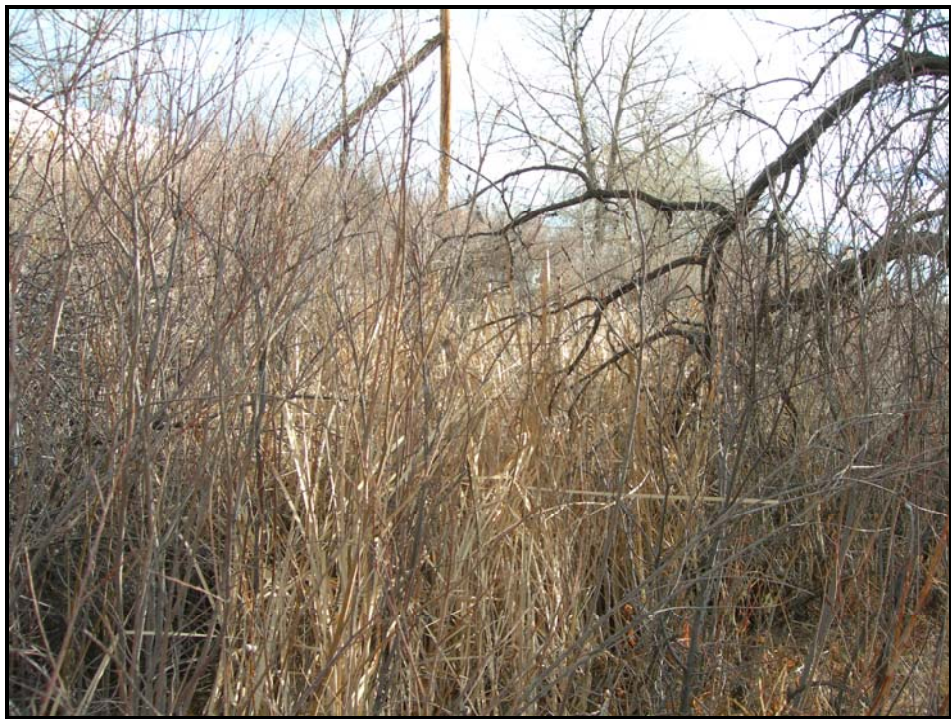
Photo 34. Wetland K-3, Data Point K-3a, looking east on January 14, 2006.

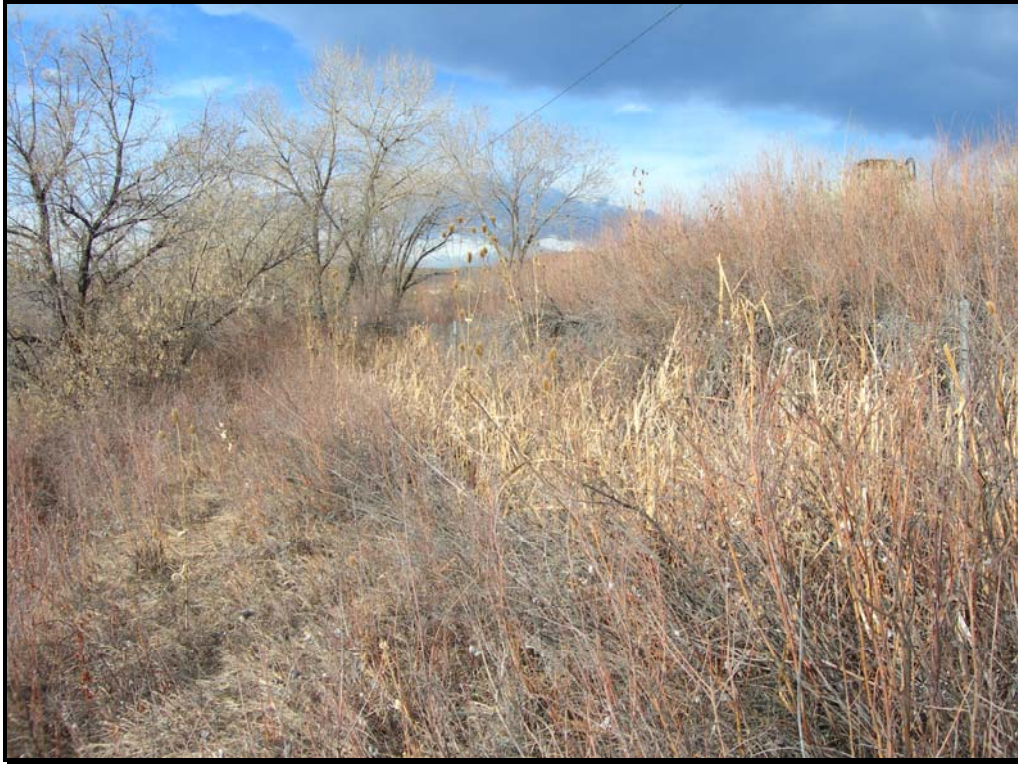
Photo 35. Wetland K-4, Data Point K-4a, looking west on January 14, 2006.

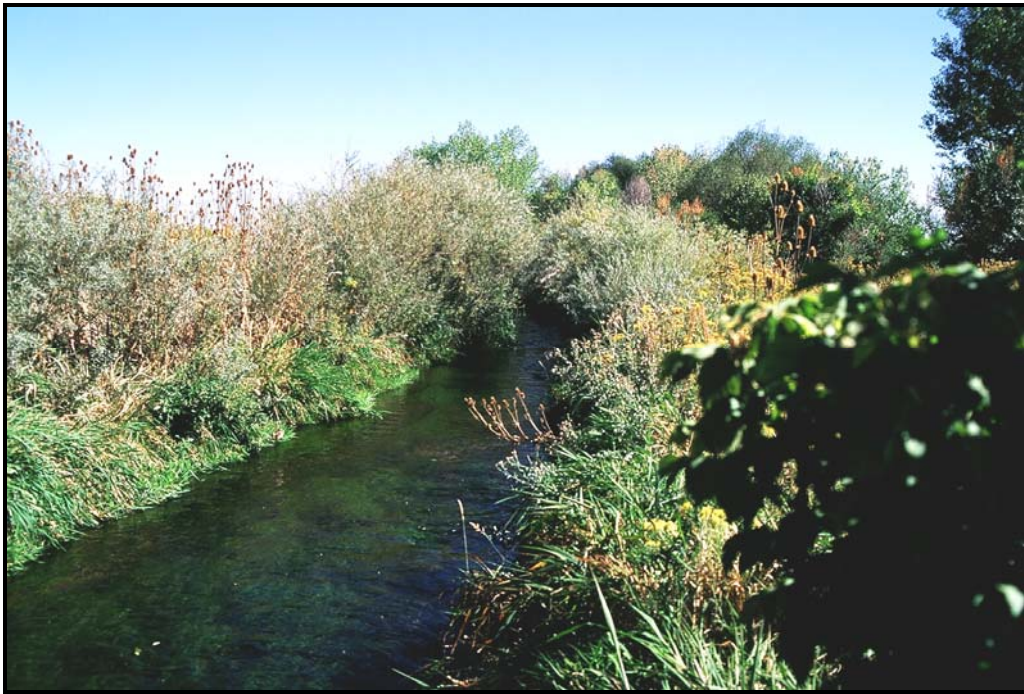
Photo 36. Wetland L-1, Data Point L-1a, looking east along the Bayou (Bayau) Ditch on September 26, 2005.

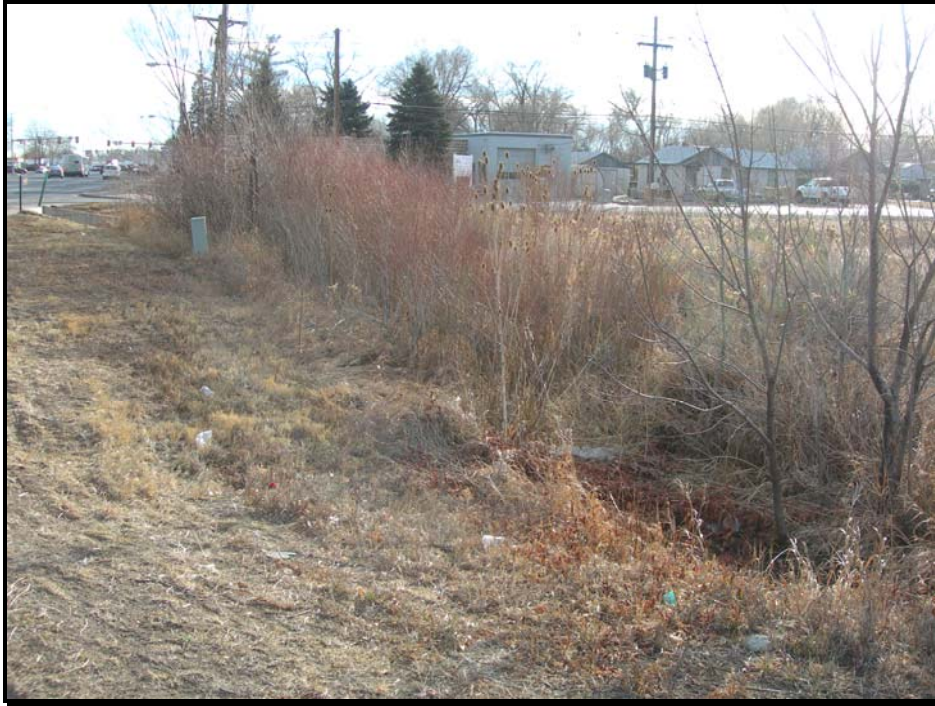
Photo 37. Wetland M-1, Data Plot M-1a, looking east from the Youngfield Street/44th Avenue intersection on January 14, 2006.

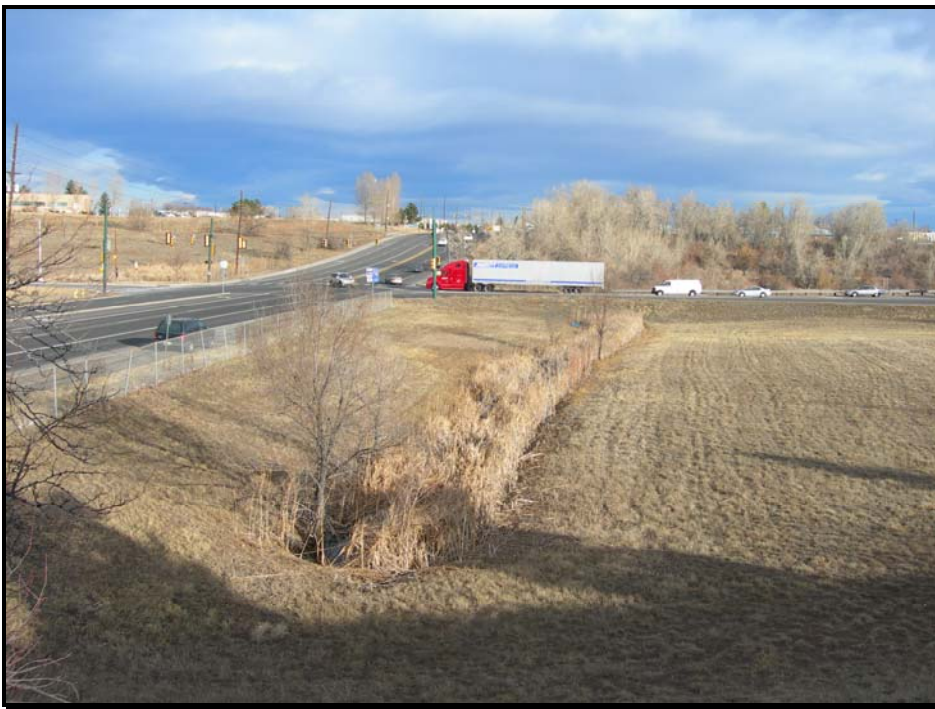
Photo 38. Wetland N-1, looking north on January 14, 2006. Data Point N-1a is at the near end of the wetland. Ward Road and the I-70 westbound off-ramp and west bound on-ramp are shown in the background.
