RE-EVALUATION, Mileposts 149 to 161

Interstate 25 Improvements through the Colorado Springs Area Environmental Assessment

WETLANDS AND WATERS OF THE U.S. TECHNICAL MEMO March 2012

Prepared for:
CDOT Region 2

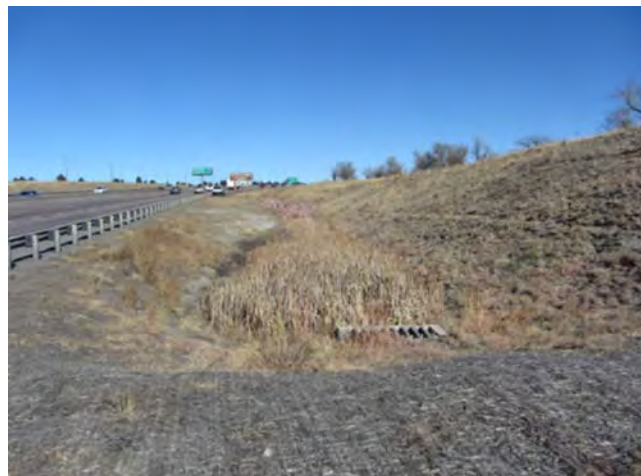
FIGURE 2. New Wetland on the Eastern Side of I-25, South of Exit 150

One new wetland area was found (New WQ Pond) located immediately north of Woodmen Road on the east side of northbound I-25. This resource consists of 0.11 acre that is considered non-jurisdictional. This wetland is within CDOT's easement from USAFA south of Exit 150 (North Academy Boulevard), on the eastern side of I-25. See Figure 2. This wetland will not be impacted by the Proposed Action.

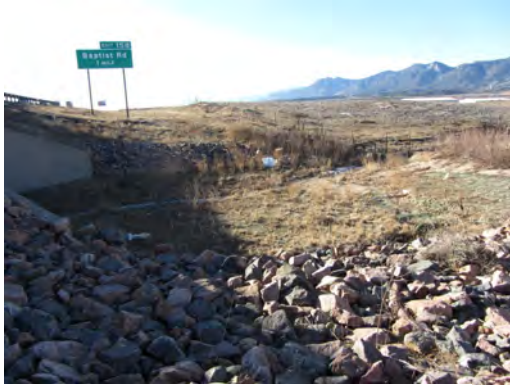
Photo #1: B -Teachout Creek (West I-25)

Photo's 1-3 illustrate perennial waterways with predominantly sandbar willow (*Salix exigua*) surrounded by upland grasses, forbs, and shrubs.

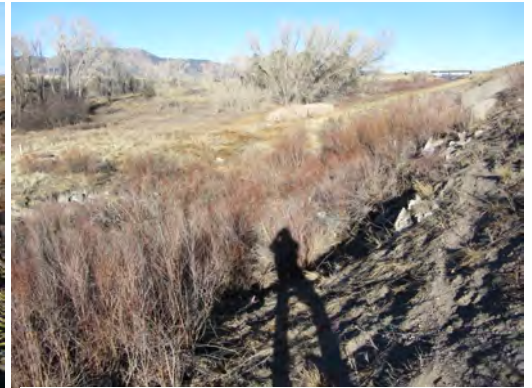
Photo #4: D -Jackson Creek (West I-25)

Photo's 4-7 illustrate the Jackson Creek waterway that crosses Baptist Road and contains sandbar willow, common cattail (*Typha latifolia*), plains cottonwood (*Populus deltoides*), and peach-leaf willow (*Salix amygdaloides*).

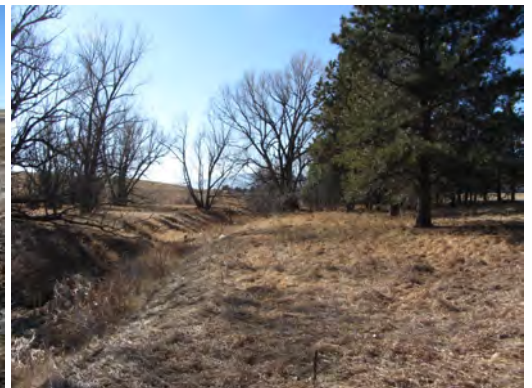
Photo #8: J -Smith Creek (East I-25)

Photo 8 illustrates the Smith Creek waterway that crosses Northgate and contains sandbar willow and common cattail.

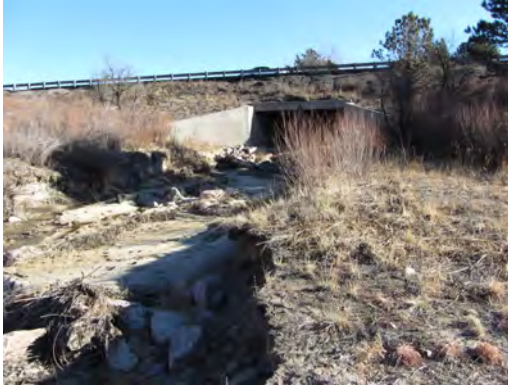
Photo #9: K -Monument Branch (West I-25)

Photo 9 illustrates the Monument Branch of Smith Creek that is a perennial waterway with predominantly sandbar willow, common cattail, plains cottonwood, and peach-leaf willow.

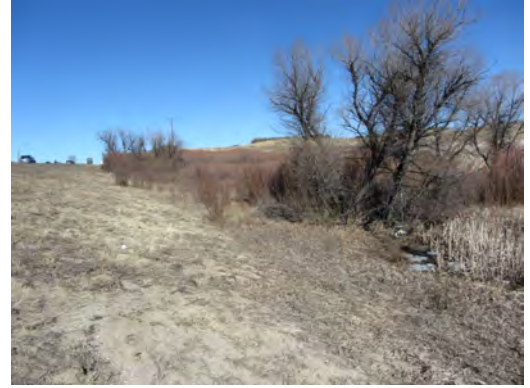
Photo #10: U AA Monument Creek (East I-25)

Photo 10 is of Monument Creek which is a large complex of wetland on either side of northbound I-25. Vegetation here is predominantly sandbar willow, common cattail, *Juncus sp.*, and peach-leaf willow.

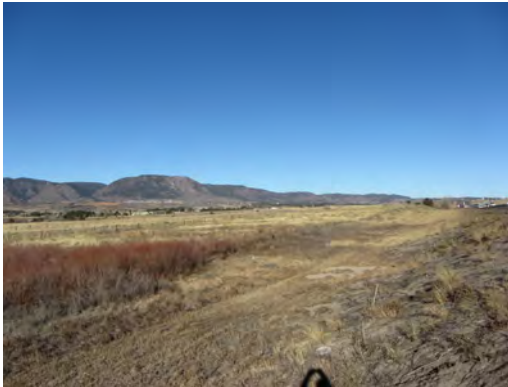
Photo #11: F Drainage (West I-25)

Photo's 11 and 12 are views of small drainages which are dominated by sandbar willow with smaller areas of common cattail.

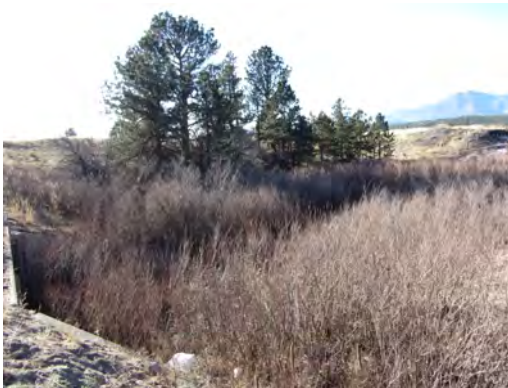
Photo #13: H -Black Forest Creek (West I-25)

Photo's 13 and 14 illustrate the difference in conditions in wetland areas on either side of I-25 at Black Forest Creek. Vegetation is a mix of sandbar willow, common cattail, peach-leaf willow and *Juncus*. The west ROW contains ponderosa pine (*Pinus ponderosa*) also in more upland areas.

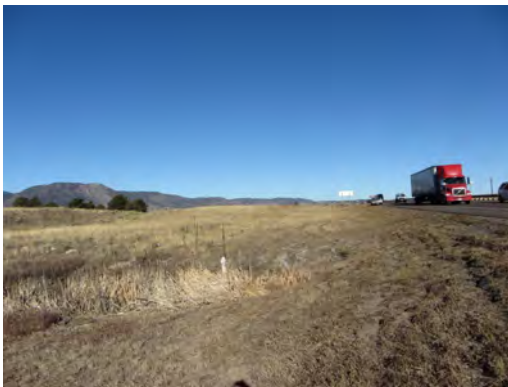
Photo #15: Ha -Pipe (West I-25)

Photo 15 is a pipe drainage that feeds Black Forest Creek with sandbar willow. Wetland areas on the west side of I-25 at L- No Name Creek (Photo 16) is a taller mix of sandbar willow and common cattail surrounded by upland deciduous trees and ponderosa pine.

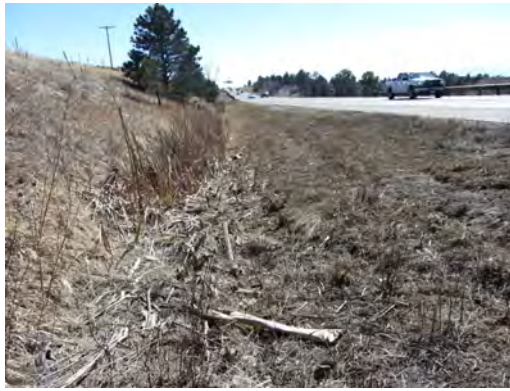
Photo #17: W Roadside Swale (East I-25)

Photo 17 illustrates a roadside drainage ditch wetland. Photo 18 illustrates the drainage area wetlands at No Name Creek that contain sandbar willow, plains cottonwood and reed canary grass (*Phalaris arundinacea*).

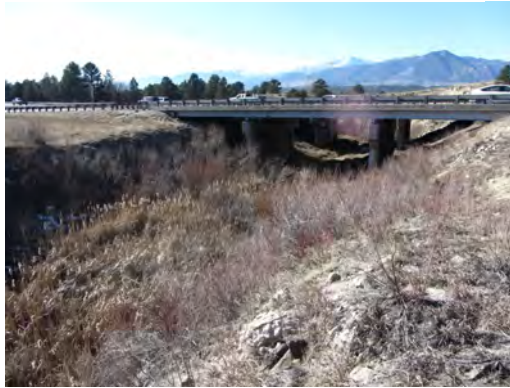
Photo #19: M Black Squirrel Cr. (East I-25)

Photo's 19 and 20 are of wetland M in the perennial Black Squirrel Creek drainage. The predominant vegetation is sandbar willow and common cattail.

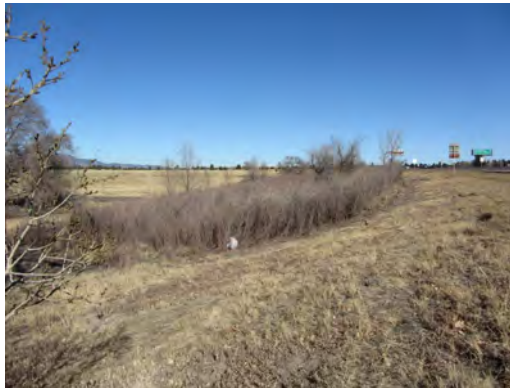
Photo #21: N Sandbar Willow (West I-25)

Photo 21 is a view of a small roadway drainage wetland dominated by sandbar willow.

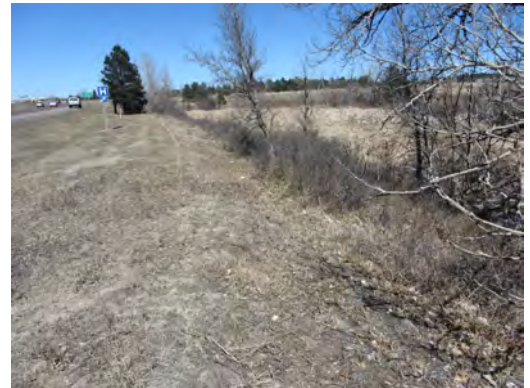
Photo #22: South Pine Creek (East I-25)

Photo 22 illustrates the wetland section of South Pine creek adjacent to I-25 in the North Academy Blvd area.

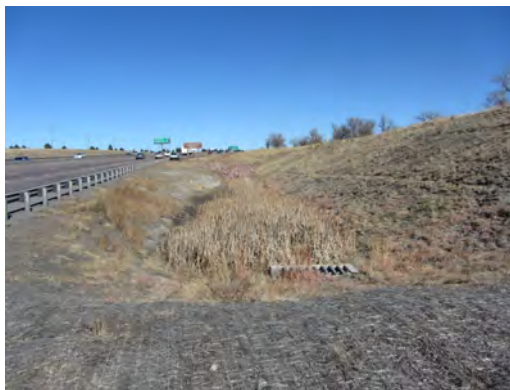
Photo #23: New WQ Pond (East I-25)

Photo 23 is a view of the new water quality stormwater pond with cattail wetland at the southern end of the project. This is a new wetland that was not present in the 2004 EA study.

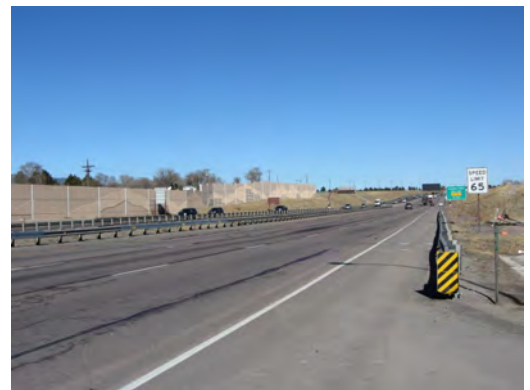
Photo #24: Former Wetlands—FF-GG

Photo 24 is a view of the area adjacent to the new soundwalls on the west side of southbound I-25. Wetlands were identified here in 2004 which are not present at this time.

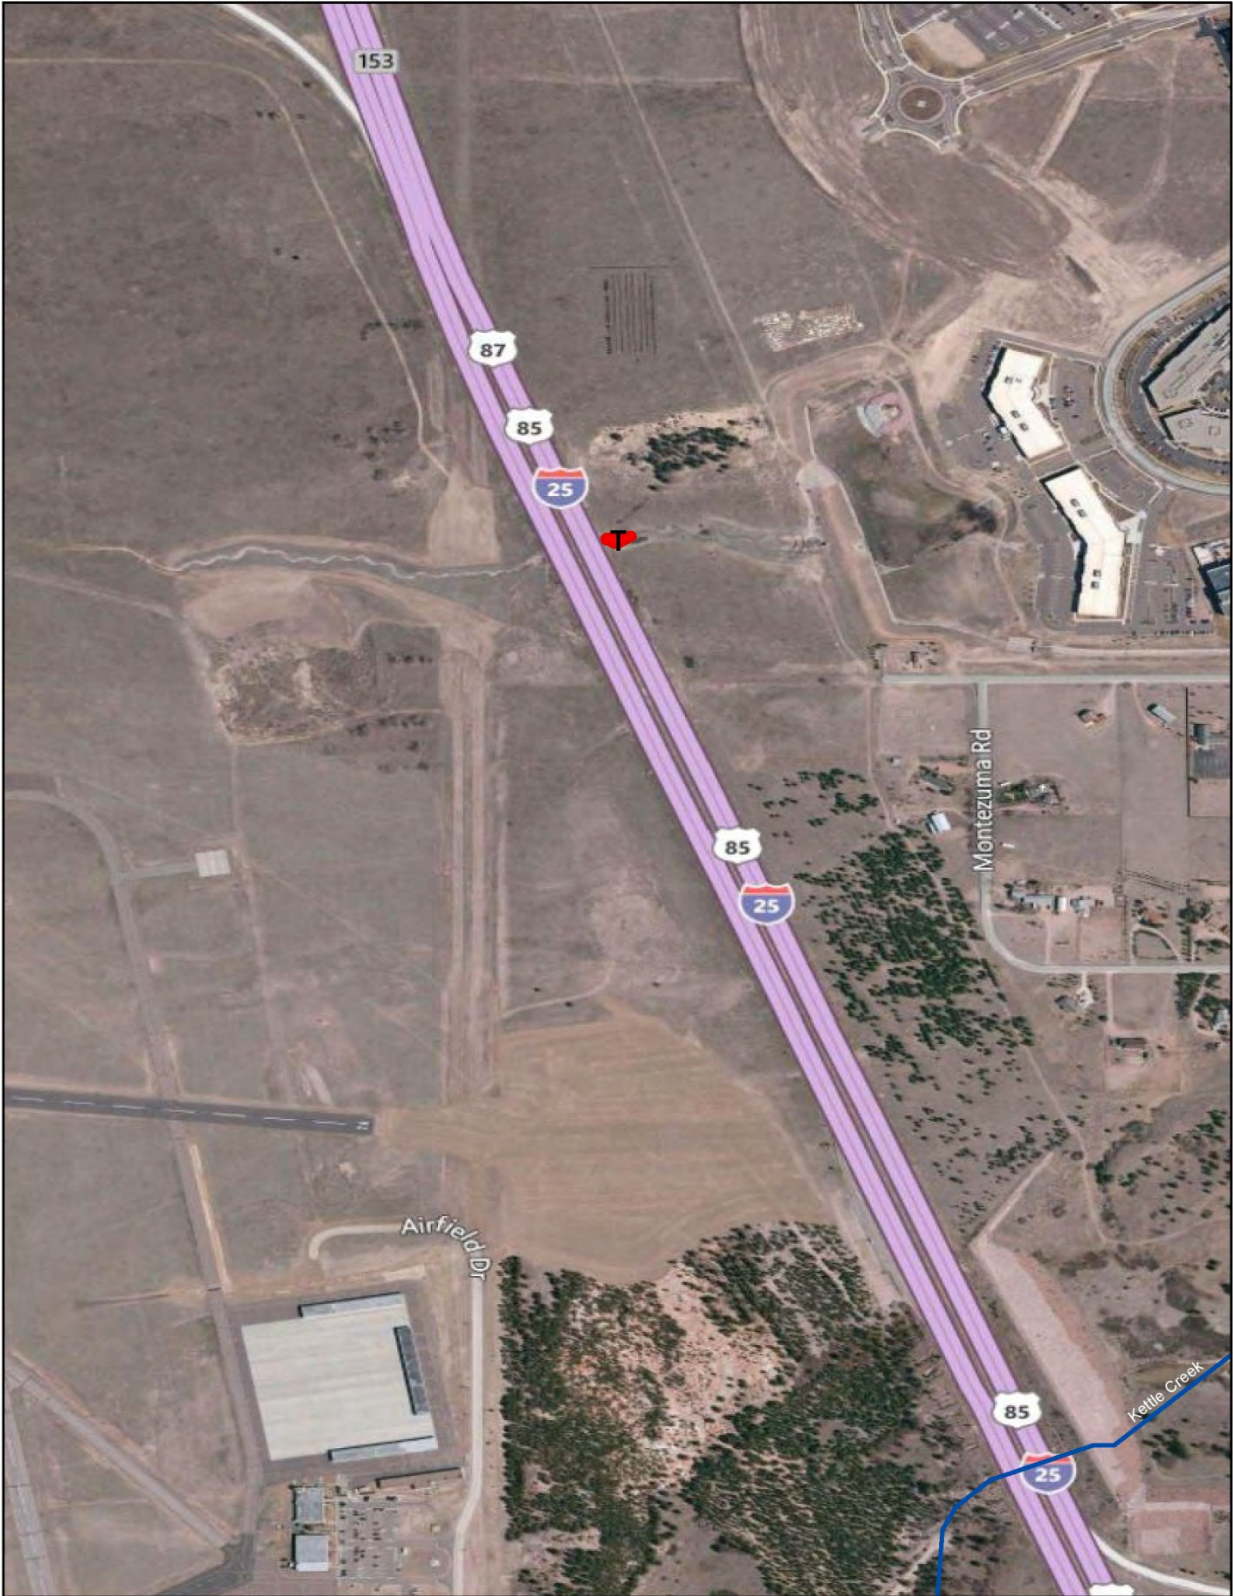
One previously identified wetland (Wetland T) was found to no longer exhibit wetland characteristics. The EA indicated that this ephemeral wetland was 0.0495 acre in size, and estimated that 0.0140 acre would be impacted by the Proposed Action.

Figure A-5. Non-wetland Area formerly Wetland T south of Interquest Parkway, I-25 Exit 153

* Area T was considered a wetland in 2004, but as of 2012 no longer has wetland characteristics. It was formerly described as 0.0495 wetland acres with 0.014 acres of non-jurisdictional impact. The wetland determination form for this non-wetland contains only vegetation information as hydric conditions were not present. No delineation form was found for the previous wetland delineation study.
