*Final
Wildlife and Wildlife Habitat –
Baseline Conditions Report*

*U.S. 24 West Corridor
El Paso County, Colorado*

SAIC Project No. 01-0203-00-8932-xxx

May 30, 2006

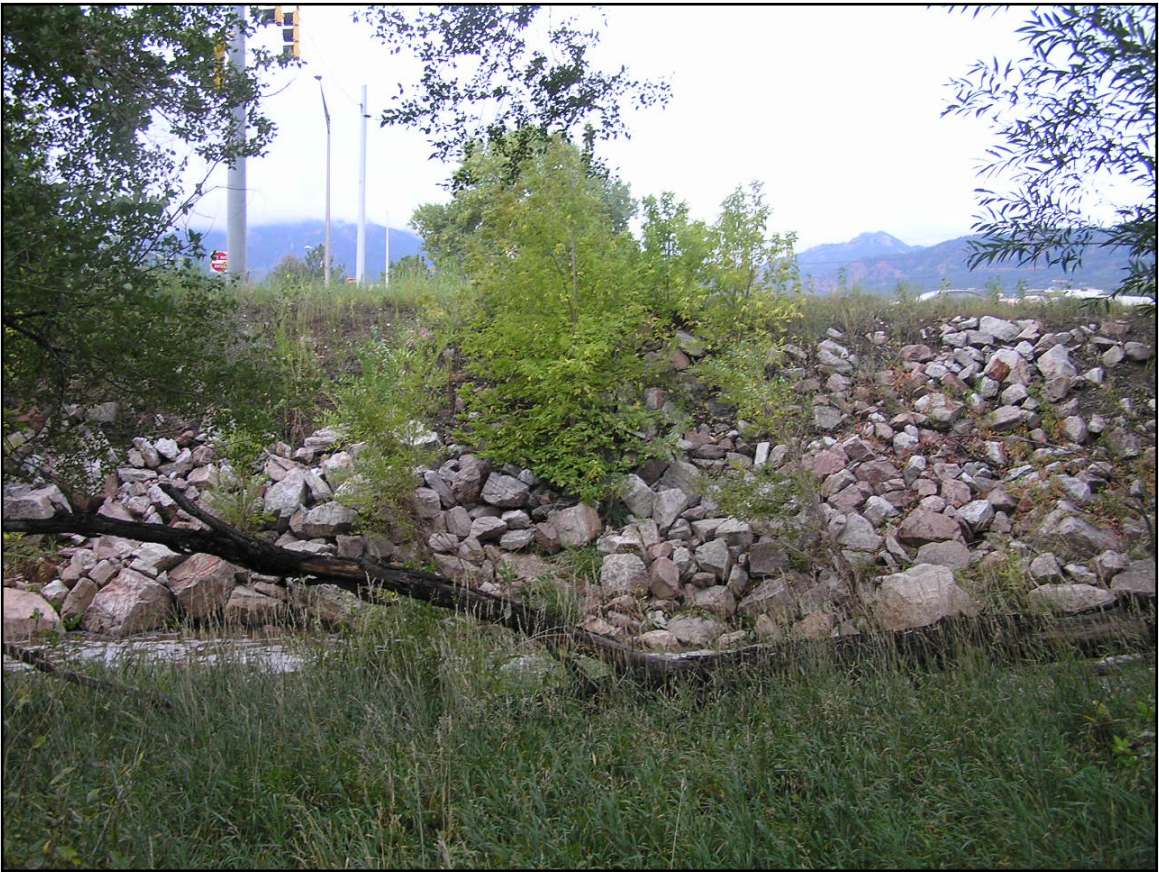
Photo 1. Boulder riprap present along the banks of Fountain Creek, Colorado Springs, Colorado.

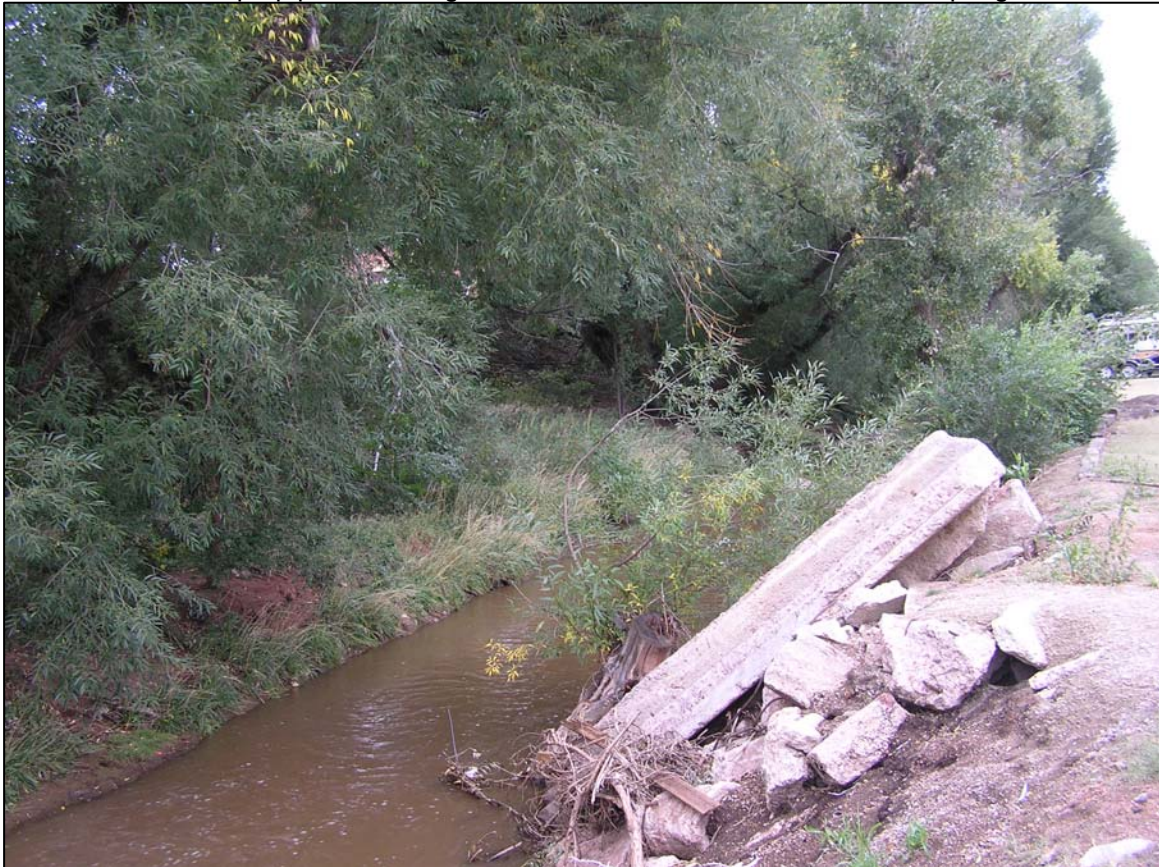
Photo 2. Concrete riprap present along the banks of Fountain Creek, Colorado Springs, Colorado.

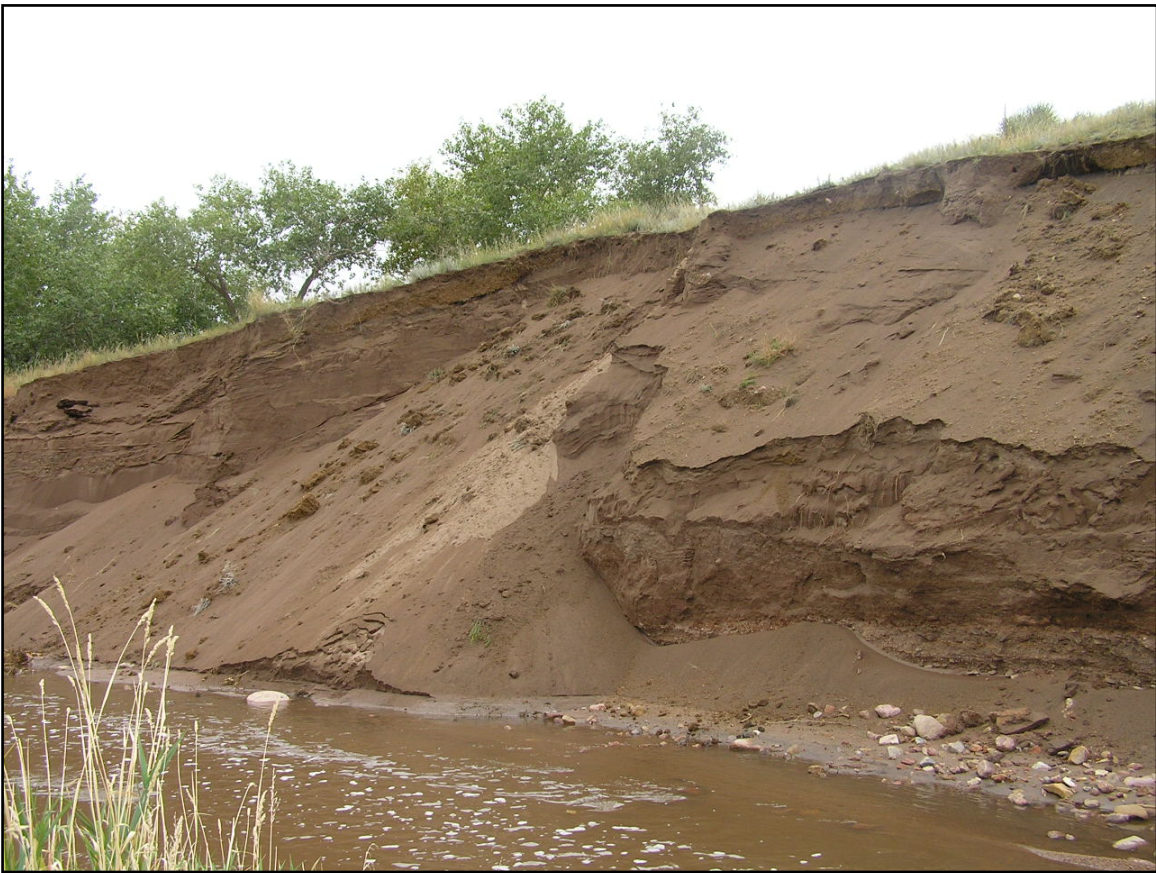
Photo 3. Bank erosion along Fountain Creek, Colorado Springs, Colorado.

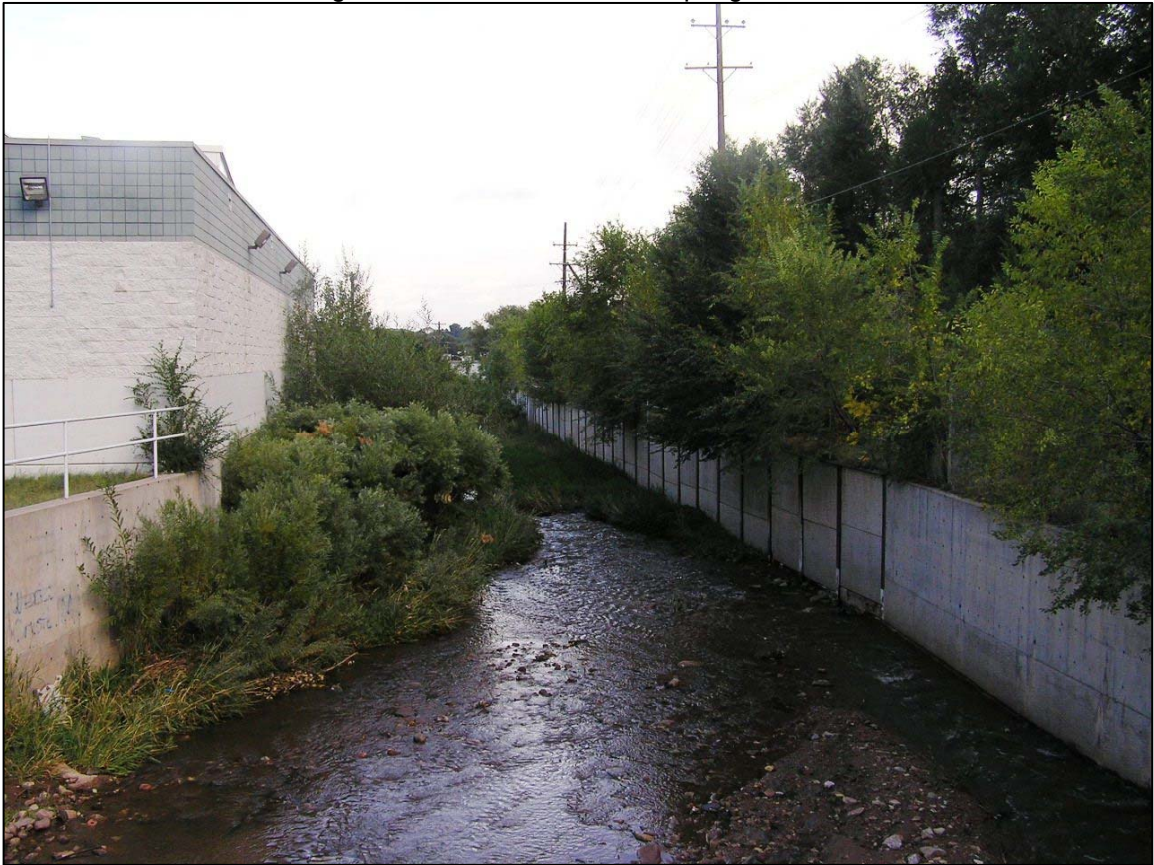
The 27-square mile Fountain Creek Watershed drains into the Arkansas River at Pueblo, Colorado and encompasses the entire study area. The watershed is bordered by the Palmer Divide to the north, Pikes Peak to the west, and a minor divide 20 miles east of Colorado Springs. For the most part, the only wildlife habitat within the study area consists of the riparian vegetation of Fountain Creek or immediately adjacent upland habitat. The banks of Fountain Creek are armored with boulder or concrete riprap along much of its length (Appendix B, Photos 1 and 2). In other areas, banks are eroded (Appendix B, Photo 3). One reach of the Fountain Creek stream channel within the study area has been restored with armored banks (Appendix B, Photo 4).

Photo 4. Armored banks present along Fountain Creek, Colorado Springs, Colorado.

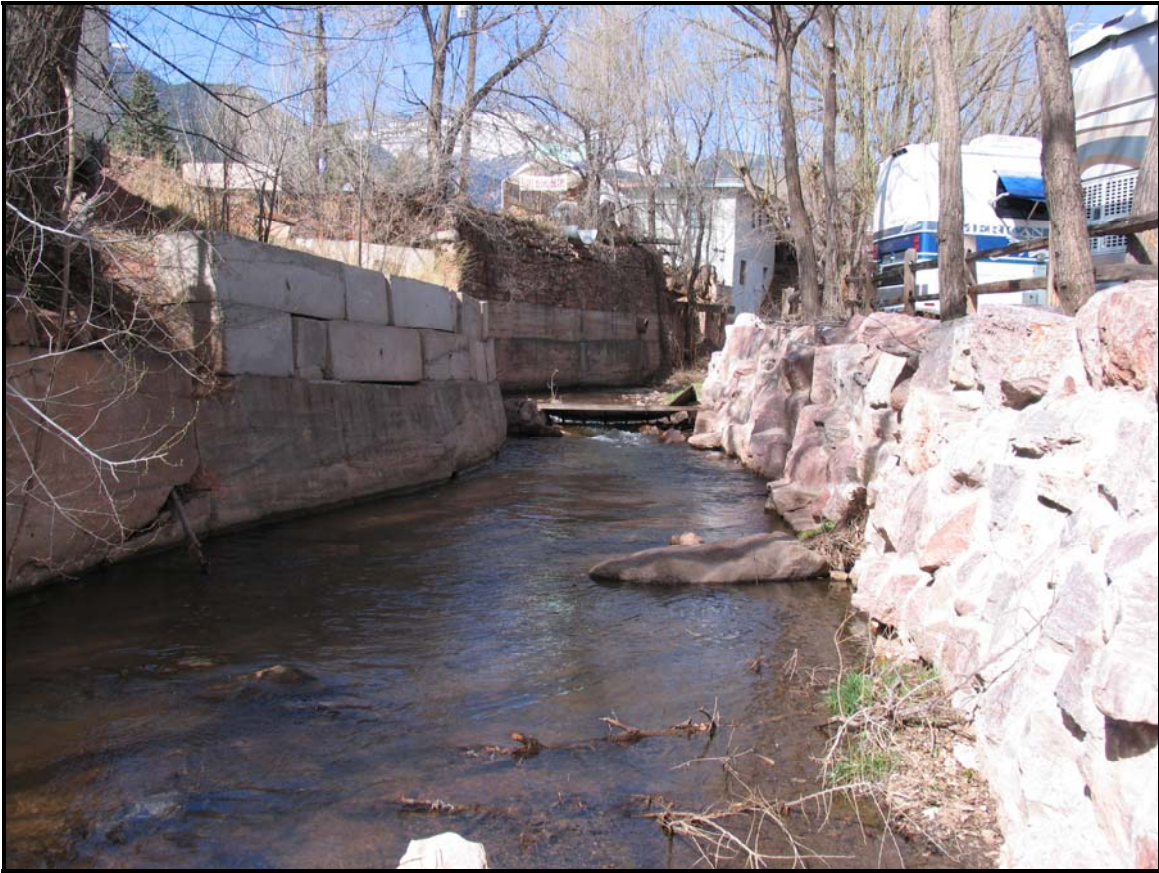
The study area is embedded within a highly disturbed urban landscape with a sparsity of native vegetation and undisturbed wildlife habitat (Appendix B, Photo 5). In some areas the Fountain Creek riparian area contains remnants of a cottonwood dominated riparian woodland; however, other areas are highly disturbed with sparse native understory vegetation (Appendix B, Photo 6) and non-native and weed infestations.

Photo 5. The highly disturbed urban landscape with little native vegetation observed within the Fountain Creek study area.

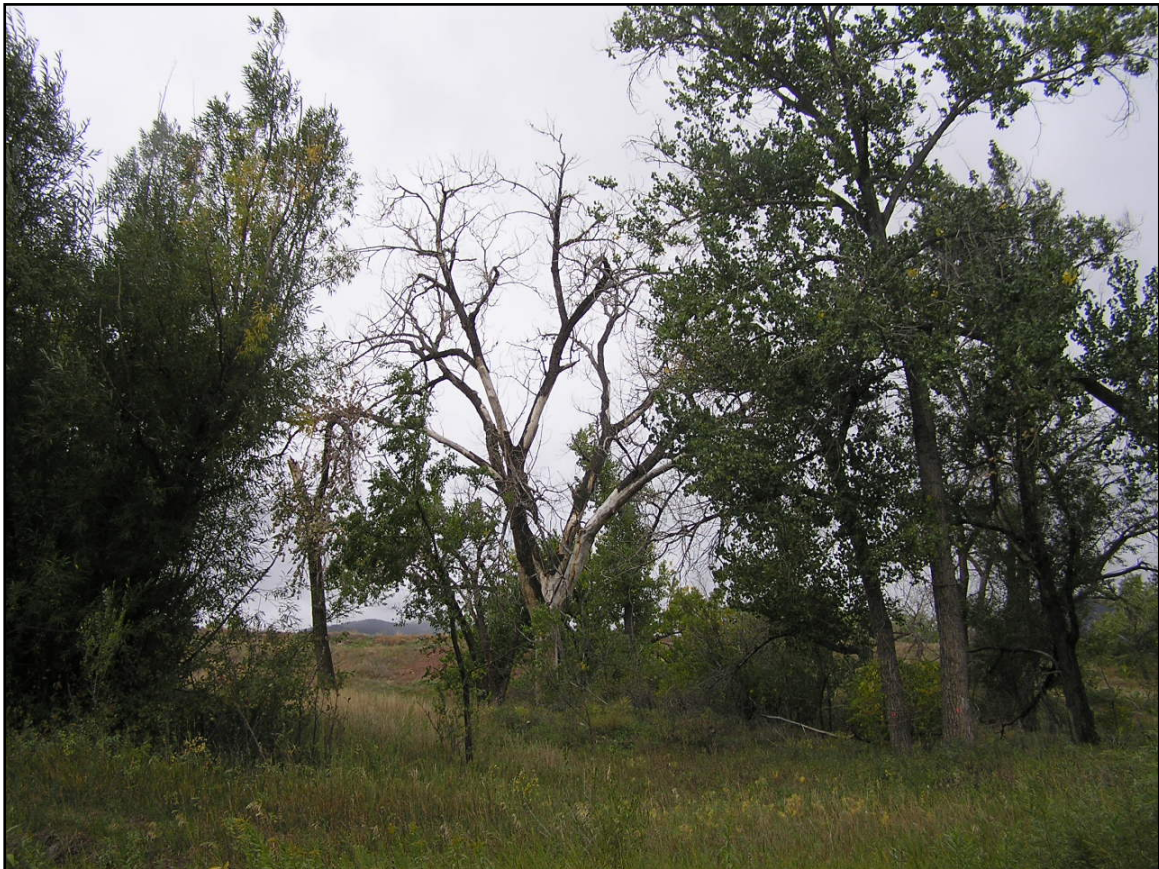
Photo 6. Riparian area along Fountain Creek showing sparse understory vegetation, Colorado Springs, Colorado.

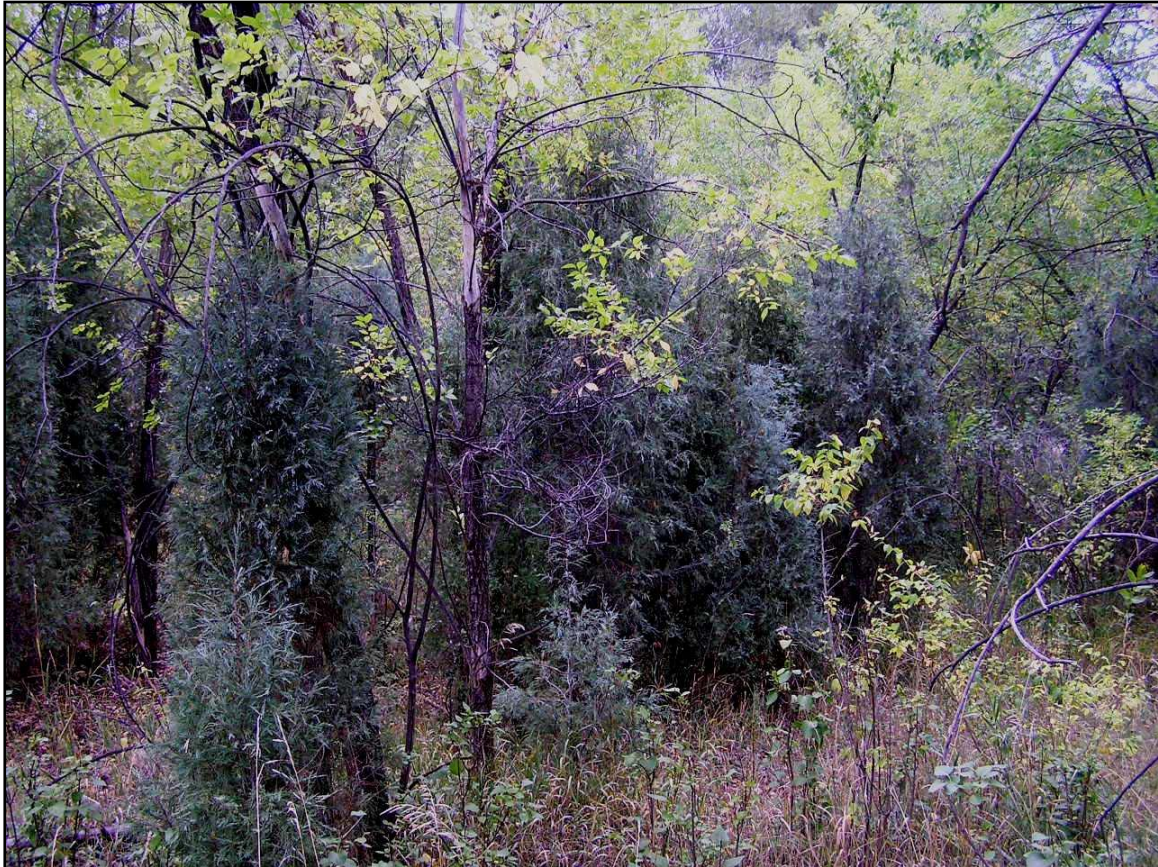
cottonwood, and finally narrowleaf cottonwood in the western portion of the study area (near Manitou Springs). Understory vegetation remains similar but green ash, common chokecherry, Rocky Mountain juniper, and western snowberry become increasingly more common (Appendix B, Photo 8). The dominant riparian community in this part of the study area could more accurately be described as transitioning to a cottonwood spp. / western snowberry woodland or a narrowleaf cottonwood / chokecherry woodland.

Photo 8. Typical understory vegetation observed along the western portion of Fountain Creek near Manitou Springs, Colorado.

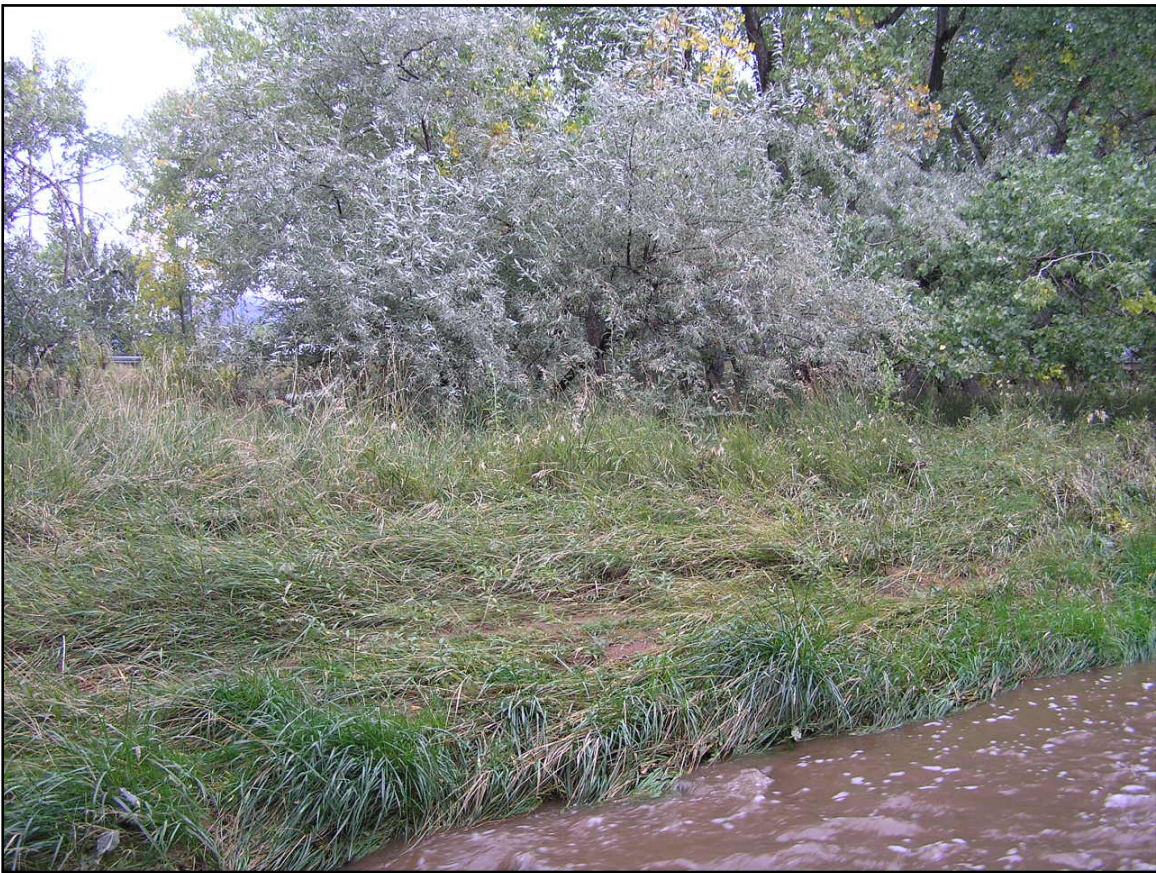
Photo 9. Russian olive (*Elaeagnus angustifolia*), a non-native species, observed along Fountain Creek, Colorado Springs, Colorado.

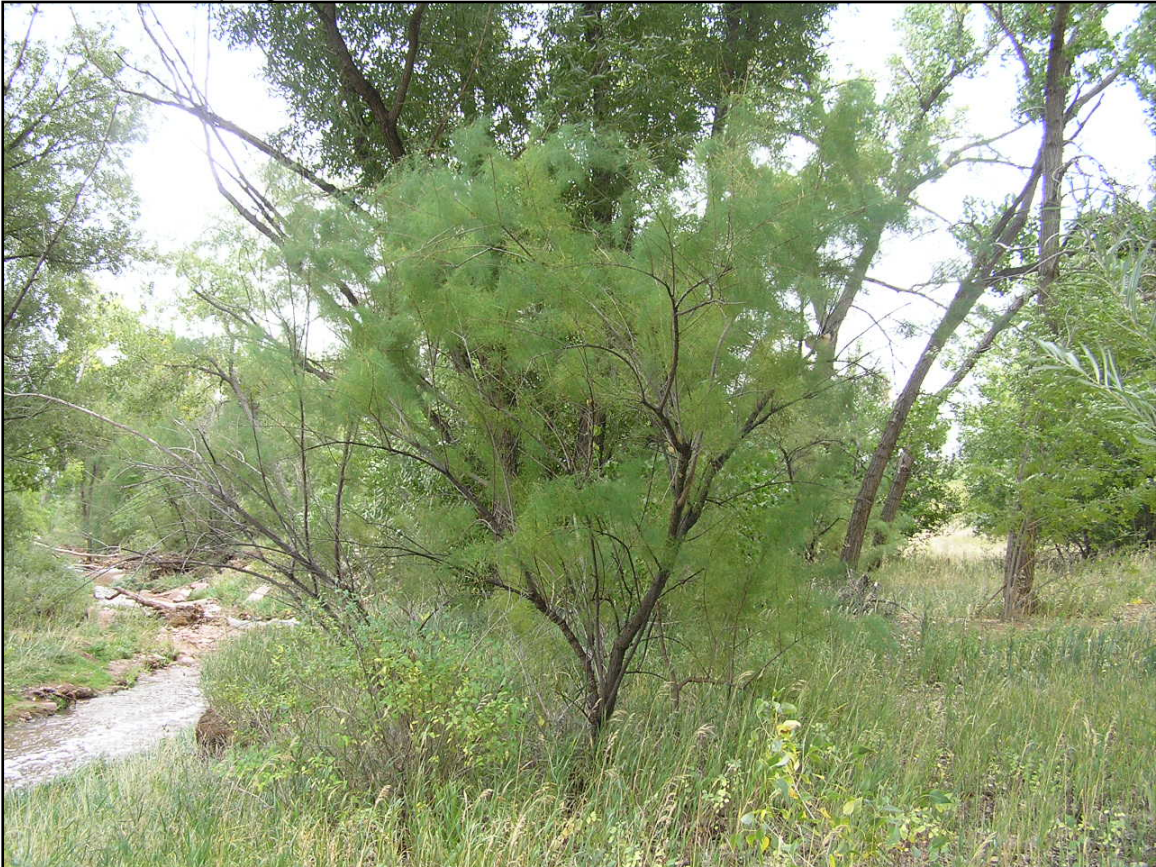
Photo 10. Tamarisk (*Tamarix* sp.), a non-native species, observed along Fountain Creek, Colorado Springs, Colorado.

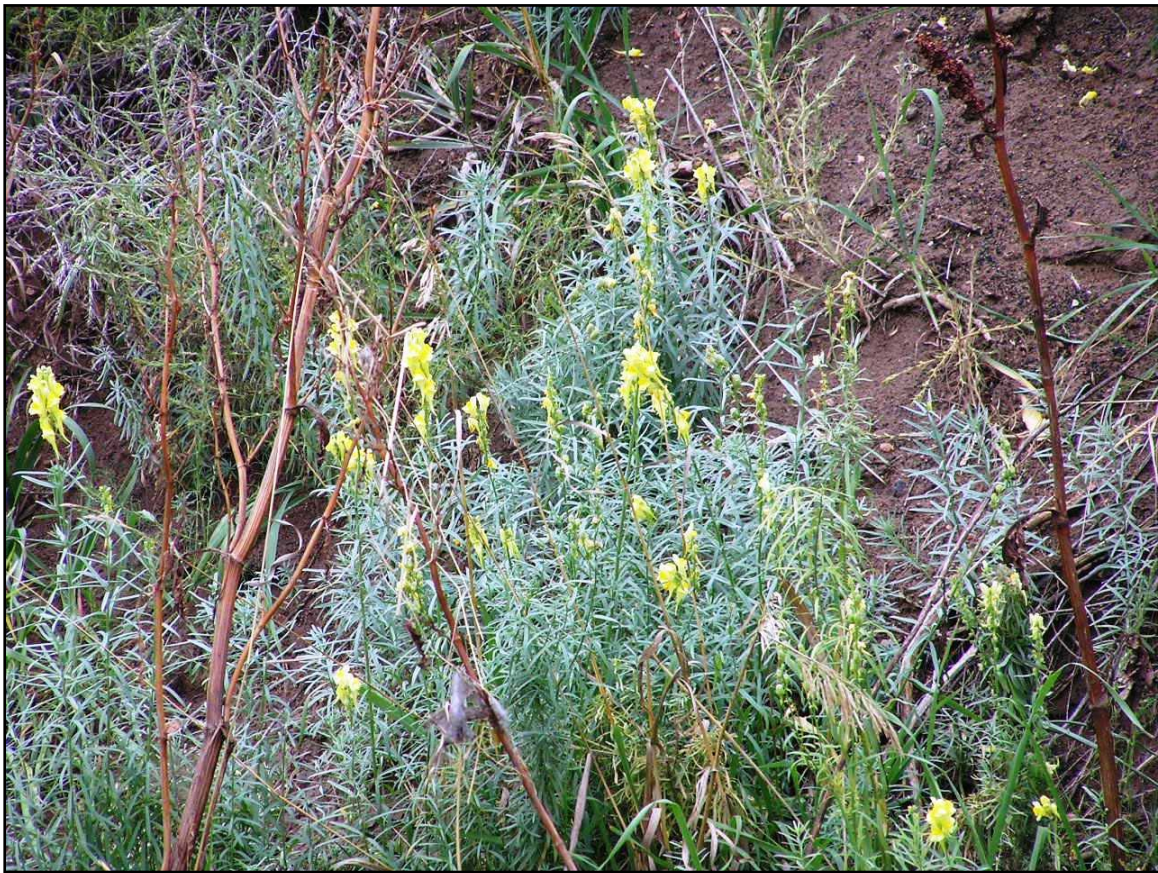
It is important to note that one of the most common trees in the subcanopy throughout the riparian area of Fountain Creek (and the dominant sub-canopy tree in many areas) within the study area is Siberian elm (*Ulmus pumila*). Although this non-native tree does not cause the ecological impact of Russian olive (*Elaeagnus angustifolia*) and tamarisk (*Tamarix* spp.), it appears to be out-competing native trees and shrubs within the study area thus reducing plant diversity of the habitat. Other non-native plant species common in the study area include: Canada thistle (*Cirsium arvense*), cheatgrass (*Bromus tectorum*), houndstongue (*Cynoglossum officinale*), kochia (*Kochia scoparia*), leafy spurge (*Euphorbia esula*), Russian olive (Appendix B, Photo 9), tamarisk (Appendix B, Photo 10), yellow salsify (*Tragopogon dubius*), and yellow toadflax (*Linaria vulgaris*) (Appendix B, Photo 11).

Photo 11. Yellow toadflax (*Linaria vulgaris*), a non-native species, observed along Fountain Creek, Colorado Springs, Colorado.
