# Supplement to the Wetlands Technical Memorandum

# Wetland Delineation

## US 24 West

CDOT Project No. NH 0242-040

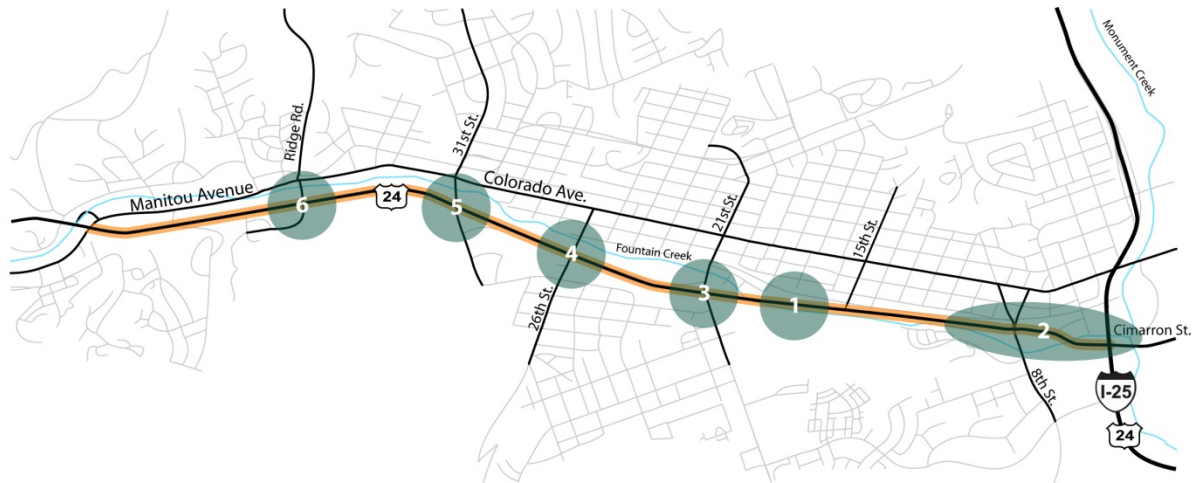
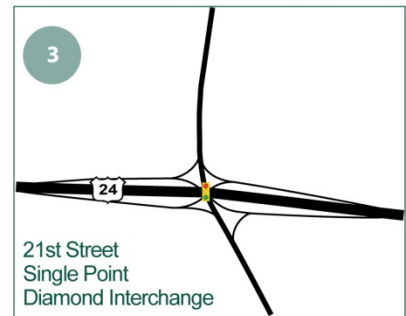
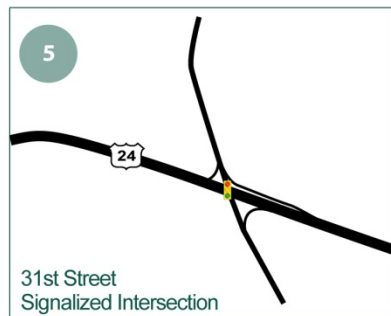
FIGURE 2  
Proposed Action

The Proposed Action would provide additional capacity on US 24 by building additional travel lanes, two new interchanges, and one new overpass. The Proposed Action includes rebuilding several cross-streets, replaces bridges over Fountain Creek, and includes modifications to Fountain Creek's channel at each bridge crossing. Sidewalks would be built at all intersections and interchanges. The Proposed Action would also accommodate a park and ride facility and two future local access points along the route, which would be built by others. The Proposed Action is illustrated in **Figure 2**.

US 24 in the project area would be built to have eight through-lanes, four in each direction, east of 8th Street, and six through-lanes, three in each direction, from 8th Street to a point west of 31st Street. New interchanges are proposed at 8th and 21st Streets.

A single point diamond interchange is proposed at the Cimarron Interchange. This interchange design differs from what was originally presented in the *I-25 Improvements through the Colorado Springs Urbanized Area EA* (I-25 EA) (FHWA and CDOT, 2004). Since the I-25 EA was approved, new opportunities have been identified to improve existing and future traffic operations, making this improved design now feasible.

Intersection upgrades are proposed at 26th Street. The intersection of US 24 and 31st Street would be widened, as would the intersection with Colorado Avenue to the north. South of US 24, 31st Street would be rebuilt to align with the highway intersection.

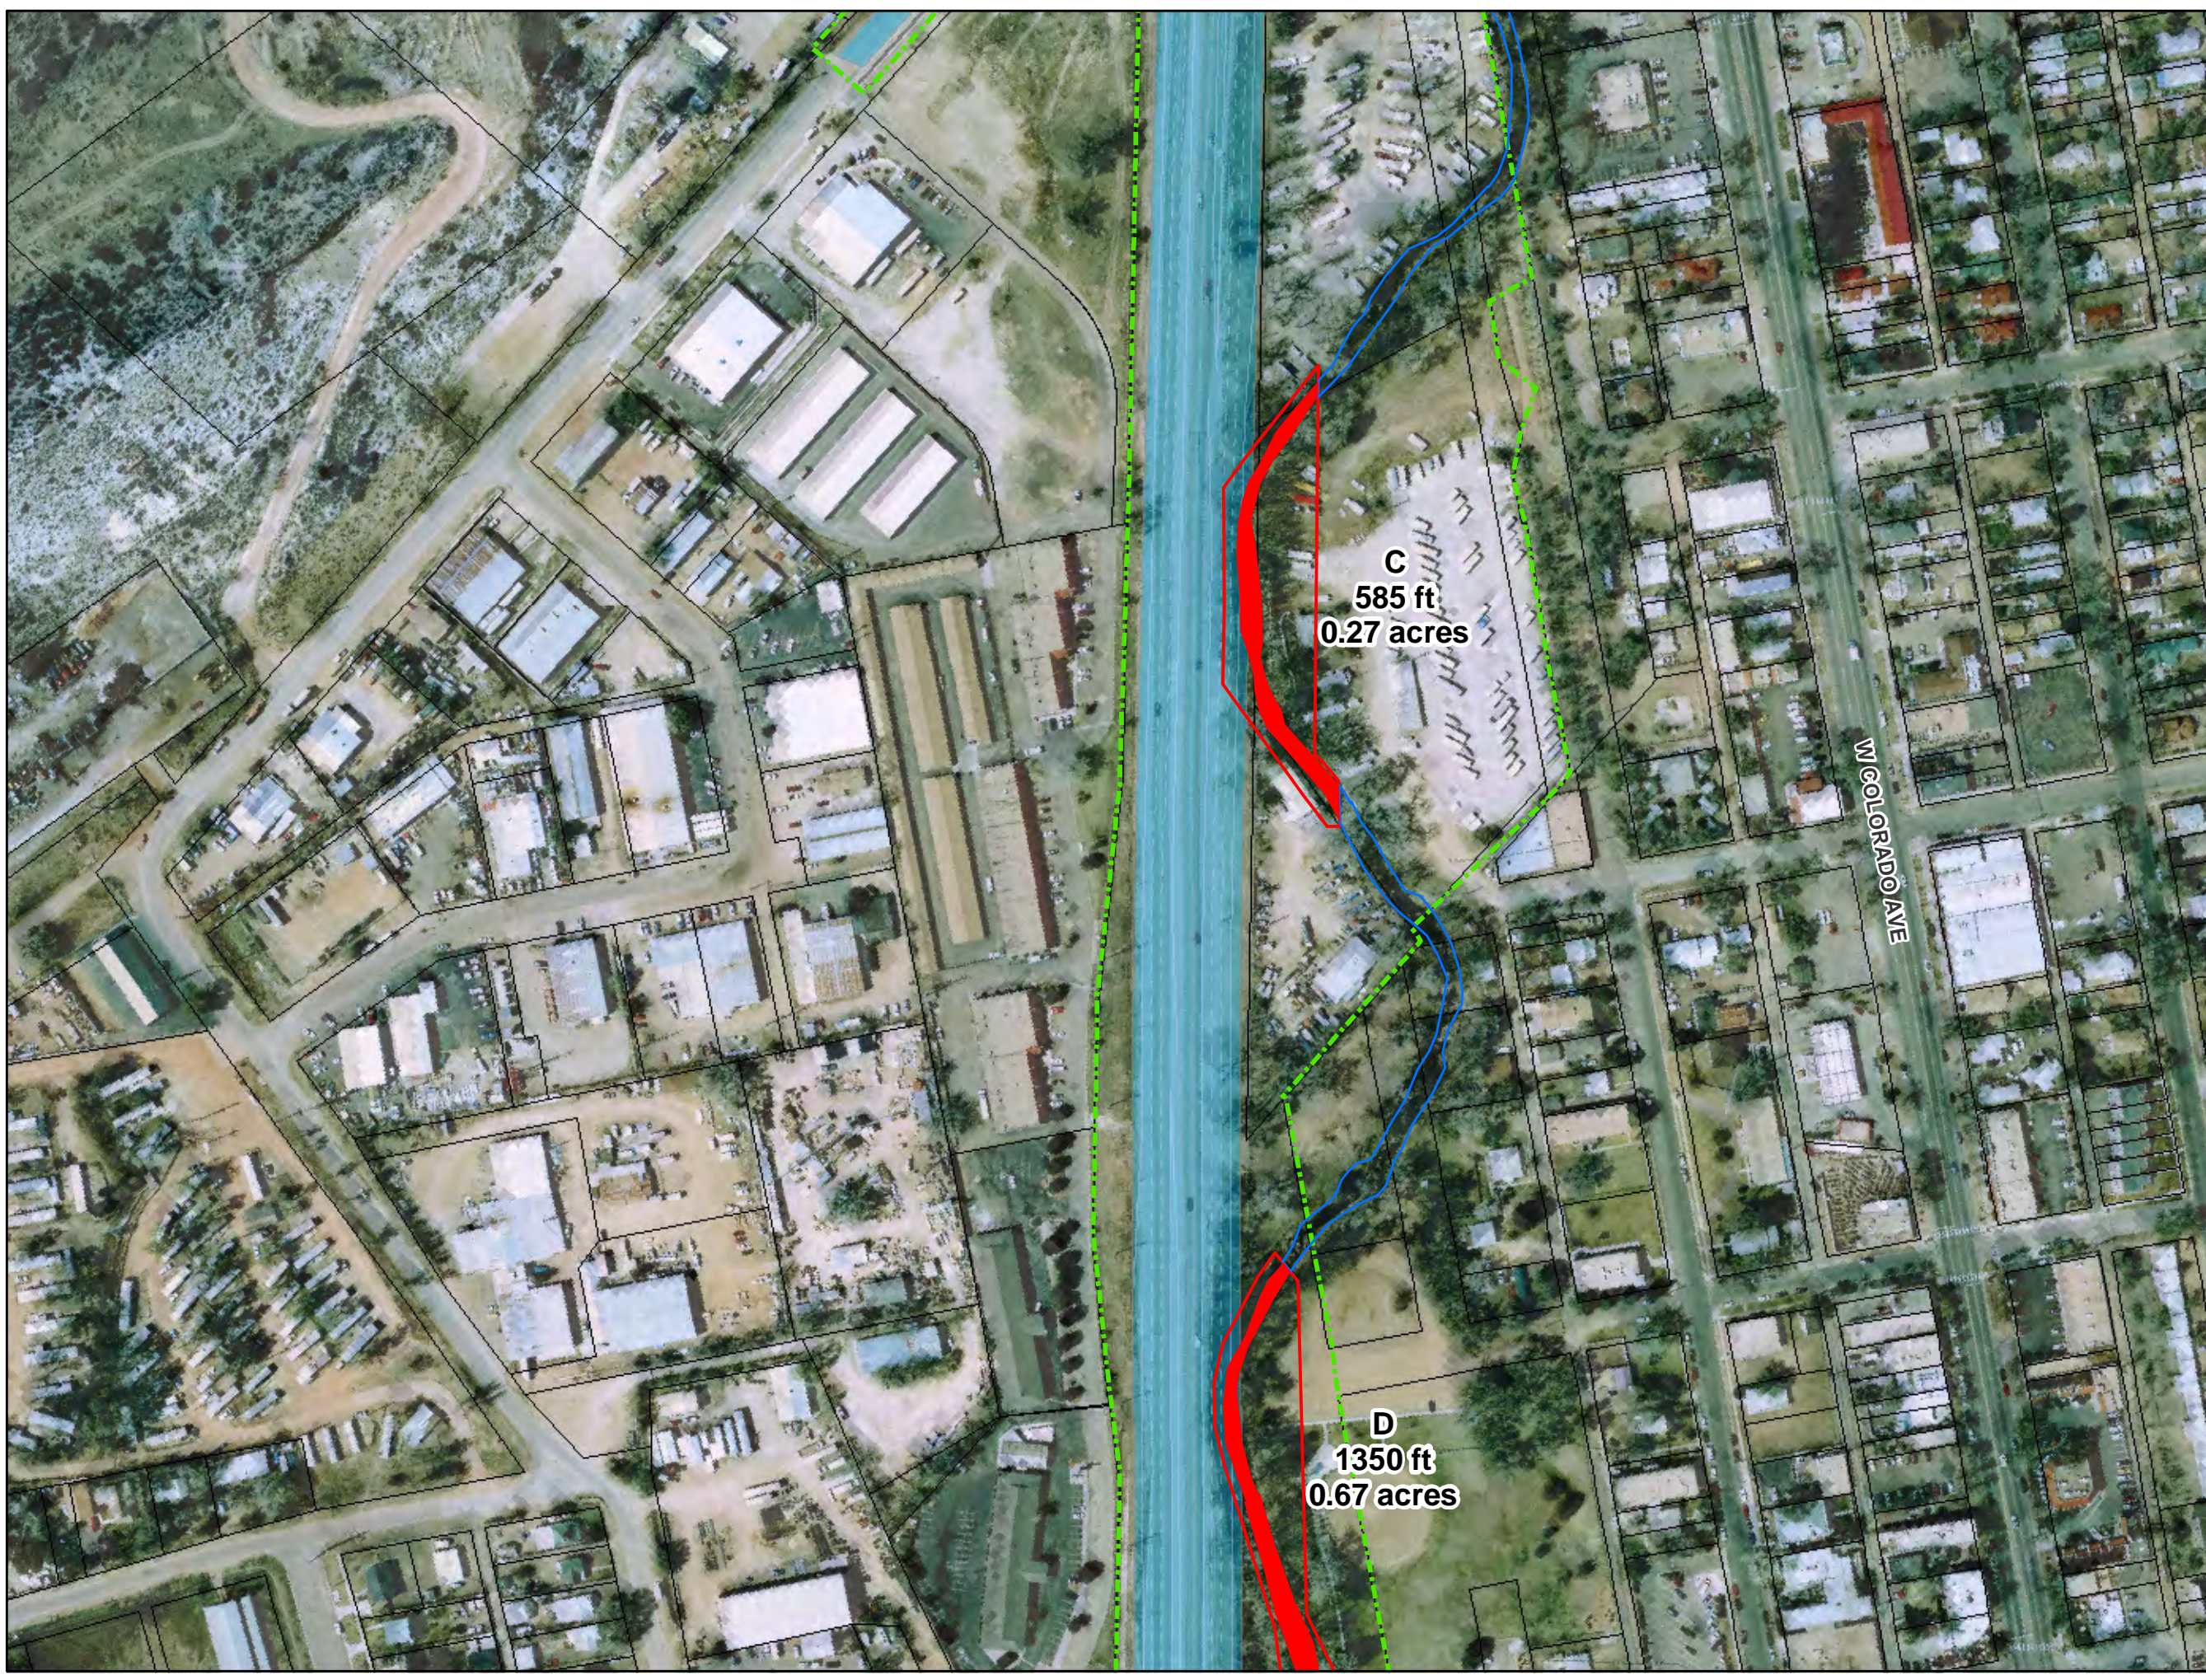
**C**  
585 ft  
0.27 acres

**D**  
1350 ft  
0.67 acres

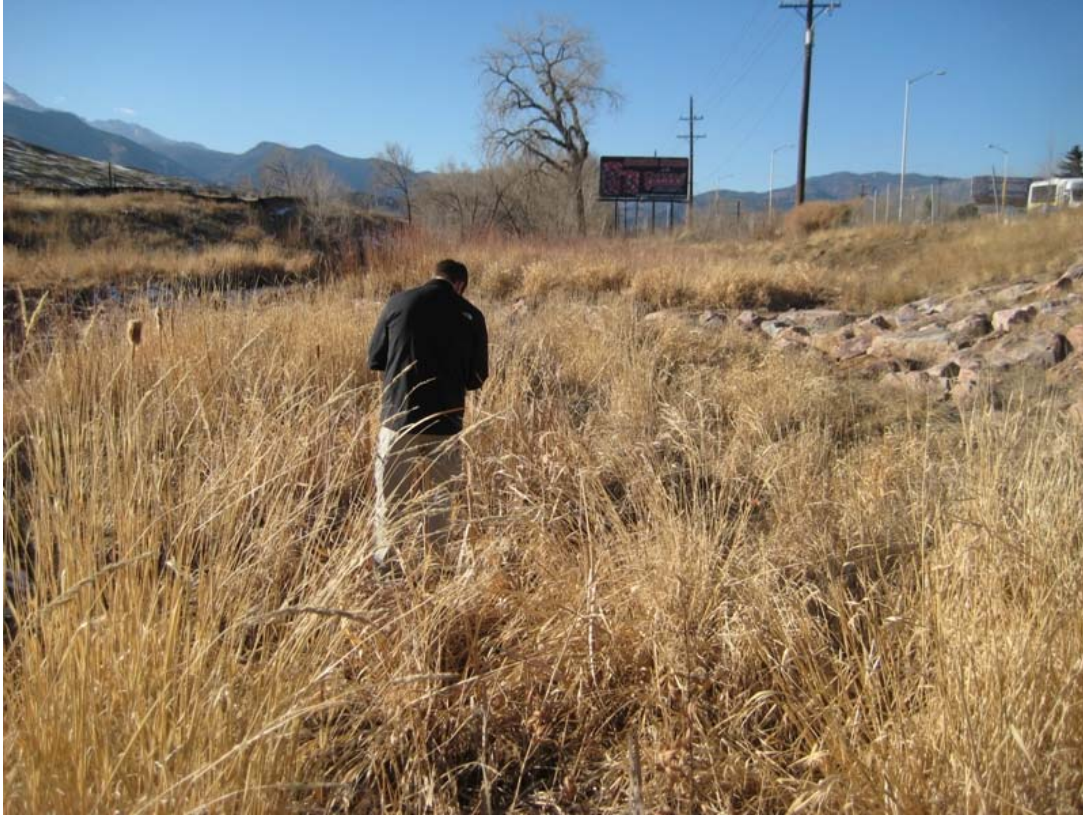
Photo 1: View to the west of Wetland 1 location within the Fountain Creek floodplain.

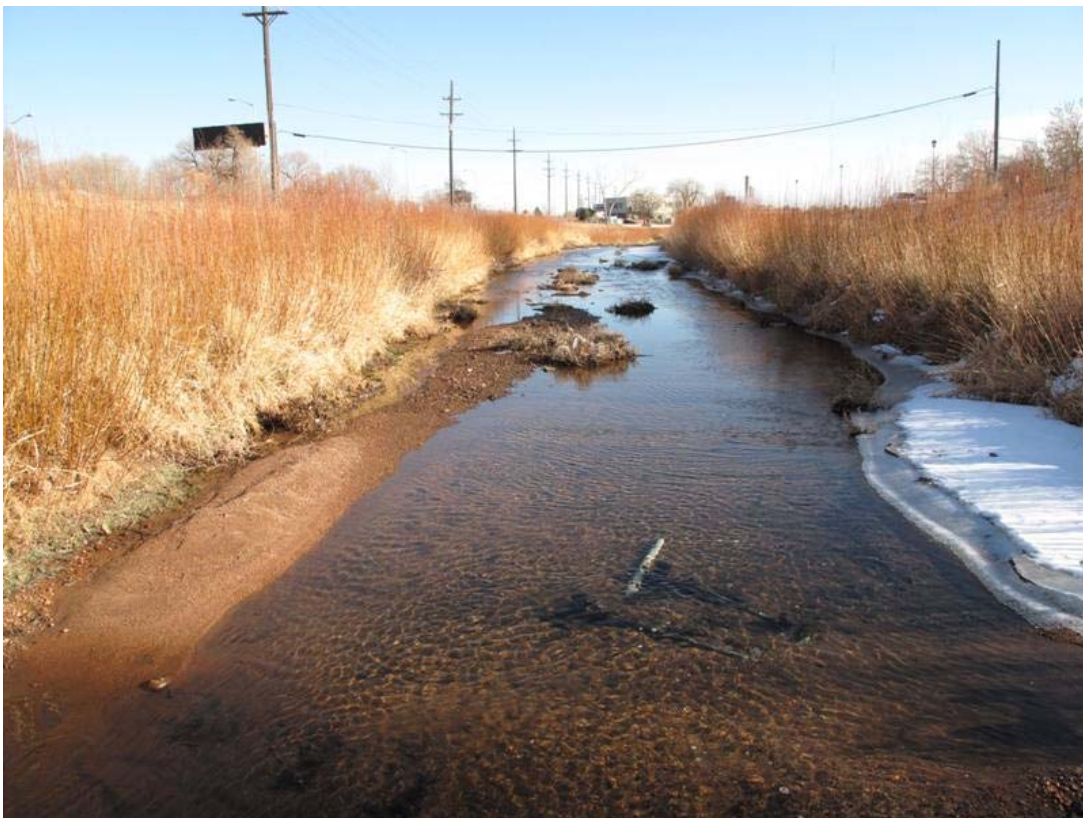
Photo 2: View to the east of Wetland 1 looking down the center of Fountain Creek showing adjacent riparian (non-wetland) fringe of sandbar willow.

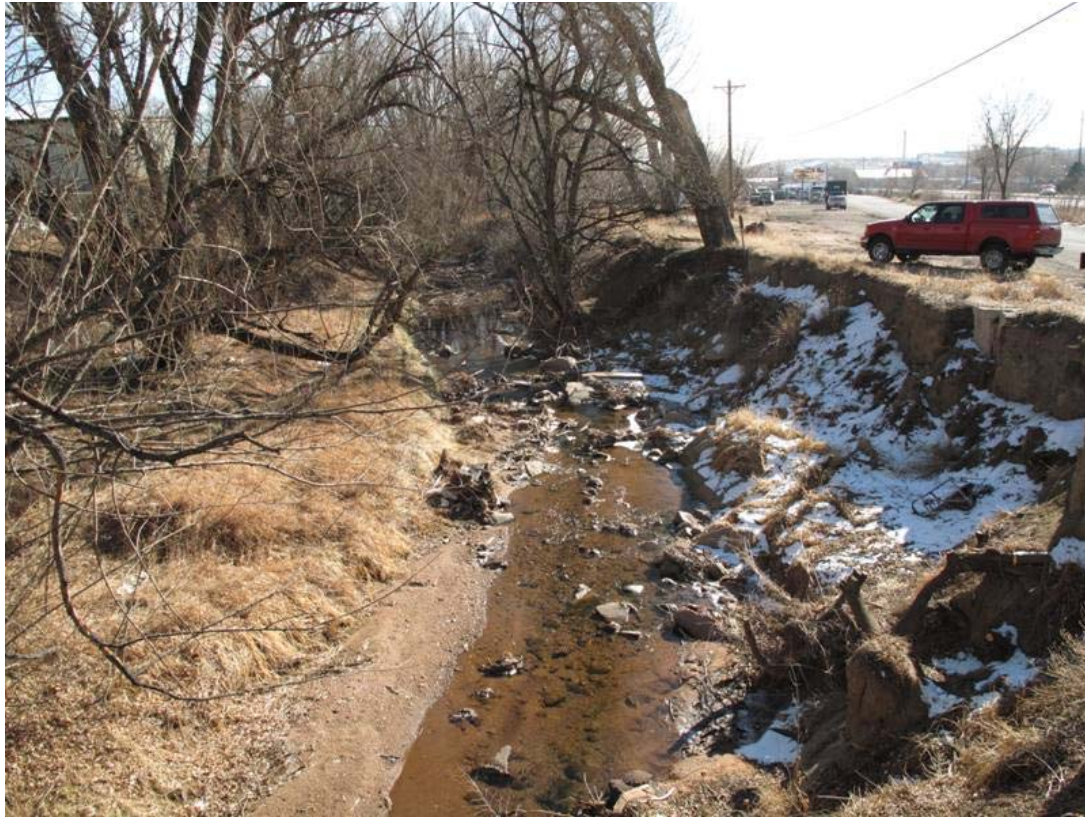
Photo 3: View of erosion along the banks of Fountain Creek near S. 25<sup>th</sup> St.

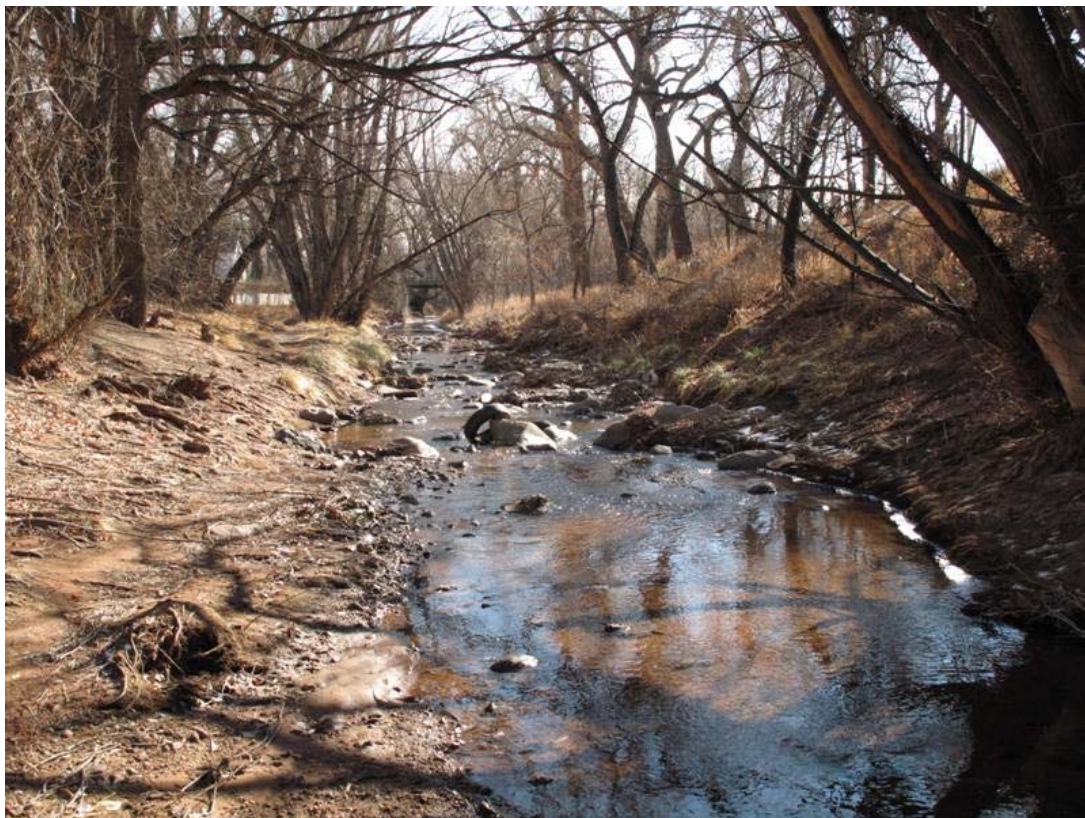
Photo 4: View to the east of Fountain Creek and typical existing conditions within the floodplain.

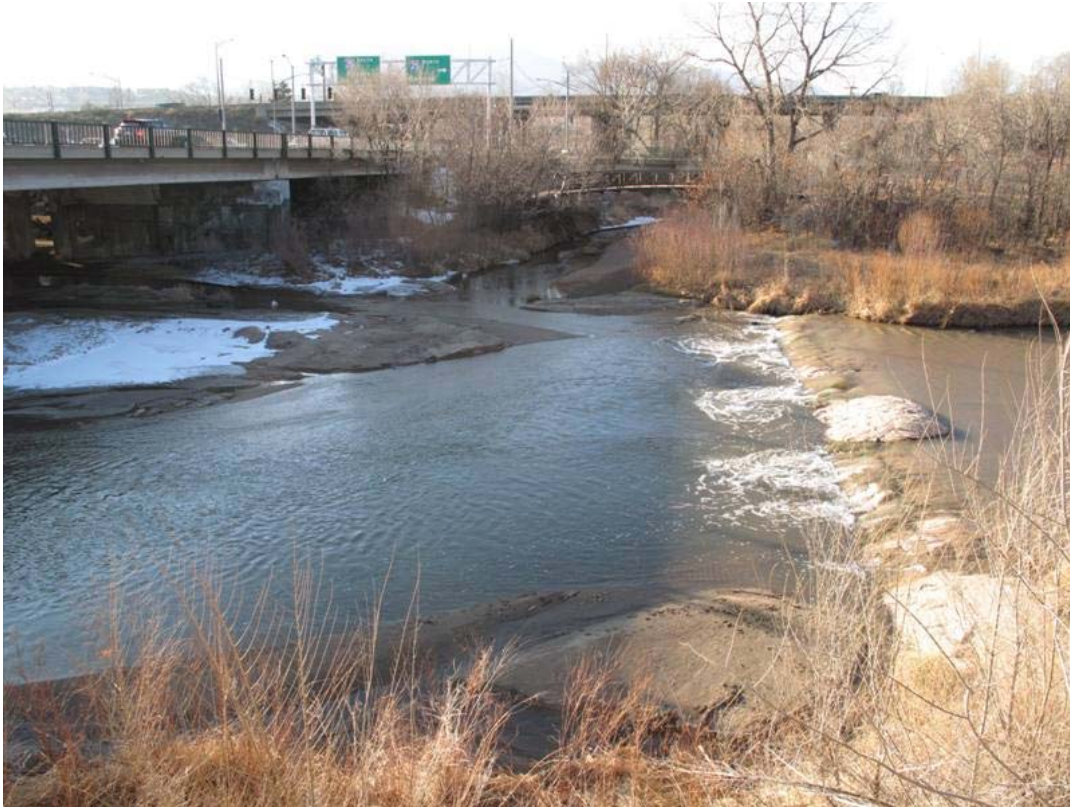
Photo 5: View of the confluence between Fountain Creek and Monument Creek, east of I-25.

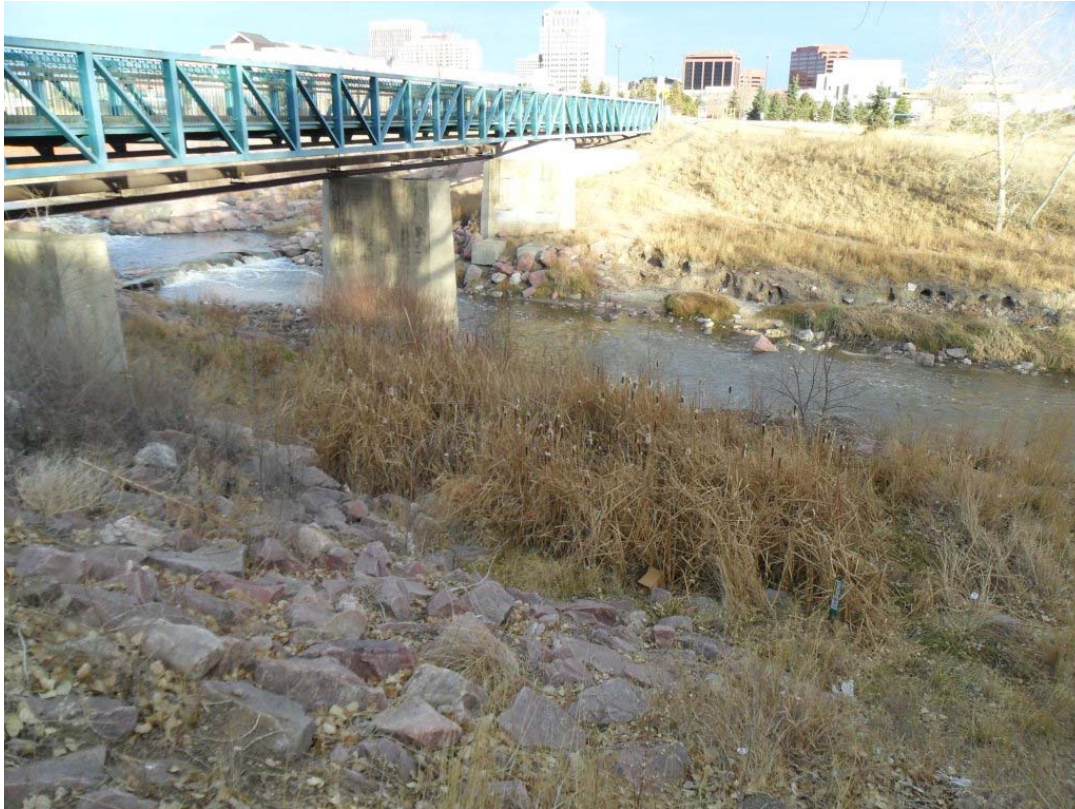
Photo 6: View of Wetland 2 on terrace adjacent to Monument Creek and under a pedestrian bridge. Wetland is dominated by cattails.

Wetland hydrology indicators observed at time of survey included water-stained leaves, drainage patterns typical in wetlands, rafted debris, oxidized rhizospheres along root channels, standing water within part of the wetland, and a soil profile saturated to the surface. This location appears to be seasonally flooded, receiving overflow water associated with a secondary channel next to a rip-rap drop structure located just upstream.

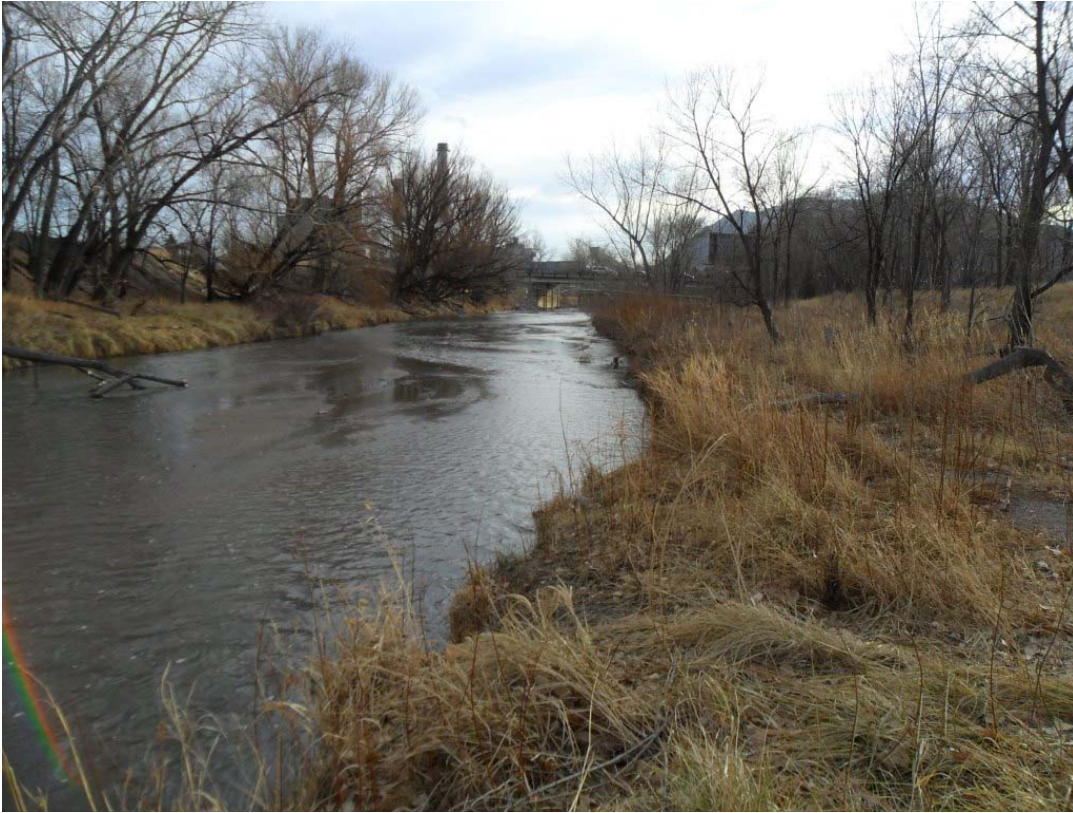
Photo 7: View of Monument Creek and riparian areas looking south towards Cimmaron St. bridge.

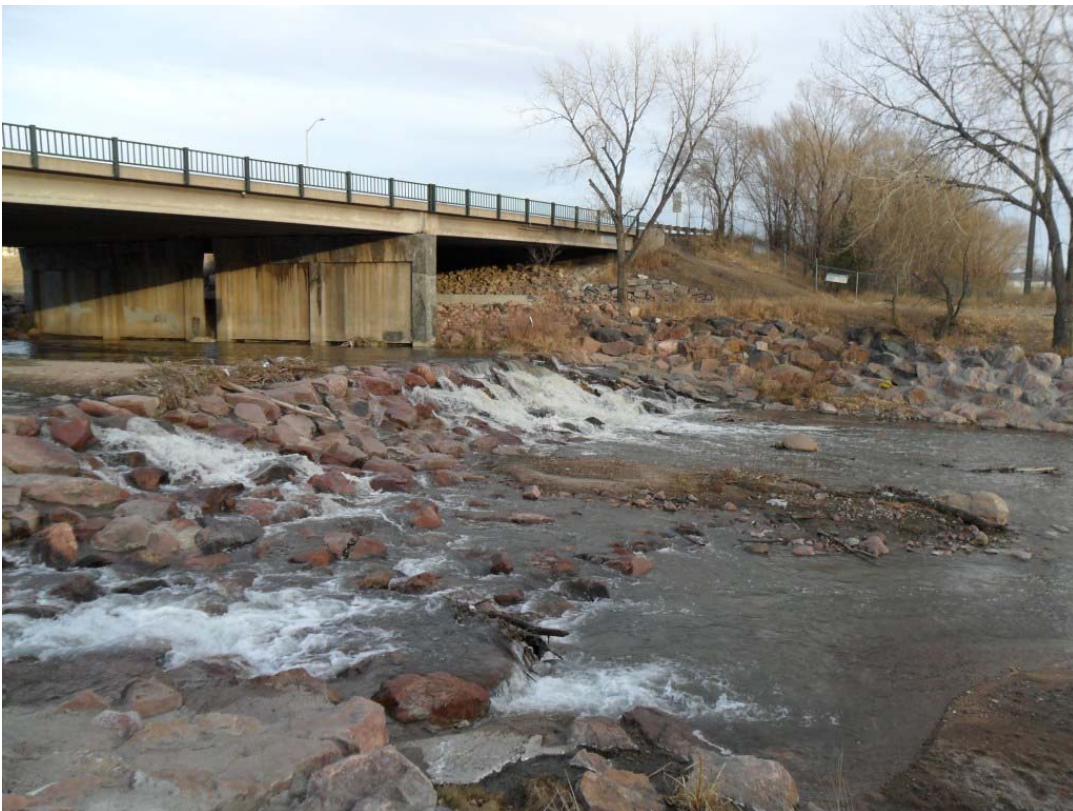
Photo 8: View of Fountain Creek at Cimmaron St. bridge.

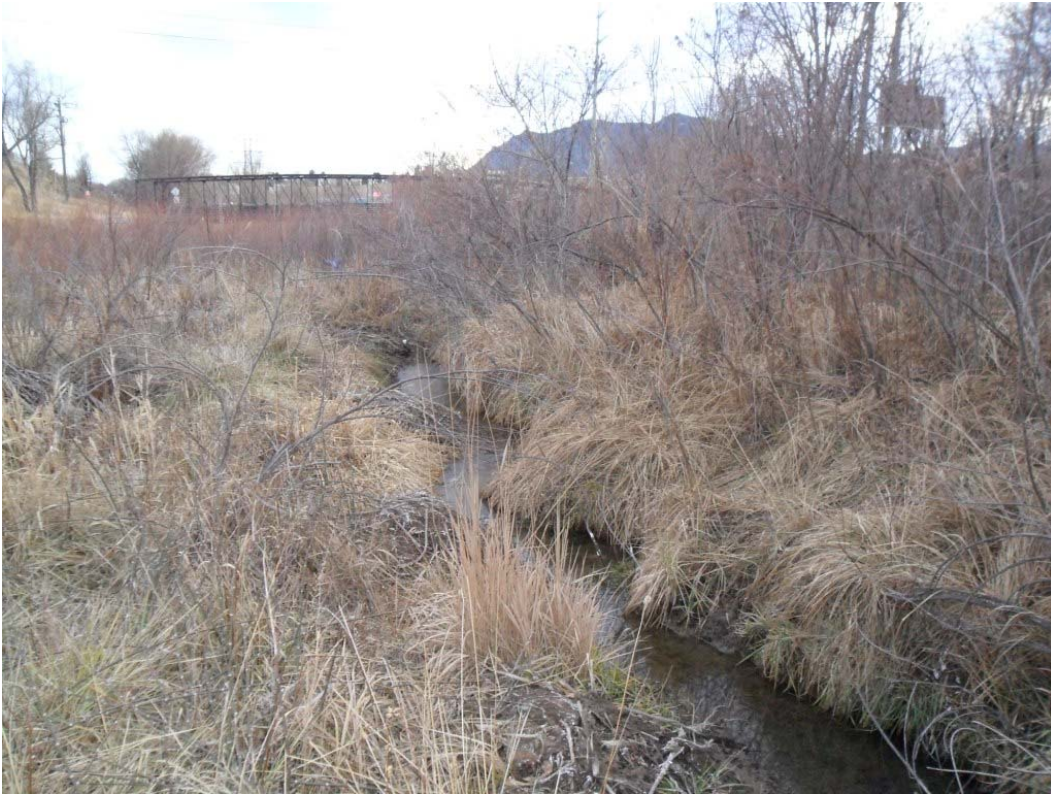
Photo 9: View of Wetland 3 looking south at standing water within sandbar willow terrace. Pedestrian bridge in the distance.

Wetland hydrology indicators observed at time of survey were similar to those found in wetland 2. These included water-stained leaves, drainage patterns typical in wetlands, rafted debris, oxidized rhizospheres along root channels, standing water within part of the wetland, and a soil profile saturated to the surface. This location appears to be seasonally flooded, receiving overflow water associated with a secondary channel next to a rip-rap drop structure located just upstream. Several overland flow paths can be seen leading out of the wetland and back into Fountain Creek at various points along the creek edge.

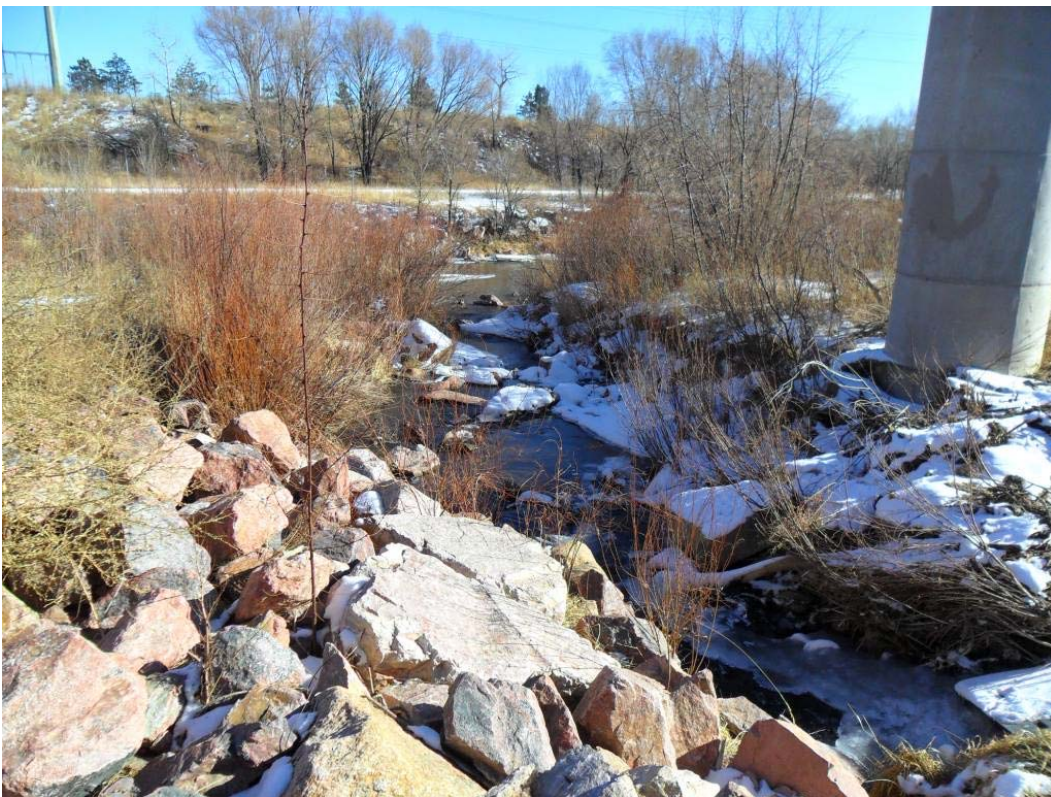
Photo 10: Looking east at Bear Creek from pedestrian underpass under I-25. Confluence with Fountain Creek is in the background.

Bear Creek is a perennial tributary of Fountain Creek. The creek flows under I-25 via a box culvert. Impacts to the creek will occur as a result of cut and fill activities within the channel from bridge/culvert upgrade and replacement work and realignment of I-25. These areas are shown in the Wetland Atlas in **Appendix A**.

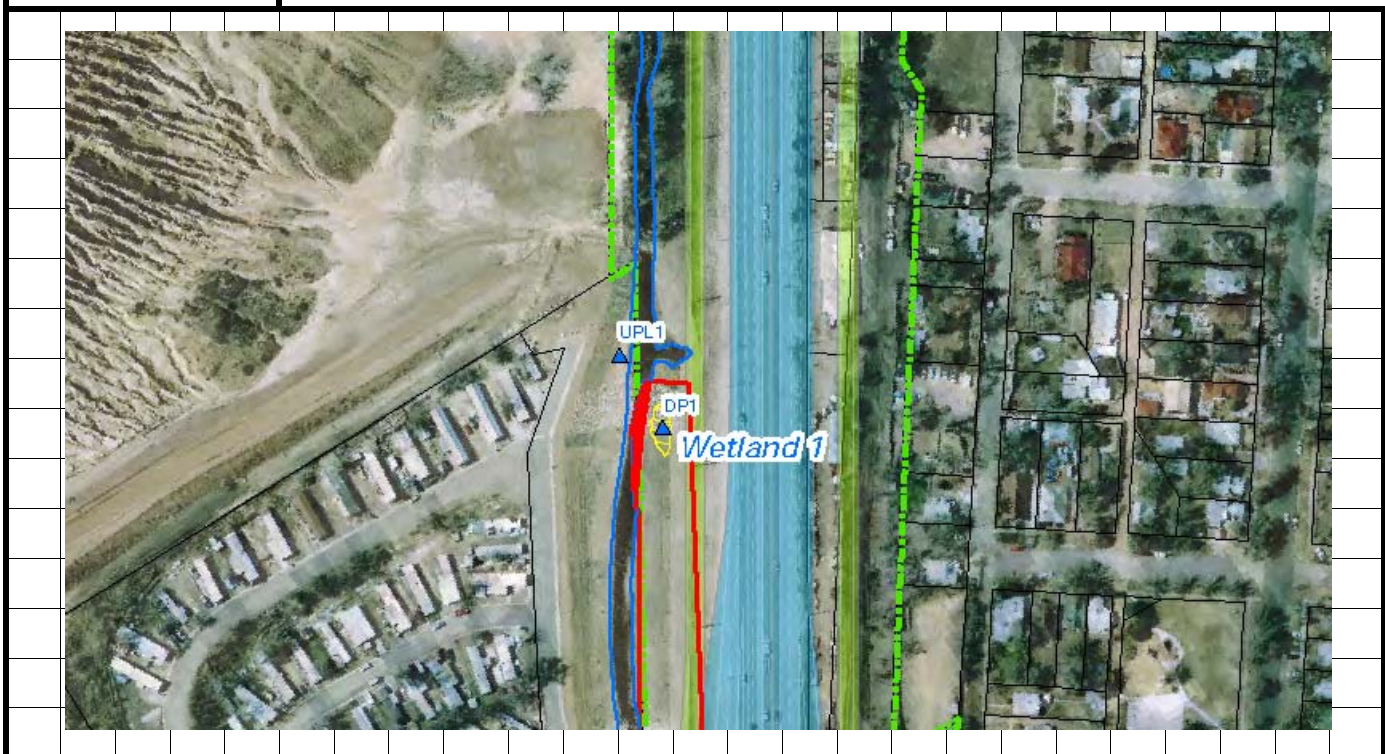
Scale: 1 inch = 200 feet

Draw a sketch map of the site including relevant portions of the wetland, AA boundary, structures, habitat classes, and other significant features.
