APPENDIX A17
VISUAL IMPACT ASSESSMENT

VISUAL IMPACT ASSESSMENT

March 2020

By David Evans and Associates, Inc.

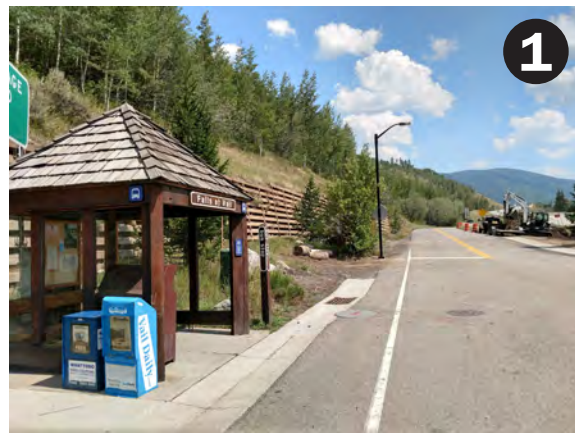
Photos 1, 2, and 3 are representative of what a motorist, pedestrian or cyclist experience near the East Vail exit. Views include background, middle ground, and foreground views of interstate bridge structures, ramps, and frontage roads. Views of southern valley walls, the western base of Vail Pass and points west can be viewed.

Photo 1 illustrates a retaining wall that was not built with the same visual aesthetic as the interstate's retaining walls and is an instance of a retaining wall within the project area that does not match the interstate's scalloped walls. The bus stop's wooden structure is representative of typical architectural forms in the area.

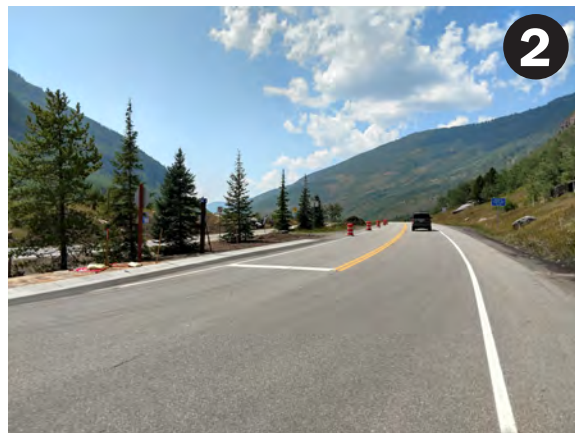
Photo 2 illustrates vegetation planted to visually buffer the interstate from the north frontage road. These elements continue to the east and buffer the limited number of residential uses that exist north of the highway in the landscape unit.

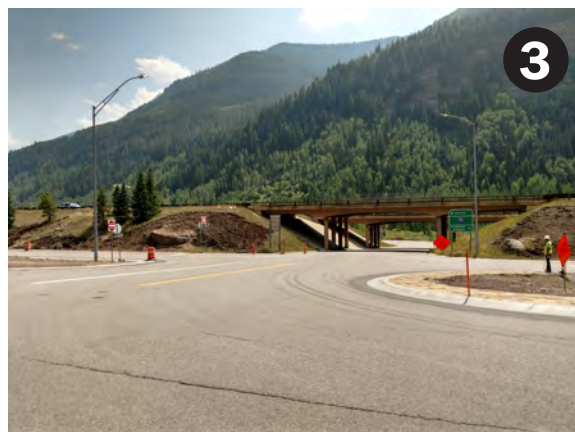
Photo 3 shows how the bridge, ramps, and ultimately the interstate impact views and interrupt the cultural and natural visual environment.

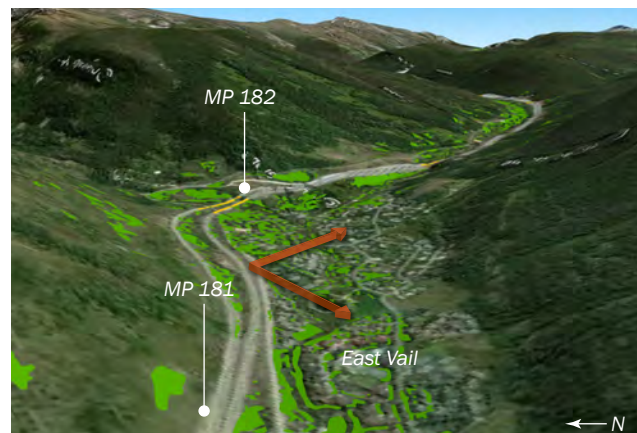
Photo 4 illustrates new construction directly adjacent to the south frontage road and in close proximity to the interstate. This condition shows how homes in the East Vail neighborhood exist near the interstate. Views from the south frontage road in this location include foreground and middle ground views of the neighborhood as well as views of to the valley's southern slopes. Foreground views to the north terminate at the steep embankments leading up to I-70.

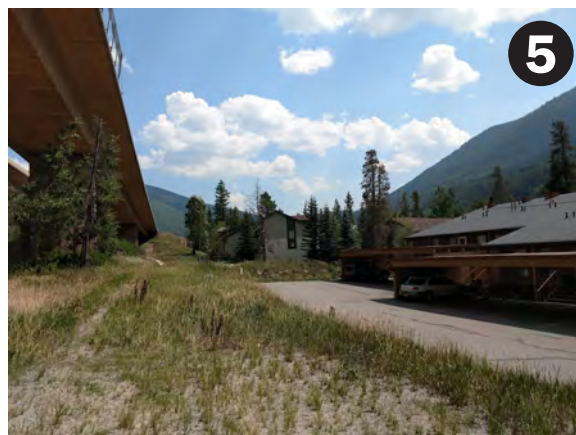
Photo 5 shows how the elevated interstate sits above the East Vail neighborhood. The visual environment of homes near the roadway is dominated by the interstate. In this location, the south frontage road does not provide a visual buffer. In this case, the visual aesthetic of I-70 is more pertinent to the neighbors than travelers because of their static condition.

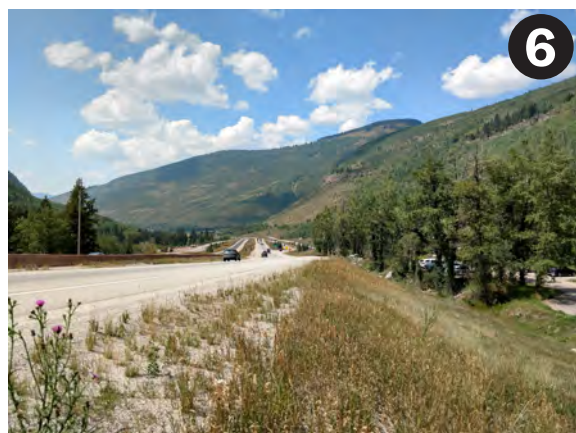
Photo 6 illustrates a traveler's view towards the East Vail exit. Expansive background views down valley are an important element in this location. In the middle ground and foreground vegetation has been planted adjacent to the interstate to visually buffer residential uses located on the north side of the highway. The sparse grass slopes of the interstate are indicative of the typical roadside condition found through the landscape unit. Background views in this location are limited by the steep slopes of the valley to the north and south. The flat topography of the facility found on the western end of the landscape unit is highlighted by the roadway's limited vertical profile.

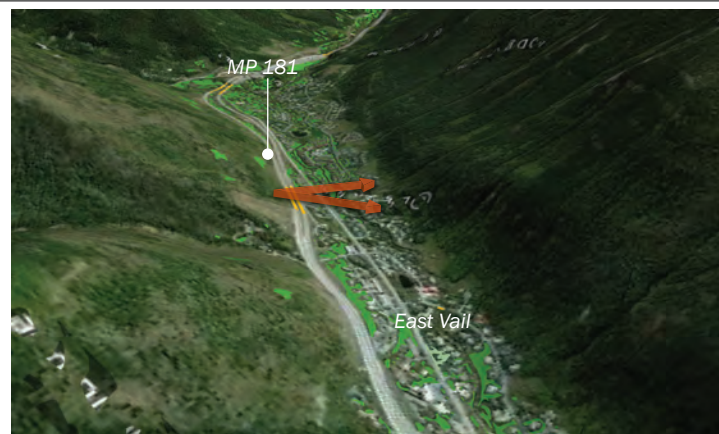
Photos 7 and 8 illustrate how the East Vail neighborhood directly abuts I-70. Photo 7 shows how development below the grade of the highway can visually coexist with the facility due to grade changes. The split condition of the bridge structure allows light to reach the ground and neighborhood, and break up the structure's mass. Photo 8 shows how development can visually coexist adjacent to the highway if buffered by horizontal and vertical distance, local roads, and vegetation.

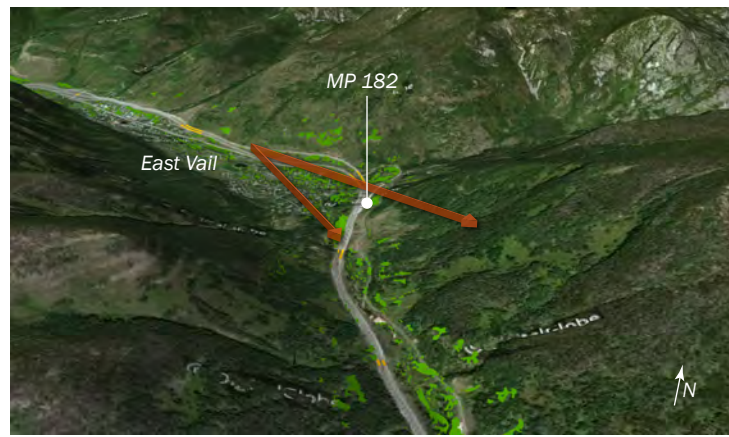
Photo 9 illustrates a typical condition found throughout middle portions of the landscape unit. The interstate's place on the lower slopes of the northern valley wall creates a horizontally and vertically separated roadway that minimizes the visual width of the roadway and provides locations for vegetation and retaining walls that contribute to a pleasing project aesthetic. Additional vertical and horizontal separation provides a visual buffer for local road users including motorists as well as for pedestrians and cyclist accessing the Vail Pass Trail Recreational via the frontage road. This condition also provides a visual buffer to residential neighbors of the facility in the area. While the condition does provide an visual separation for the community, extensive slopes visually impact neighbor's views.

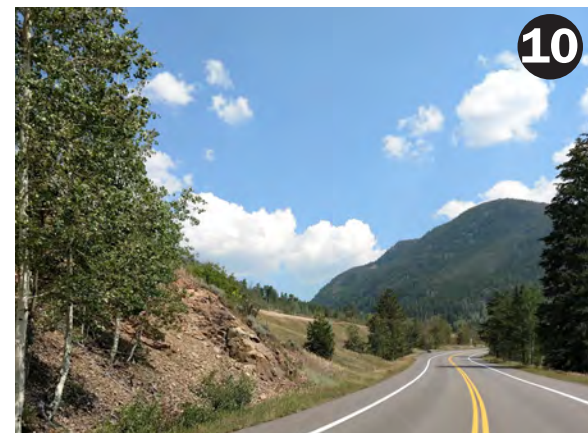
Photo 10 shows how the original design ameliorated visual impact in a select locations. The grass slope of the highway has been sculpted and planted to mimic the landforms and vegetation found on northern valley slopes. In this condition, cyclists and pedestrians traveling along the south frontage road are visually buffered from the interstate.

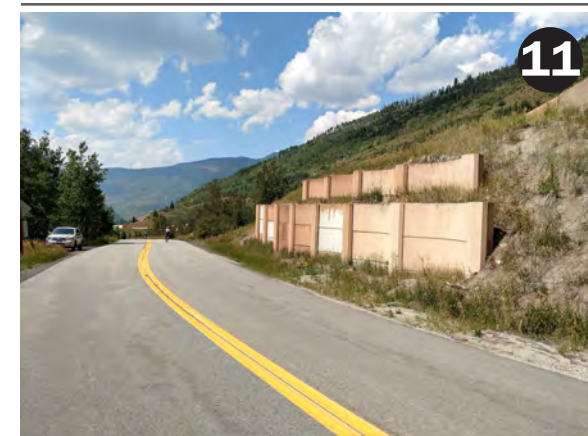
Photo 11 shows the first scalloped retaining wall that cyclists and pedestrians see as they approach the Gore Creek Campground and the western trail head of the Vail Pass trail. The grass slope to the right leads to I-70 and extensive vegetation has been planted near residential structures adjacent to the frontage road as a buffer.

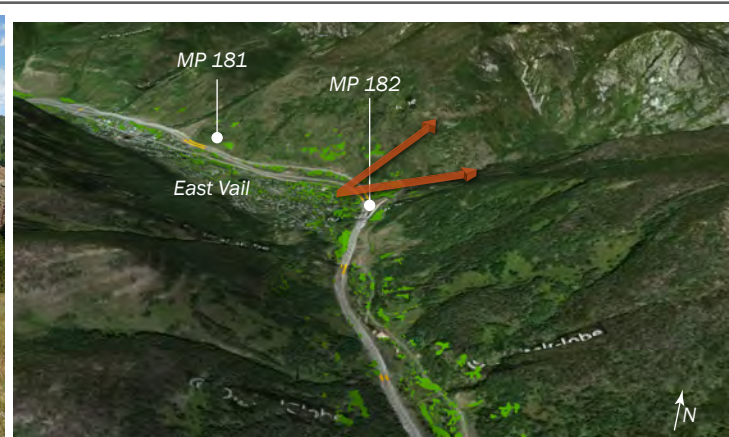
Photo 12 illustrates a view of the curvilinear bridge found at the base of West Vail Pass near the East Vail neighborhood. This view is accessible to a number of single family homes that sit south and west of the structure. The bridge substantially impacts middle ground and background views from the rear of these residences. This is the same bridge that motorists, pedestrians, and cyclists pass under to access the Gore Creek Campground and the Vail Pass Recreational Trail. The bridge is also located near the confluence of Black Gore Creek and Gore Creek. The location offers views up the Gore Creek Valley and the lower summits of the Gore Range.

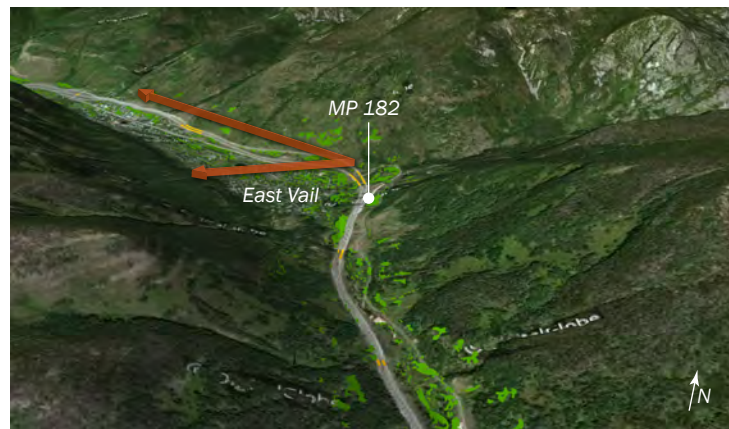
Photo 13 illustrates the distinct visual difference between the northern and southern slopes of the Vail Valley. Northern aspects encompass more vegetation and land cover, while southern aspects are less vegetated. This condition is primarily the result of sun exposure. This is also a critical view for travelers arriving from the east and serves as the first substantial background view of the long valley. Views of the East Vail Neighborhood are limited due to differences in elevation, producing a visual environment that encompasses foreground, middle ground, and background views to the west and north and middle ground views to the south.

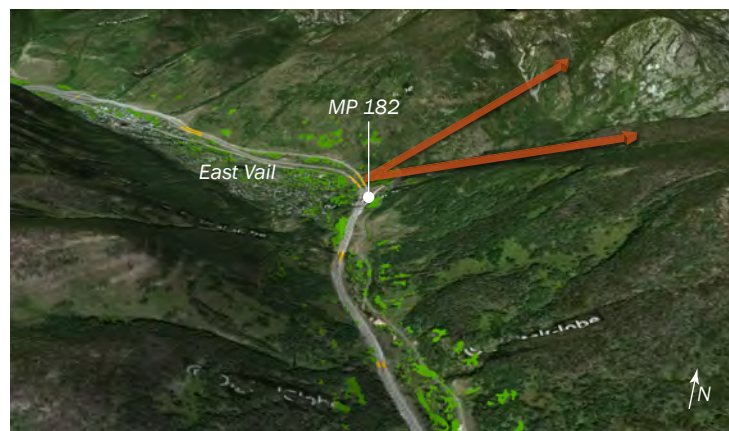
Photo 14 is a critical view that looks up the Gore Creek Valley from the northern edge of the interstate. This view is limited for eastbound travelers and more accessible to westbound travelers due to the separated form of the interstate in this location. This is an important view for local motorists, cyclists, and pedestrians as they pass under the interstate to access the Gore Creek Campground and the Vail Pass Recreational Trail.

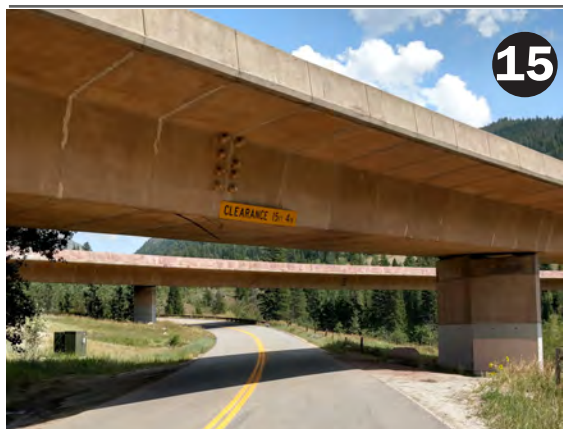
Photo 15 articulates how local motorists, cyclists, and pedestrians' view of the Gore Creek Valley is impacted by the interstate bridge as they approach the Gore Creek Campground and Vail Pass Recreation Trail trail head via the frontage road. Note how the split structure allows light to reach the local road. This condition reduces the mass of the structure and allows it to better visually fit the natural context.

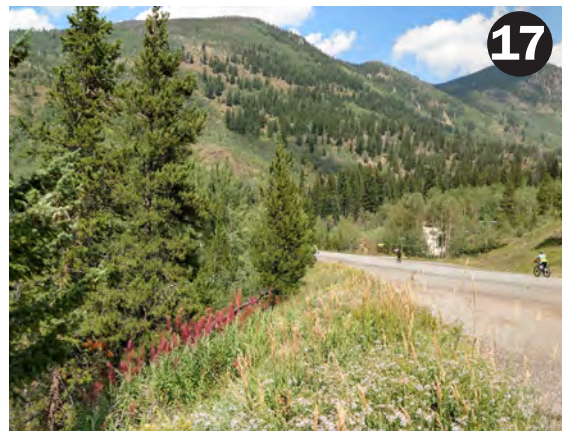
Photo 17 illustrates the visual environment of pedestrians and cyclists as they reach the western terminus of the Vail Pass Recreation trail at the Gore Creek Campground. In this location the trail sits high above the interstate and is further buffered by extensive land cover and vegetation. This condition creates a harmonious natural environment for these critical neighbors and serves as a welcoming visual gateway into the Vail Valley.

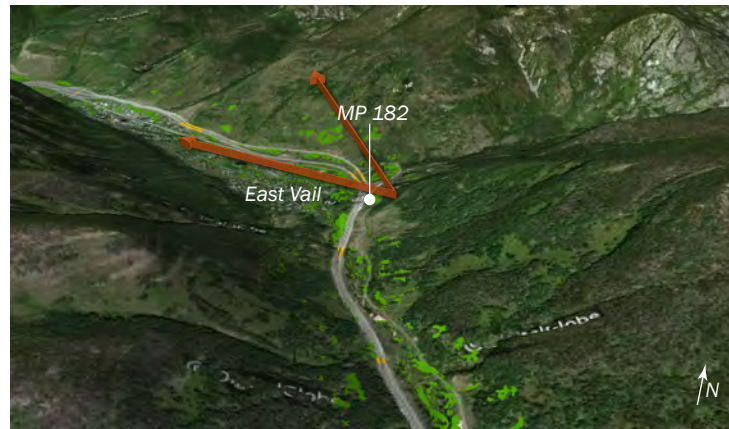
Photo 18 is the most important view for highway travelers in the Valley Floor Landscape Unit. The views appears when descending the final steep hill into the valley (westbound travelers) and allows viewers to access the entire cultural, natural, and project visual environment of the landscape unit. The view is the primary visual gateway for the Vail Valley.

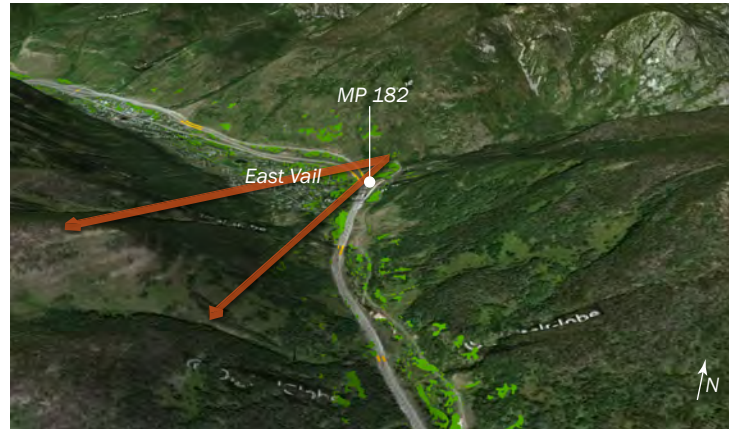
Photo 20 shows the views local motorists, cyclists, and pedestrians see when leaving the the Gore Creek Campground and Vail Pass RecreationTrail trail head area via the frontage road. In this location, background views up the pass and to southern valley walls are found. This bridge serves as a notification that users are leaving the natural visual environment and progressing into a more intense cultural visual environment.

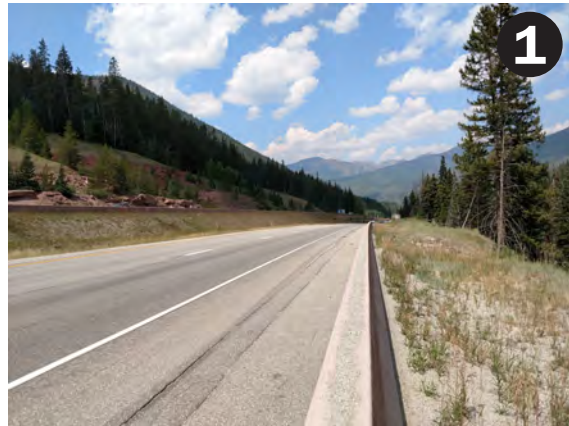
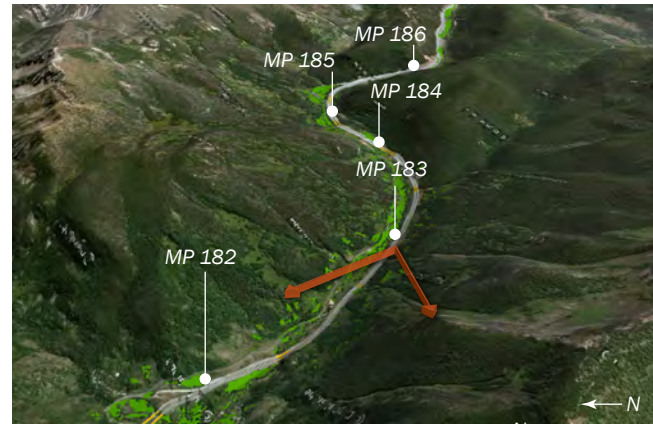
Photo 1 illustrates the long background view towards the Vail Valley with the Gore Range above it. This view is the transition point between the Valley Floor and the Mid-Pass Valley Landscape Units and represents one of the only long background views within the landscape unit. The roadway is both horizontally and vertically separated and illustrates the warm, red colored sandstone that predominates the landscape unit. Highway barriers incorporate color to match the surrounding geological context.

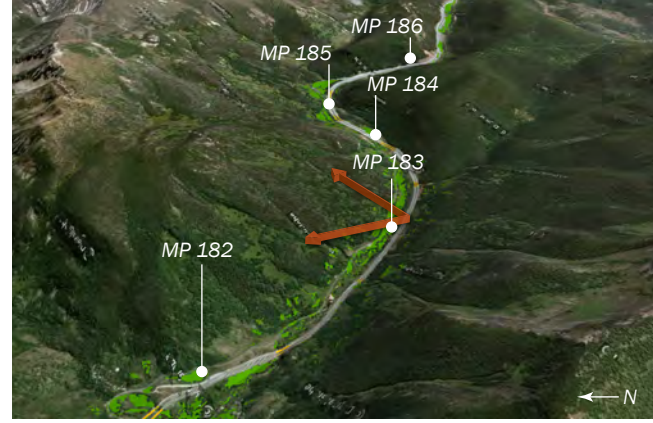
Photo 3 shows the Vail Pass Recreation Trail on the opposite side of Black Gore Creek across from the interstate. In this location, roadway travelers would have no inclination of the presence of the trail due to buffering. This condition is supported by ample horizontal separation from the roadway and extensive vegetation. This is a typical condition of the trail until it passes under the interstate near mile post 185.

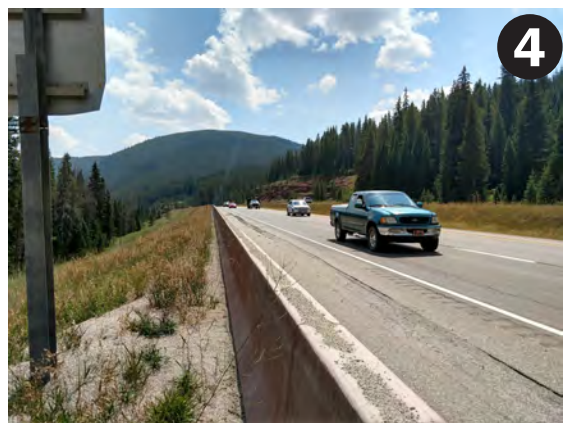
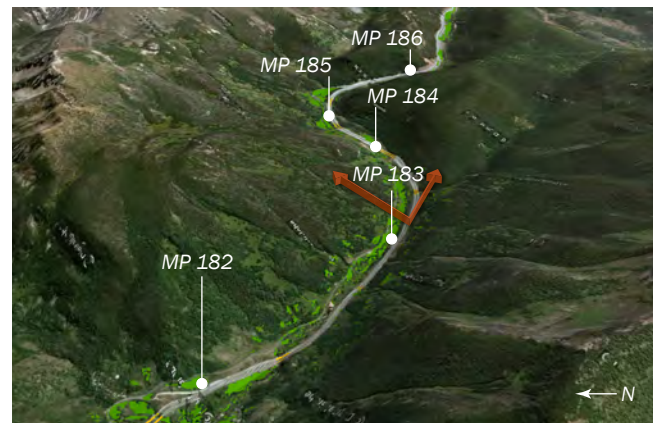
Photo 4 shows a view roadway travelers see when moving from the Valley Floor Landscape Unit to the Mid-Pass Valley Landscape Unit (west to east). This is one of the longest background views within the unit and alludes to a visual and physical tightening of the valley as the interstate moves east. Diverse roadside vegetation progresses in height as it moves away from the roadway and frames views for eastbound travelers.

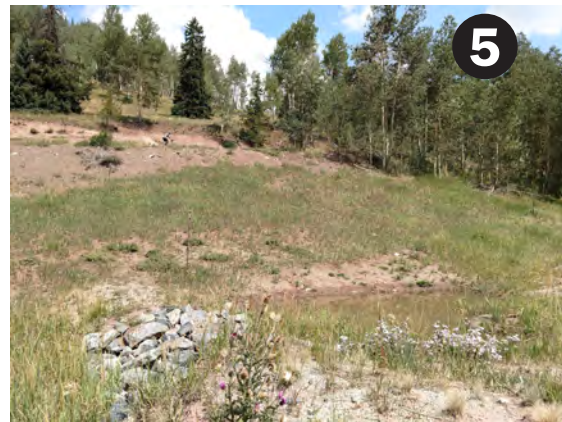
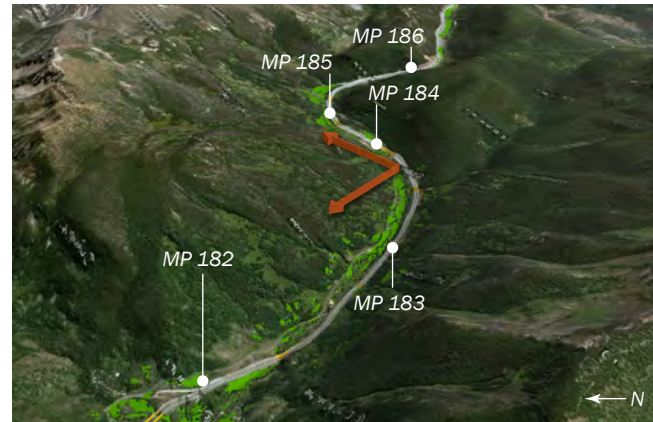
Photo 5 shows a typical view seen by roadway travelers as they reach the western end of the landscape unit. The Vail Pass Recreation Trail is well hidden from the roadway and is located in the top left corner, situated slightly above the interstate. In this location, the interstate visually intrudes upon the trail users due to the lack of vegetation. However, horizontal separation does provide some relief. Intermittent exposure to the interstate is due to stands of Aspen that periodically break up the large alpine meadow. This land cover pattern predominates northern slopes of the landscape unit's western end.

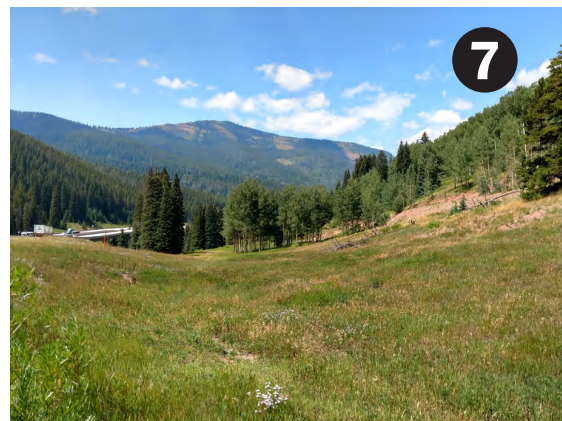
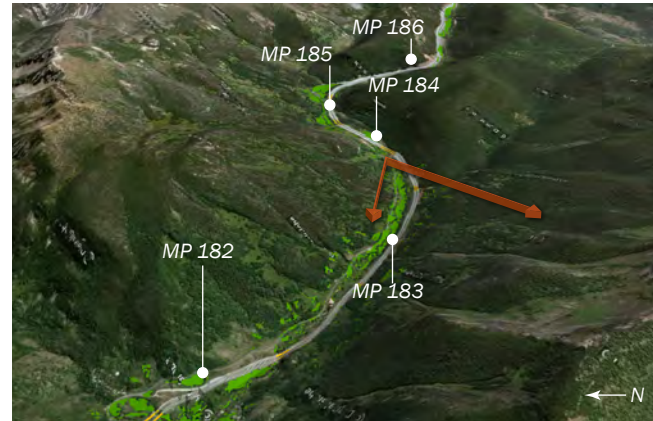
Photo 7 is a picture of the same sub-alpine meadow shown in Photos 5 and 6. In this iteration the photo illustrates an optimal visual conversation between the trail and the roadway. The trail is located on the lower reaches of the valley slope to the right and is buffered by stands of aspen. The roadway is well separated from the trail and slight elevation differences between the two facilities provides further relief. In this location, designers were cognizant of the visual value of the meadow, the ecological importance of Black Gore Creek, and the experiences of trail users. This photo is a prime representation of the interstate's contextual design.

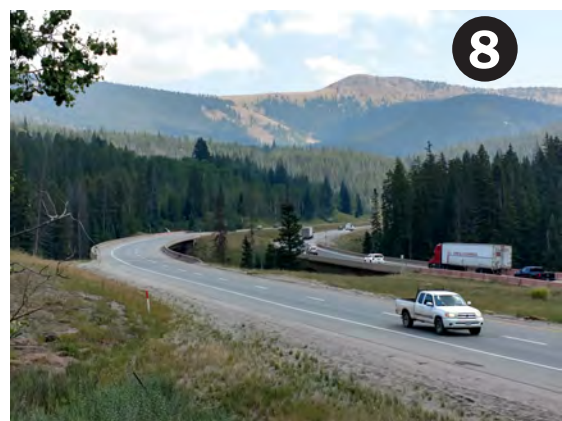
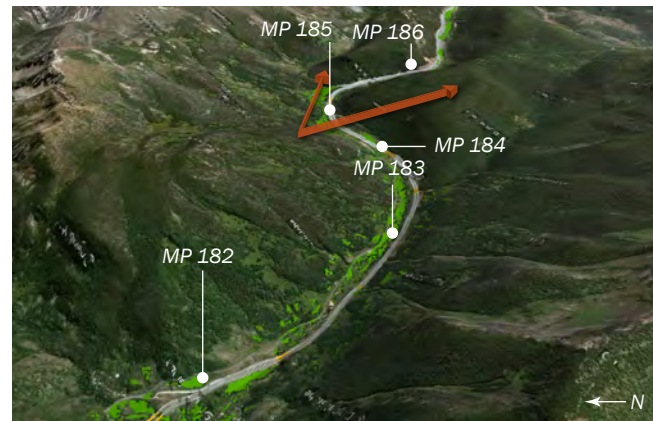
Photo 8 was taken from the Vail Pass Recreation trail and illustrates how the roadway can impact foreground, middle ground and background views for trail users when located close to the interstate. The trail's location slightly above the roadway creates an inharmonious natural environment for trail users. Conversely, due to speed and elevation differences the trail is relatively unseen by interstate travelers.

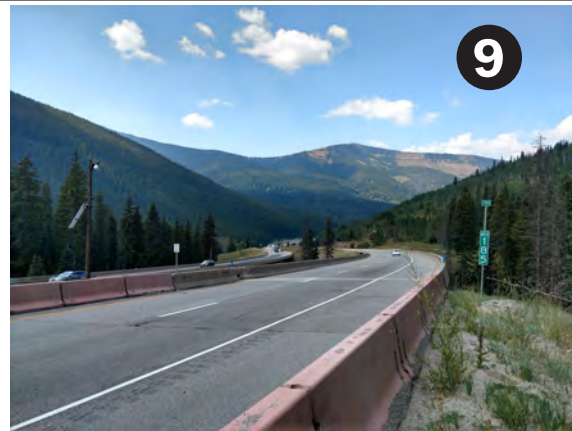
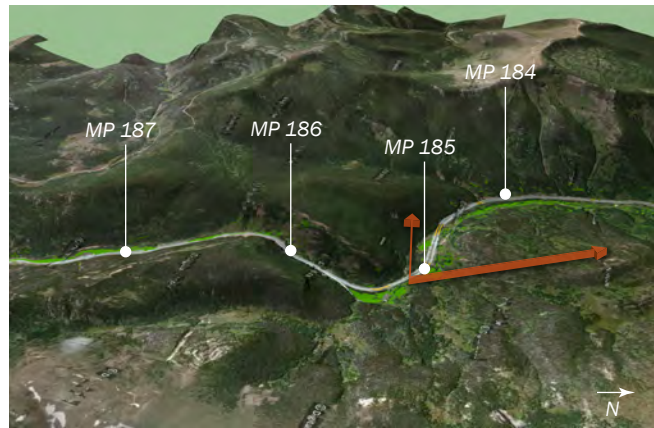
Photo 9 illustrates a view roadway travelers see when moving down the pass toward the Town of Vail. At this location high-speeds and tight corners make the view difficult to access for interstate travelers but does allow travelers their first glimpse of the Vail Ski Resort (located at the top of the furthest ridge line). The Vail Pass Trail crosses under the bridge seen in the immediate foreground of the photograph.

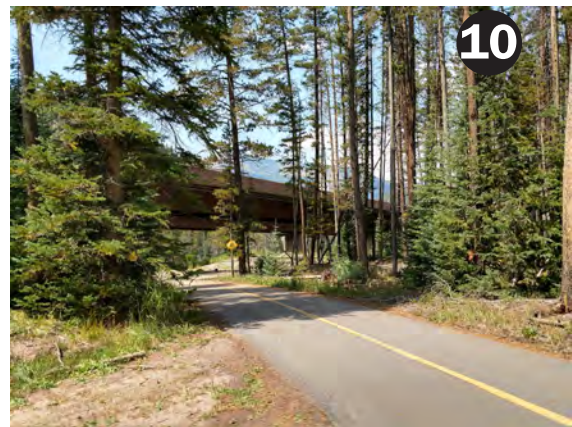
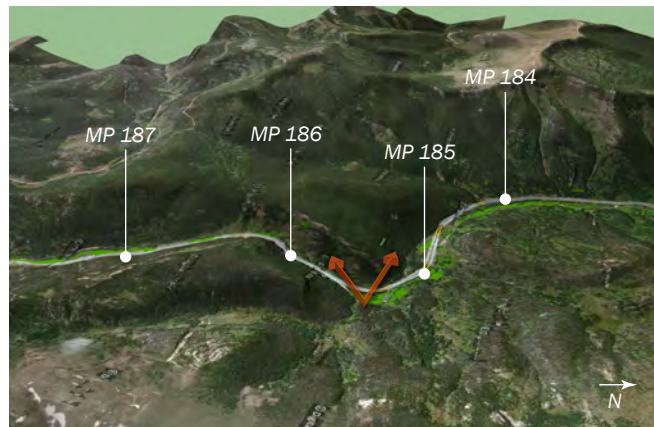
Photo 10 shows the location where the trail crosses under the interstate between mile posts 186 and 185. Extensive vegetation provides a visual buffer for trail users, screening them from the bridge structure and fast moving vehicles on the roadway, and reduces noise impacts. Extension of the natural landscape to the edge of the roadway helps to blend both facilities into the natural visual context.

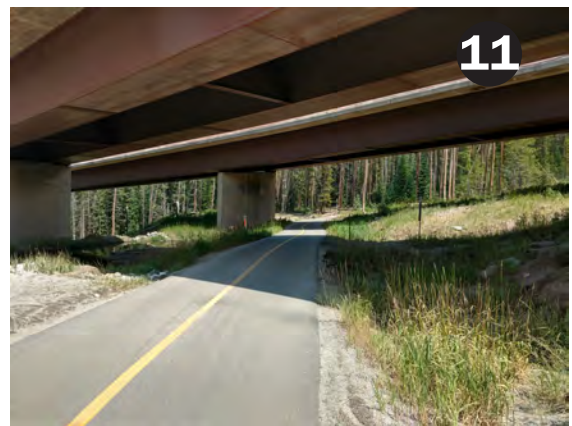
Photo 11 looks in the opposite direction of Photo 10 and illustrates the visual landscape found under the bridge crossing. Separated bridge structures are a critical design element of West Vail Pass. Separation not only lets light reach the trail, it also provides sun for low lying grasses and vegetation, creating a visually interesting environment at one of the landscape unit's most visually conflicting locations.

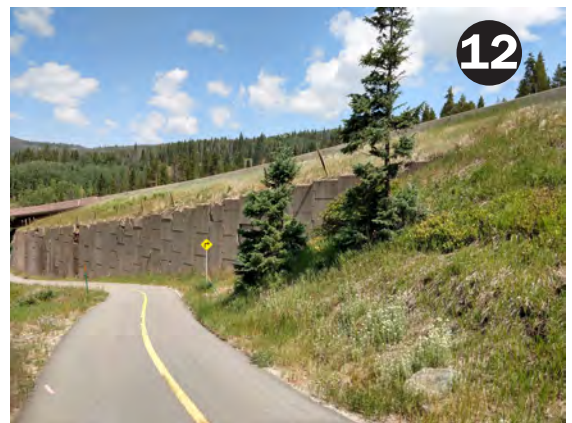
Photo 12 shows the Vail Pass Recreation Trail as it emerges from under the bridge. The existing retaining wall does not incorporate the scalloped design of the roadway and is visually disparate, detracting from the otherwise consistent visual form found in the area. A diverse, naturally vegetated fill slope is located between the trail and the roadway and is reflective of nearby natural landscapes. Extensive grade differences provide for visual relief even though both facilities are close horizontally.

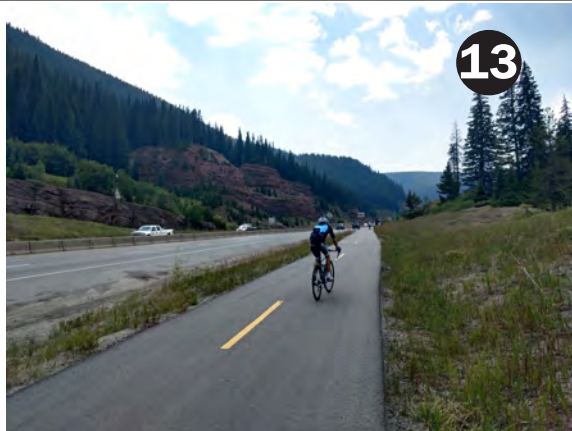
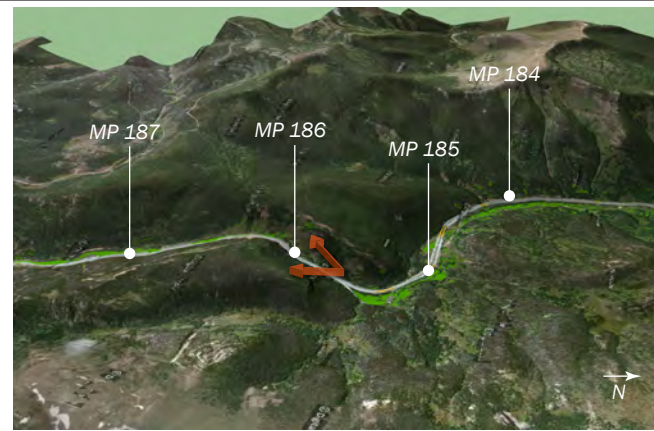
Photo 13 shows the trail in close proximity to the interstate near mile post 186. Horizontal and vertical separation between the two facilities is negligible. At this location the visual aesthetic as well as the safety of trail users is heavily impacted by the interstate.

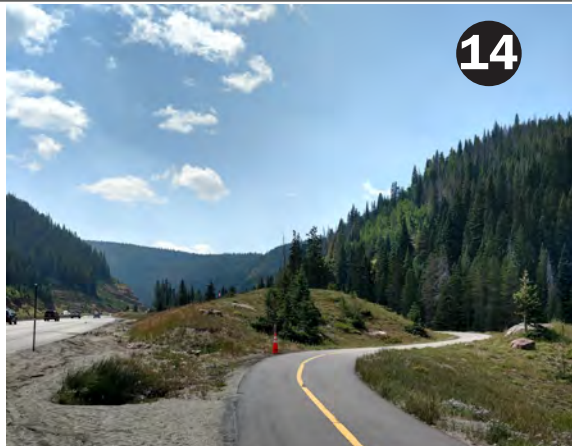
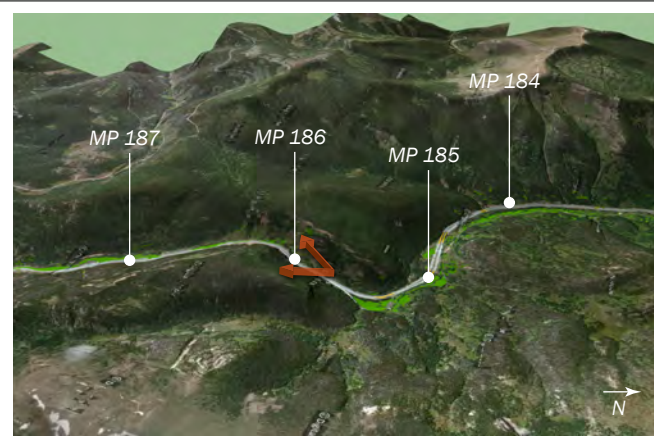
Photo 14 shows a brief departure of the trail from the interstate. In this location, existing landforms were re-contoured and native vegetation was planted to provide both land cover and land forms, buffering trail users. This strategy not only contributes to a better visual environment for trail users but also a more appealing roadside environment for interstate travelers.

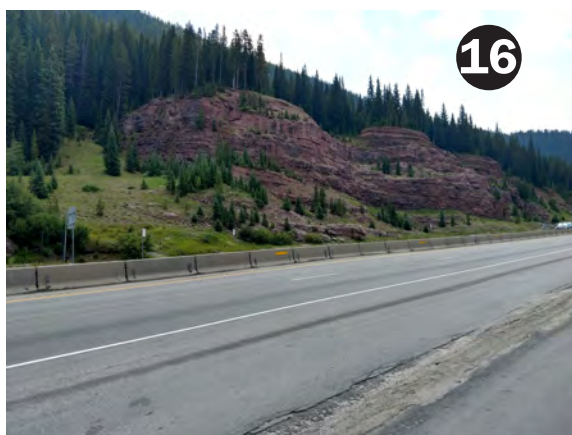
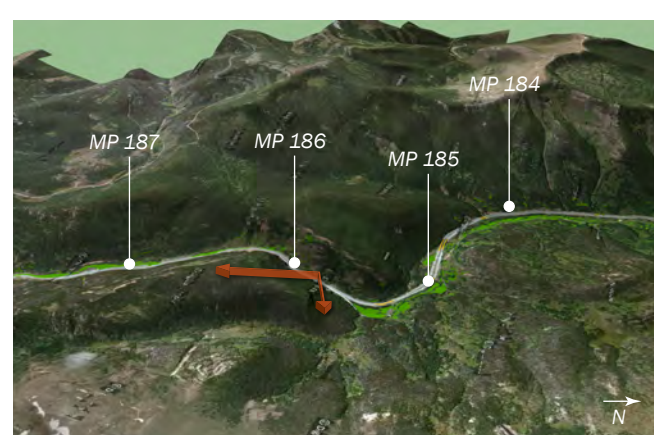
Photo 16 shows how natural land form contouring during construction contributed to a blended and pleasing natural visual environment. Rather than blasting through rock to create a vertical wall, designers terraced and contoured the rock cut and then included re-vegetation measures to create a seemingly natural sand stone cliff. This design created a recognizable landmark that visually expresses the contextual natural environment for viewers of all types.

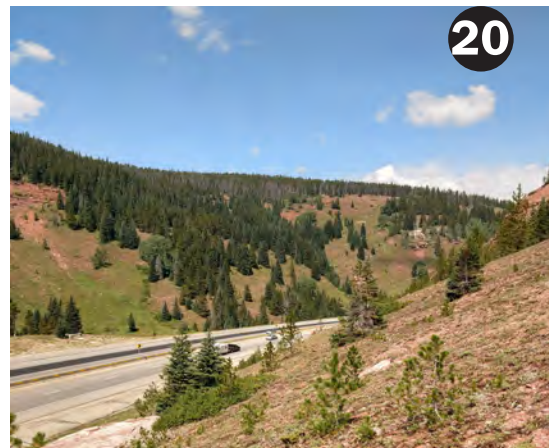
Photo 20 was taken just east of the large sandstone feature identified in Photo 16 and illustrates the warm hues of the landscapes units' geology. It also illustrates the tight and constricted nature of the valley and of the landscape unit in general. While much of the landscape unit is forested; open meadows and slopes directly adjacent to the roadway can be found in select locations, providing visual interest and diversity for travelers and trail users.

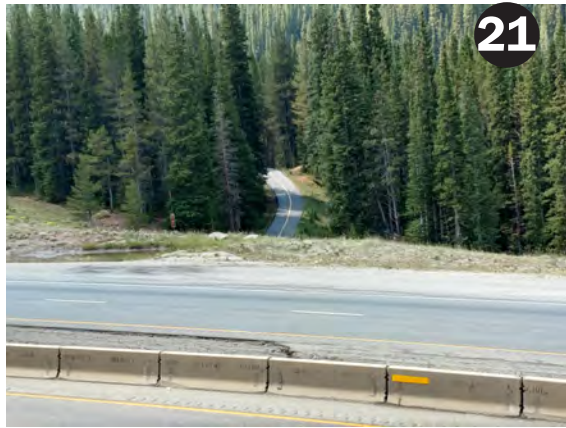
Photo 21 shows the Vail Pass Recreation Trail finally exiting its adjoining interstate alignment near mile post 187. The trail west of this location travels along or near the highway for almost two miles. The well-forested environment of the trail in this location visually buffers users from the externalities of the interstate and signals an alignment that is mostly separated from the interstate until it reaches Copper Mountain.

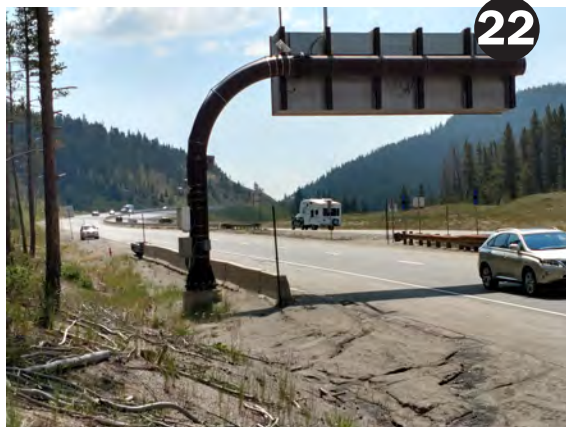
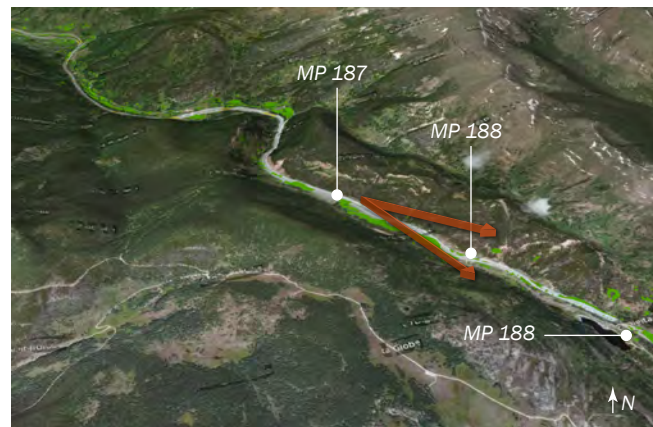
Photo 22 shows one of two variable message signs located on West Vail Pass. The sign and its mast arm have been painted to match the existing environment and are in the same visual vernacular as other project elements. Photo 23 shows how the forest was brought to roadside in order to blend it with surrounding land cover. In this instance colored concrete barriers were not used. Note the dead-fall and stumps in the foreground. During construction designers placed stumps and dead-fall adjacent to the roadway to blend with the adjacent forest.

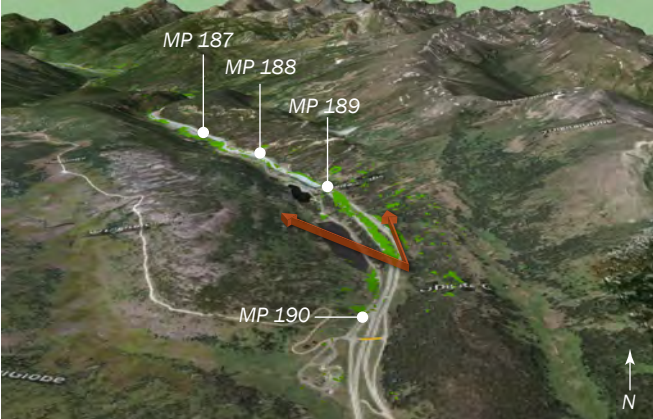
Photo 6 illustrates the substantial revegetation/preservation techniques used when the interstate was originally constructed. These screening strategies used in combination with a separated facility and topographic differences create a visually pleasing view that blends the facility with its spectacular natural context.

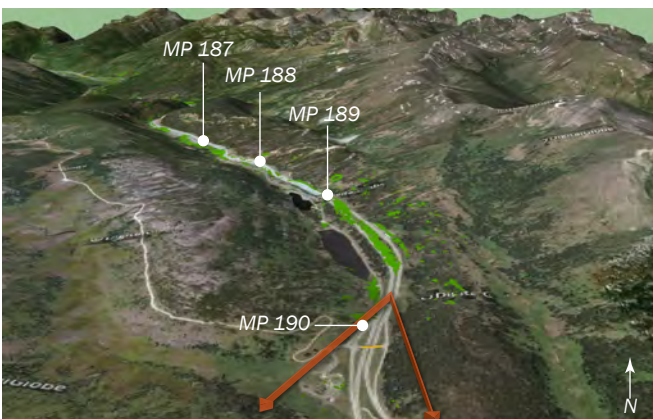
Photo 7 looks east from the CDOT maintenance facility toward the Vail Pass Rest Area. Eastbound travelers have substantial background views of the Ten Mile range that sits east of Copper Mountain. These long and expansive background views define the landscape unit.

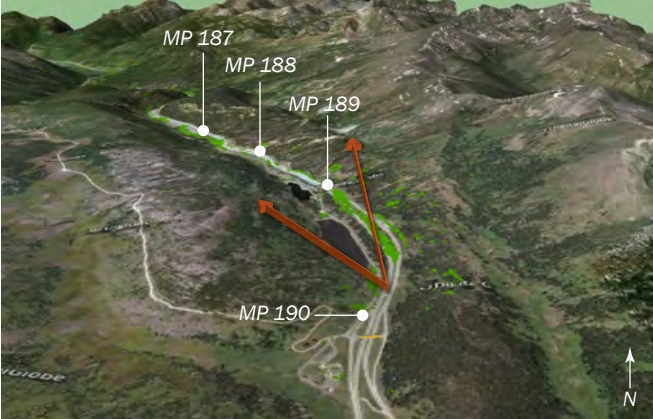
Photo 8 shows one of the few locations that the Black Lakes are visible from the interstate. For travelers to see the lake, eastbound travelers would need to look down and backwards due to elevation differences, vegetated screening, and roadway barriers. Note the warm tone used in the barriers to blend with surrounding geology. The old US 6 alignment is used to access the Black Lakes from the top of the pass. This alignment is shared with the Vail Pass Recreational Trail near the lakes and at the Vail Pass Rest Area exit.

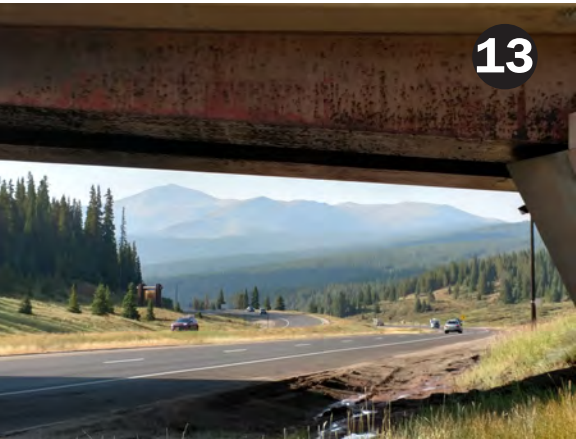
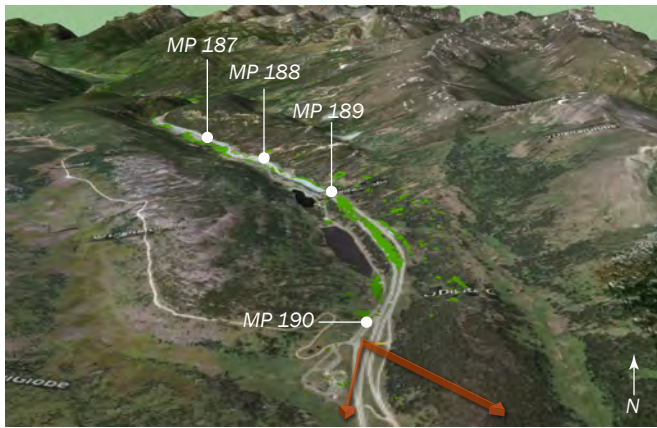
Photo 13 shows the view of eastbound travelers as they pass the rest area exit. The bridge's low-profile frames views of the Ten Mile Range in the distance for travelers. Note how the northern slopes work with the interstate and the bridge to frame the view. Roadside vegetation that matches the natural environment can be seen to the left.

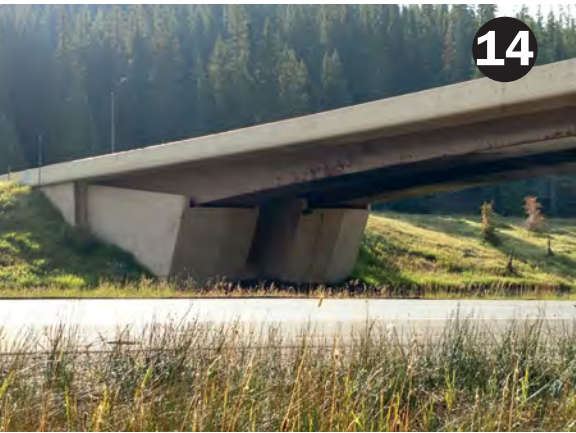
Photo 14 shows how the low profile design and colors of the bridge blend with the natural visual landscape. Note how the dense forest of northern slopes restrict background views at the edge of the facility. This condition persists for the length of the landscape unit's northern roadway edge.

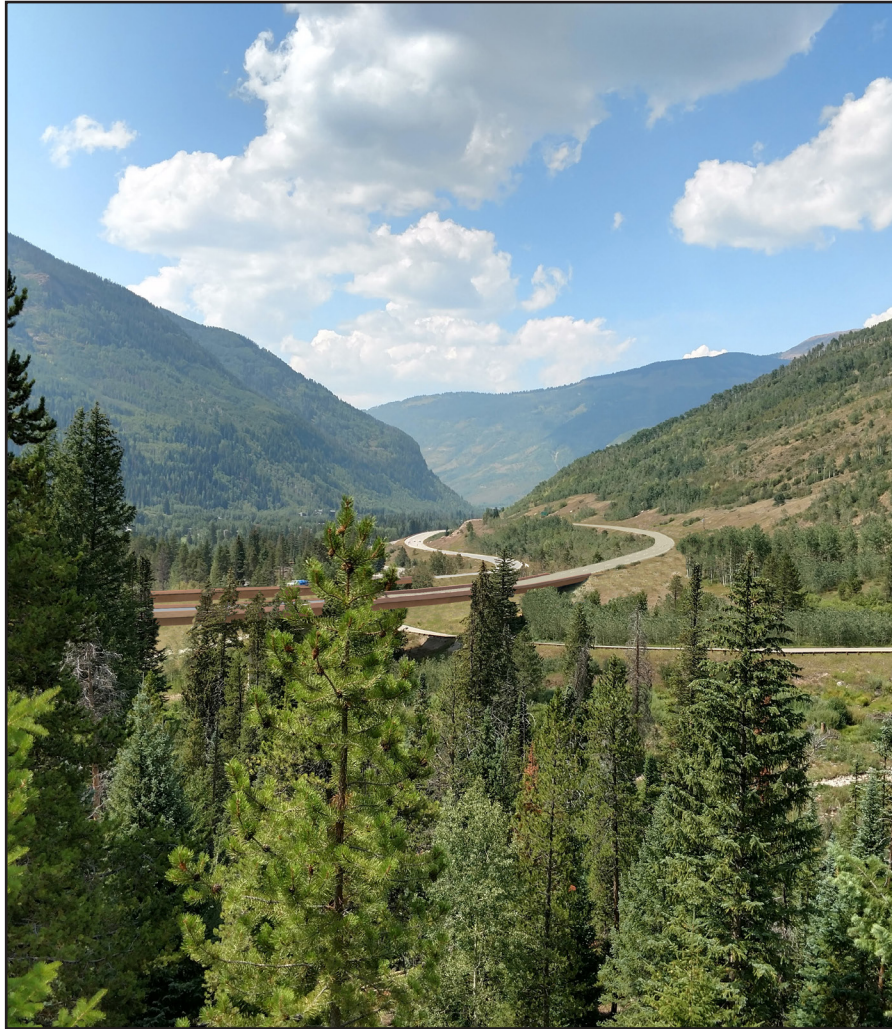
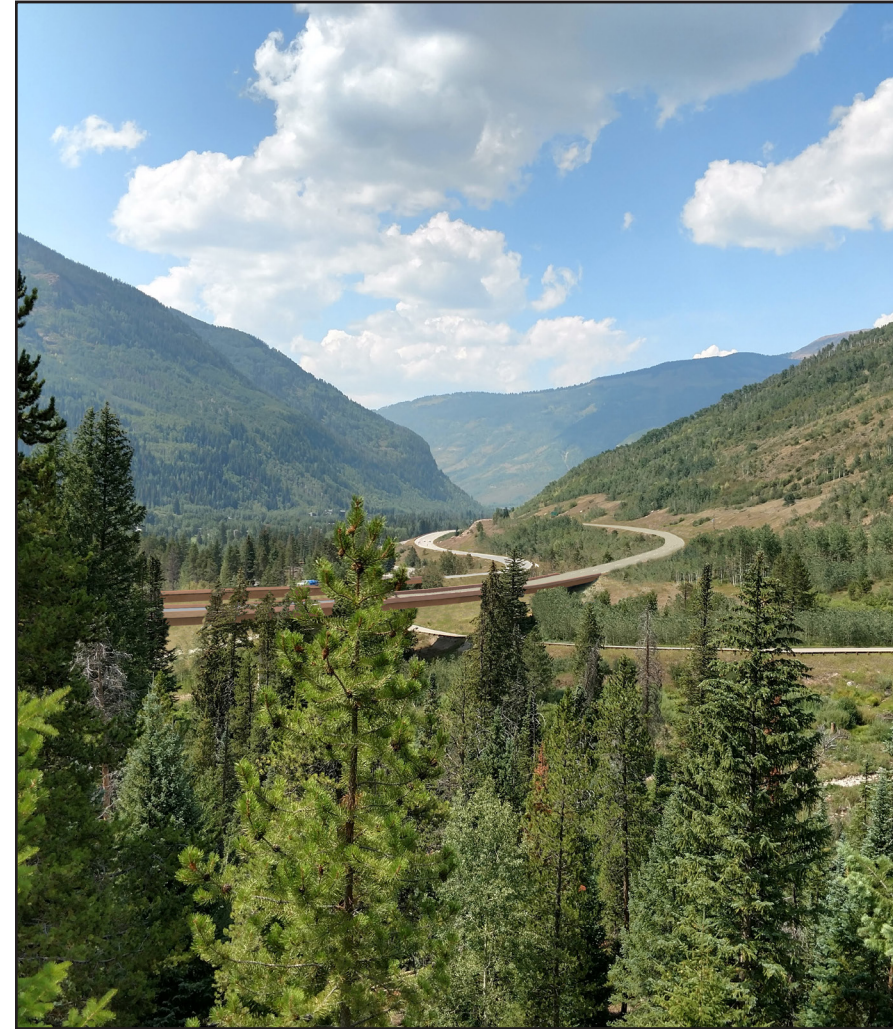
Natural Harmony (Neutral): Widening of I-70 and bridges to six lanes will have an adverse impact upon the natural environment due to additional width needs, requiring the construction of larger structures. Larger bridges will be placed south and west of their existing location, the Gore Creek Campground, and the Vail Pass Recreational Trail. However, movement of the bridges to the south and west of this location will lessen visual impacts due to their increased distance from this location.

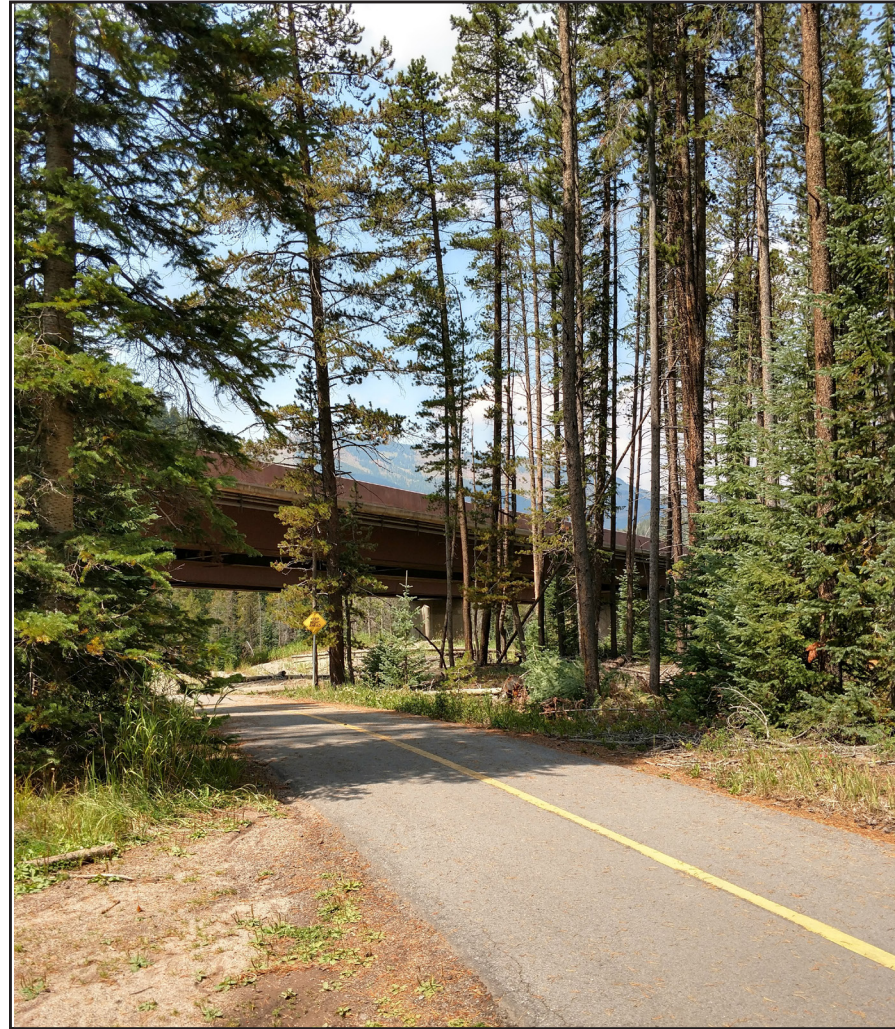
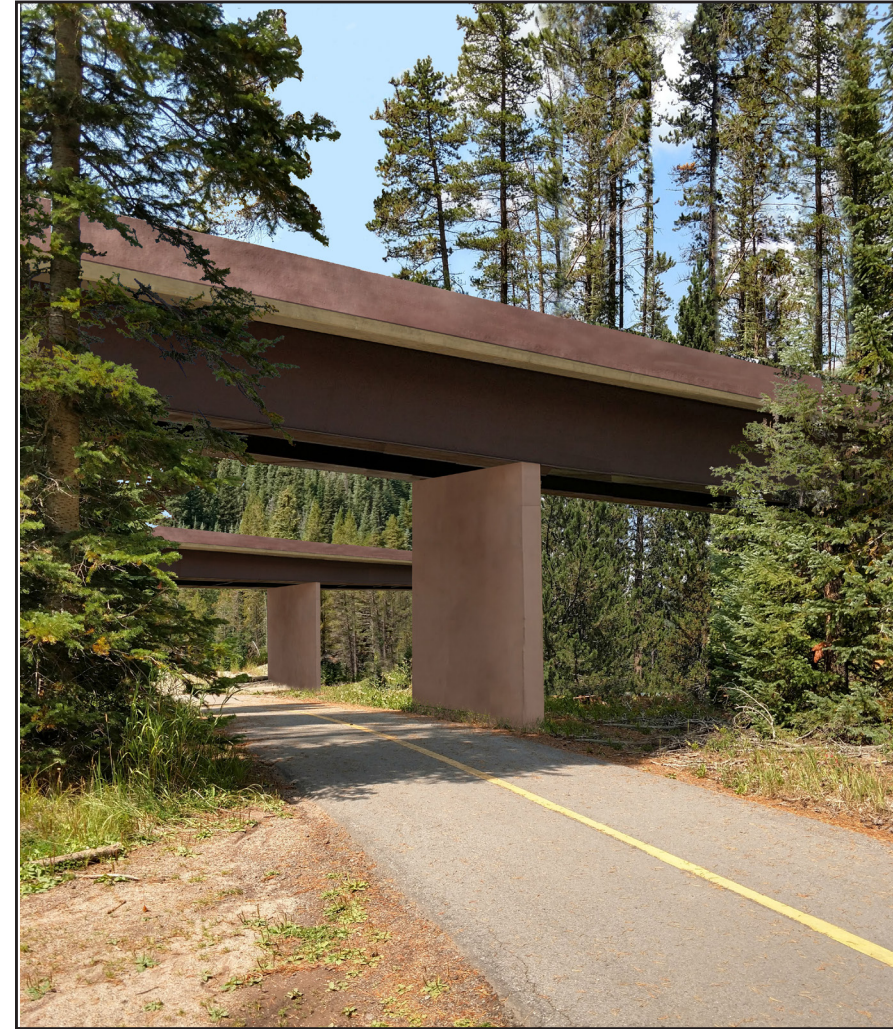
Natural Harmony (Neutral): Widening of I-70 and bridges to six lanes will have an adverse impact upon the natural environment due to additional width needs, requiring the construction of larger structures. However, the new bridges are planned to be constructed further apart. Lessening their combined visual intensity for all users and for recreational neighbors in particular.
