APPENDIX A17
VISUAL IMPACT ASSESSMENT

VISUAL IMPACT ASSESSMENT

March 2020

By David Evans and Associates, Inc.

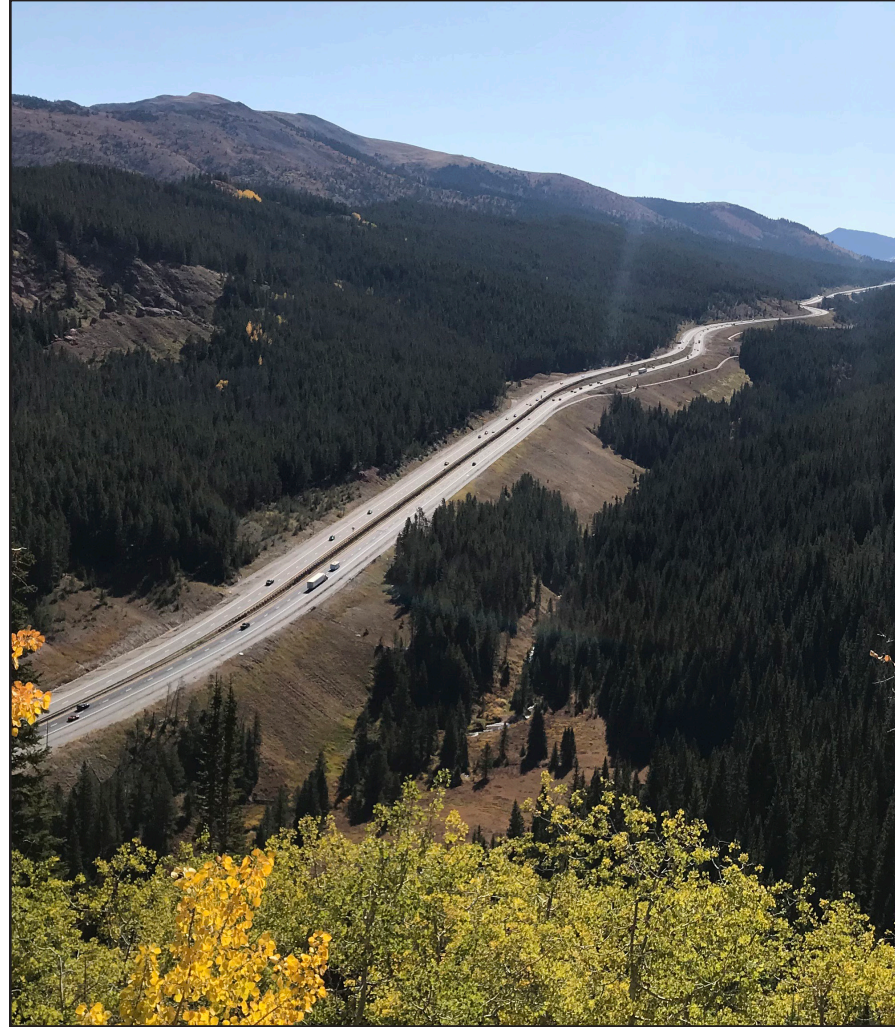
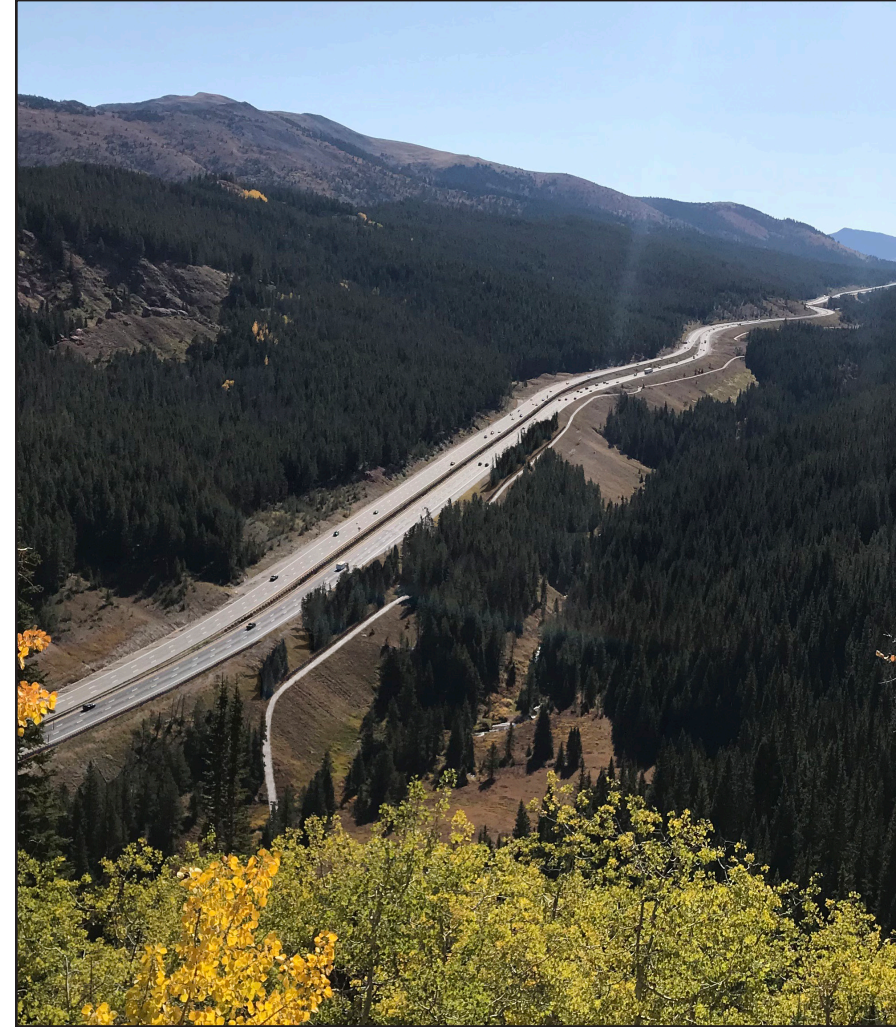
Natural Harmony (Beneficial): Recreational neighbors within the current built condition experience a disjointed and unharmonious visual environment due to the proximity of the trail to I-70's EB travel lanes. Movement of the trail away from I-70 will create a visual composition that is better integrated into the natural context. For travelers, relocation of the trail will have a neutral impact on their perception of visual natural harmony.

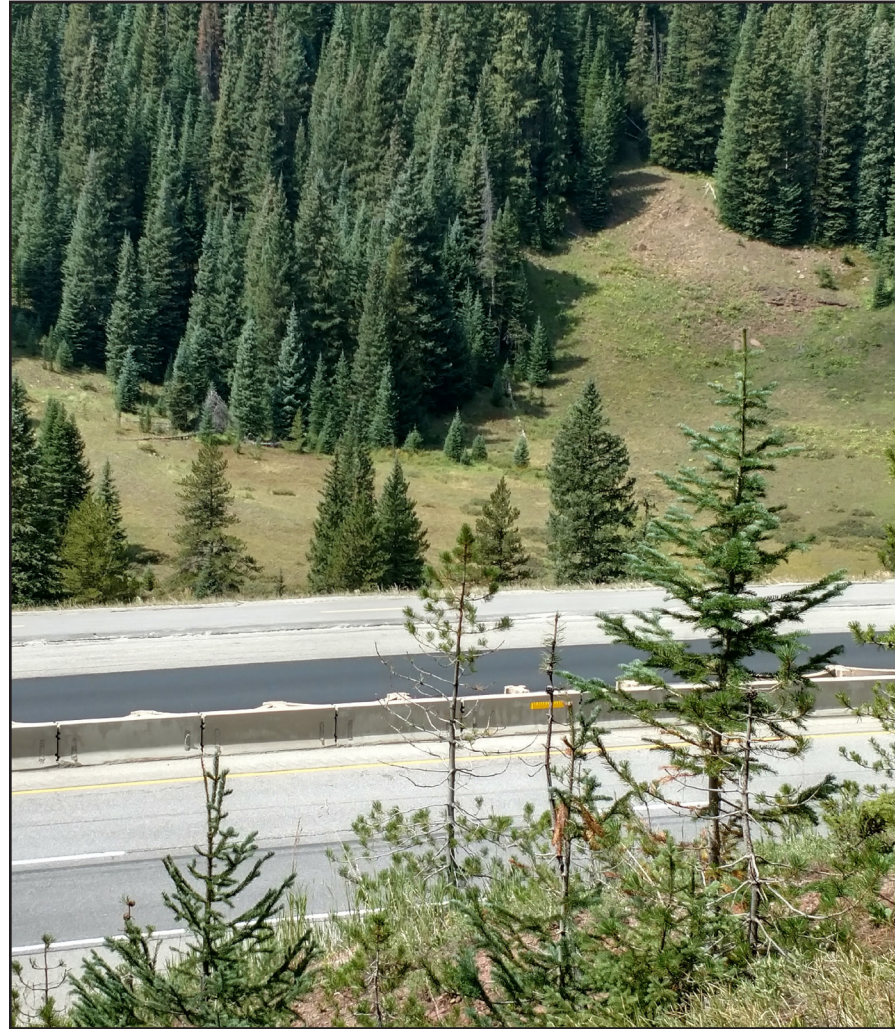
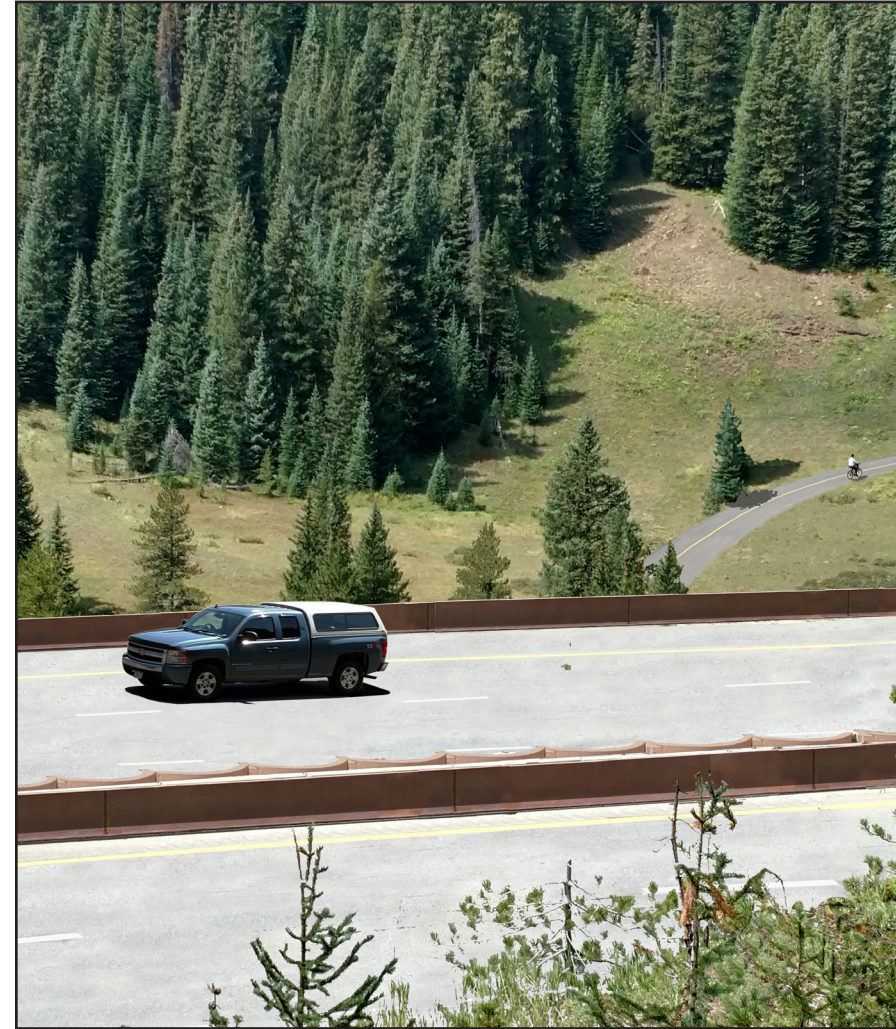
Natural Harmony (Beneficial): Recreational neighbors within the current built condition experience a disjointed and unharmonious visual environment due to the proximity of the trail to I-70's EB travel lanes. Movement of the trail away from I-70 and to the other side of the valley create a visual composition that is better integrated into the natural context. For travelers, relocation of the trail will have a neutral impact on their perception of visual natural harmony.
