### COLORADO HIGHWAY 71 *(Limon north to Colorado/Nebraska state line)* TRUCK FREIGHT DIVERSION FEASIBILITY STUDY

# ENVIRONMENTAL SCAN TECHNICAL REPORT

State Highway 71 Super-2 Design  
Limon, Colorado to the Nebraska State Line

STA 071A-019

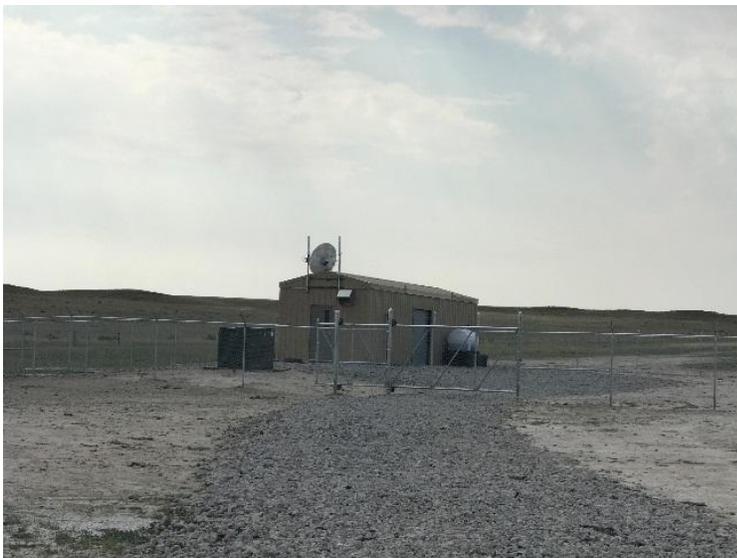
*Figure 2. Existing generator and AST in the Study Area*

The windshield review identified the following potential hazardous material sites:

- Oil and gas facility north of milepost 127
- Telecommunications facility at milepost 129
- Fire station north of milepost 138
- Oil and gas facilities south and north of milepost 141
- Telecommunications facility south of milepost 142
- Abandoned equipment house north of milepost 152
- Oil and gas facility north of milepost 153
- Electrical substation north of milepost 174
- Equipment junk yard at southeast corner of SH 71 and Business I-76
- ASTs just south of milepost 177
- Generator and AST south of milepost 220 (see Figure 2)
- Oil and gas facility north of milepost 230 (see Figure 3)

In future project activities, additional assessment may be required. The purpose of conducting a more detailed hazardous material assessment is to provide the information needed to plan to avoid or minimize impacts on known and potential hazardous materials and contaminated sites. During the final planning and design process, the information provided in this environmental scan report can be used to identify avoidance options, when possible, and to assist with the development of specific contaminated soils/groundwater material management or mitigation measures. Properties to be acquired also may require individual site assessments and/or preliminary site investigations as part of the right-of-way (ROW) acquisition process.

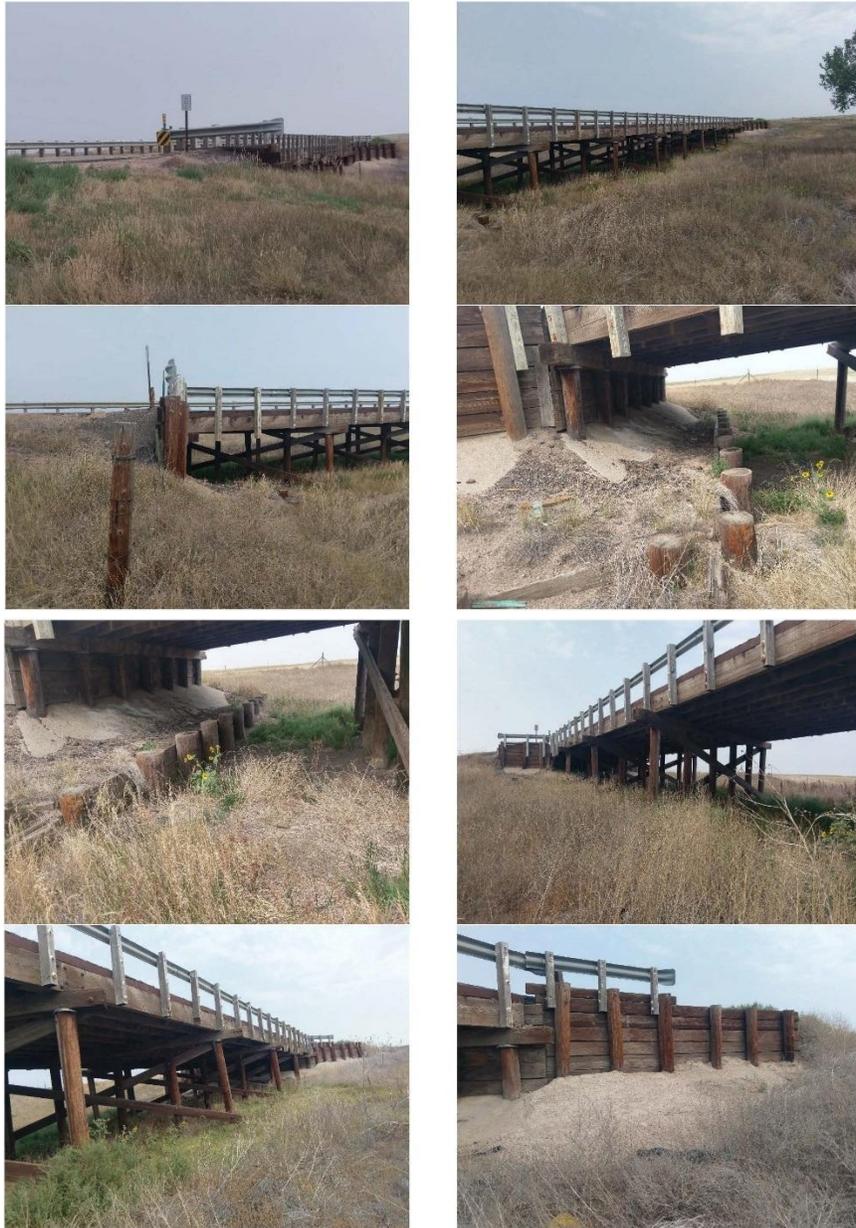
Figure 4. Bridge D 22 C Pictures

The 100-year flood plain is well maintained farmland on either side and is conveyed under the roadway via what appears to be a historic waterway. There was no flow on the day of the field study. The waterway is conveyed under Bridge D 22 C. The bridge structure is made of lumber and the abutments are a combination of lumber and concrete. The bridge shows no structural problems and appears to be weathering the environment well. There are some cracks in the concrete portions of the abutments, but no significant shifting.

The lumber support structures show normal wear and the mud on them from water flows is only a few inches high. The ground is relatively smooth and shows no signs of scouring. The supports also show no signs of scouring. The condition of the bridge on the day of the field study can be seen in Figure 4, Figure 5, and Figure 6.

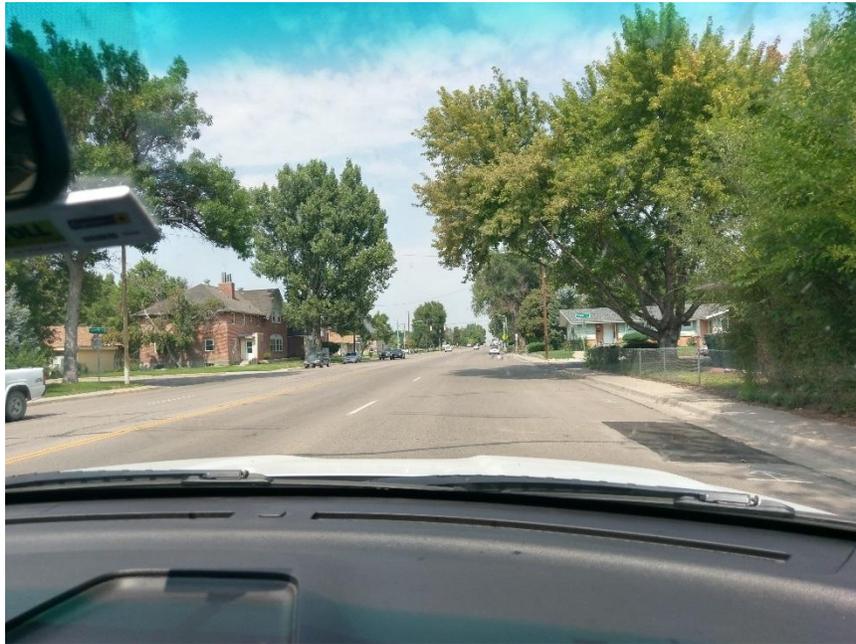
*Figure 7. Colorado Avenue within 100-year Flood Plain*

The conveyance of the 100-year flood under SH 71 is by Bridge C 22 BS. Most of the 100-year flood plain, however, conveys over SH 71 as sheet flow. Figure 7 below is a picture of Colorado Avenue within Brush, looking north.

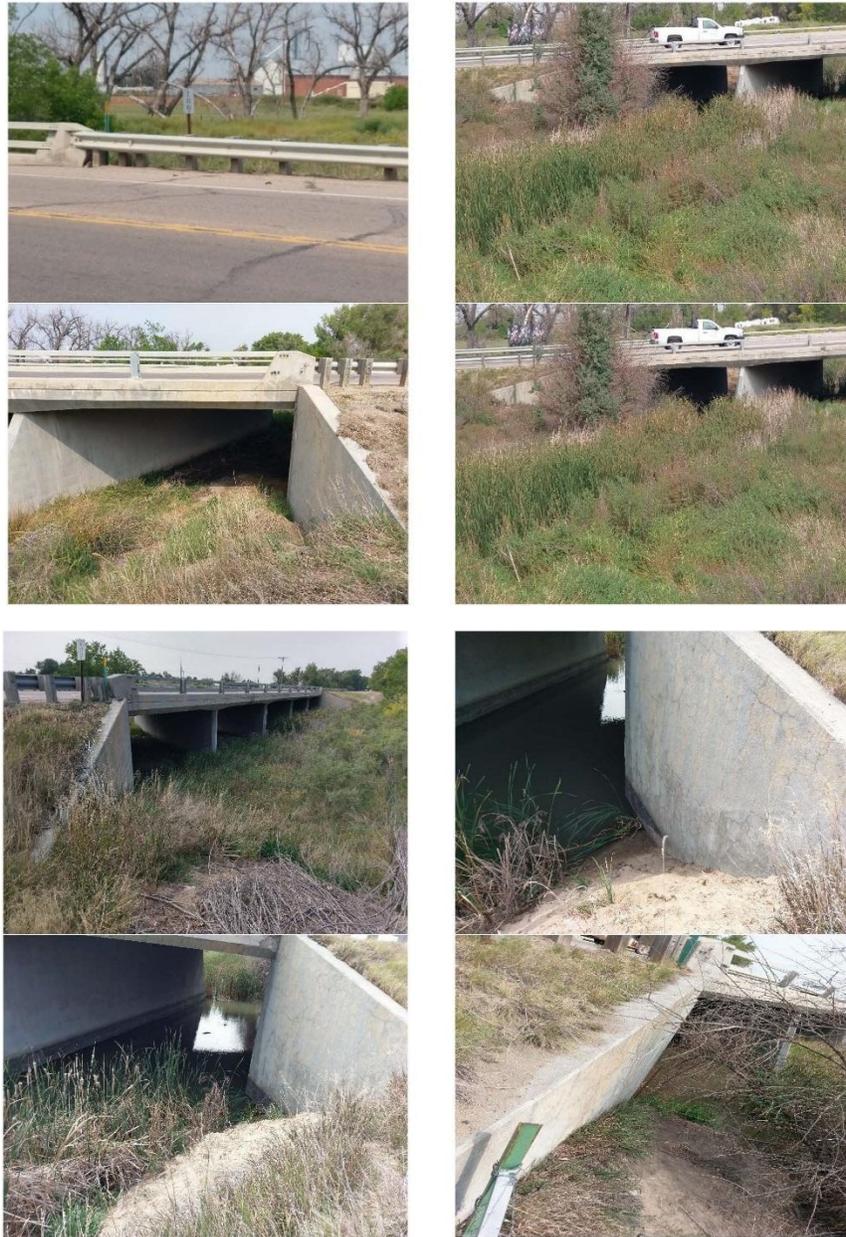
Figure 8. Bridge C 22 BS Pictures

Bridge C 22 BS is concrete and steel construction. The bridge generally is in very good condition. There is minimal degradation of the structure. There are four concrete structures bearing the bridge that define five segments under the bridge. Slow moving flow runs through the center segment while the other segments are merely wet, grassy areas.

The exception is the western most segment. Here, there is a standing pool of water under the bridge. While this appears to be the result of scouring, the pool appears to be only of deposited materials. This implies that the scouring only brought the elevation back down to the natural elevation.

Figure 8 below, shows the condition of Bridge C 22 BS on the day of the field study.

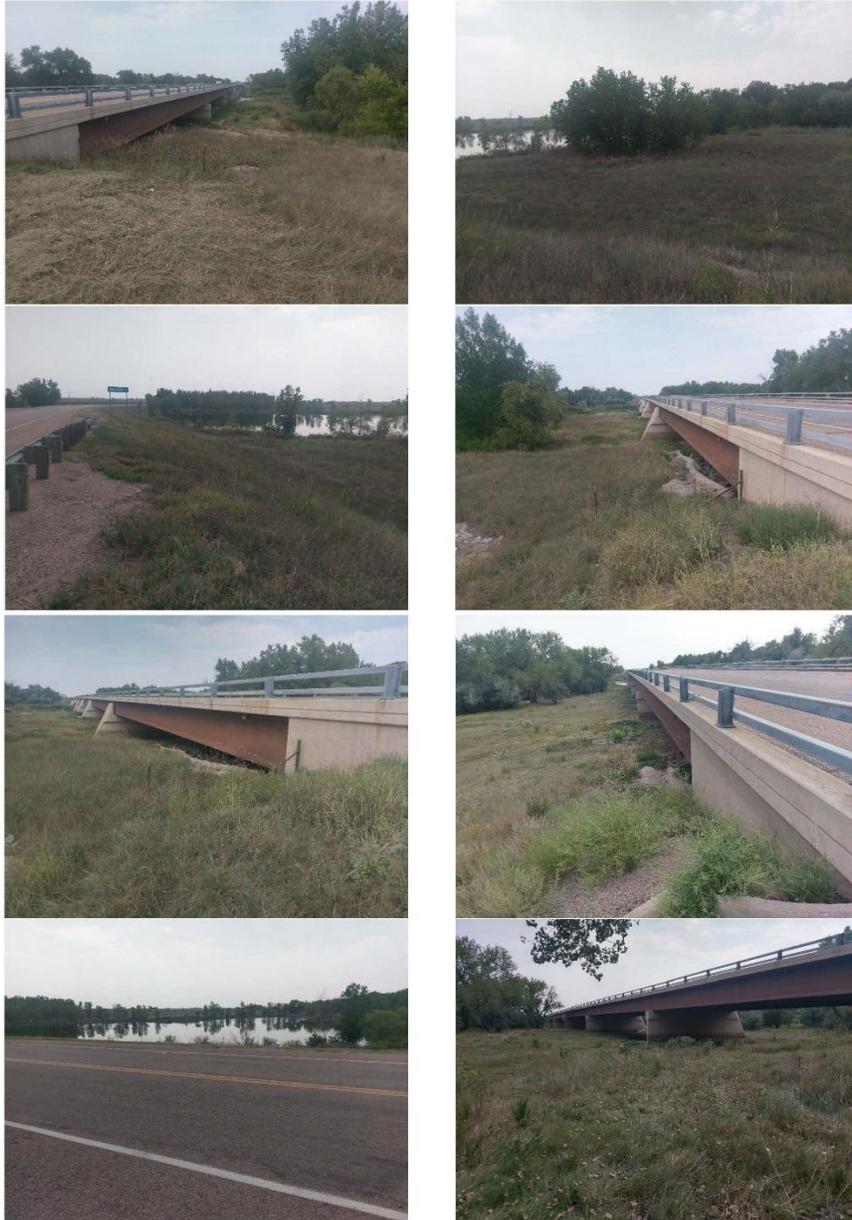
*Figure 9. Bridge C 22 BT Pictures*

It conveys under SH 71 via Bridge C 22 BT. The bridge generally is in very good condition. There is minimal degradation of the structure, most of the paint is intact even to within inches of the stream bed. There are

The condition of the bridge on the day of the field study can be seen in Figure 9 and Figure 10.

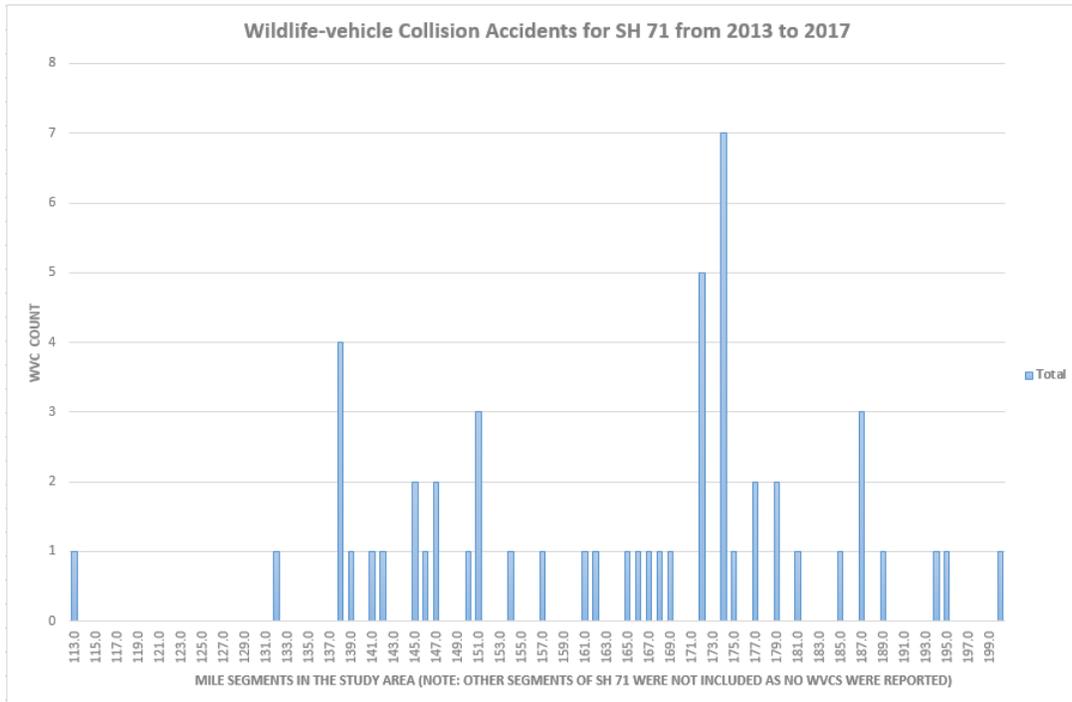
Figure 11. Wildlife-vehicle Collisions Reported on SH 71 between 2013 and 2017.

Deer are the most commonly reported species. This is likely because they are more visible and cause more damage to vehicles than the smaller wildlife species present. In general, WVCs are usually under-reported across the state, as wildlife will typically move away from the scene of an accident if they are still able to. Other reasons for under-reporting can also be due to if a collision doesn't cause damage to a vehicle or injury to a person.

Based on a review of available crash data, WVC's are spread out across 87 miles of the study area and no WVC's were reported on Route 071F (north of SH 14 to the Nebraska state line). The largest increase in WVCs occurs between Mile Post 172 and 175, south of the Town of Brush where SH 71 enters a more built-up environment and where there are curves that may reduce visual site-distance for drivers to avoid hitting wildlife. There are other WVCs along SH 71 that are located along similar curves that likely occurred due to similar site-distance limitations. Figures 11 and 12 below identify WVC occurrences at mileposts along SH 71 between 2013 and 2017.

While WVCs occur in the study area, they are at lower levels than on other highways in the state and it is likely due to the overall flat terrain, high permeability of the roadway, and lower traffic volumes.

A more detailed analysis of WVCs and carcass data is recommended during future project design/NEPA stages for improvements to SH 71 as this analysis will inform on target species, design elements, and potential mitigation plans.
