# 4.0 AFFECTED ENVIRONMENT

This chapter discusses the existing social, economic, and physical environment of the I-25 Corridor and US 85 Corridor. The project limits along I-25 are from C-470 to Douglas Lane and along US 85 from C-470 to Meadows Parkway.

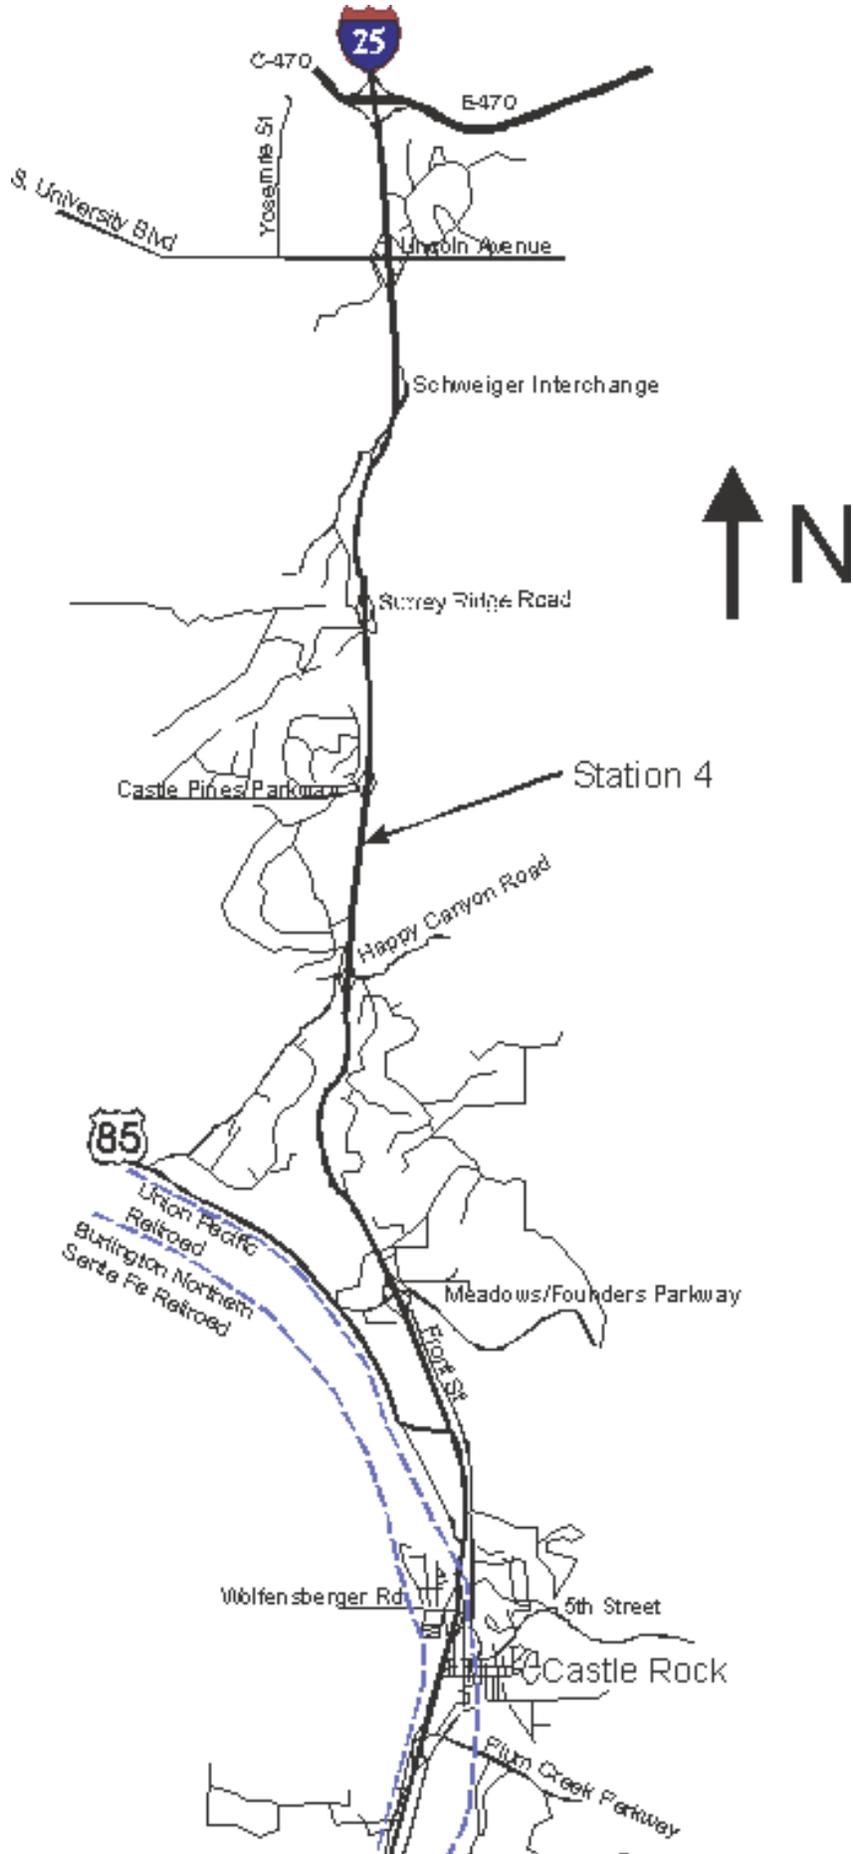
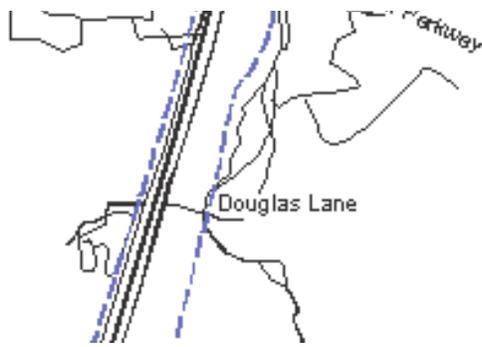
**Figure 4.5a**

### Wildlife Tracking Station Locations along the I-25 corridor

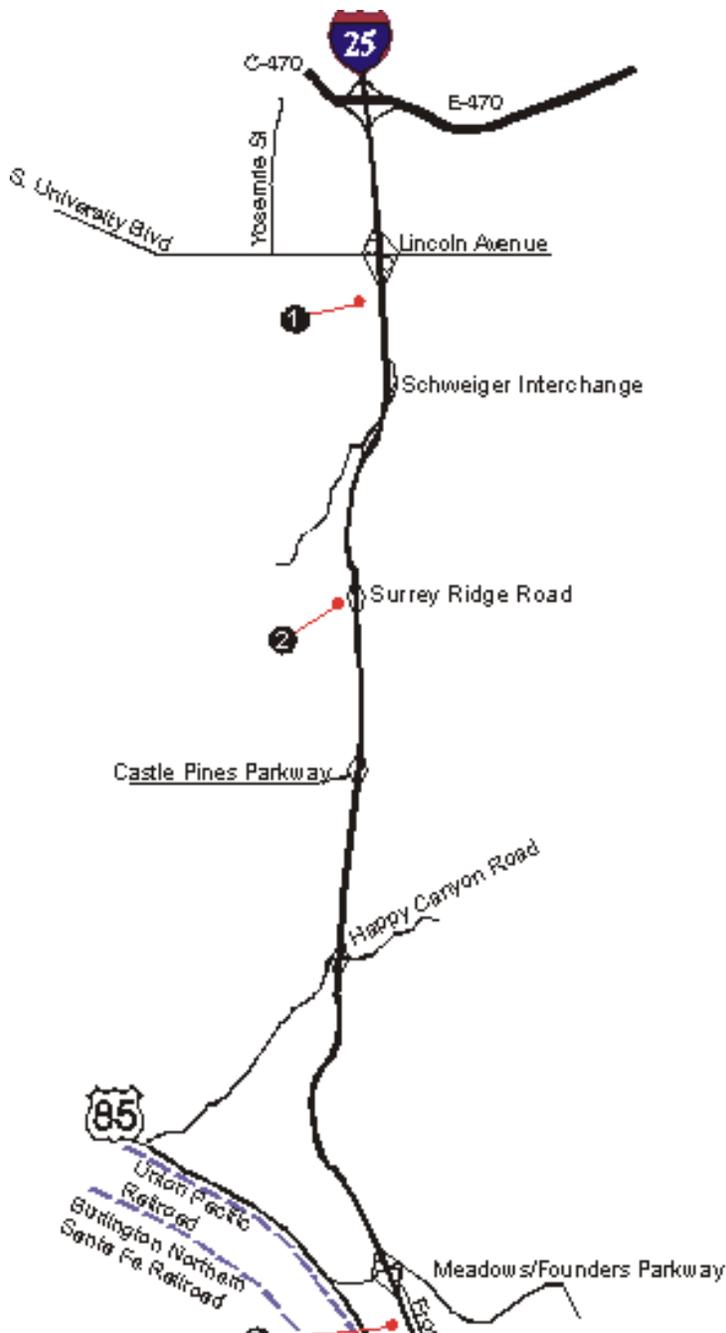
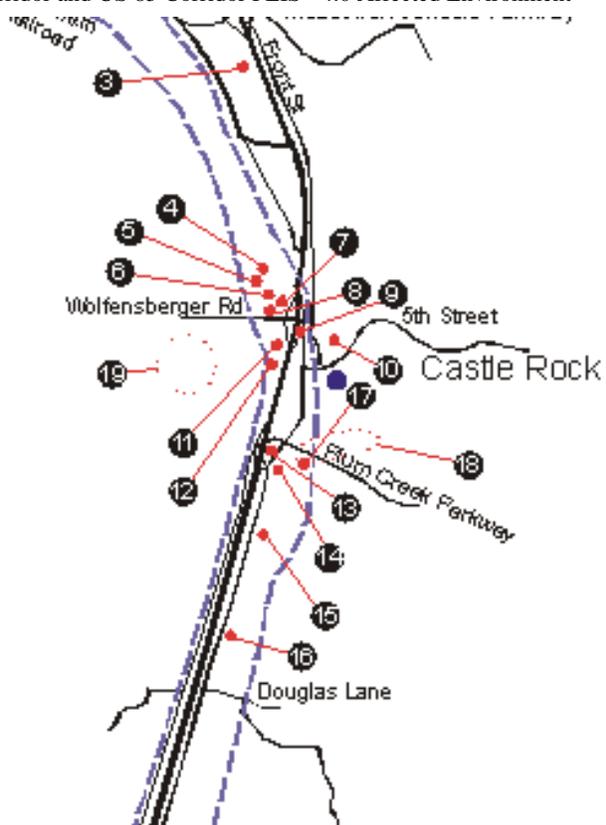
**Figure 4.10b**  
**Potential Hazardous Waste Sites**  
**along the I-25 Corridor**

- ① Possible Fill
- ② Mile High Equipment Spill Site
- ③ Dirt and Rock Pile Area
- ④ Trailers USA
- ⑤ Traffic Sign Storage Area
- ⑥ Bayer Tire Store
- ⑦ Mobile Home Sales Lot
- ⑧ Car Dealership
- ⑨ Phillips 66 Gasoline Station
- ⑩ Western Gasoline Station
- ⑪ Fill Dirt and Disturbed Soil Area
- ⑫ Abandoned Railroad Station
- ⑬ Self Service Gasoline Station
- ⑭ Western Truck Stop
- ⑮ Medved Brutyn Ford
- ⑯ Scrieber Equipment
- ⑰ Former Douglas County Justice Center
- ⑱ Andrews Addition Landfill

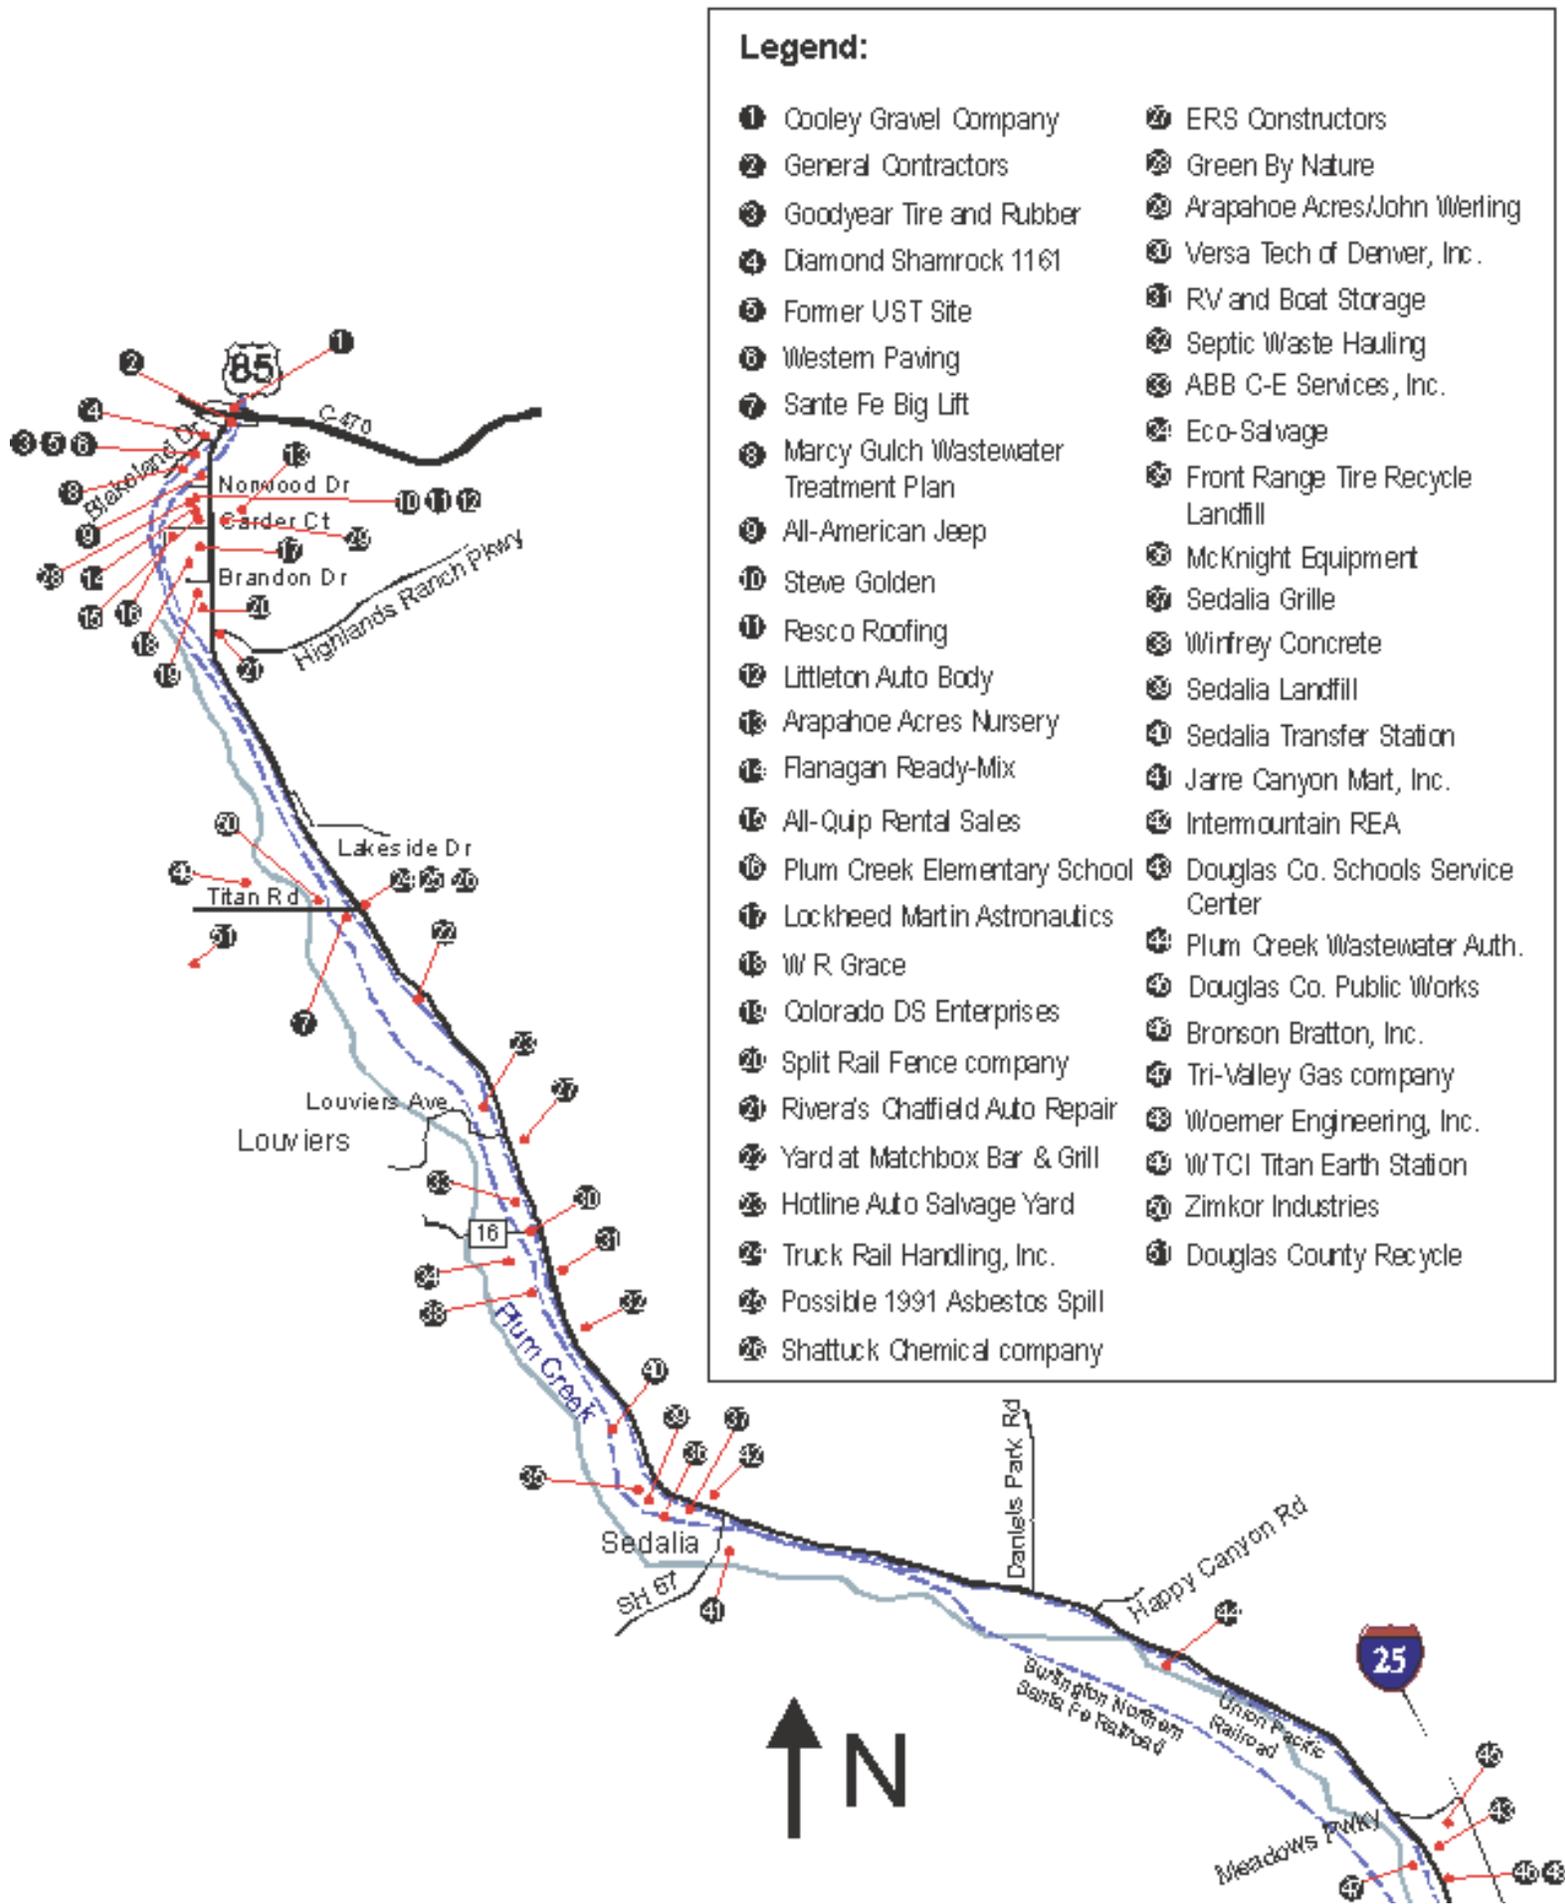
**Figure 4.10d**  
**Potential Hazardous Waste Sites**

along the US 85 Corridor

Fifty-one potential hazardous waste sites were located within the study area (Figure 4.10d). These sites of potential concern could be within future highway construction zones.
