**SH 7A (Lower)
Raymond to Lyons
Site Repairs between Mileposts 19 and 33**

**Boulder County
COLORADO**

Damage Assessment Report

**100% DRAFT
Revised: July 28, 2014**

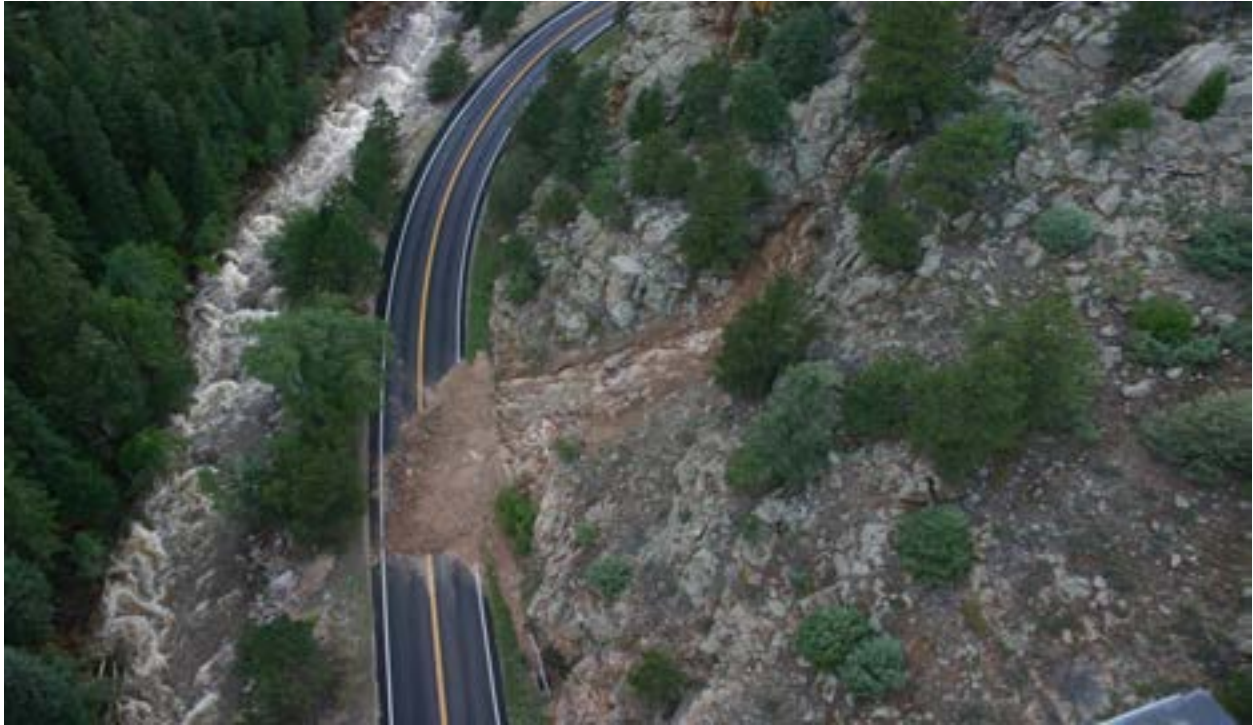
Figure 26 - MP 24.0, Rock slide covering both roadway lanes.

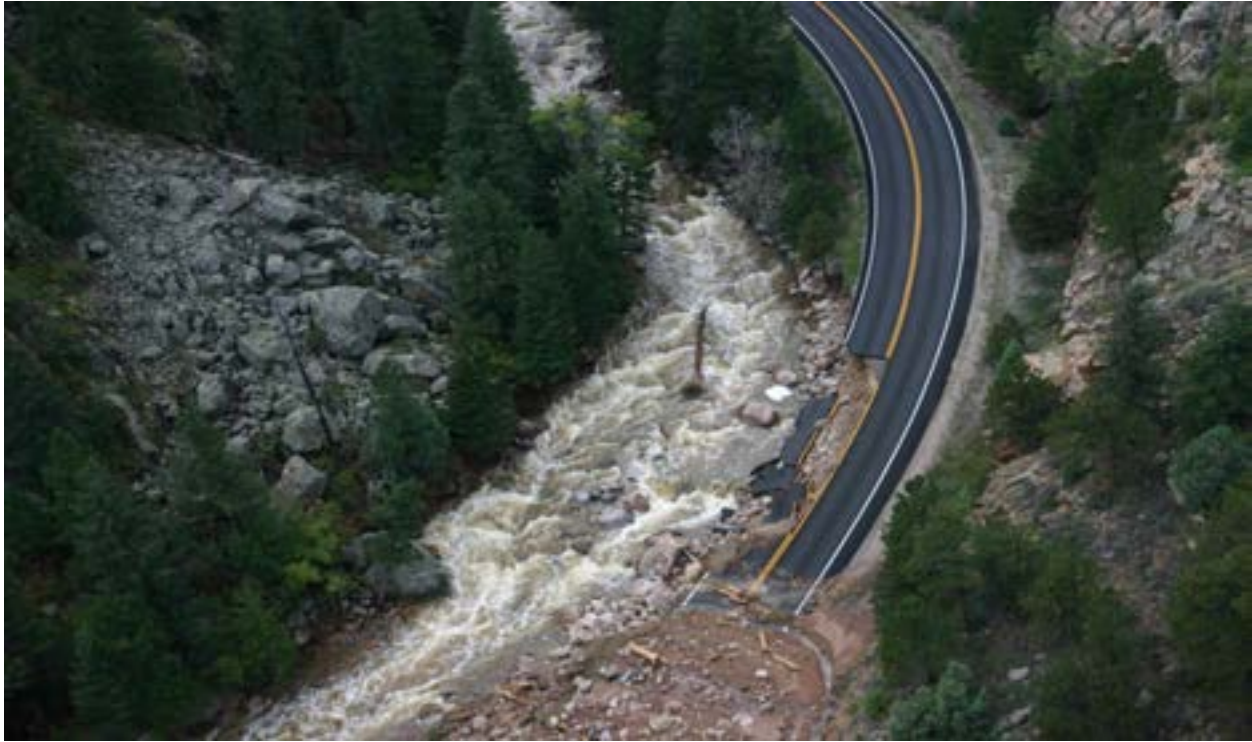
Figure 28 - MP 24.75, Rock slide and debris covering roadway lanes, embankment and roadway washout.
