Report No. CDOH-DTD-R-90-3

**COLD-RECYCLING OF
ASPHALT PAVEMENT - U.S. 24
PROJECT CX-04-0024-25**

Donna S. Harmelink
Colorado Department of Highways
4201 E. Arkansas Avenue
Denver, Colorado 80222

Final report
June 1990

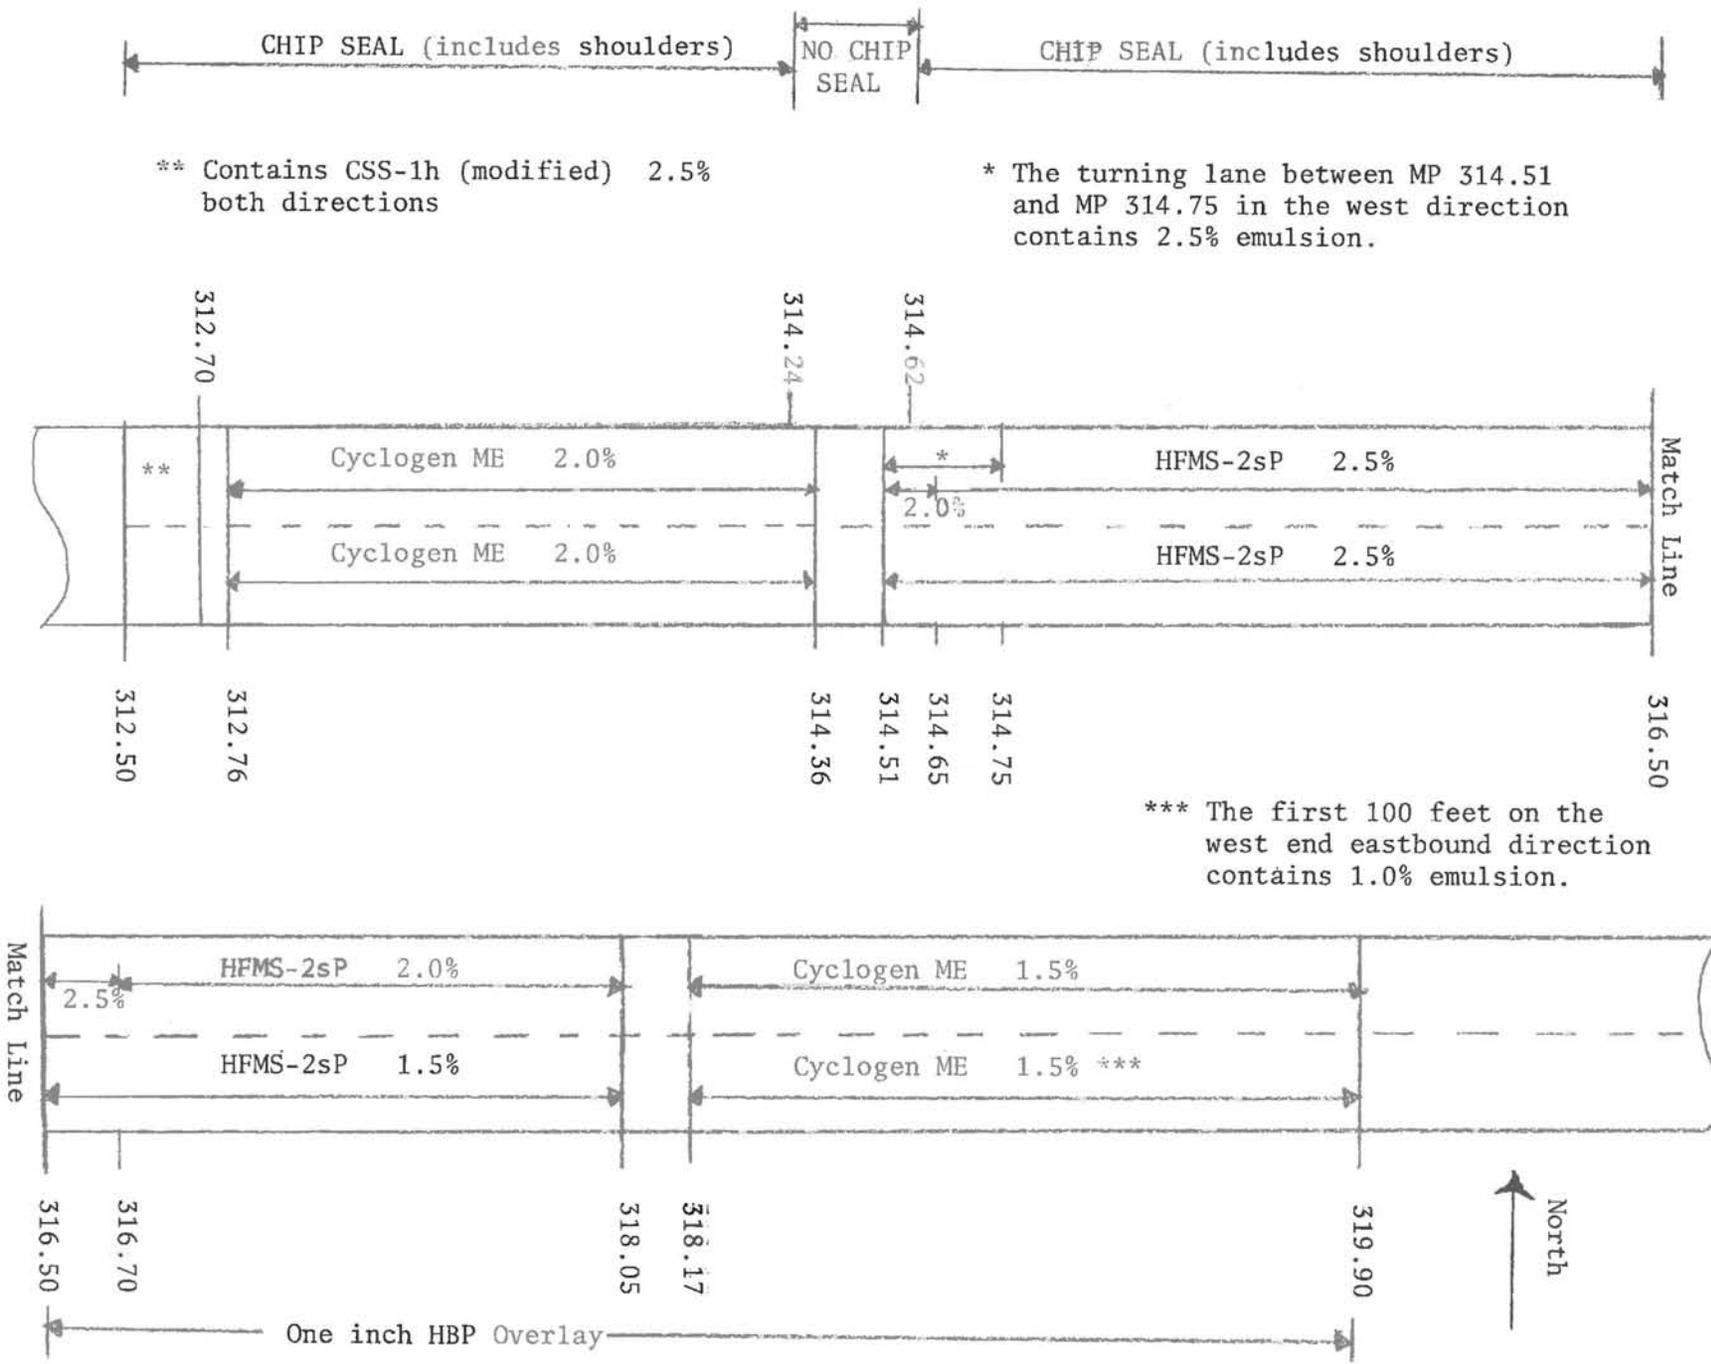
FIGURE 2

Table A contains the final percentages of emulsion that were added in each section. A map of the project with the percentages in each section is shown in Figure 2.

Emulsion/Application Rate Locations

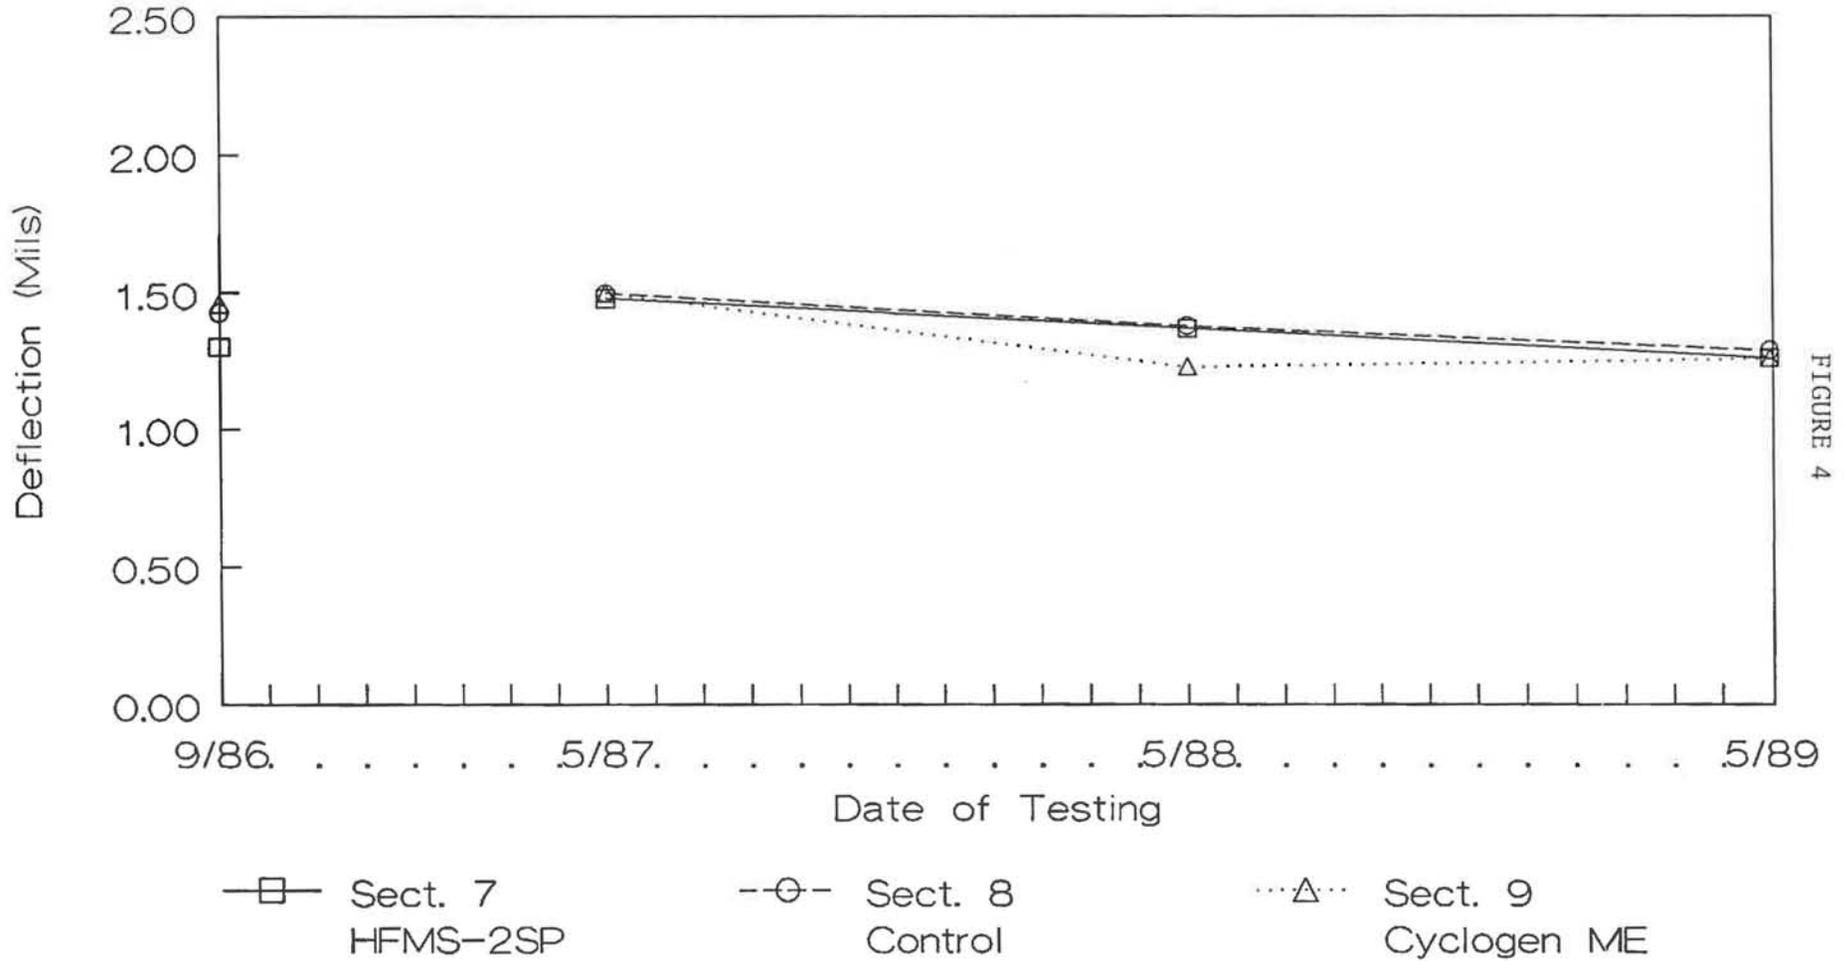
FIGURE 4

The Research Branch's Dynaflect was used to measure pavement deflections. Measurements were made at 50 foot intervals throughout each test section, and only the sensor directly beneath the load was used for evaluation purposes. Deflection measurements were taken prior to construction, immediately following construction, and in the spring of each year following construction. Graphic representation of deflection results can be seen in Figure 4 and Figure 5.

** Dynaflect Readings Sensor No. 1, Sections 7, 8, and 9

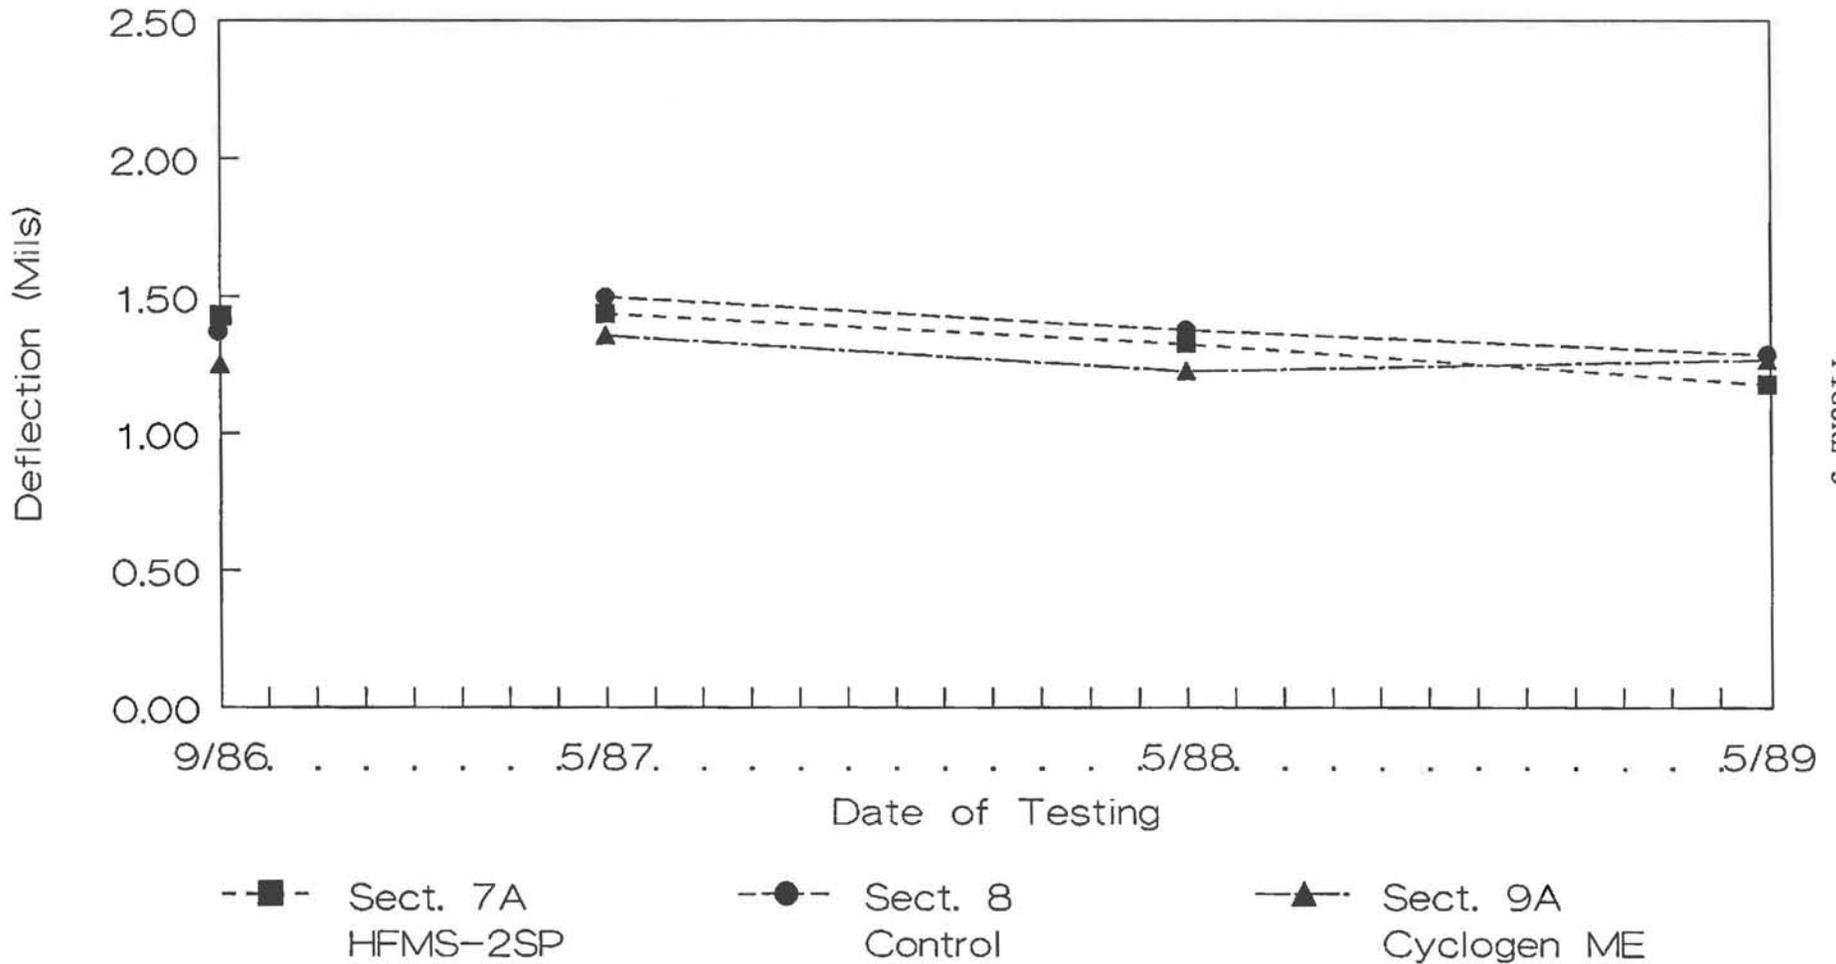
** Dynaflect Readings
 Sensor No. 1, Sections 7A, 8, and 9A
