Report No. CDOT-DTD-94-5

Large-Stone Hot Mix Asphalt Pavements

**Final Report
April 1994**

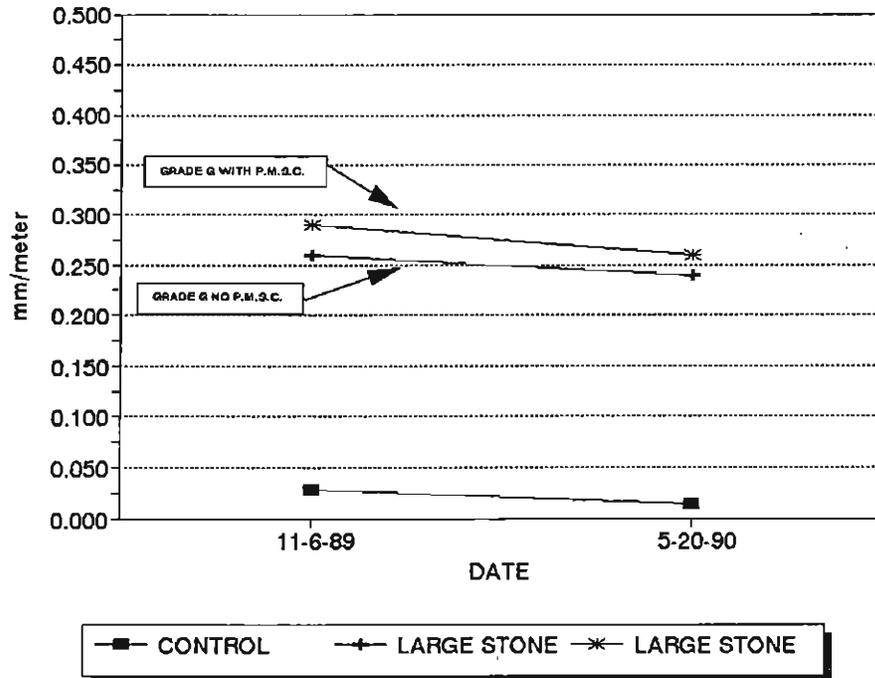
Figure 22 - I-70 Profilograph Results

Figure 22 shows the results of smoothness testing starting with November 1989 (immediately after construction), and May 1990. Testing was performed for only two years because of the premature rehabilitation during the summer of 1990. Figure 22 shows that placing a smooth mat with the large-stone HMA was difficult. The large-stone HMA after construction showed 260mm and 290mm per kilometer, where the control section (Grading C) was constructed with a Profilograph reading of 28mm per kilometer.

* Surface Coat (P.M.S.C.) was removed 10/10/90 preventing further profile testing.

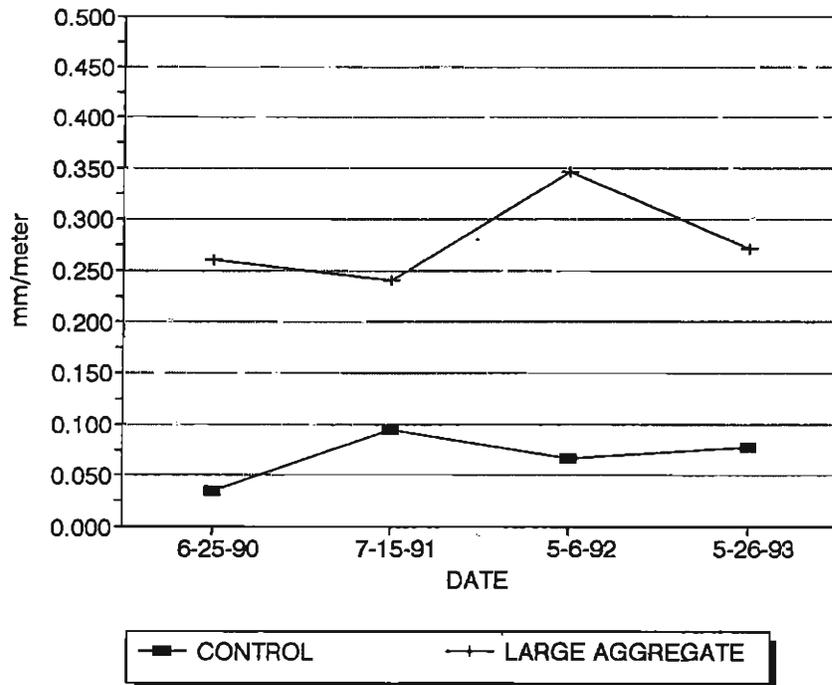
Figure 23 - SH-14 Profilograph Results

Figure 23 shows the results of smoothness testing starting immediately after construction with yearly testing for the following three years. This figure shows similar results to that seen on the I-70 site. Immediately after constructing the test section (Grading G), it showed 260mm per kilometer, well above the maximum 1994 CDOT specification. Corrective work and disincentive pay would be required. The control section (Grading E) was placed very smoothly at 35mm per kilometer. The contractor would be awarded an incentive.

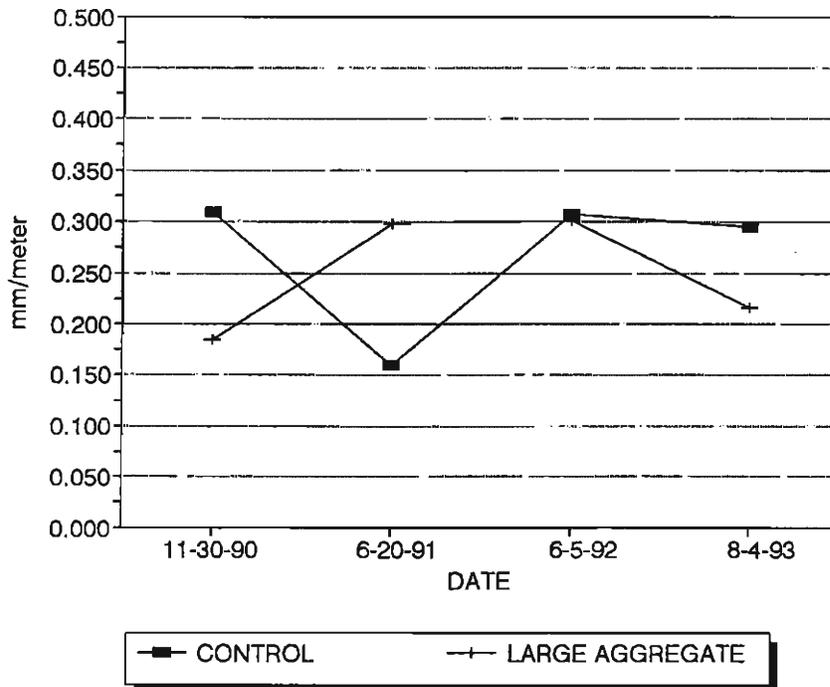
Figure 24 - SH-40 Profilograph Results

Figure 24 shows the results of smoothness testing immediately after construction starting in 1990 and continuing for a three year period. Once again it can be seen that the test section (Grading G) was not smooth immediately following paving. The large-stone HMA section showed 309mm per kilometer after construction. Corrective action and disincentive pay would be required. The control section (Grading C) was better at 185mm per kilometer. The contractor would be assessed a disincentive, but no corrective action would be required. Neither section was acceptable when compared to the 1994 CDOT Smoothness Specification. The smoothness did not improve with time.
