Colorado Procedure 79-22

Standard Practice for

Evaluating MIT Scan Images for Dowel Bars

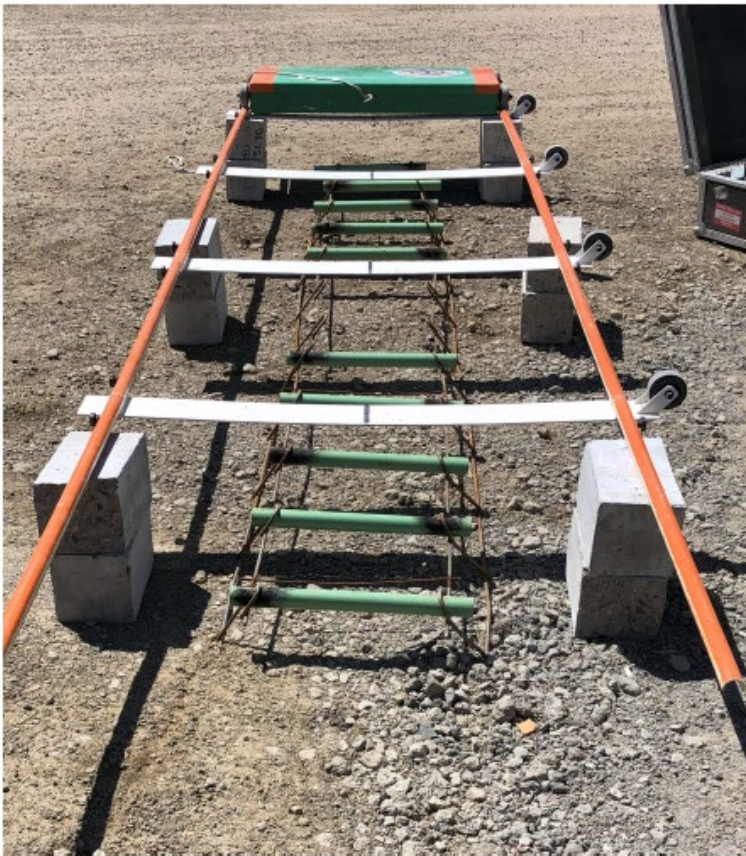
2.1 Figure 79-1 shows a properly aligned dowel basket under the MIT Scan-2 tracks. Figure 79-2 shows the corresponding MIT Scan-2 image map. This joint would be accepted without requiring corrective work.

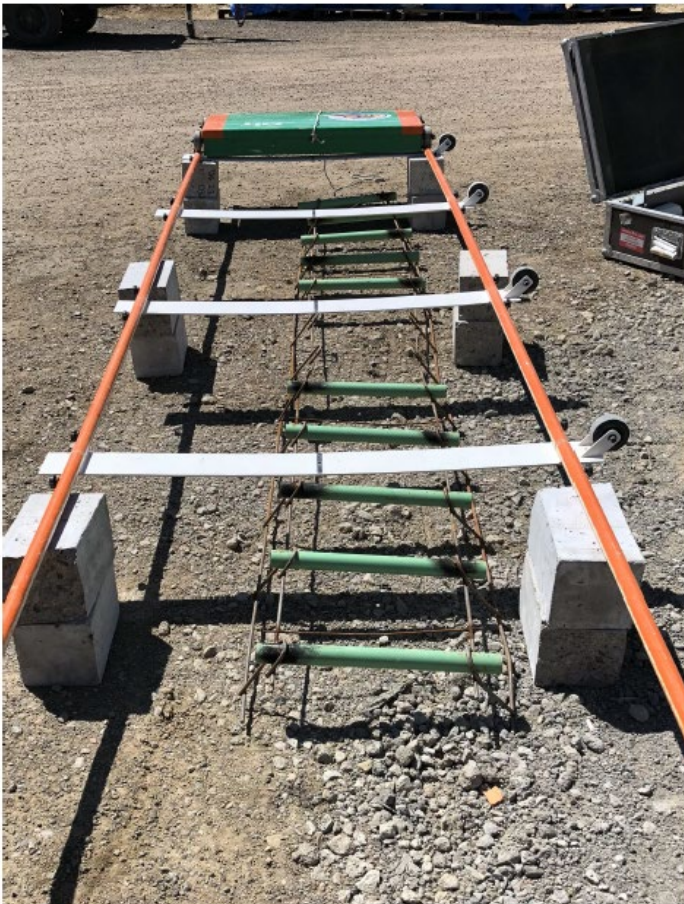
2.2 Figure 79-3 shows a basket that is not centered on the saw cut joint but otherwise aligned. The saw cut is indicated by the black line on the MIT Scan-2 tracks. Figure 79-4 shows the corresponding MIT Scan-2 image map. Further investigation of this joint with cores or a pachometer should be conducted to determine if the minimum 6 inches of embedment on each side of the joint is achieved. If 6 inches of embedment on each side of the joint is not achieved, the joint is rejected and requires corrective work.

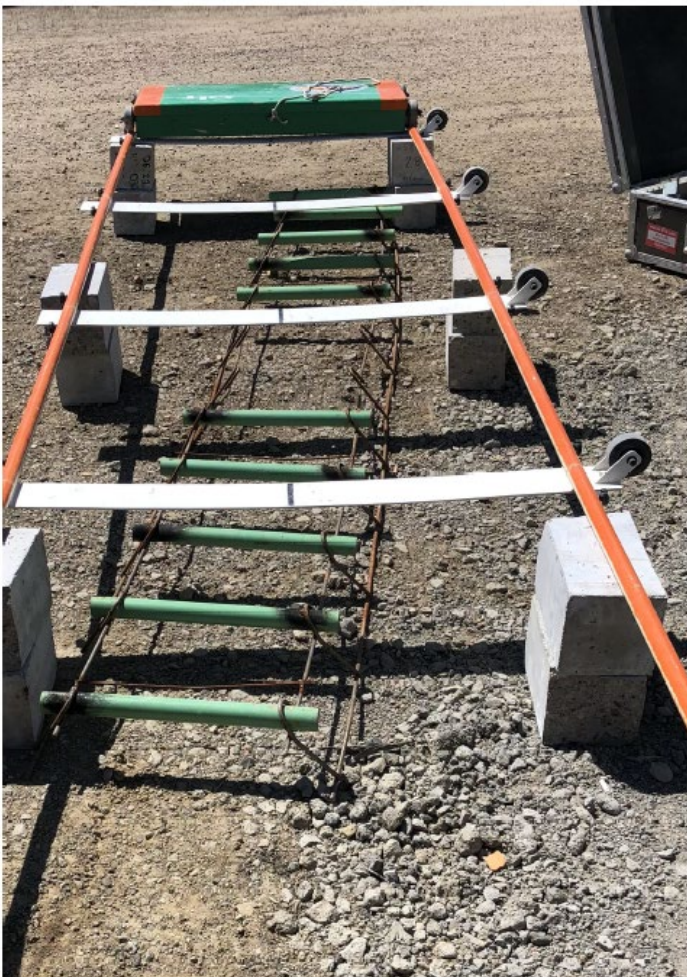
2.3 Figure 79-5 shows a skewed basket to the saw cut joints. The saw cut is indicated by the black line on the MIT Scan-2 tracks. Figure 79-6 shows the corresponding MIT Scan-2 image map. This joint should be further evaluated to determine if the saw cut is skewed and the basket is properly aligned or if the saw cut is correct and the basket is skewed. If the saw cut is skewed and the bars are properly aligned and each bar has the minimum embedment on each side of the saw cut, the joint can be accepted, otherwise, it is rejected and corrective work must be performed. If the saw cut is correct, this would be a locked joint and would require corrective work if adjacent joints are also locked.

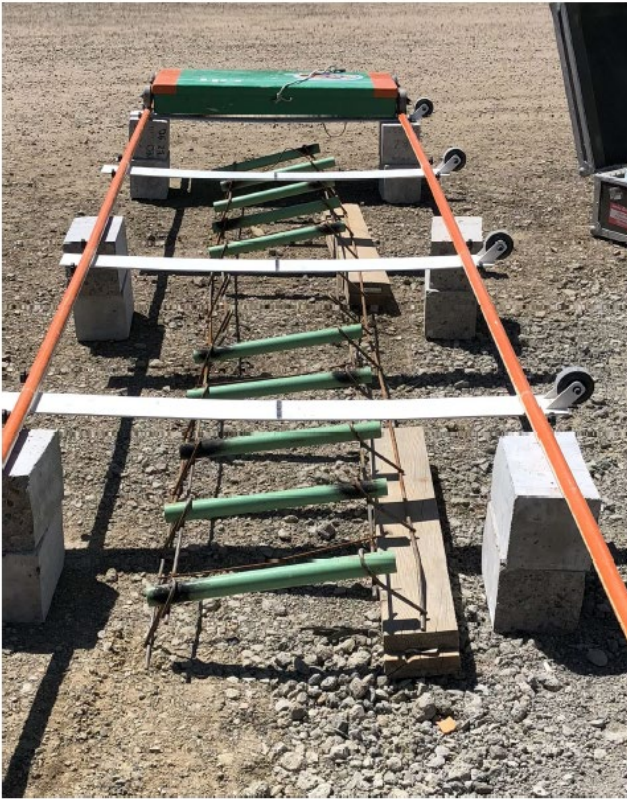
2.4 Figure 79-7 shows a basket that has been tilted. Figure 79-8 shows the corresponding MIT Scan-2 image map. This joint should be further evaluated by coring or a pachometer to determine the overall rotational misalignment of each bar. A joint score can be used to determine the acceptability of the joint using the criteria in subsection 412.13 and if corrective work is required. A single joint like this can be left in place without corrective work if the adjacent joints are correct and there is the required minimum cover above and below the dowel bars. Otherwise the joint requires corrective work.

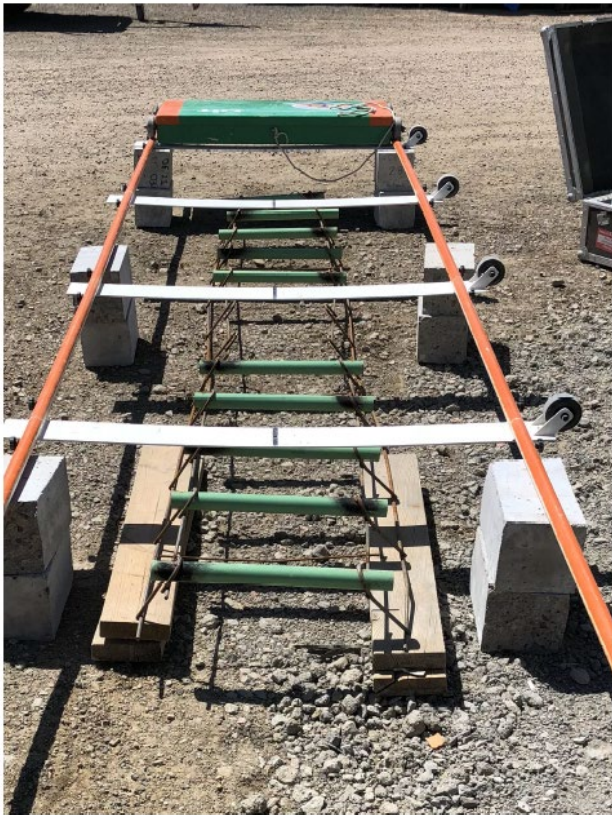
2.5 Figure 79-9 shows a basket that is deeper on one end than the other but is otherwise aligned. Figure 79-10 shows the corresponding MIT Scan-2 image map. This joint should be further evaluated by coring or a pachometer to determine if there is the required minimum cover above and below the dowel bars. If there is the proper cover above and below the dowel bars, the joint can be accepted, otherwise, corrective work would be required.

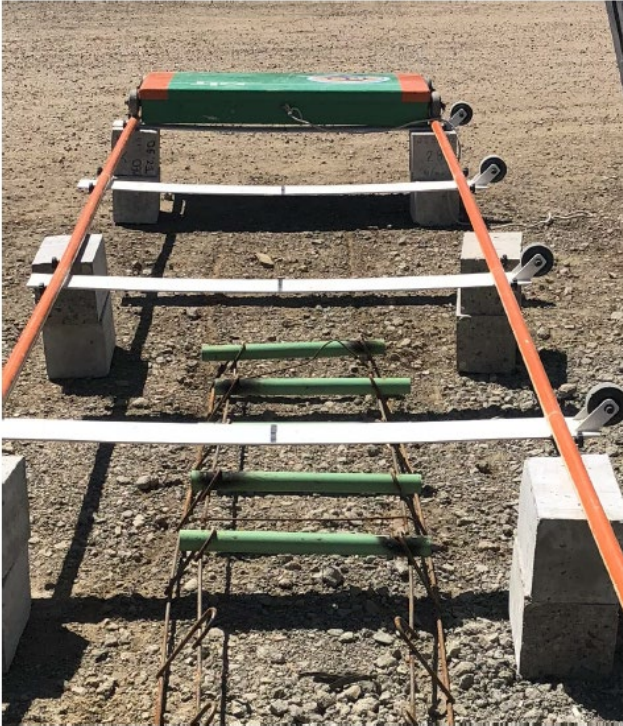
2.6 Figure 79-11 shows a basket that is only on one wheel path. Figure 79-12 shows the corresponding MIT Scan-2 image map. The top half of the MIT Scan-2 image map shows what a joint with no bars would look like. This joint requires corrective work to install the missing bars
