4.19 GEOLOGY, SOILS, AND MINERAL RESOURCES

4.19.1 AFFECTED ENVIRONMENT

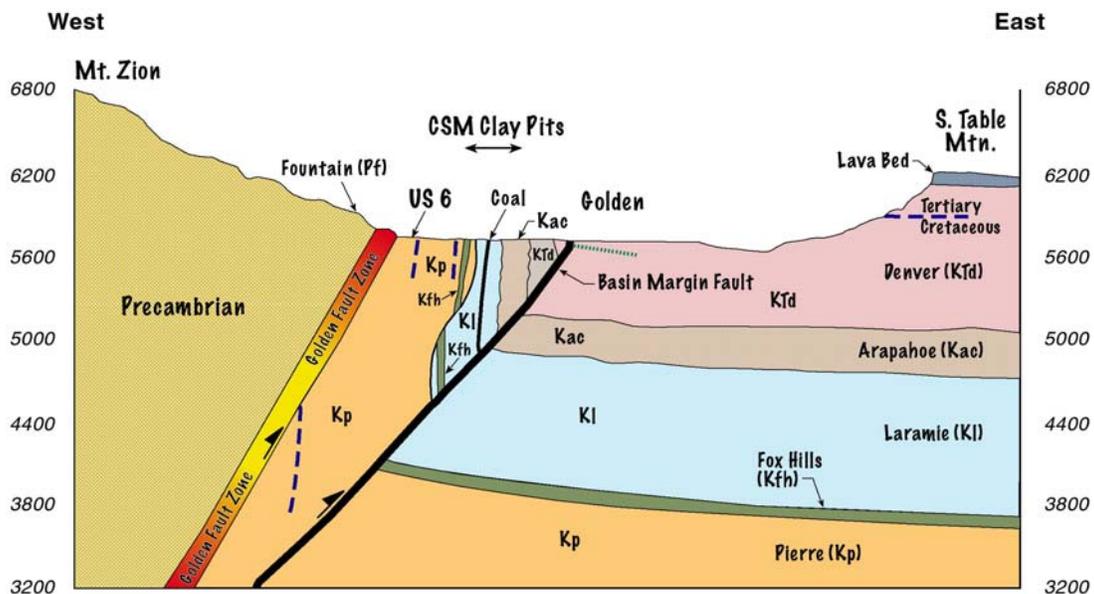
Figure 4.19-1 Cross-Section of Front Range near Golden

The study area lies along the eastern edge of the Rocky Mountain Front Range and the adjacent western edge of the Denver Basin. A representative diagram of geology in the study area shows a fault zone along the mountain front with eastward steeply dipping sedimentary rock layers into the Denver Basin (see **Figure 4.19-1**). A few miles to the east, the sedimentary rock layers are nearly horizontal. The configuration of the fault system varies along the mountain front. Nonetheless, steeply dipping sedimentary rocks near the mountain front, interrupted by faulting, and tilted, much less steeply sloping sedimentary rocks within a short distance to the east of the mountain front, are typical in the study area.

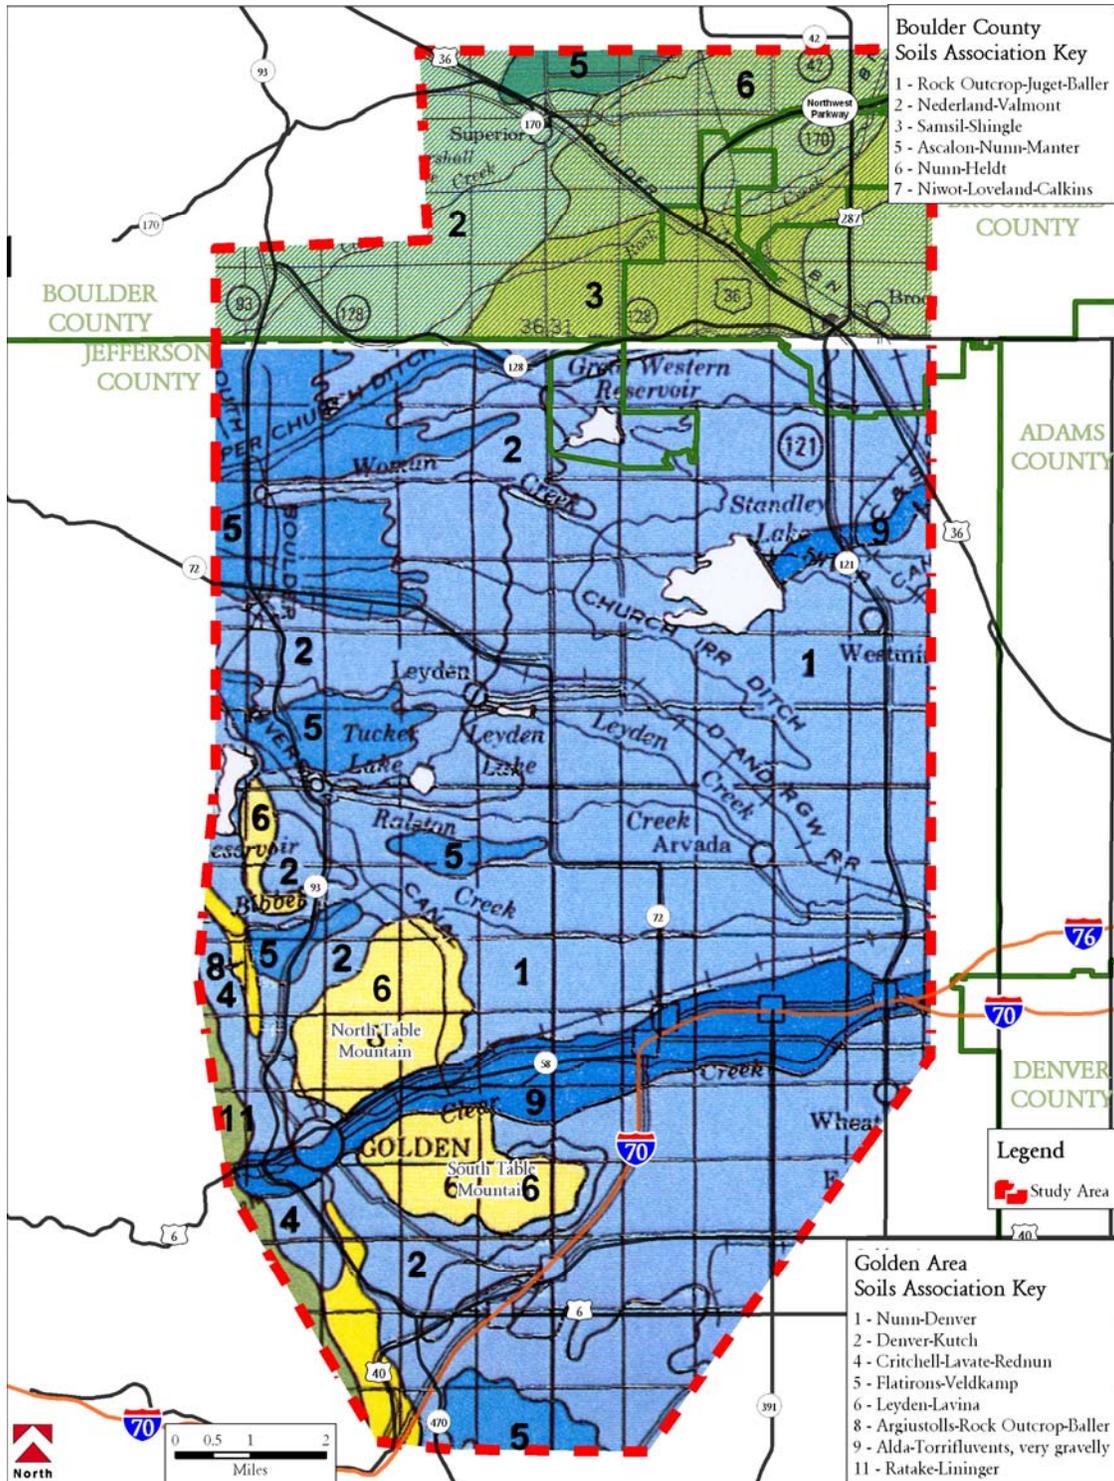
Figure 4.19-2 Soil Associations

Twelve soil associations are representative of soils in the study area (see **Figure 4.19-2** and **Table 4.19-1**). Physical and chemical characteristics for the major soils are compiled (see **Table 4.19-1**). Many area soils have high shrink-swell potential, a consideration for all construction. All of these soils are moderately to highly corrosive to uncoated steel, and some are moderately corrosive to concrete. Some have seasonally high water tables, and some are highly susceptible to erosion. Higher quality agriculturally suitable soils are found along the bottoms of many valleys where irrigation is possible. Soils on drier surfaces and on most slopes are generally shallow and of little agricultural value.
