**SH 7A (Lower)
Raymond to Lyons
Site Repairs between Mileposts 19 and 33**

**Boulder County
COLORADO**

Damage Assessment Report

**100% DRAFT
Revised: July 28, 2014**

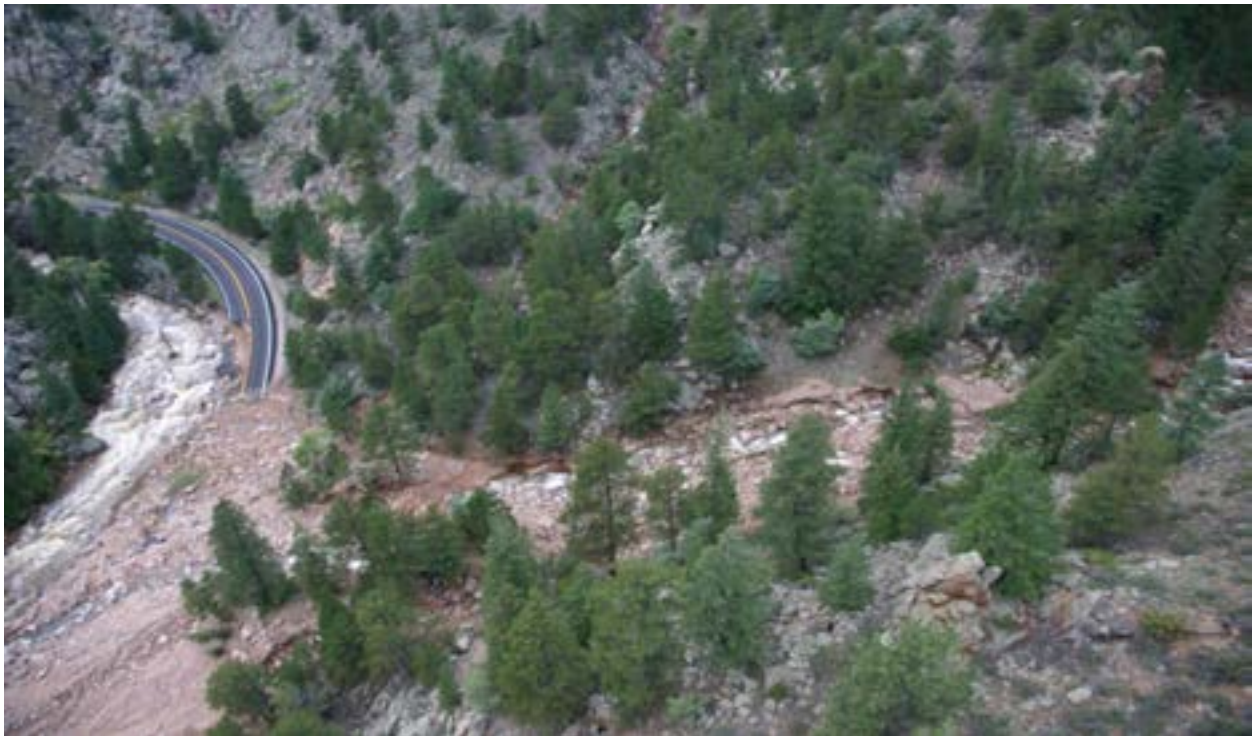
Figure 29 - MP 24.75, Rock slide covering roadway lanes. Embankment and roadway washout.

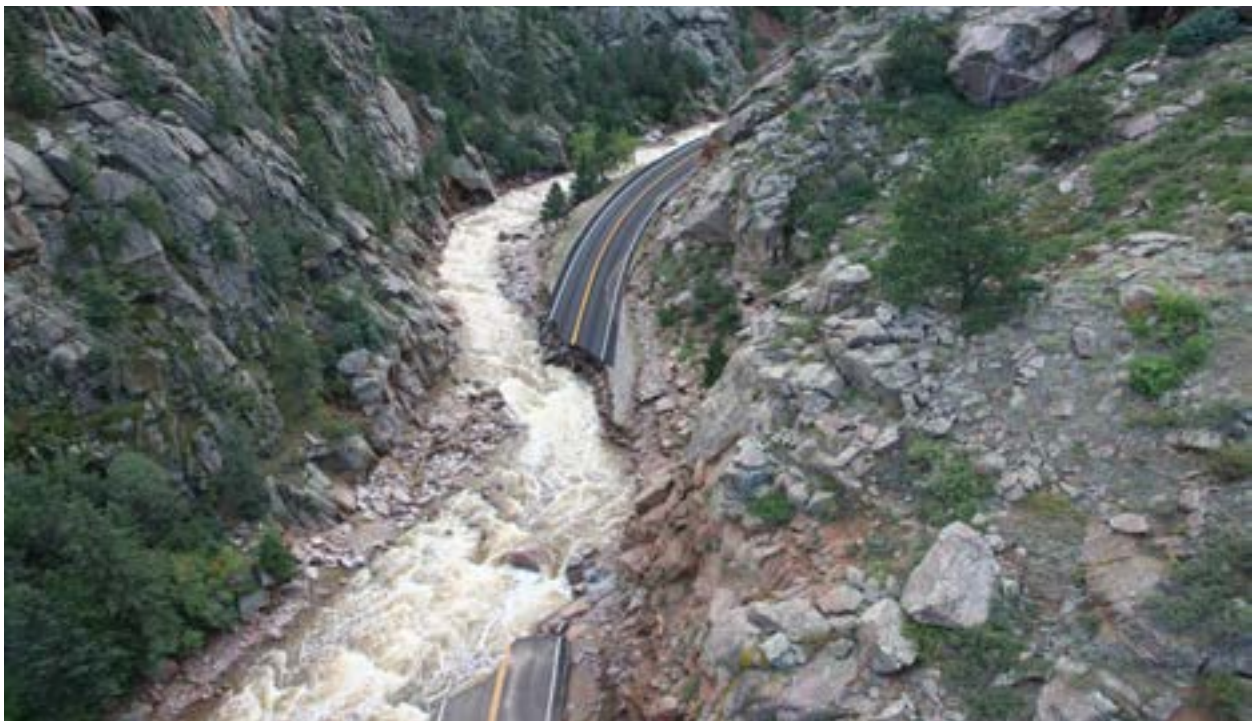
Figure 35 - MP 26.9, Complete roadway loss due to overtopping at the river bend
